Michelucci & Associates, Inc.
Geotechnical Consultants

ATTACHMENT 6-F

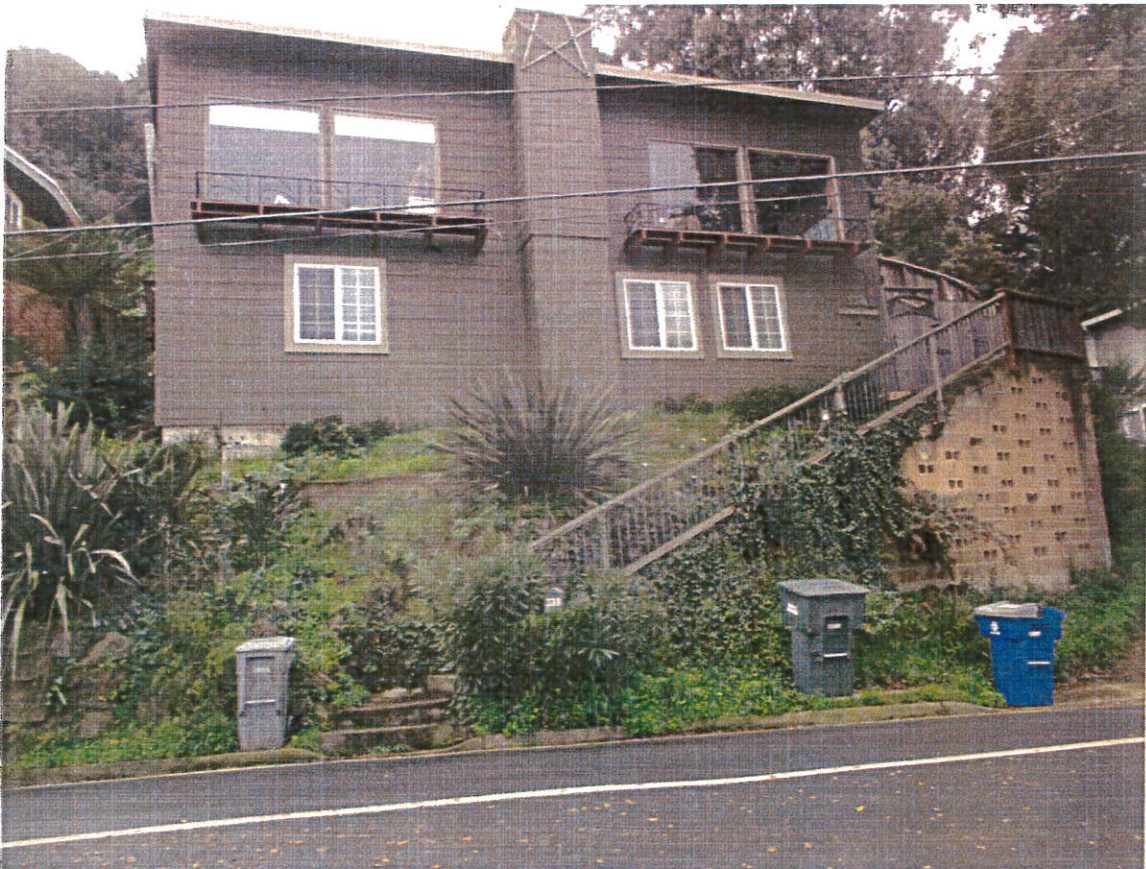
Photo 1: View of the front of the residence from Kings Road. The garage addition is planned on the right side of the residence (on the right side of the photo).

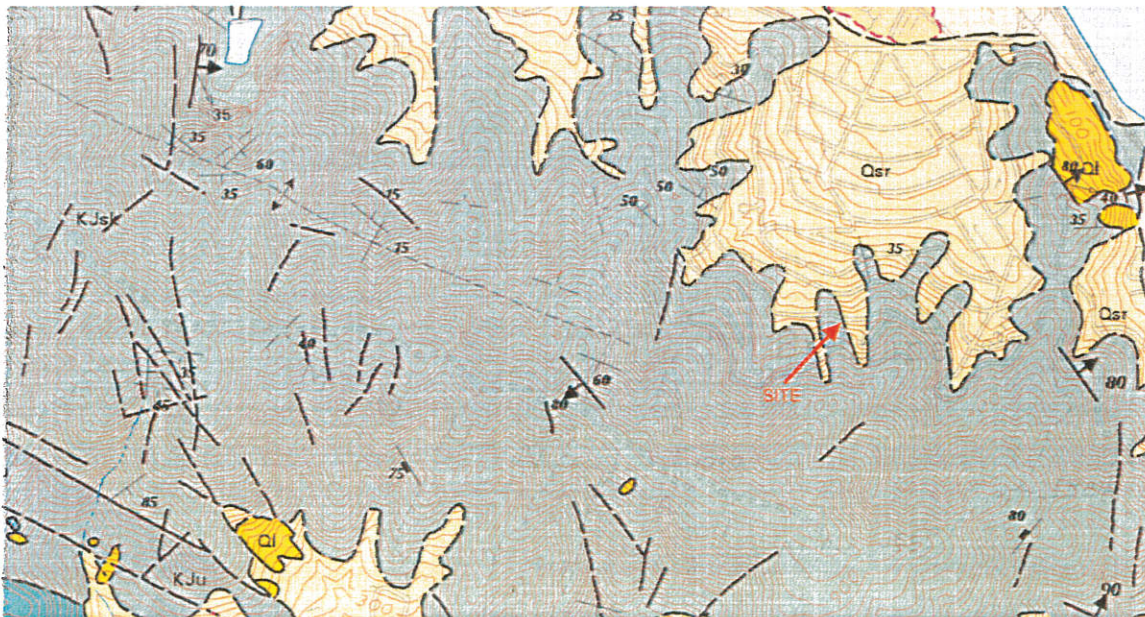
The site has been mapped by Brabb, Graymer and Jones (1998) and Bonilla (1998) to be underlain by Franciscan sandstone and shale (Kjsk). Brabb, Graymer and Jones describe the sandstone as *dark-gray to yellowish-brown greywacke interbedded with shale, in approximately equal amounts*. As noted, dense Franciscan sandstone was encountered in all of our test borings for the project. A scan of Bonilla's geologic map follows.

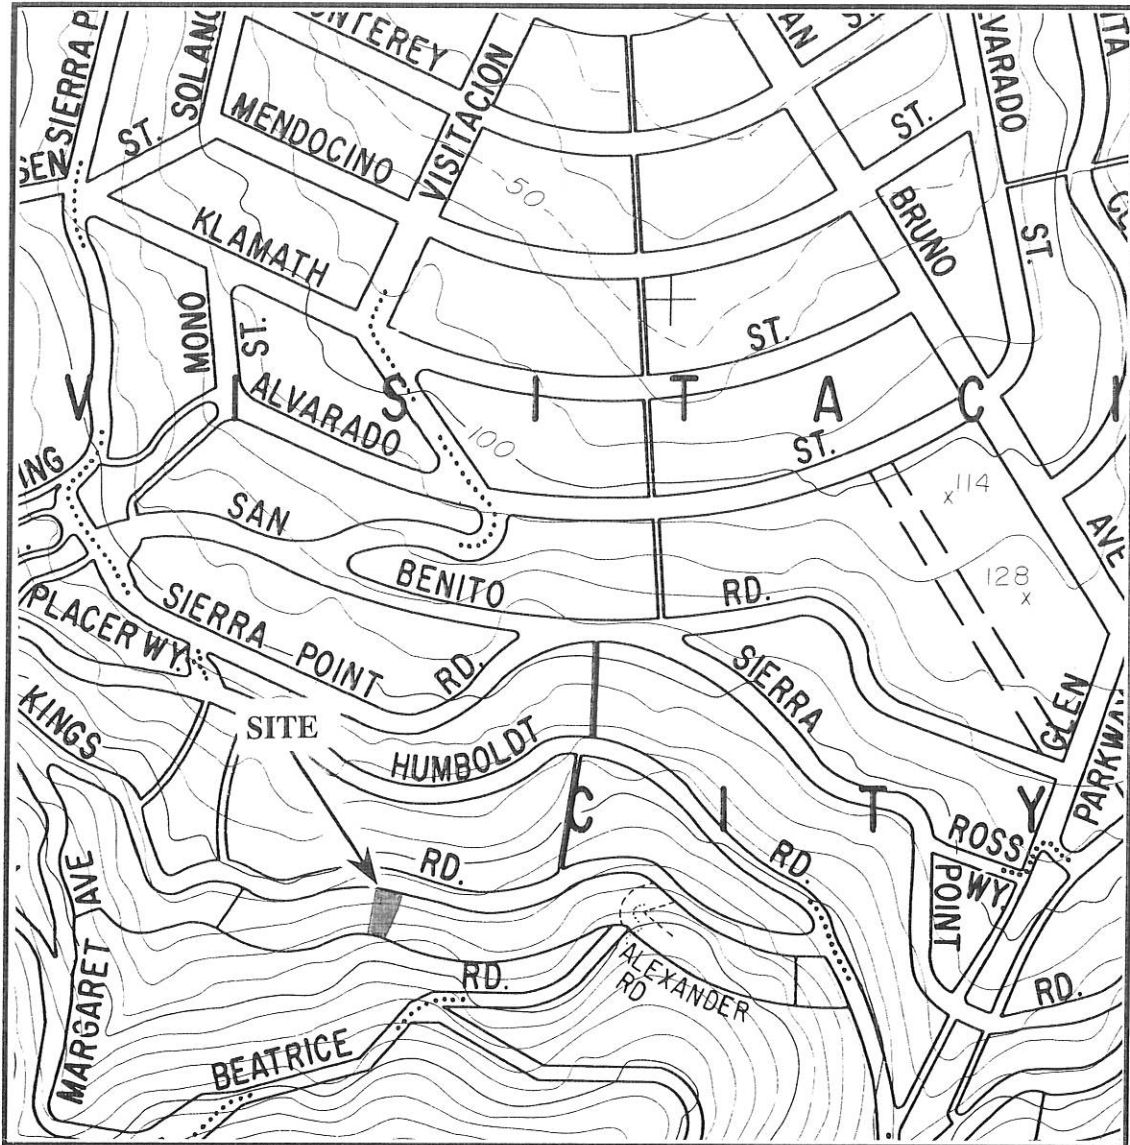
*BASE MAP FROM COUNTY OF SAN MATEO CADASTRAL TOPOGRAPHIC SERIES, SHEET 2D, 1973, (REVISED 1-1-86).

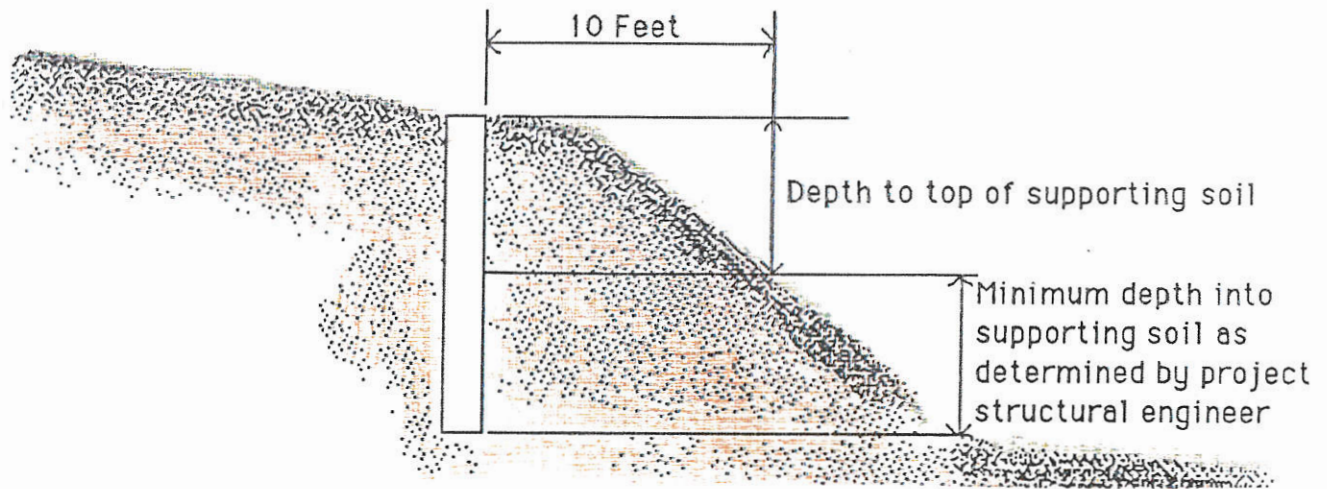
GUIDE SPECIFICATIONS FOR SUBDRAINS BEHIND RETAINING WALLS

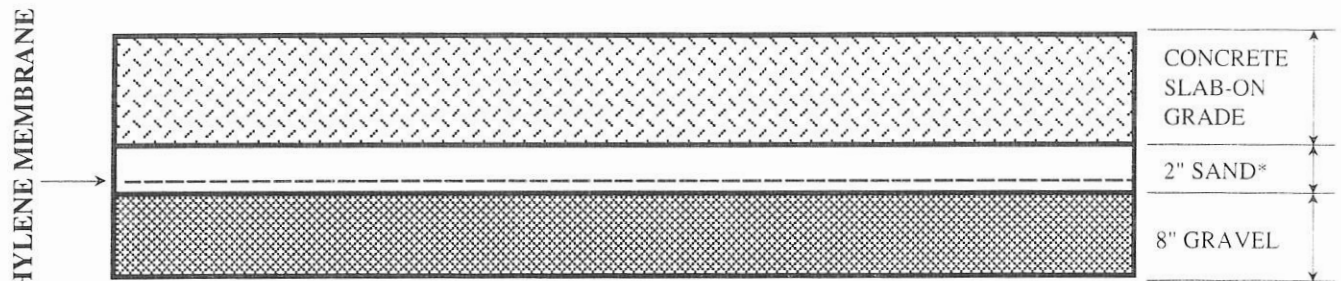
MOISTURE RETARDANT BENEATH CONCRETE SLABS
TYPICAL SECTION

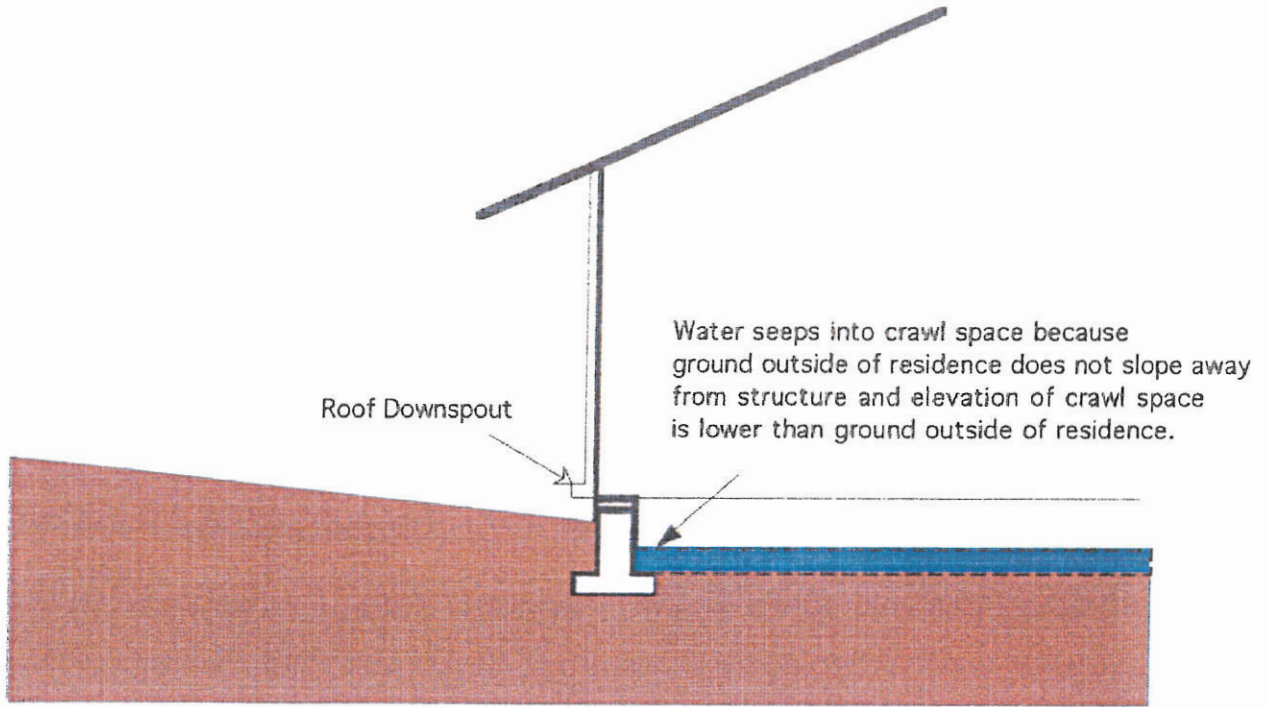
RECOMMENDED METHOD TO MITIGATE EXCESSIVE MOISTURE
