BHDC

Review of Proposed Work 50 Thames St.

Summary:

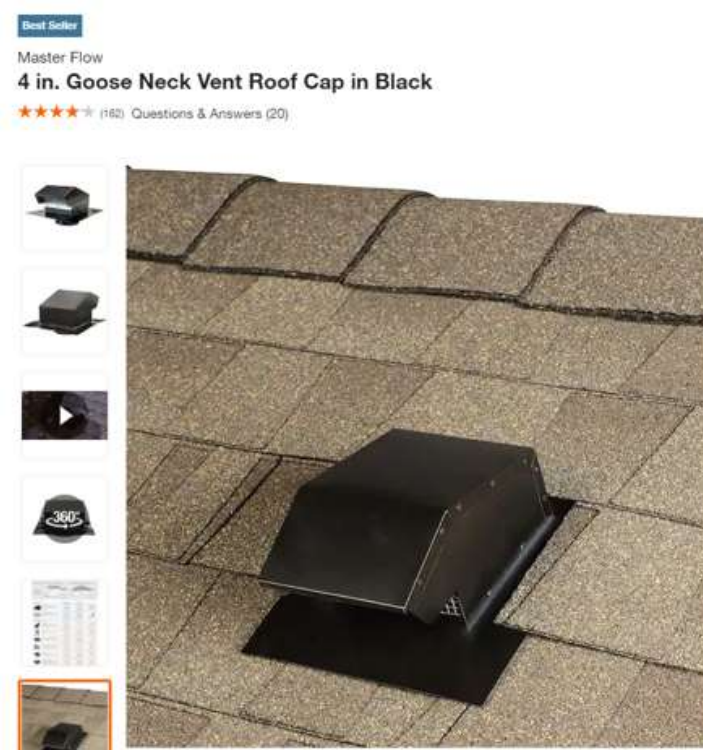
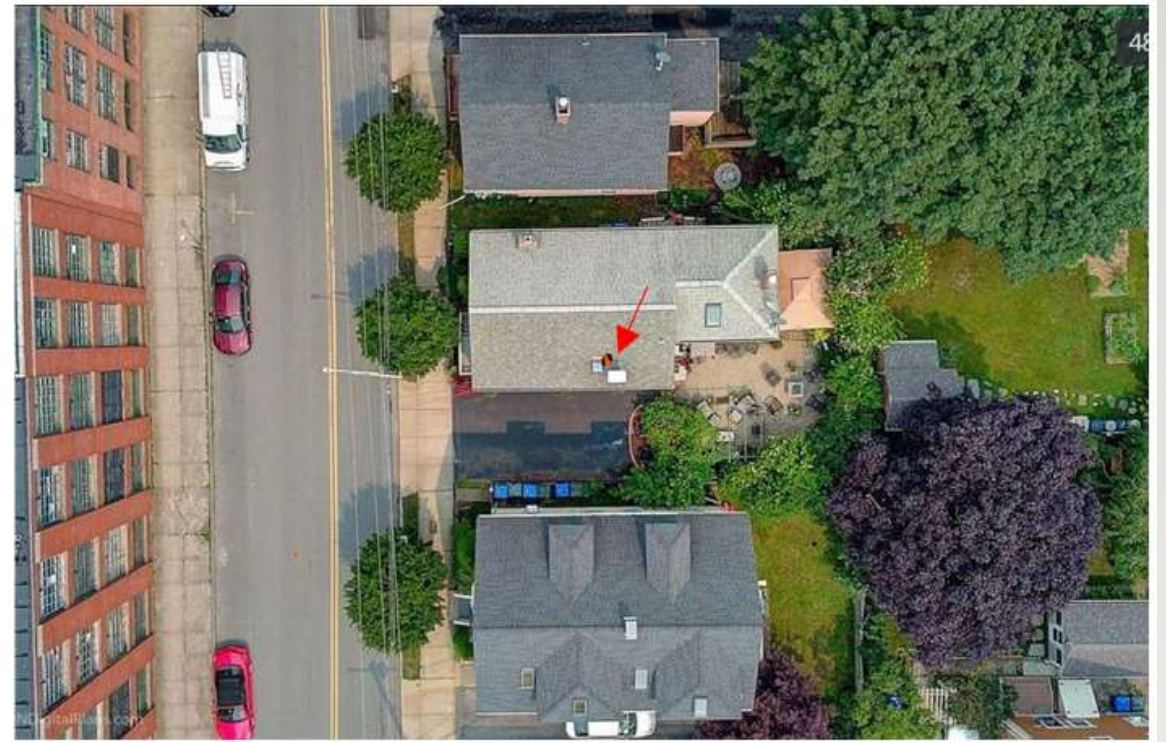
1. New bathroom vent through the roof on the South side
 - a. Currently vents into the attic space and resolution is a prerequisite before RISE will insulate it. Space identified as having subpar insulation
 - b. Mitigates mold and moisture concerns
 - c. Low profile and available

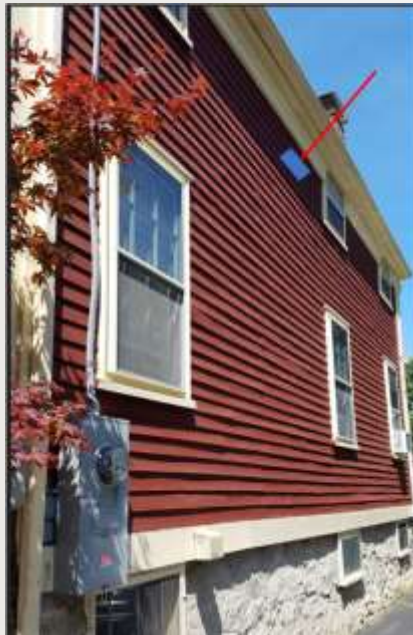
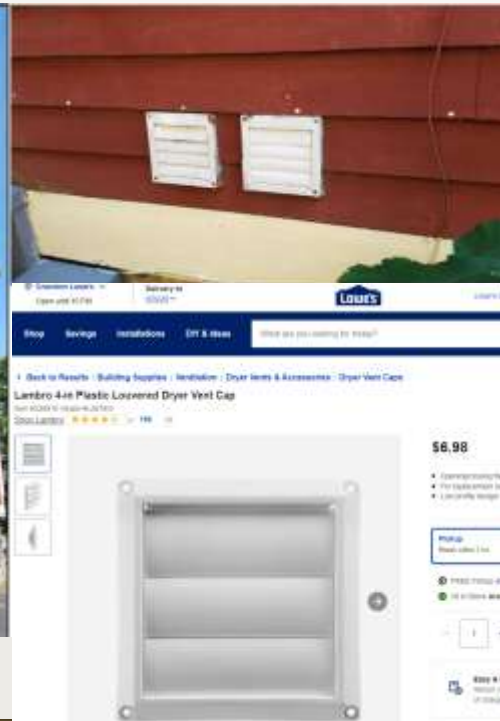
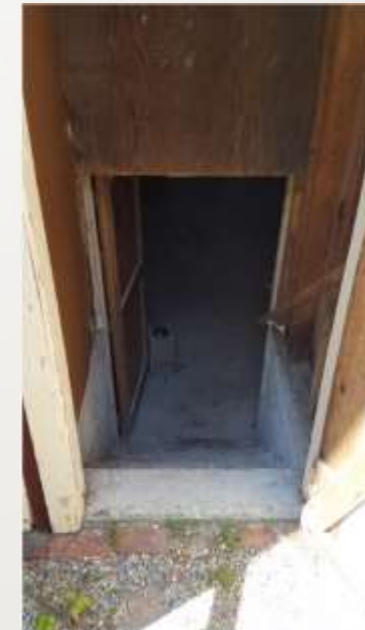
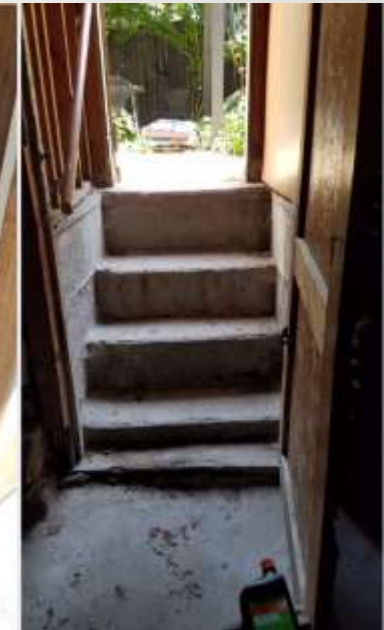
2. New dryer vent on the South face, 2nd floor
 - a. W/D are in the cellar, accessible only from the outside and along with foul weather access concerns, the stairs present a safety concern for ingress/egress
 - b. New W/D planned on the 2nd floor.
 - a. Low profile vent proposed, matching existing on the North face and can be painted to match exterior

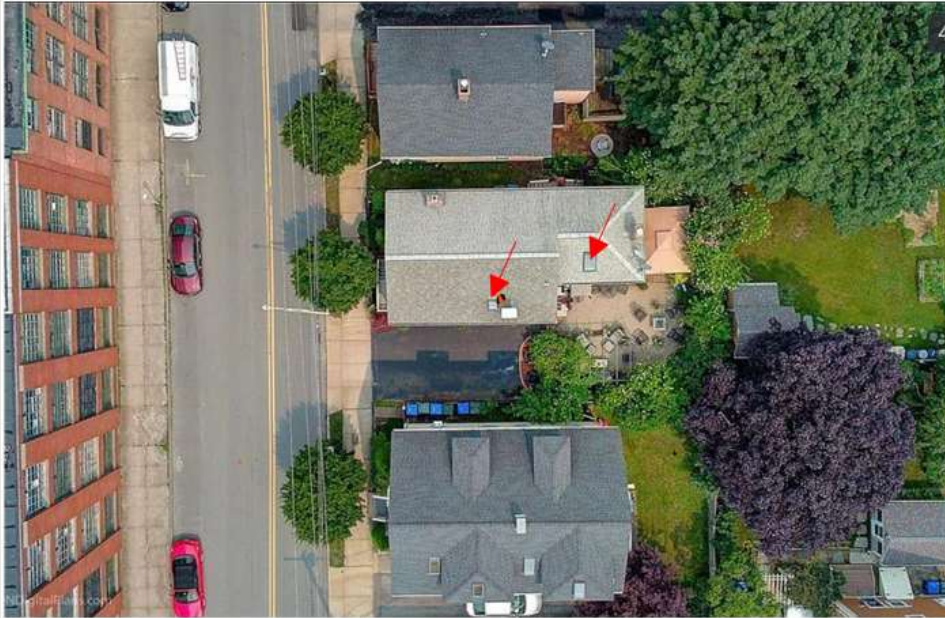
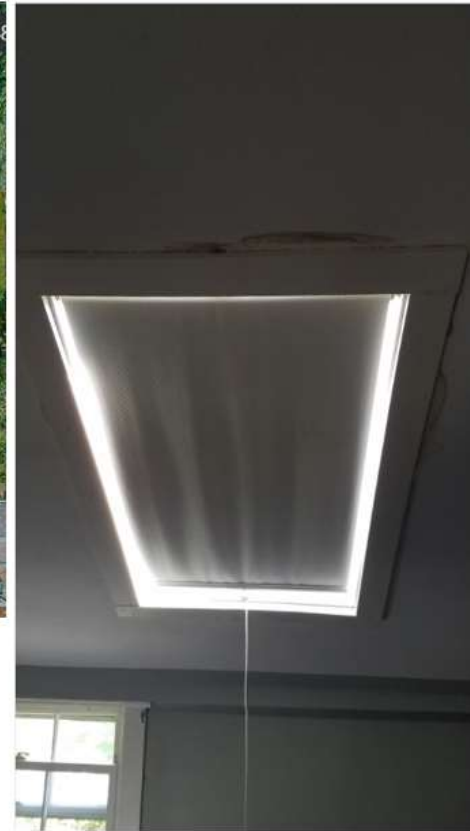
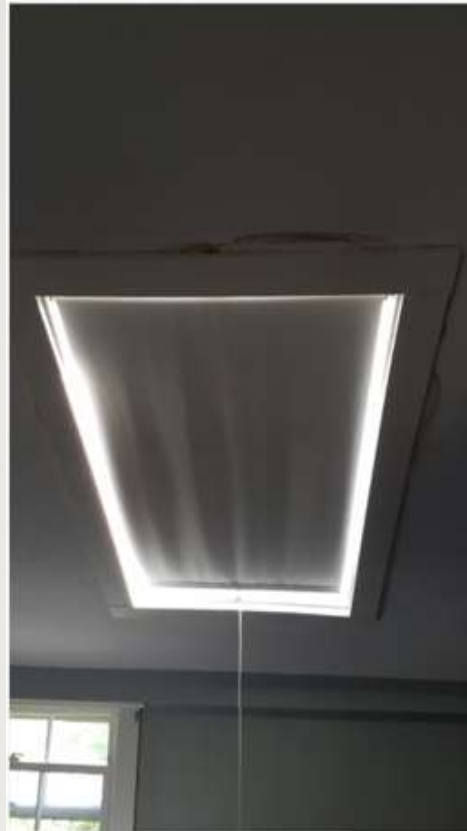
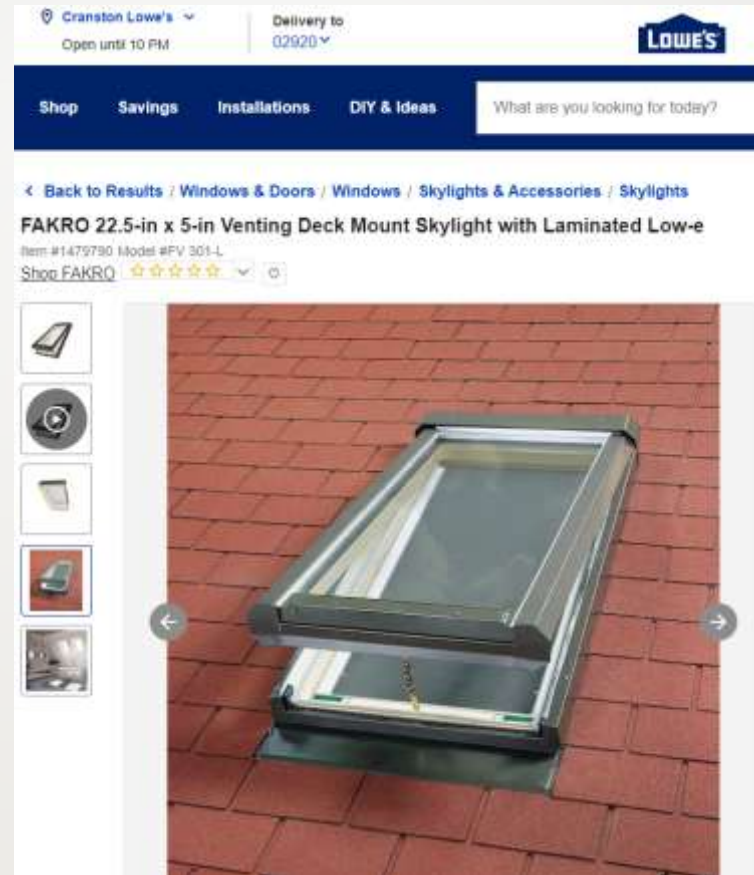
3. Replacement of existing South facing sky lights, one of which is leaking

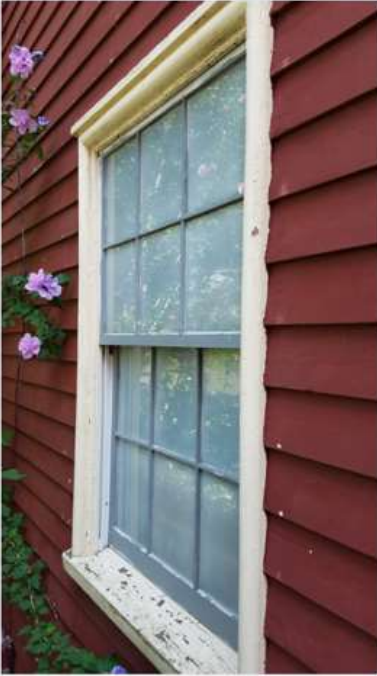
North face missing

4. Replacement of storm/screen installations on a few windows to match existing or replacement of all depending on condition of existing - aluminum product available and preferred
 - a. Preservation of sills, window glazing, benefits of storms windows and screen

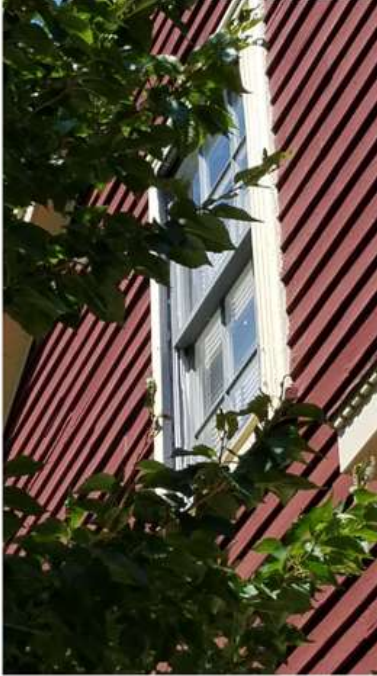
West face missing

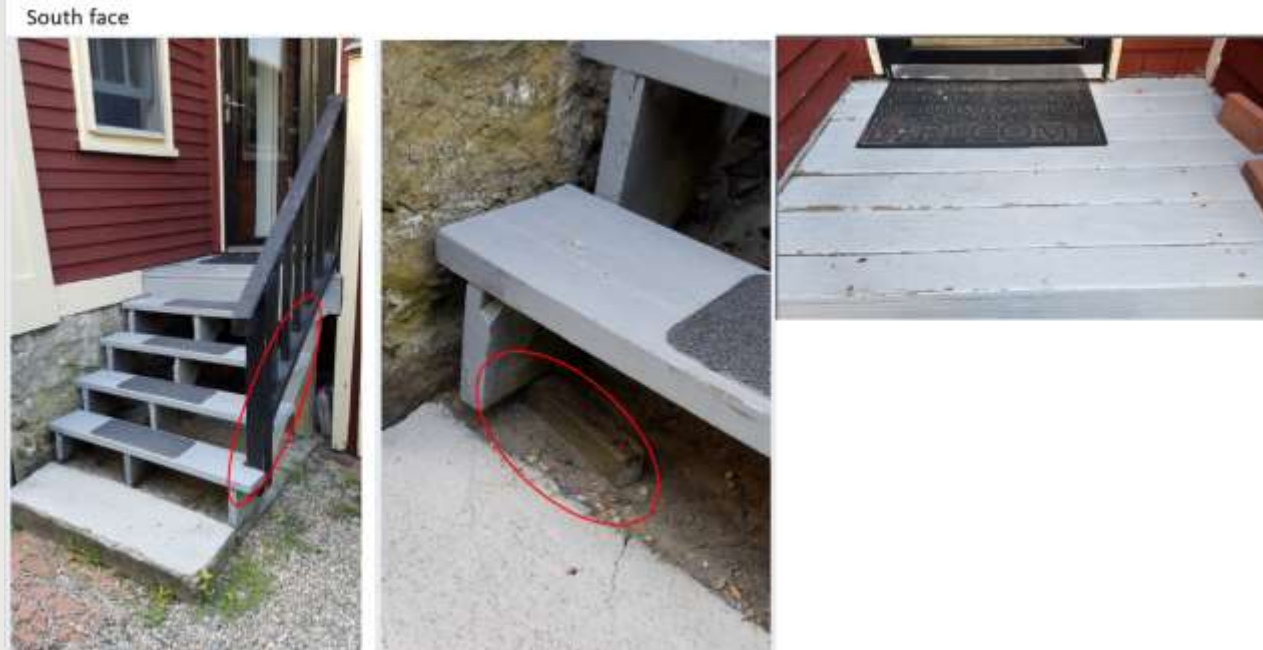
5. Repairs / stabilization of stairs - South
 - a. South face presents a safety concern
 - i. Some balusters not attached, deck deteriorating and not secured, frame not properly set
 - ii. Propose repairs and risers installed for stability and aesthetics

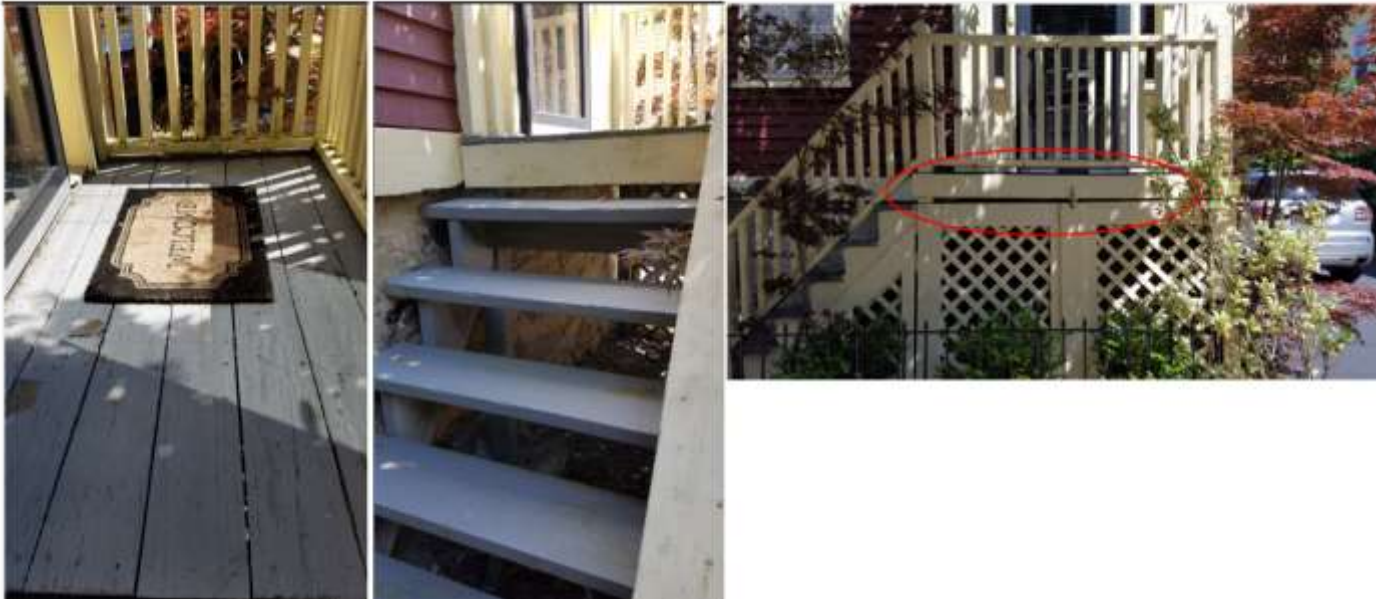
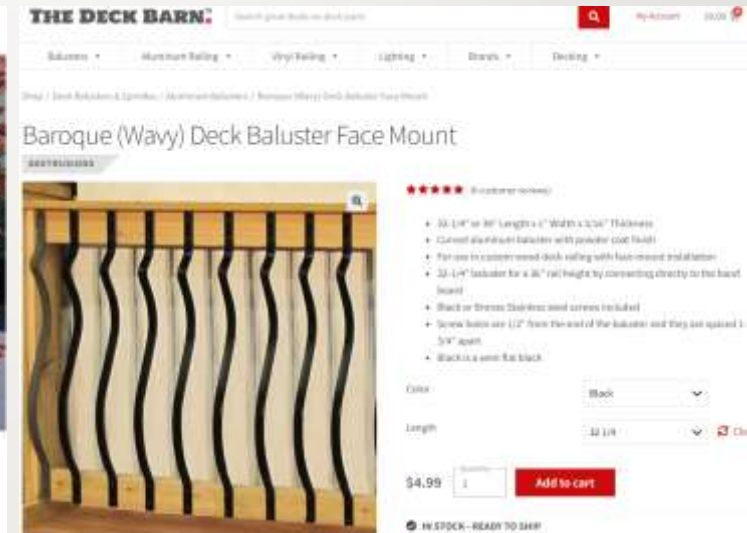
West face

5. Repairs / stabilization of stairs - West
 - a. West side stabilization
 - i. Deck deteriorating and not secured
 - ii. Propose repairs and risers installed for stability and aesthetics
 - iii. Realign gate
 - iv. Installation of aluminum balusters to enhance aesthetics

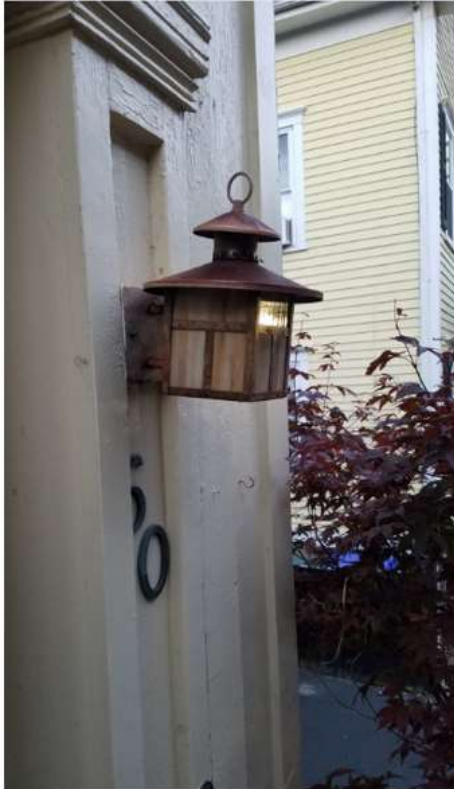
West

6. Replacement of exterior lighting on West, South face
 - a. Both fixtures are older, loose, a potential electrical safety hazard and in need of replacement.
