474 and 484 Thames St Bristol RI Page 5

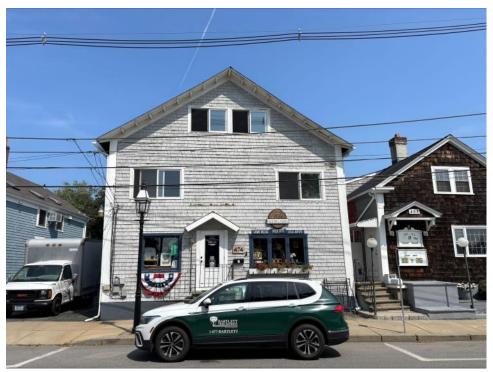
Front of building showing gable end view. Previous owner had replaced with vinyl sliding windows. Looking to replace with Pella wood clad 6/6 double hung windows to look more to the original windows.

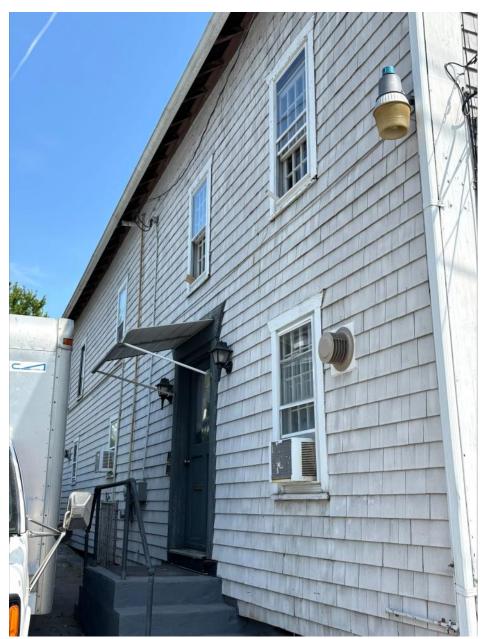
Left side view along driveway, windows are in poor condition, many rotted and/or inoperable. Looking to replace with Pella wood clad 6/6 double hung windows.

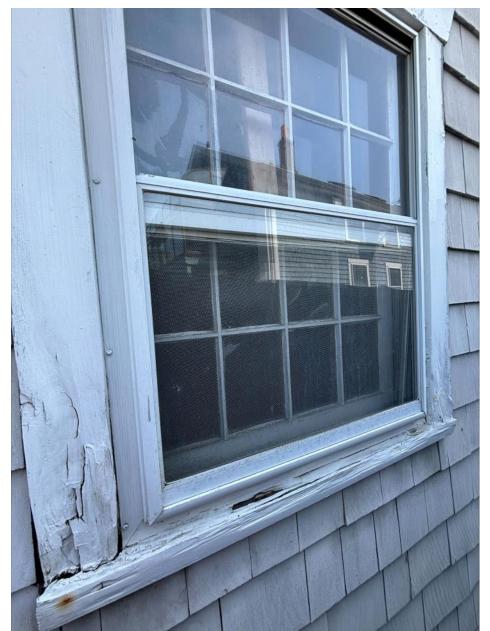
View of one of many rotted windows in poor condition.

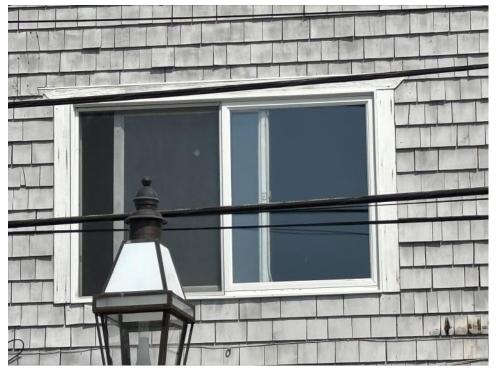
Close up view of existing vinyl windows.

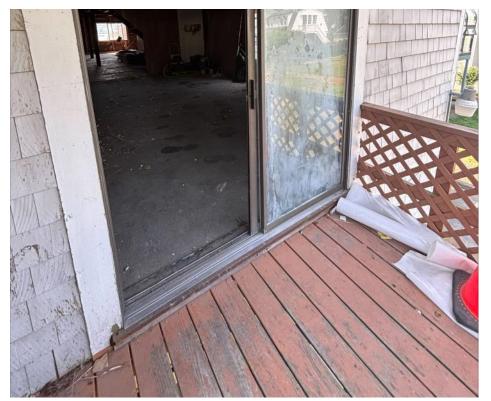
Existing rear sliding door. Looking to replace with 36" French door 9 lite.

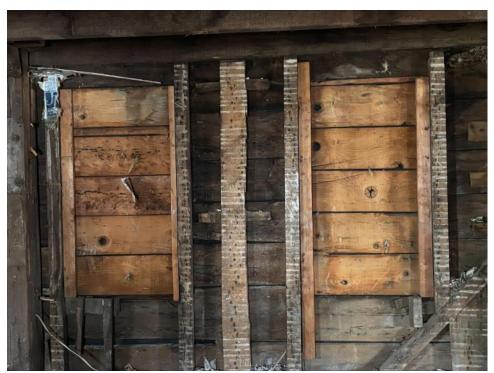
Evidence of original windows along the right side of the house that were previously boarded up. 6 on 1st floor, 6 on second floor. Proposing to reinstall with matching Pella wood clad 6/6 double hung windows. Same size and style windows as the left and rear sides.

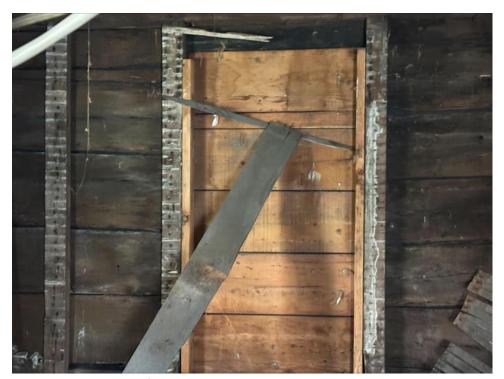
Another view of previously boarded up window.

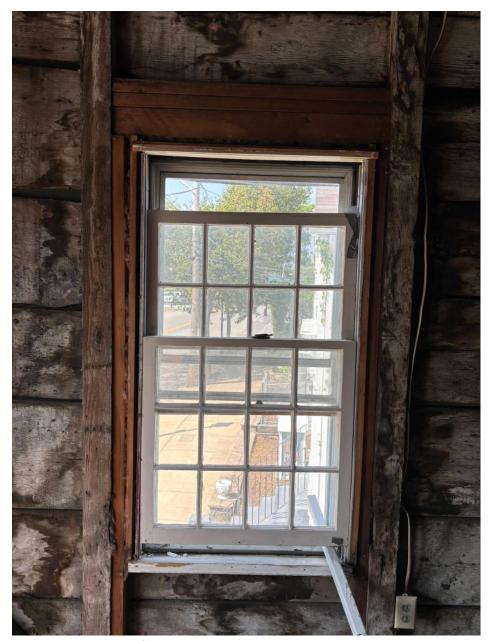
Interior view of existing windows. These windows are not original to the house.

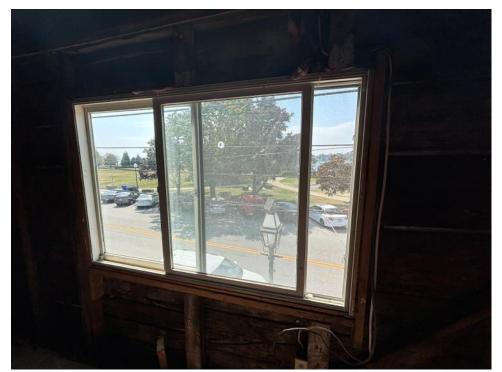
Interior view of existing vinyl sliders. Proposed to replace with Pella wood clad 6/6 double hung windows.
