CRITICAL AREA REPORT FOR PARCEL # 253124-000

Submitted to: City of Camas

Camvest GM LLC 7905 NE 173rd Ave Vancouver WA 98682

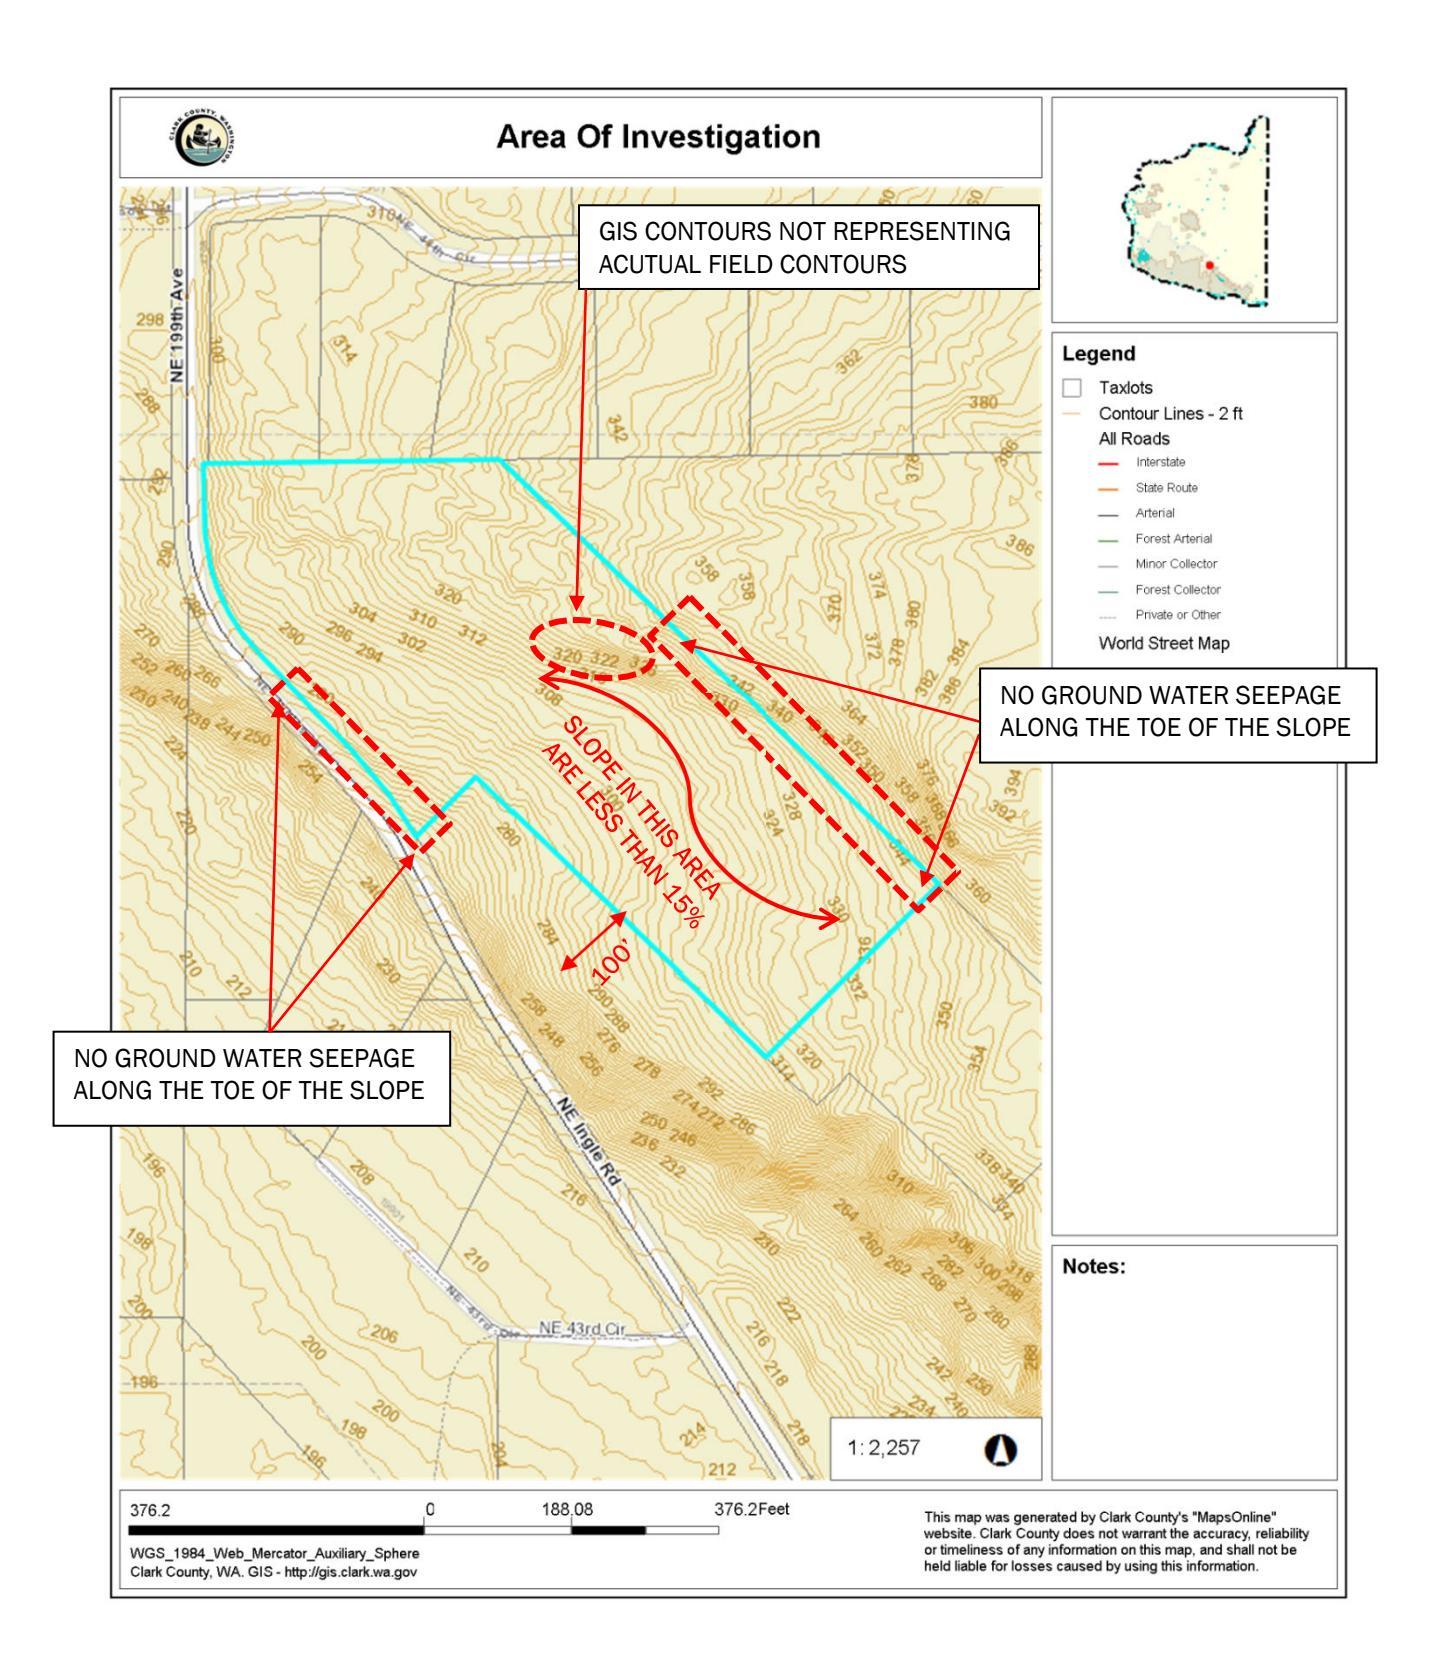
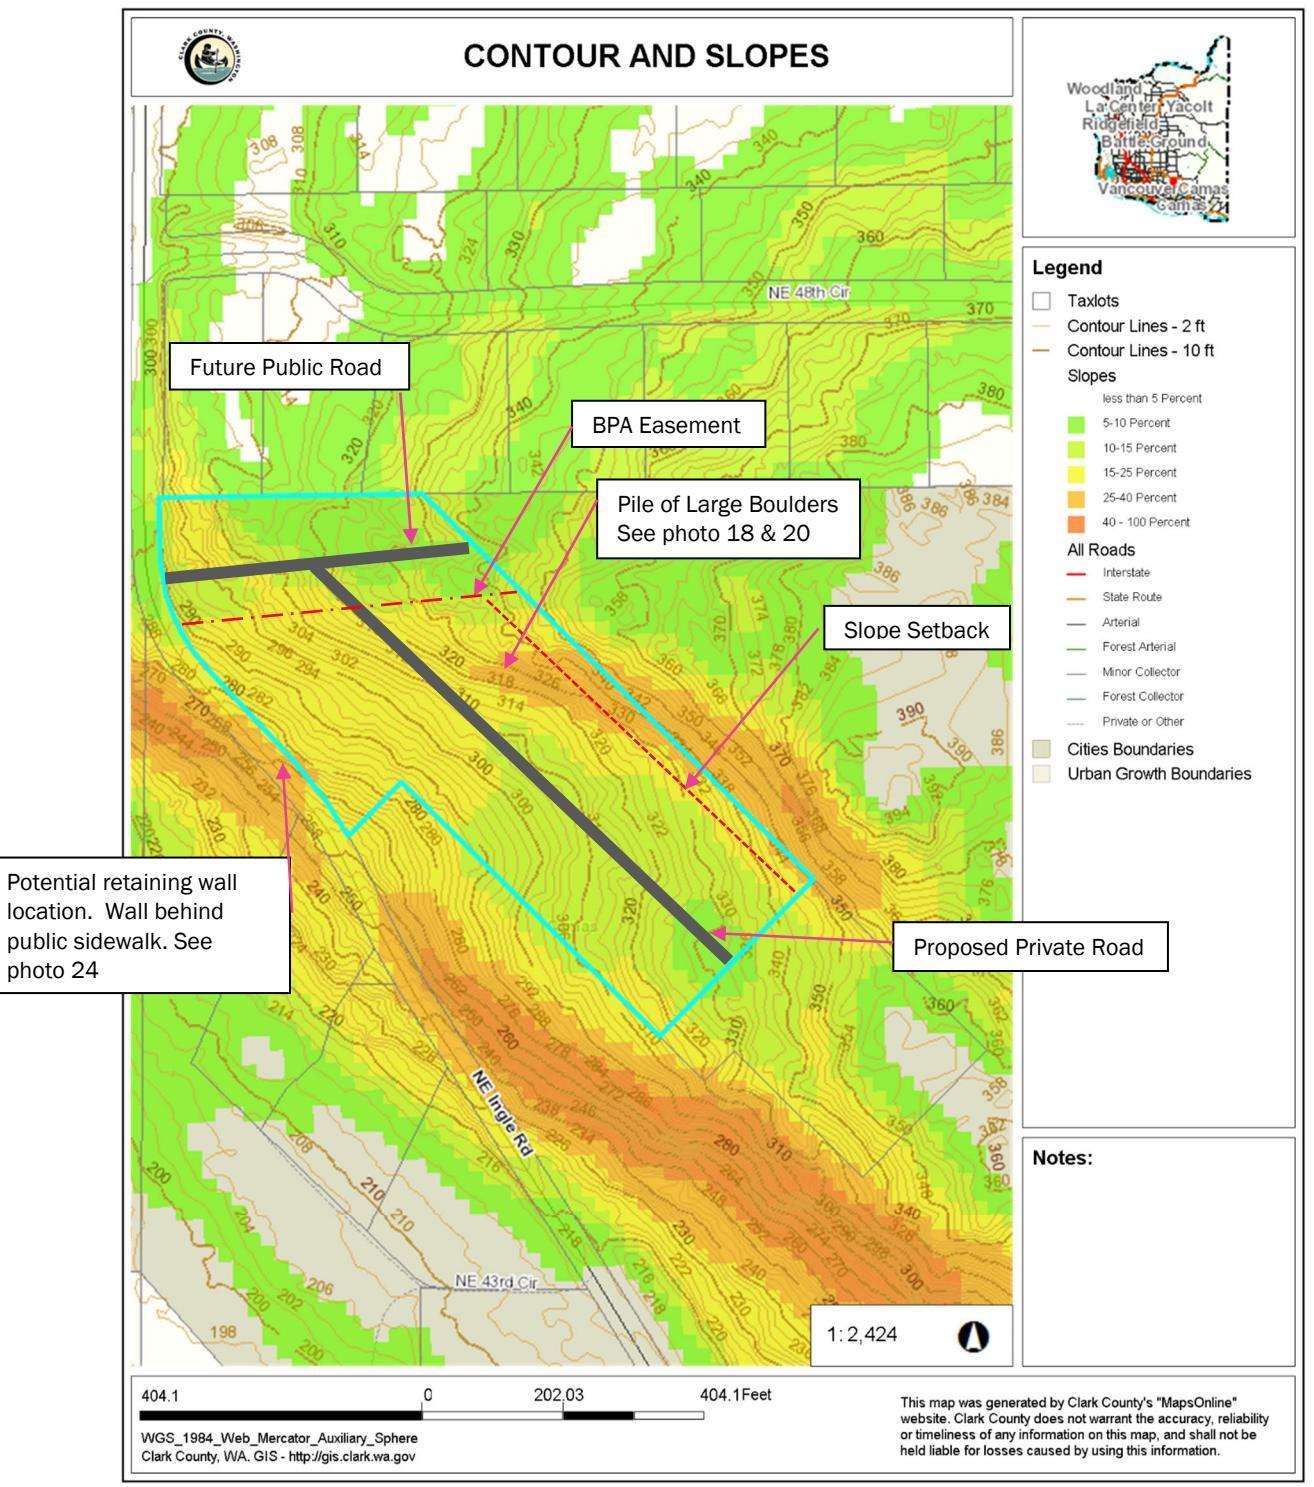
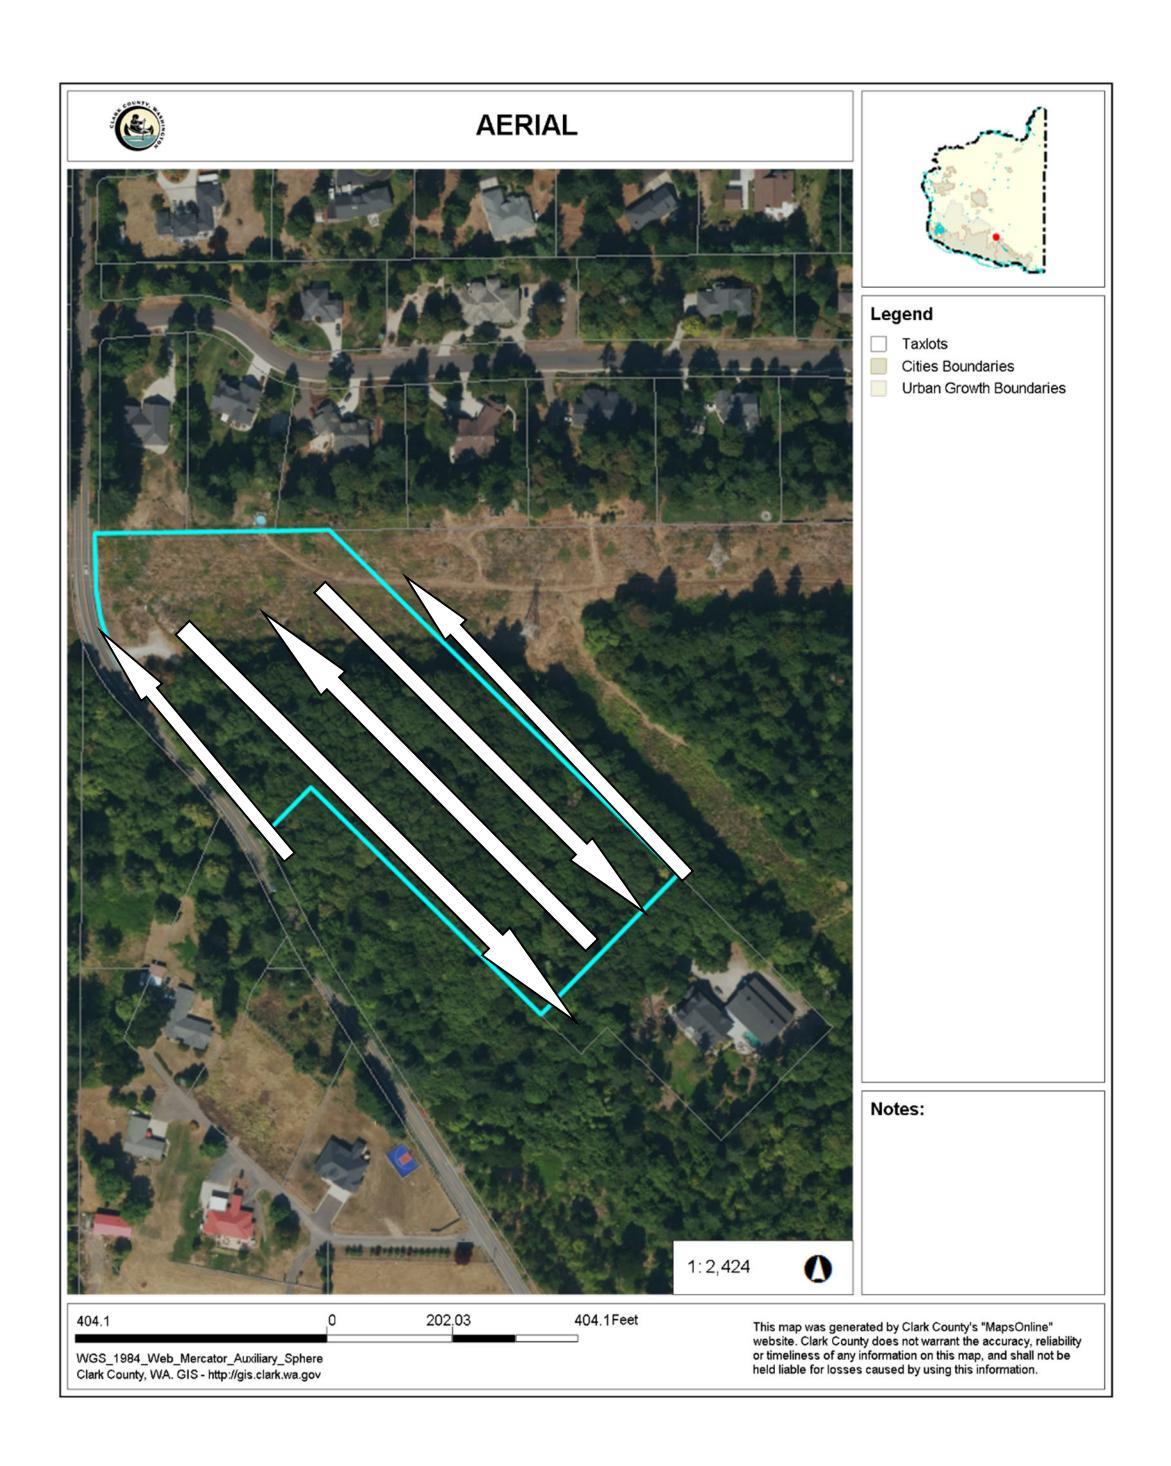
GIS Contour and Slope Map

The proposed homes will be built on slopes ranging from 5 to 14.5 percent. an area containing 8% slopes. The slopes in the area of the proposed building envelopes are based on filed measurements. Clark County GIS indicates that the slopes on the subject site range from more than 5% (green) to greater than 40% (dark orange) with the intermediate slope broken into categories including 5-10% (green), 10-15% (yellow-green) 15-25% (yellow) and 25-40% (light-orange).

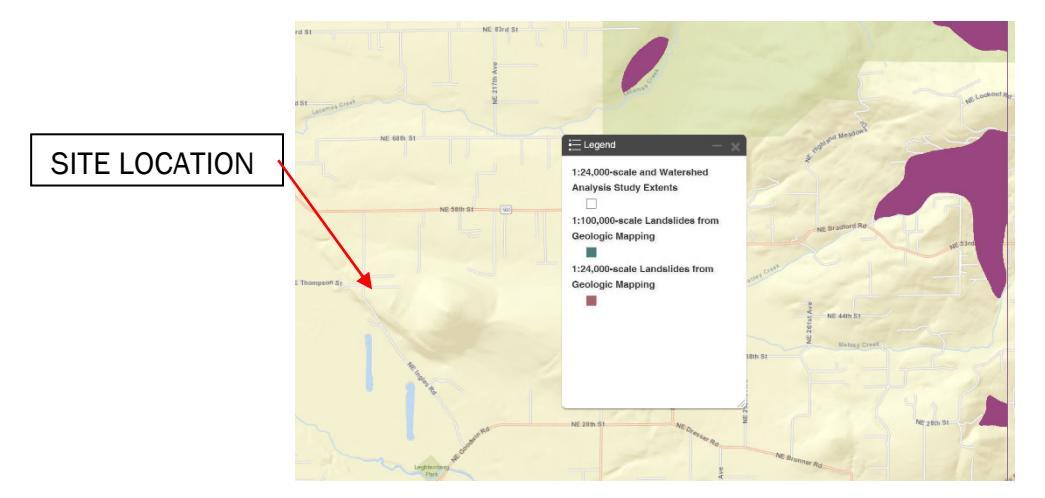
There are no potential instability, historical or active landslides on the parcel. The nearest known landslide area is located 1.5 miles to the east of the project site.

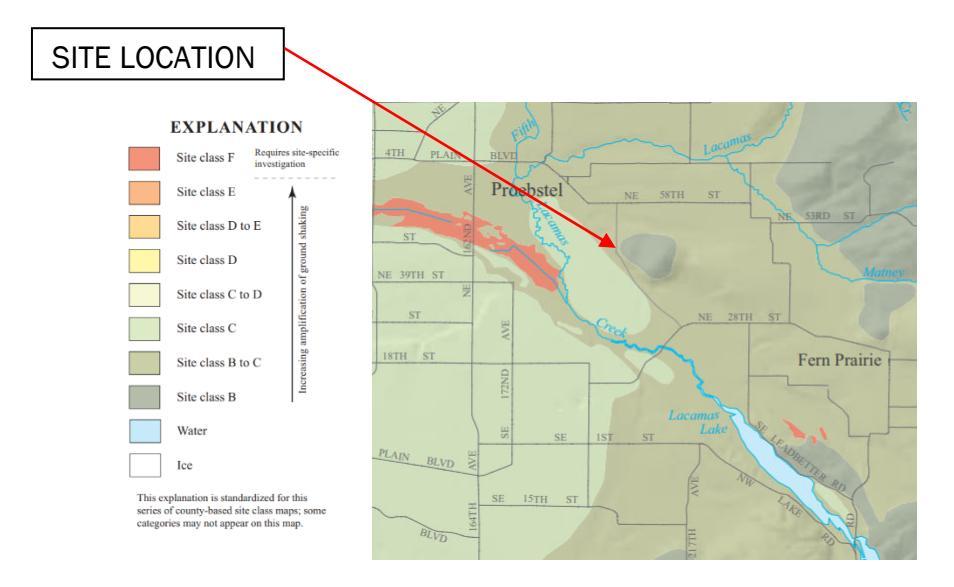
The project site is located within 900 feet of the Lucama's Lake fault (see map below). All earthquakes occur along faults; surfaces between two rock masses where one mass slides past other. Where a fault is located at the surface, movement of the fault can damage structures built on the fault. The most recent rupture of the Lacamas Lake Fault occurred sometime between 10,000 and 100,000 years ago.

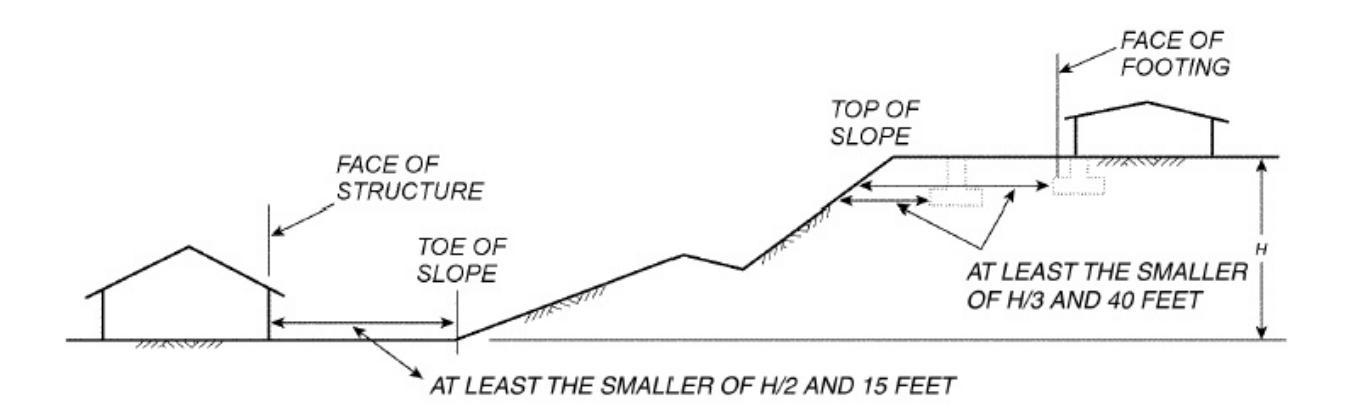
Foundations on or adjacent to slope surfaces shall be founded in firm material with an embedment and set back from the slope surface sufficient to provide vertical and lateral support for the foundation without detrimental settlement. Except as provided for in <u>Section 1808.7.5</u> and Figure 1808.7.1, the following setback is deemed adequate to meet the criteria. Where the slope is steeper than 1 unit vertical in 1 unit horizontal (100-percent slope), the required setback shall be measured from an imaginary plane 45 degrees (0.79 rad) to the horizontal, projected upward from the toe of the slope.

Based on the review of the proposed subdivision plan and site invistrtion Based on reviewing the proposed subdivision plan, Engineering Northwest PLLC recommends rear slope setback of 15-feet for lot 9 thru lot 14.
