Oliver Terrace Subdivision Preliminary Tree Report

Date: August 2025

Prepared By: Bennett Kocsis, Certified Arborist

Site Information: 1004 SE Everett Road
Camas, WA 98607
Parcel #178221-000

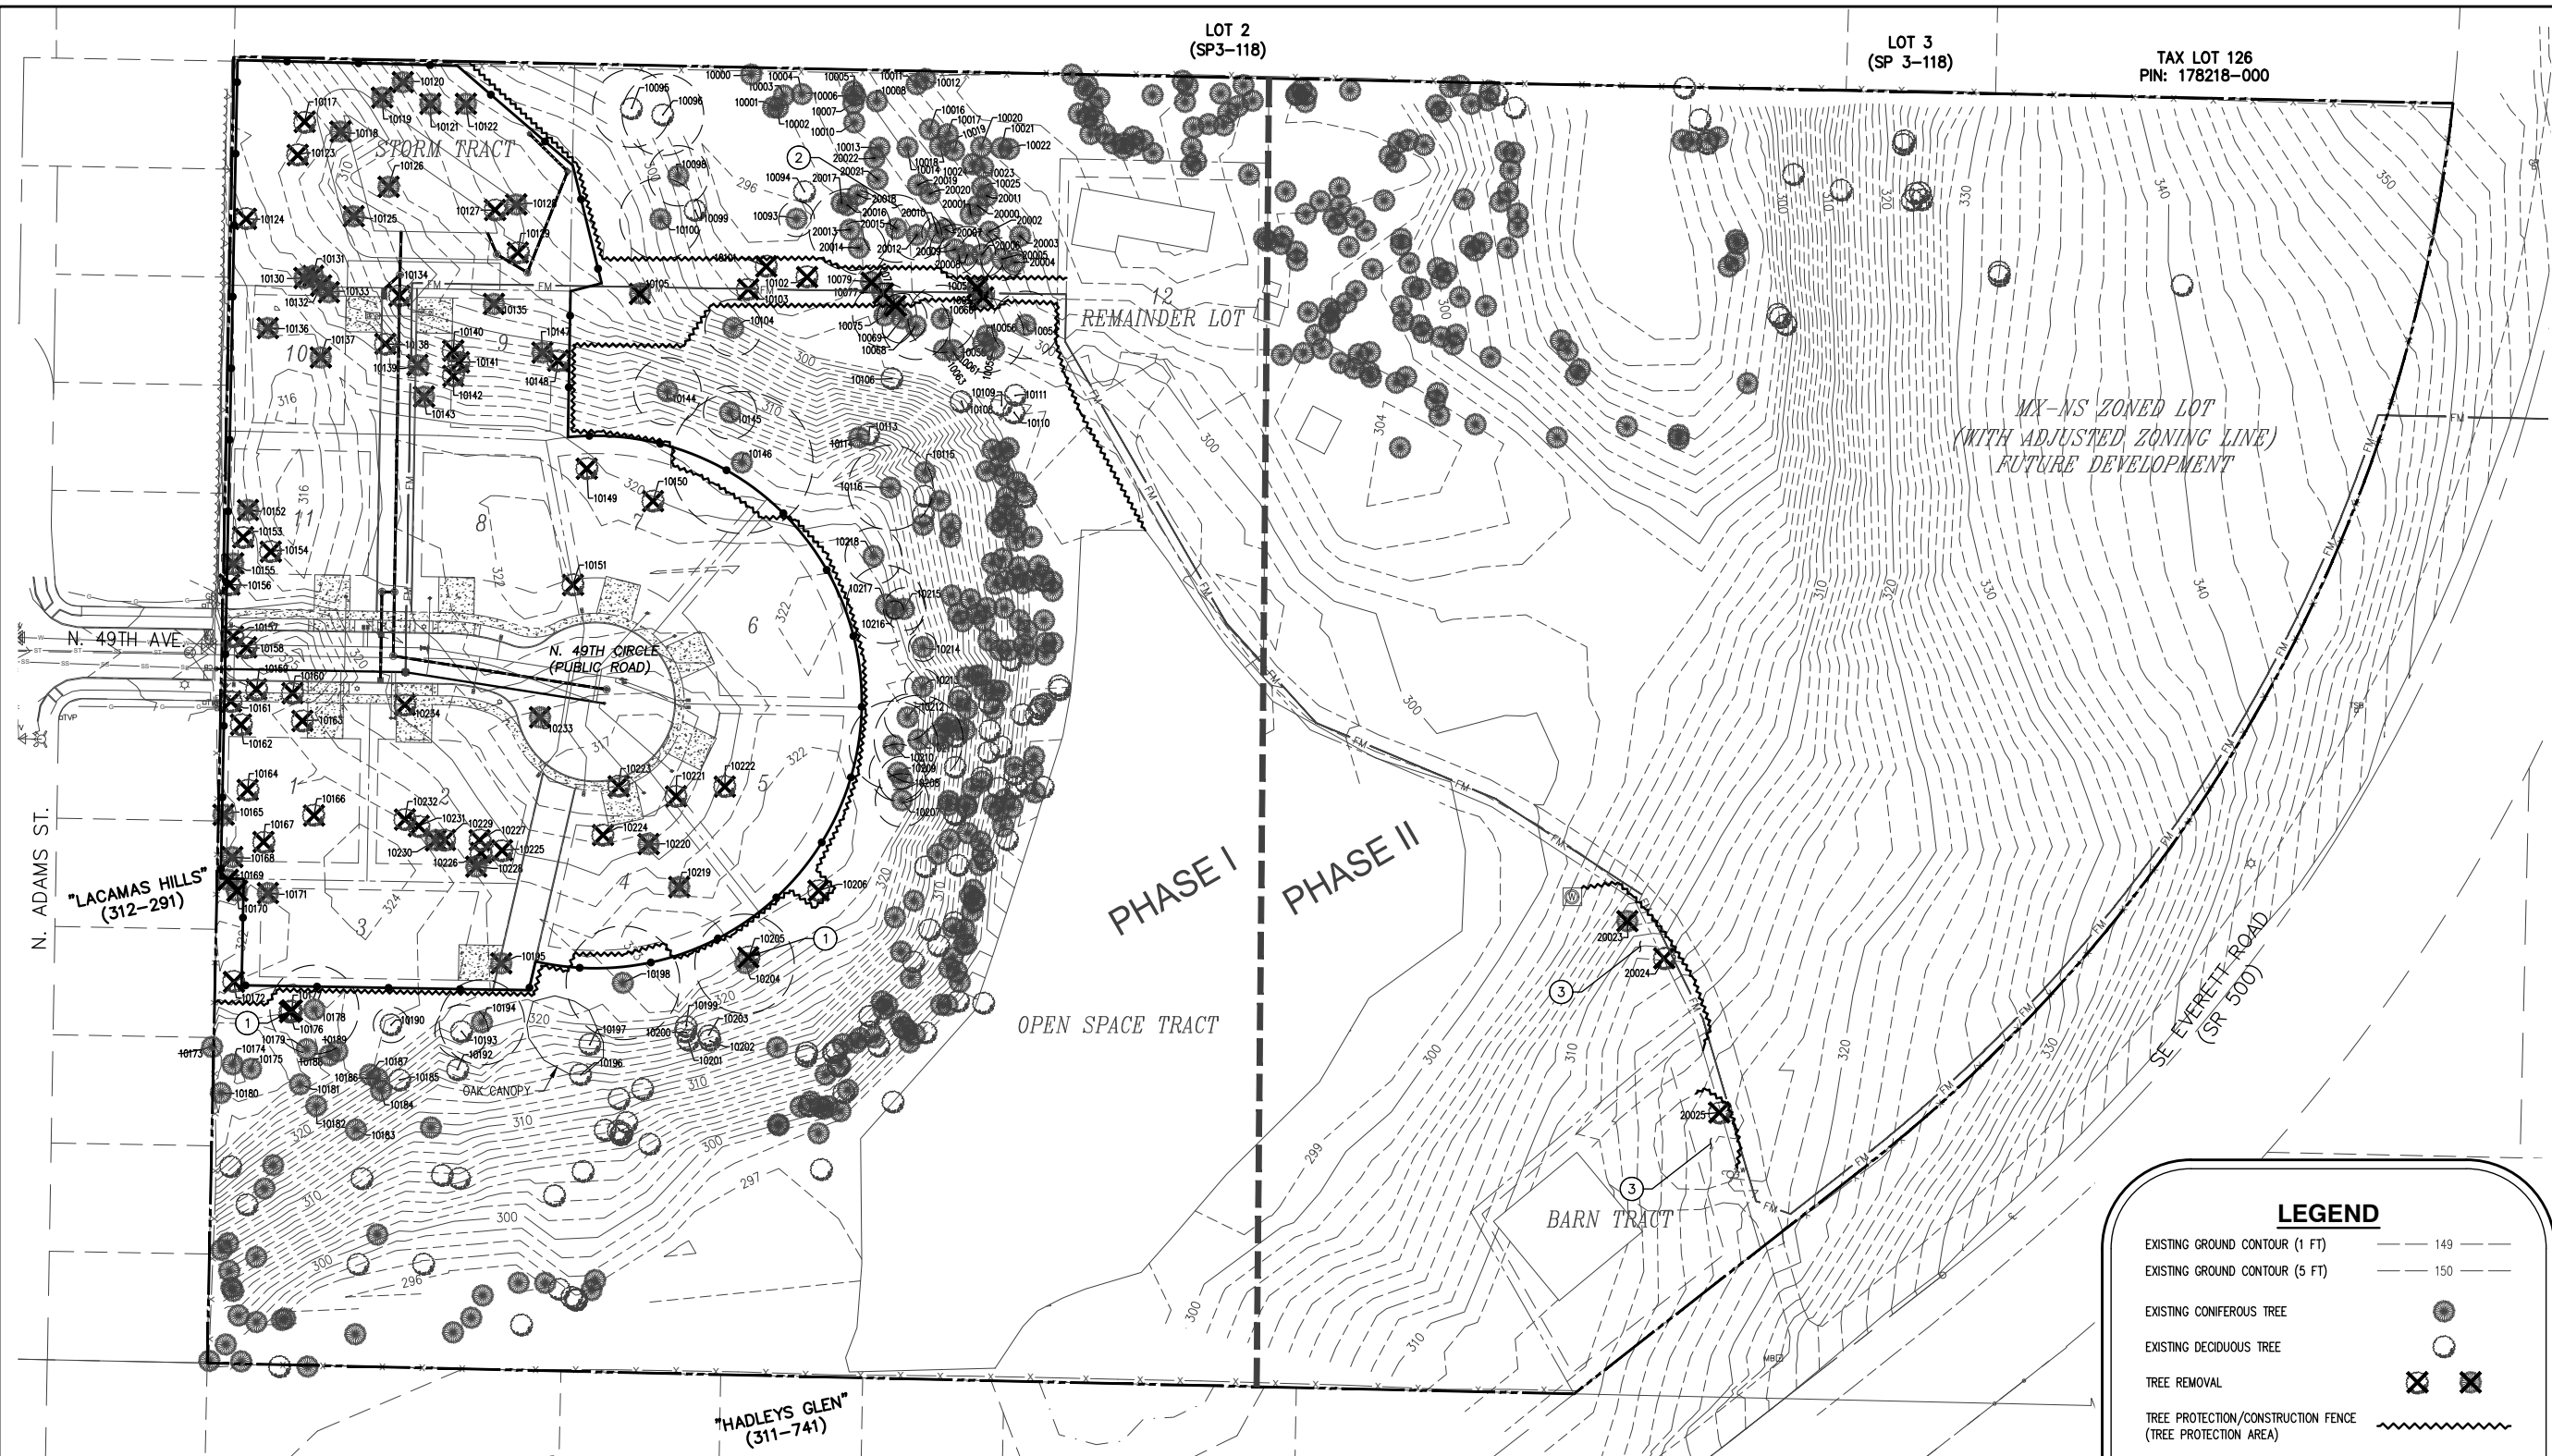
Appendix B: Tree Preservation and Removal Plan

- VARIOUS TREES EXHIBIT FORMS OF HEALTH CONCERNS OR STRUCTURAL DEFECTS, AS NOTED IN THE TREE TABLE (SEE SUPPLEMENTAL ARBORIST REPORT), THAT CURRENTLY PRESENT MINIMAL CONCERNS; HOWEVER, IT IS RECOMMENDED TO MONITOR THESE TREES OVER TIME AS ADDITIONAL MITIGATION OPTIONS MAY BE WARRANTED IF THE HEALTH AND/OR STRUCTURAL CONDITIONS WORSEN. WE RECOMMEND USING A CERTIFIED ARBORIST FOR FUTURE MONITORING.

- ARBORIST OBSERVATION REQUIRED DURING TREE REMOVAL BEHIND TREE PROTECTION FENCE.
- SOME DEAD TREES IN THIS AREA NOT SHOWN ON THE SURVEY. ADDITIONAL ARBORIST REVIEW IS RECOMMENDED DURING FINAL ENGINEERING DESIGN.
- ARBORIST OBSERVATION RECOMMENDED DURING UTILITY TRENCHING IN THIS AREA. TREE PRESERVATION OR REMOVAL TO BE DETERMINED BY THE PROJECT ARBORIST BASED ON ROOT IMPACTS OBSERVED DURING CONSTRUCTION. TREE REMOVAL IS LIKELY BASED ON PROPOSED DESIGN.
