Preliminary Geotechnical Engineering Report

Project Information: Camas Valley Estates
GeoPacific Project No. 21-5741
March 8, 2021

Site Location: 22630 NE 28th Street
Camas, Washington 98607
Clark County Property No. 173157000

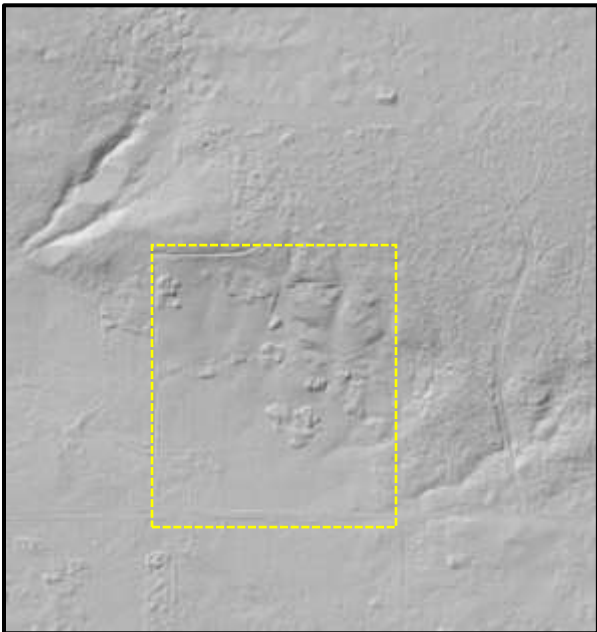
Published regional geologic mapping and the Washington State Department of Natural Resources online LiDAR database show no mapped landslides at the subject site. We reviewed available LiDAR imagery of the site which indicates relatively smooth, topography for the majority of the subject site. The imagery does not indicate hummocky terrain or other typical features generally associated with the presence of a landslide. The subject site is located within the yellow square in the LiDAR imagery shown below.

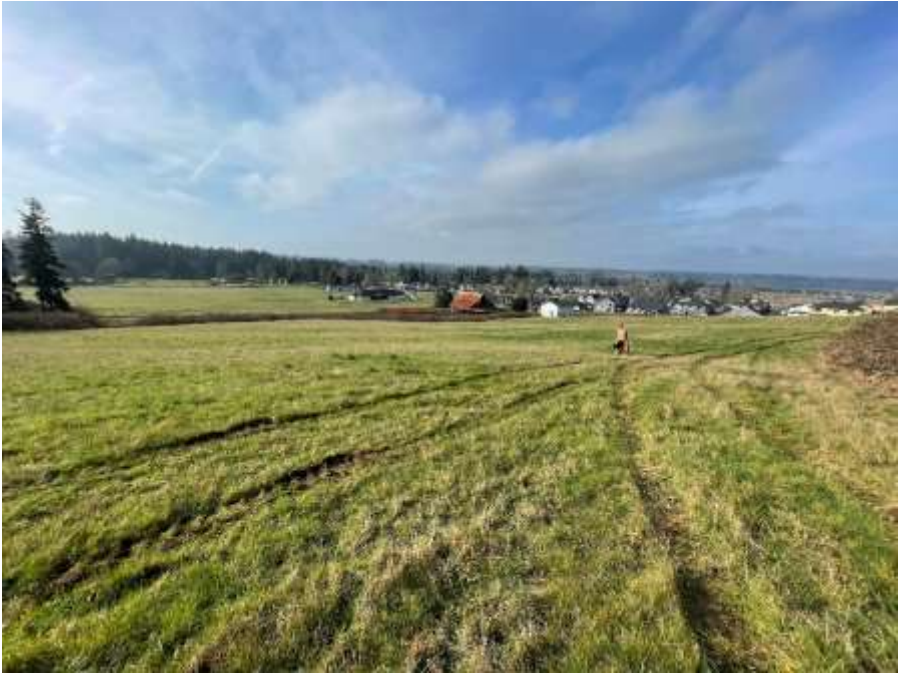
Site Facing Southwest

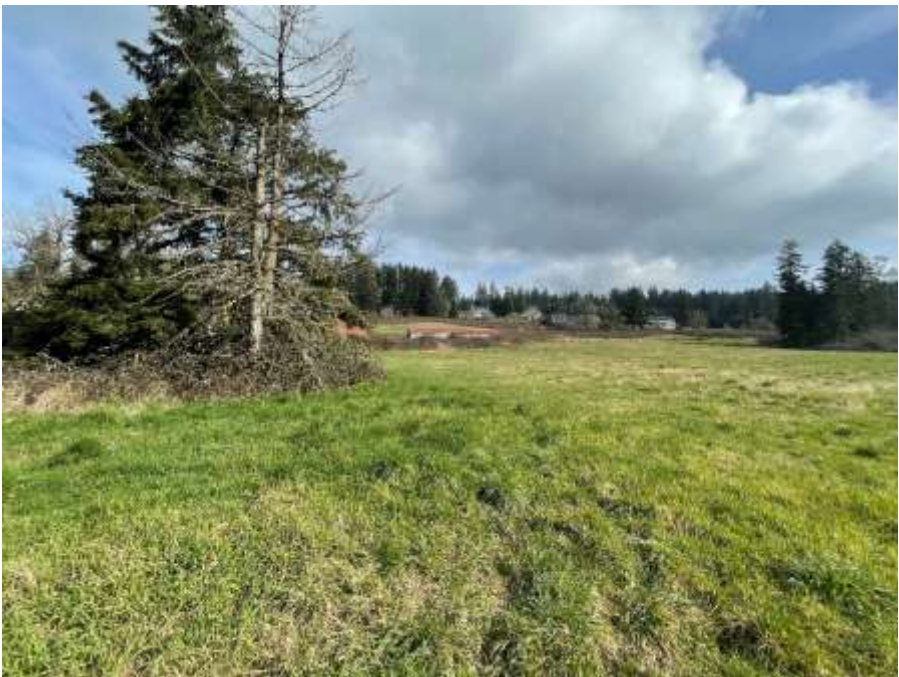
Site Facing Northeast

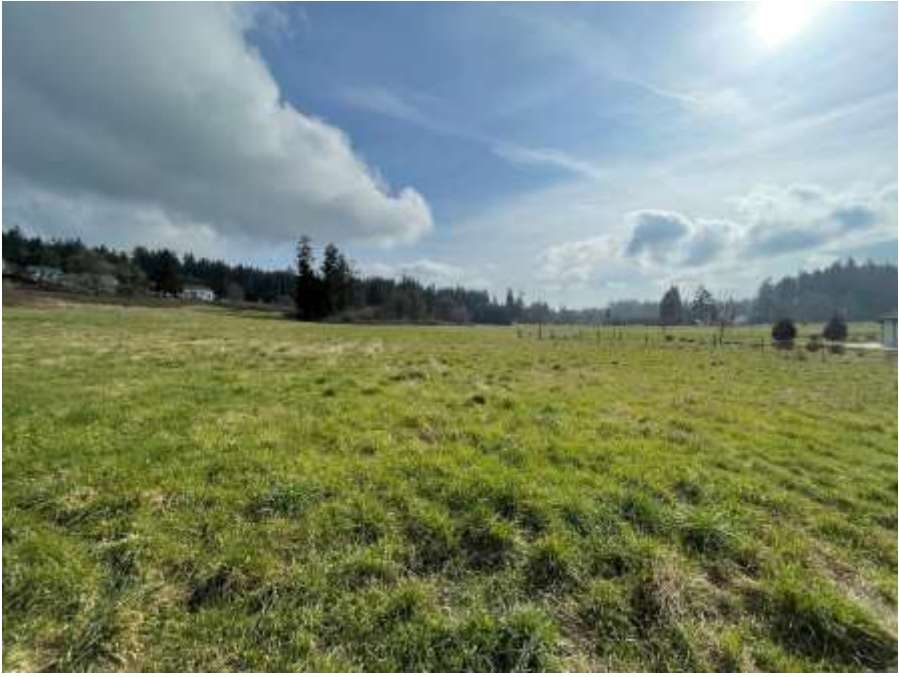
Southern Half of Site, Facing East

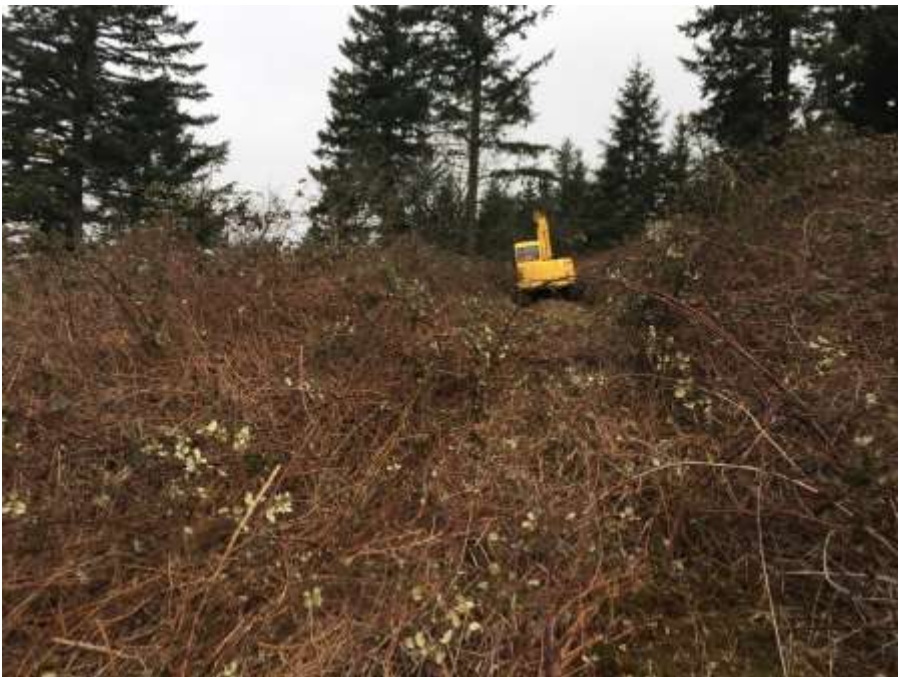
Northern Portion of Site Facing South, Moderately Sloping Area

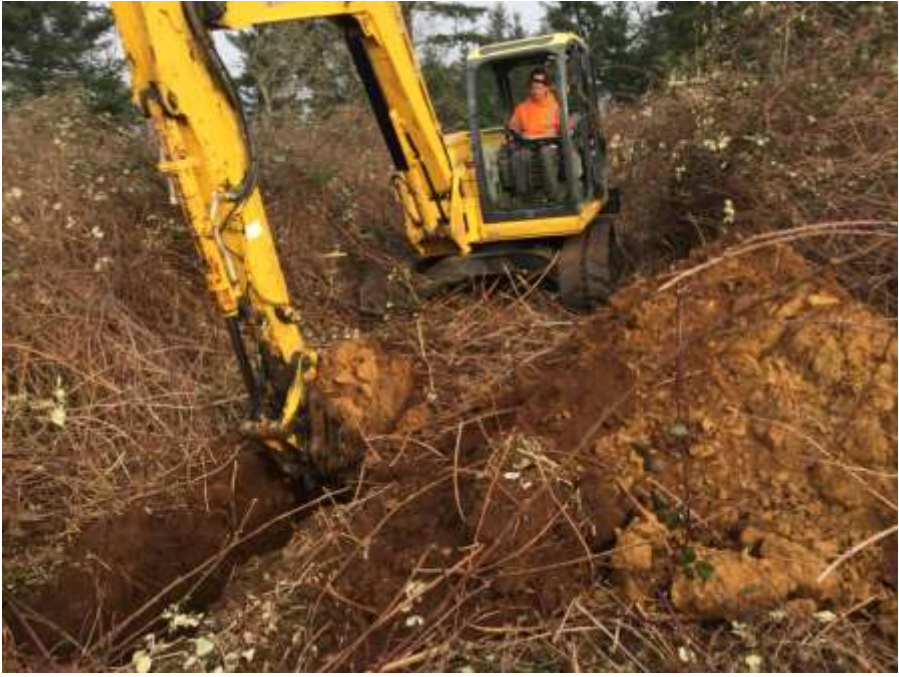
Excavator Test Pits

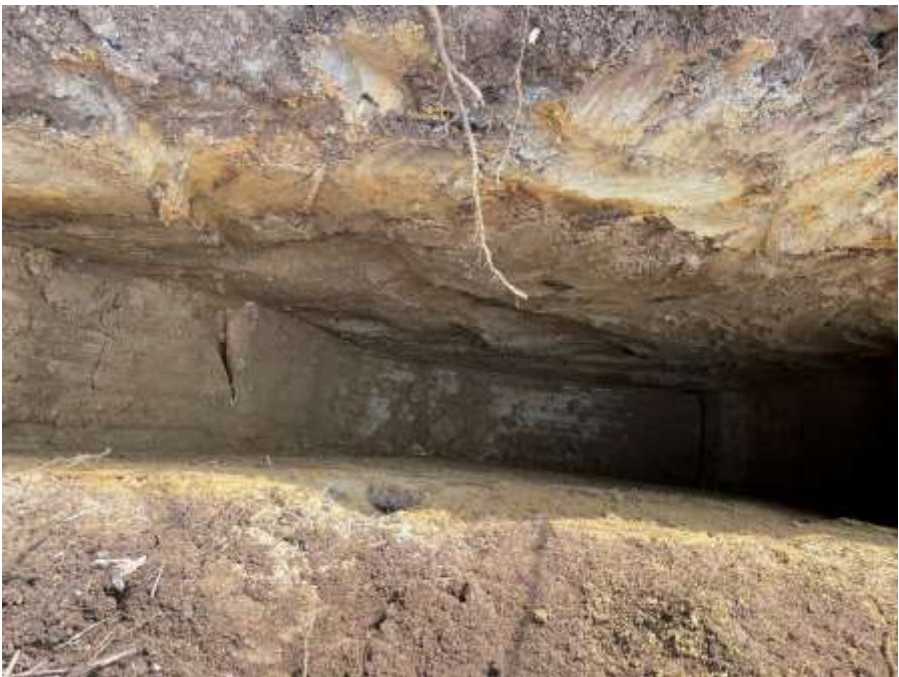
Test Pit TP-1

Clayey SAND (SC): At the locations of test pits TP-1 and TP-2, brown, orange, gray, and light gray, medium dense, very moist to wet, low plasticity, Clayey SAND layers were encountered below the Lean CLAY soil type at depths ranging from approximately 4.5 to 7 feet and extending to approximate depths of 9 to 10 feet bgs.

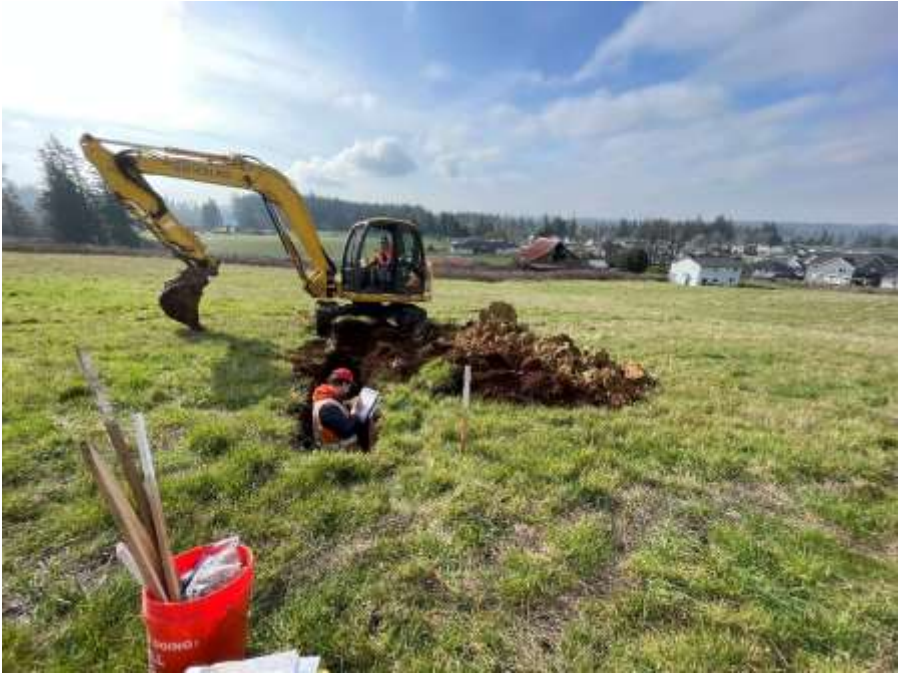
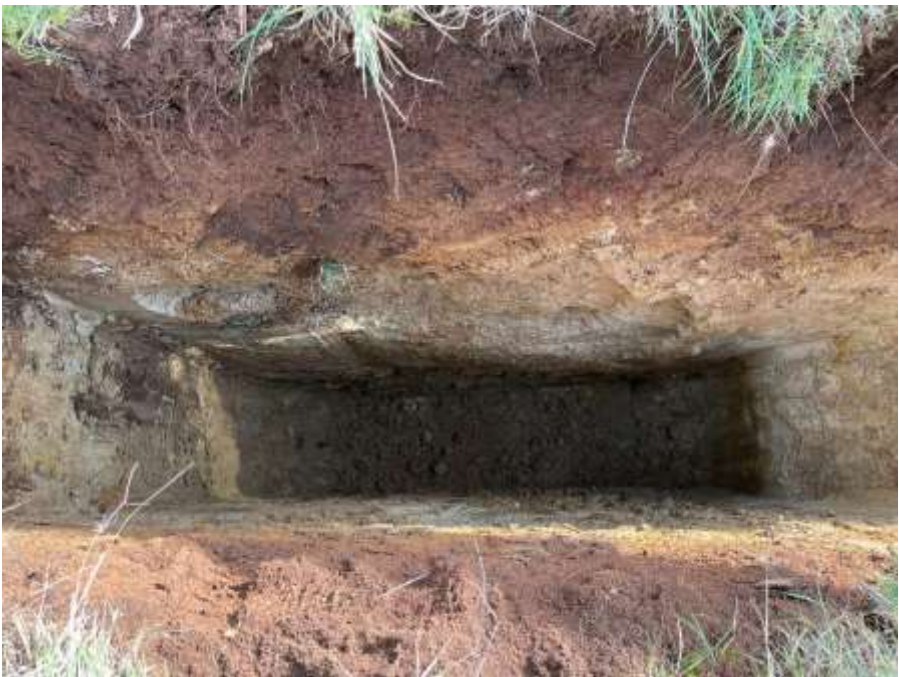
Test Pit TP-4

Clayey GRAVEL (GC): At the locations of test pits TP-4, and TP-5, brown to gray, medium dense, very moist to wet, low plasticity, Clayey GRAVEL containing subrounded gravel to cobble-sized rock was encountered below the Lean CLAY soil type at depths ranging from approximately 4 to 7 feet and extending to the maximum depth of exploration.
