Camas Station Project

TREE SURVEY

January 31, 2022

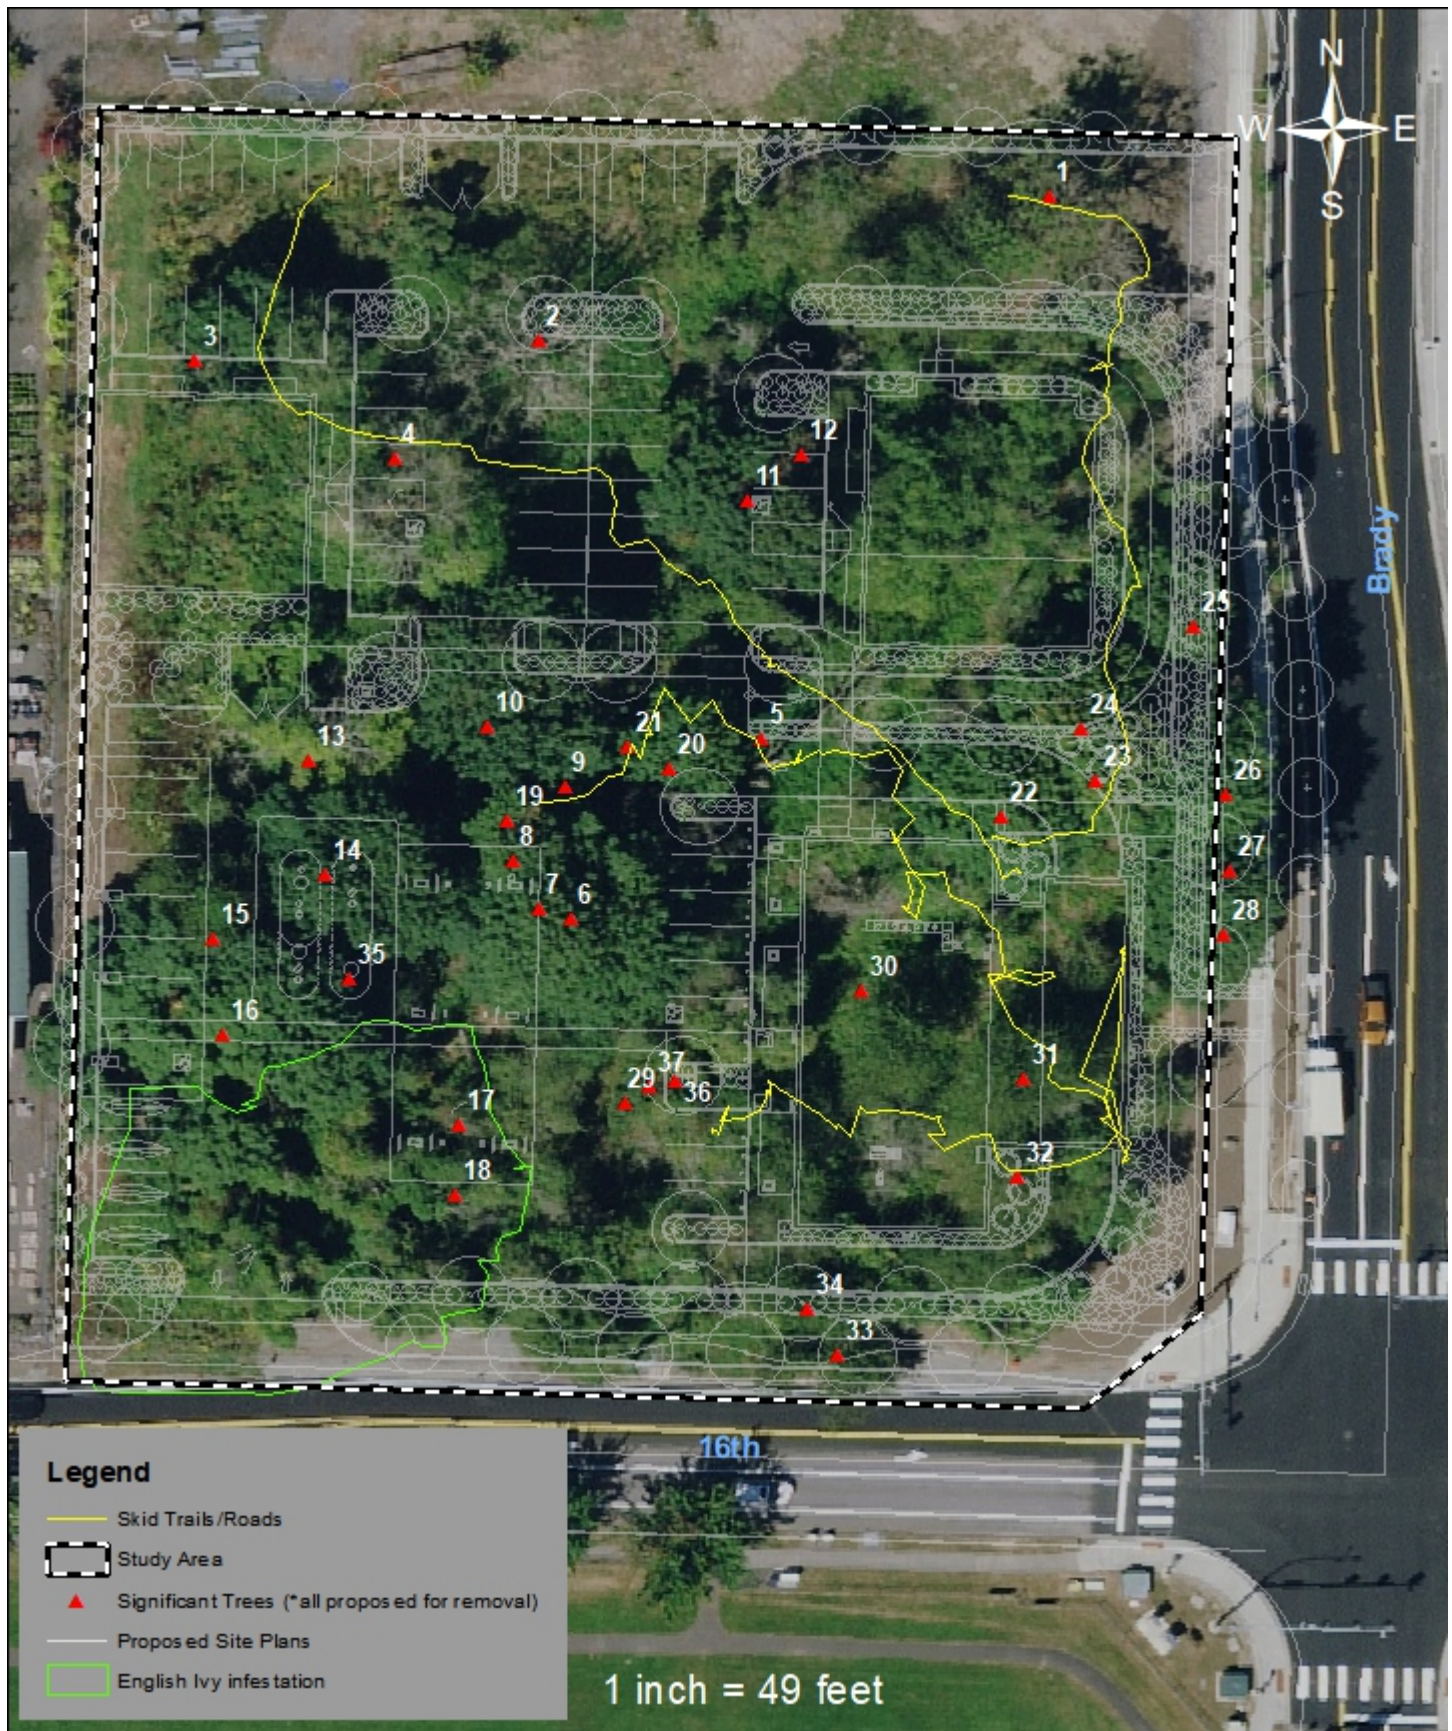
Figure 3

A high proportion of the trees on the property are in poor health, dead, and/or structurally unsound. Because targets (*e.g.*, people or property) are currently not at risk of being impacted by these trees, they were not rated as high risk. The only tree that was rated as a high level of risk to life or property was tree#16 (Fig. 4). Tree# 16 is a large over-mature, multi-stemmed big-leaf maple with multiple defects (Appendix A). In the event of failure, this tree would most likely impact the adjacent property owner’s fence and warehouse building.

Large areas of the site have been aggressively invaded by English ivy and blackberry; the former is significantly affecting tree health in the areas indicated on Figure 4. Additionally, recent disturbance along a series of skid trails/roads throughout the parcel has caused significant levels of erosion (Photo Sheets 1-3) and visible injury to trees. Extensive root damage in these areas is also likely based on the level of disturbance that was observed. In conclusion, the general condition of the site is very poor based on structural condition of many of the trees, invasive species infestations, and ground disturbance/damage.

Based on the proposed site development, it is OE’s recommendation to remove all significant trees on the property. Due to the topography on-site (Fig. 3), it is necessary for the Applicant to grade the entire study area. It is unlikely that any trees on the property would survive grading and subsequent construction.
