April 10, 2023, revised September 27, 2023

Black Mountain Project No. 220031-GHE

**Subject: Geologic Hazard Evaluation**

PS25 Camas School Relo

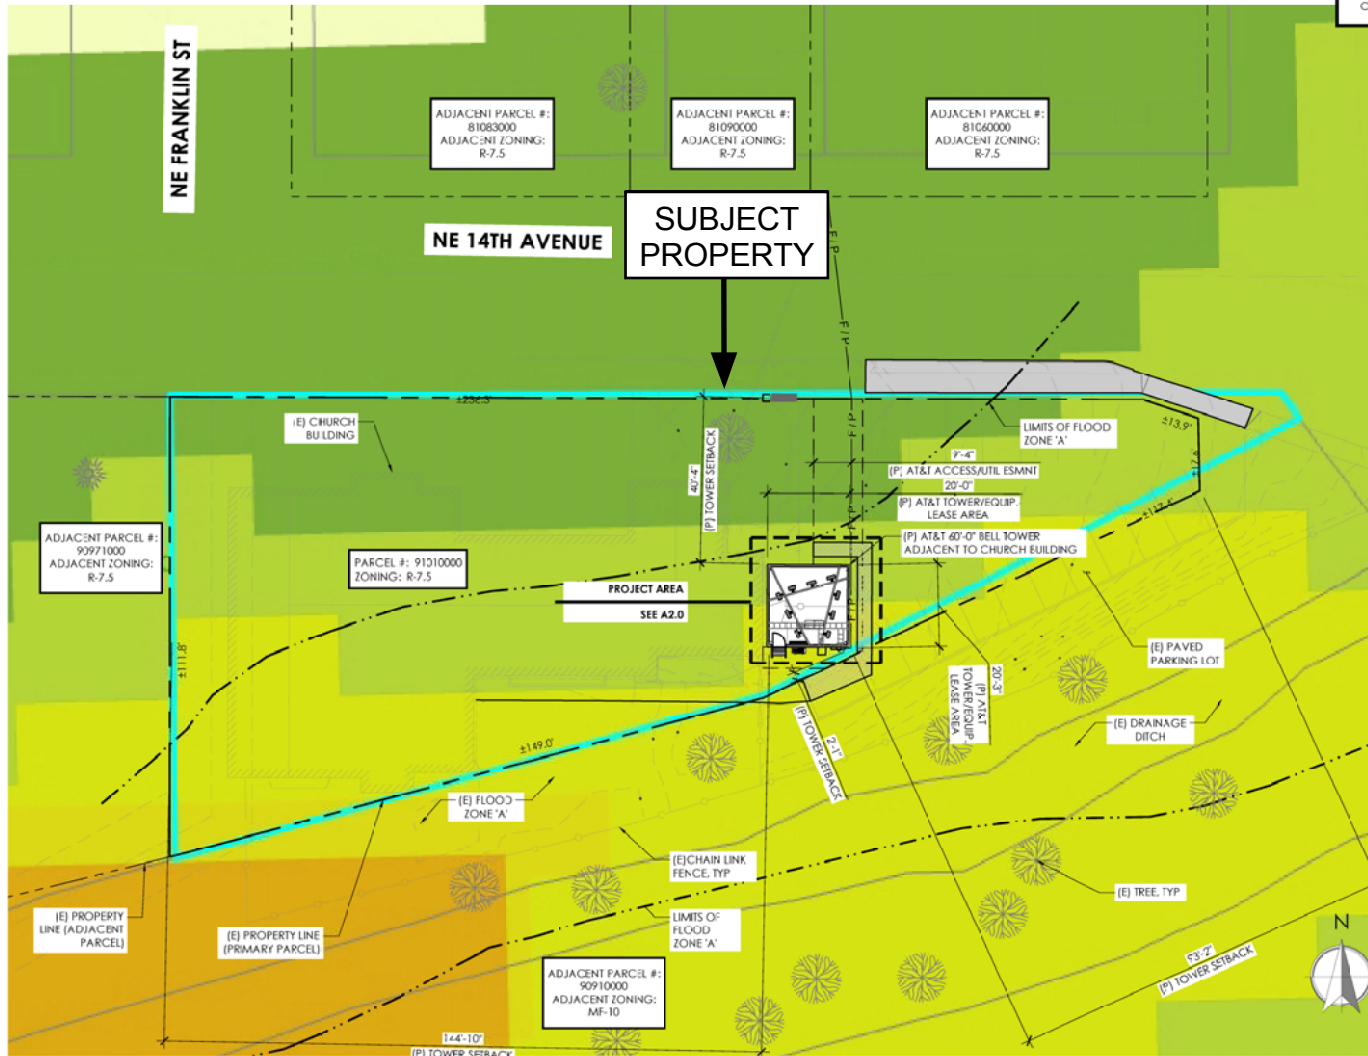
**FIGURE 2 - Geologic Hazard Map**

The lease area is located adjacent to a building (United Methodist Church) and is landscaped. The building is located on a level terrace and an asphalt-paved driveway provides access to the lease area. The project site and surrounding area are shown on the attached *Geologic Hazard Map* (Figure 2).

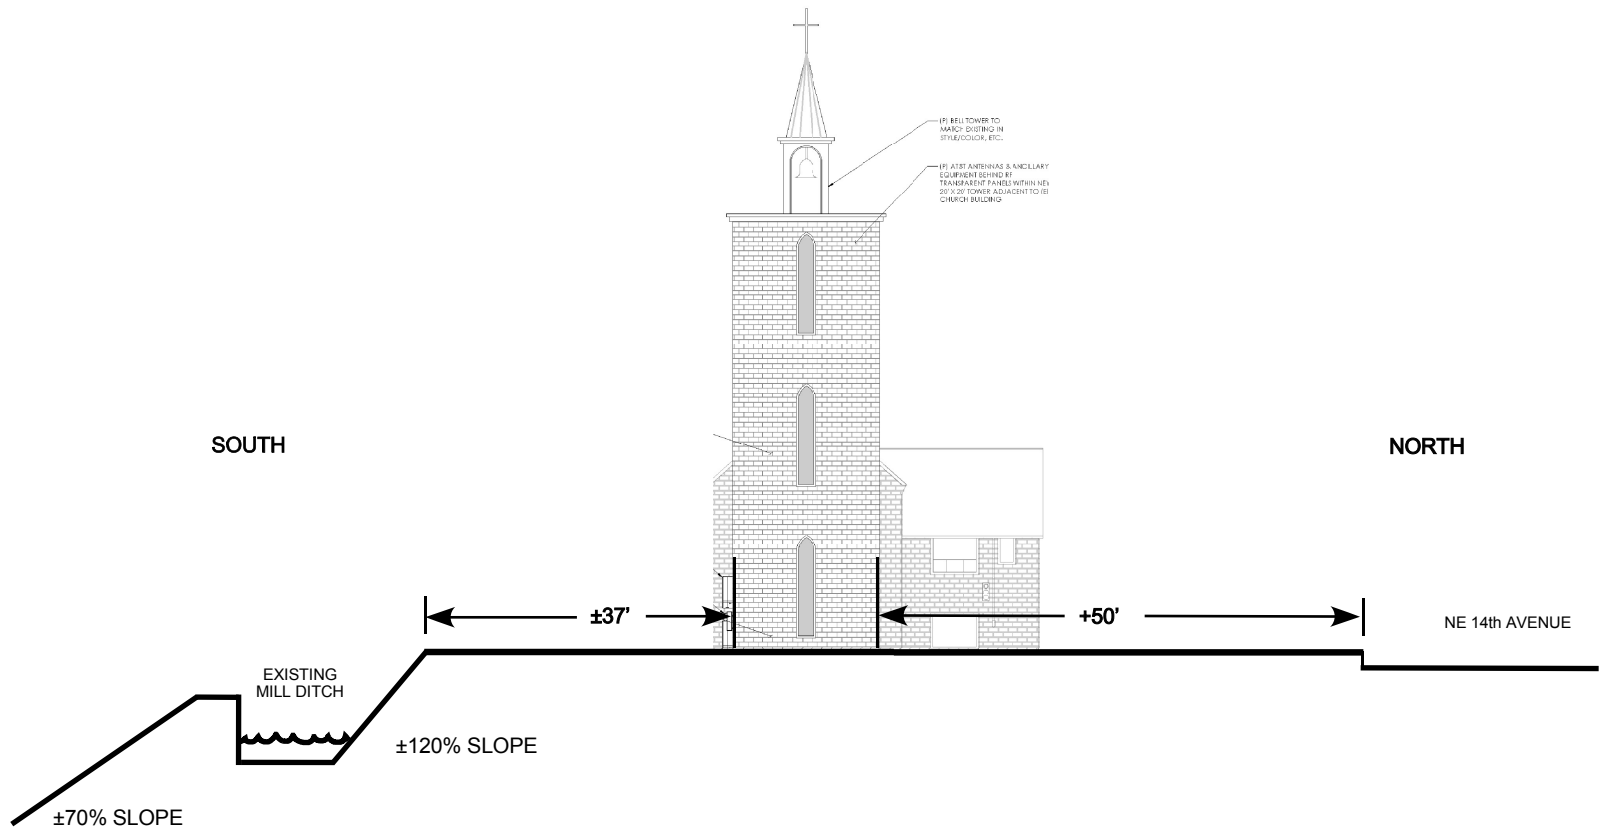
**FIGURE 3 - Slope Cross Section, North-South**

We did not observe ground cracks, evidence of scarps, fissures or other manifestations of recent slope movement (denuded areas, debris accumulations, chaotic vegetation) on the slope above the canal at the time of our site visit. No spring activity was noted. Vegetation on the slope adjacent to the lease area consists primarily of blackberry bushes. Figure 4, Slope Cross Section, illustrates the topography in the immediate vicinity of the proposed compound.

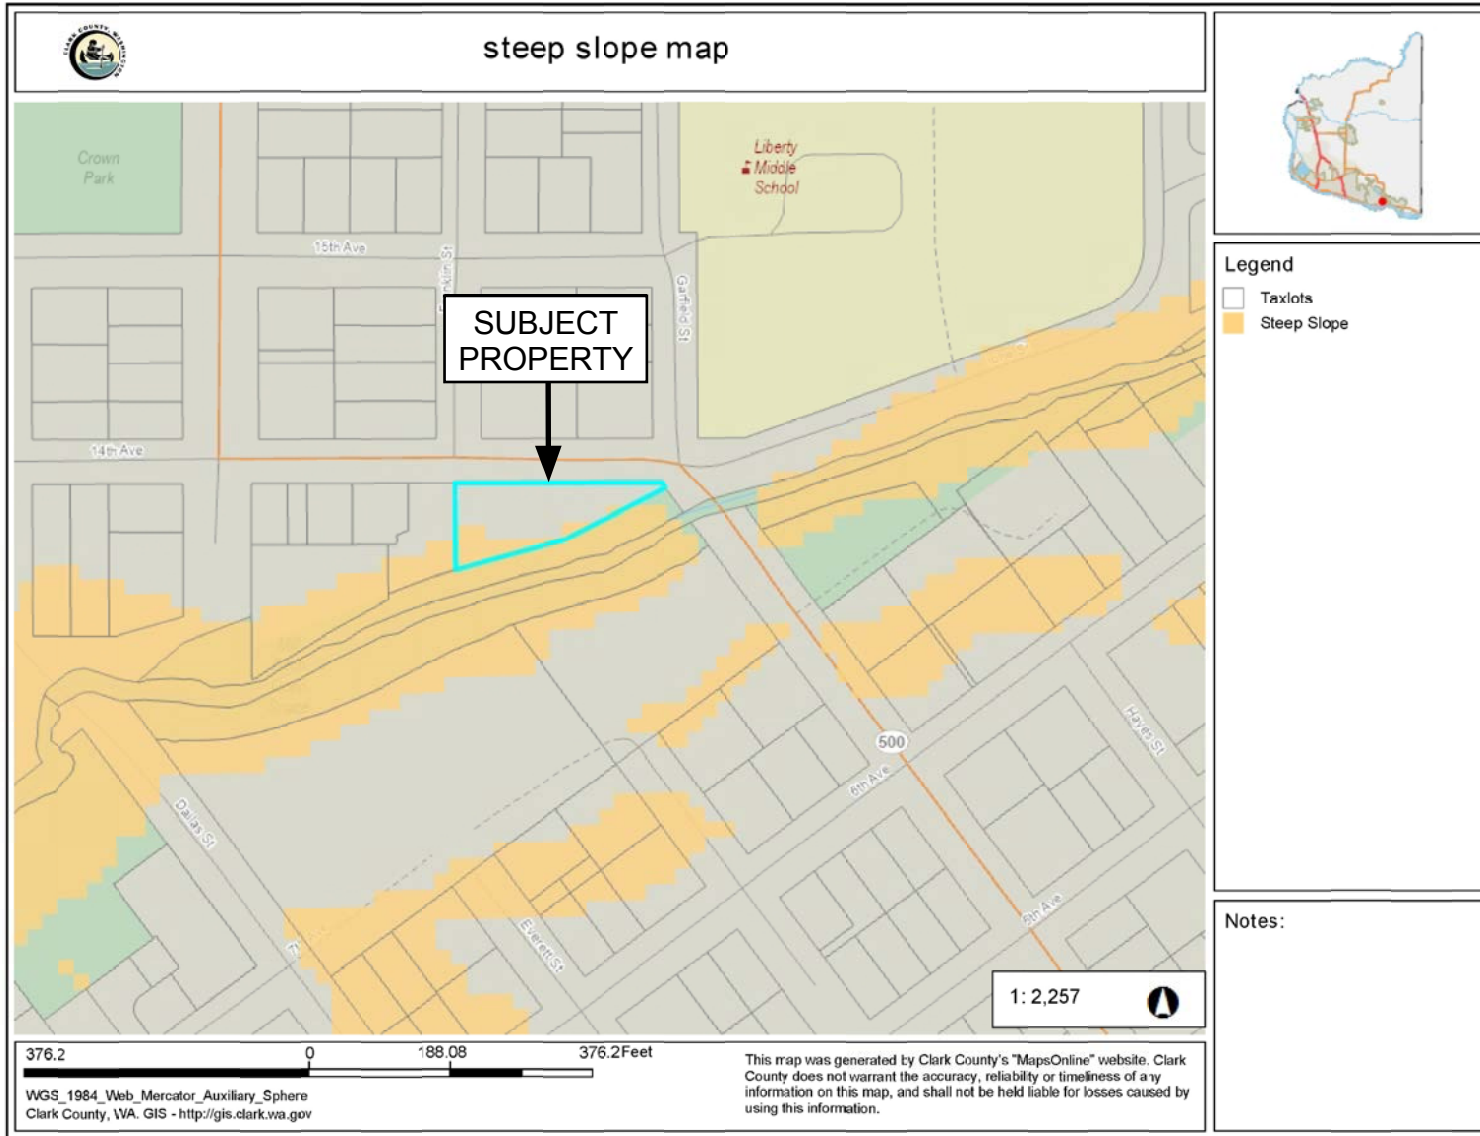
**FIGURE 4 - Steep Slope Hazard Map**

Steep slope hazard areas are typically considered to be any ground that rises at an inclination of 40 percent or more (a vertical rise of 10 feet or more for every 25 feet of horizontal distance). Based on our site visit and geologic profiling, the man-made slopes in the vicinity of the site are on the order of 84 to 120 percent, and are “steep”. The approximate distance from the edge of the proposed tower foundation to the slope is about 37 feet (horizontal). Exposed soils along the slope indicate that soils underlying this site consist of silt extends to at least 10 feet below the lease area.

The site is located adjacent to steep slopes; however, the surrounding slopes appear to be stable at the existing slope gradient, and have been in place since at least 1937. Based on our reconnaissance and review of existing reports, we conclude that the planned construction will not have a significant impact on slope stability or other geologic hazards at the site or on adjacent properties. We did not observe indications of major land movement that may jeopardize the proposed project.

We recommend that all structures be located a minimum of 25 feet from the edge of the existing slopes adjacent to the canal.
