# NW 18th Avenue Subdivision

## Tree Survey

### Camas, Washington

October 28, 2021

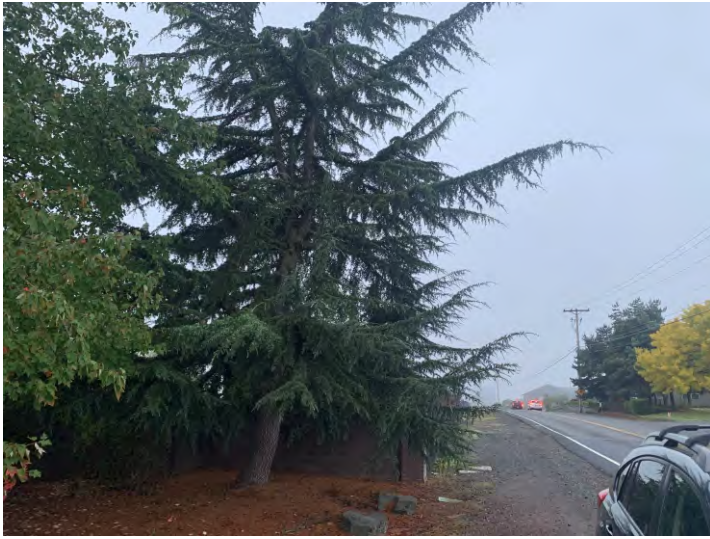
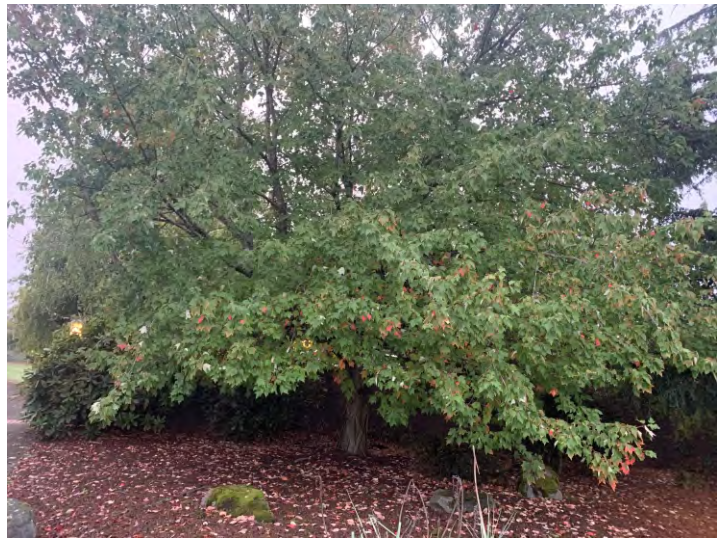
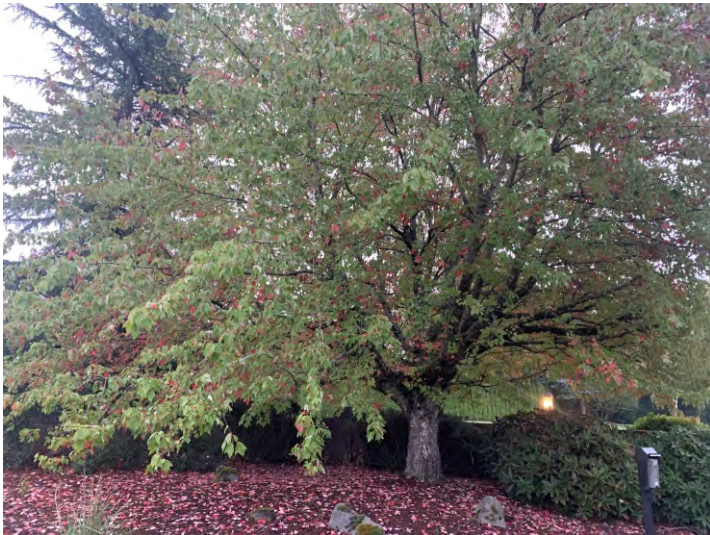
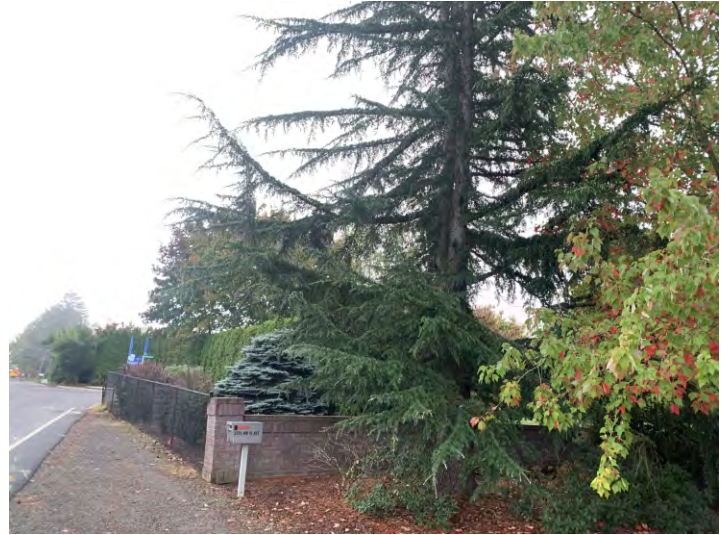
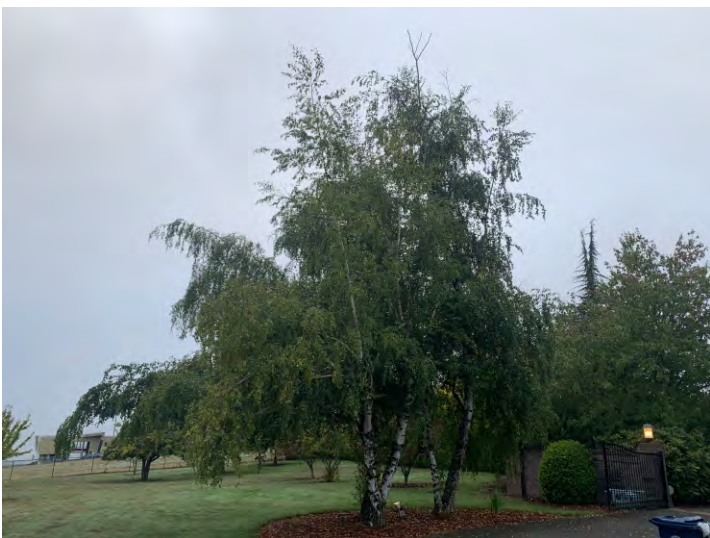
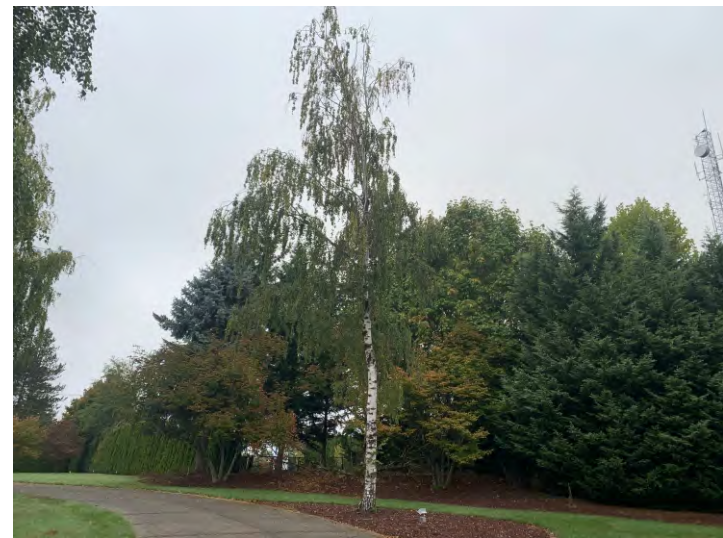
**Photo-Sheet 1**

Paper-birch (*Betula papyifera*) occurs in small groups along the driveway (Photo Sheets 1 and 2). Most of these trees are in fair condition with some dead wood and moderate vigor representative of the species. Just north of the main house there is a landscaped island -all of the tree roots in this location are severely exposed, with some root plates beginning to lift (Photo Sheets 3 and 4). One red oak (*Quercus rubra.*) tree#32) is marginally within strike distance of the house in the event of failure, and is considered a moderate to high risk. Targets for the

remaining trees within the island (tree# 33-35) are lawn and landscaping and were therefore not considered to be a high level of risk.

Based on the site design proposed by the Applicant (Fig. 2), it is not practical to retain any of the trees within the study area. There is a high probability that construction and excavation would result in root zone impacts and tree mortality for all significant trees identified within this report. For these reasons, OE recommends removal of all of the trees identified (Fig 4). In addition, it is our understanding that off-site tree#86 and 87 (Photo Sheet 14) will be removed during the course of road improvements off-site. If these trees are not removed, we recommended notification of the owner due to on-site construction impacts to their root zones, which could result in eventual tree failure.

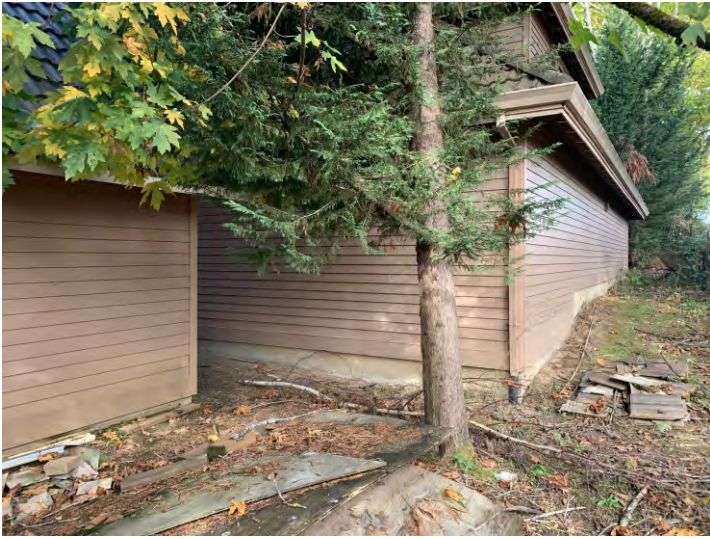
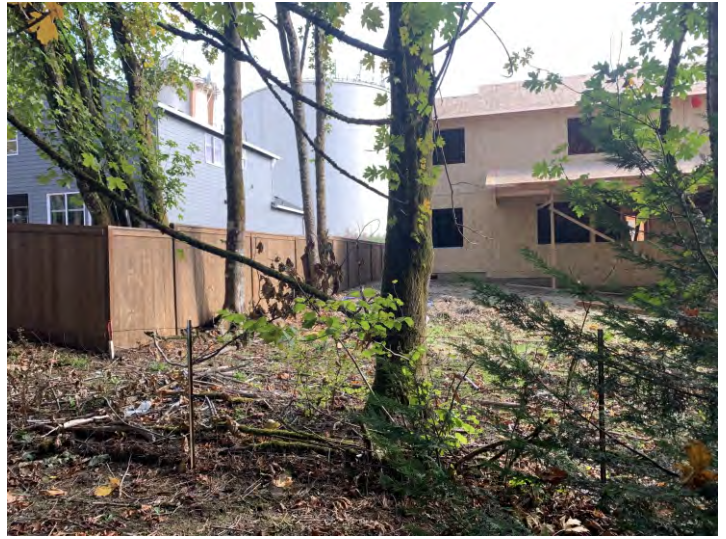
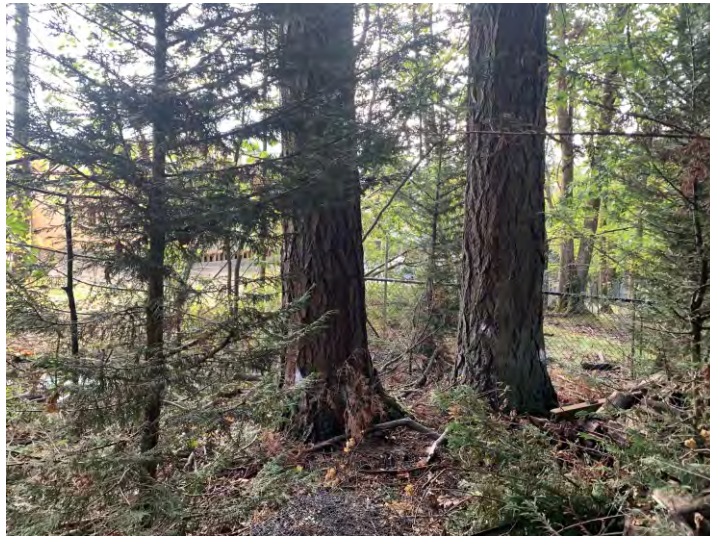
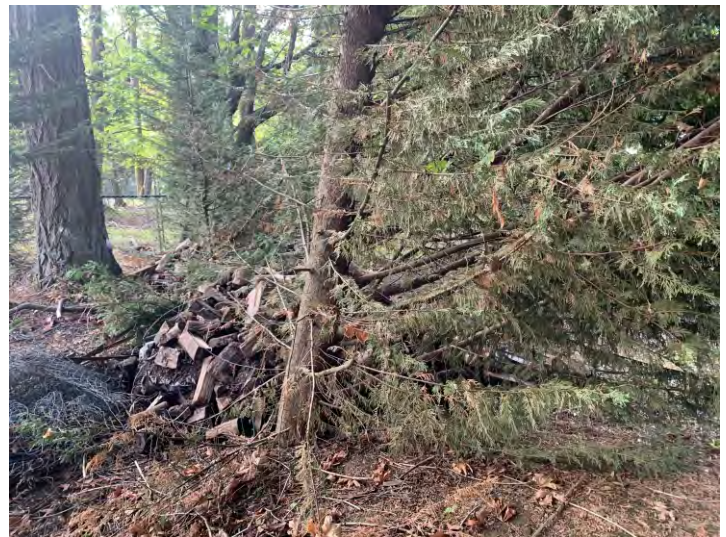
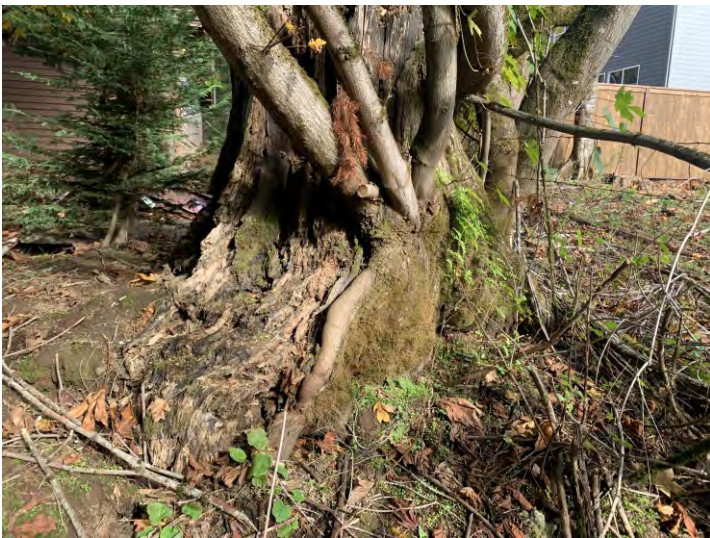
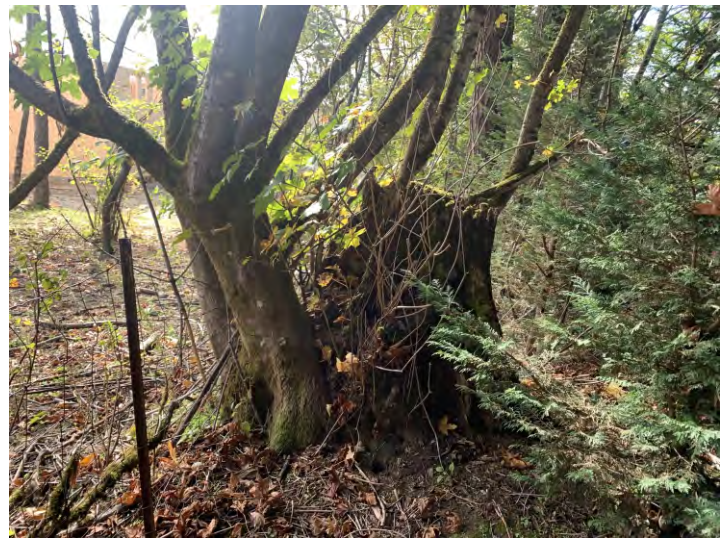
**Photo-Sheet 5**

The eastern property boundary is composed primarily of a mix of arborvitae (*Thuja spp.*) and big-leaf maples, among a few other species from the garage north-ward (Photo Sheets 5-7). All of the large big-leaf maples in these areas are over-mature and displaying varying degrees of heartwood and sapwood decay, which is typical of this species given their age and size. Previous upper-canopy and main stem failures were also observed among some of these trees (especially tree#21, 22, 23, and 29). In addition, tree# 14 and 19 are currently dead. Targets for these trees in the event of failure are the lawn and the adjacent property. Due to the potential impacts to these targets (the adjacent property, in particular), they are considered to be high risk.
