P A S T
CONSULTANTS LLC

Re: 1555 Lincoln Ave., Capitola, CA – Final SOI Standards Design Review Letter
APN. 034-041-13

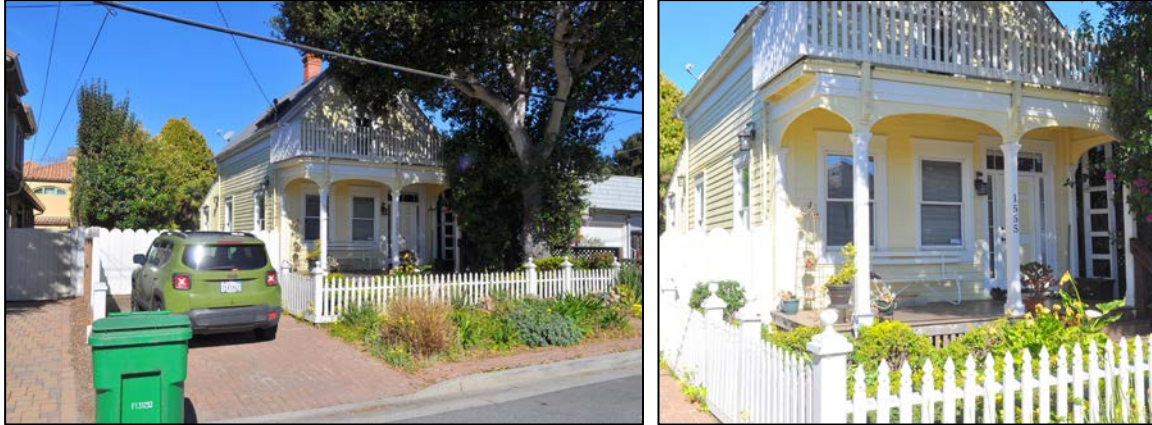
Figures 1 and 2. Left image shows the front (east) elevation, as viewed from the street. Right image details the front porch, which was replaced in the 1970s and the porch roof converted to a deck.

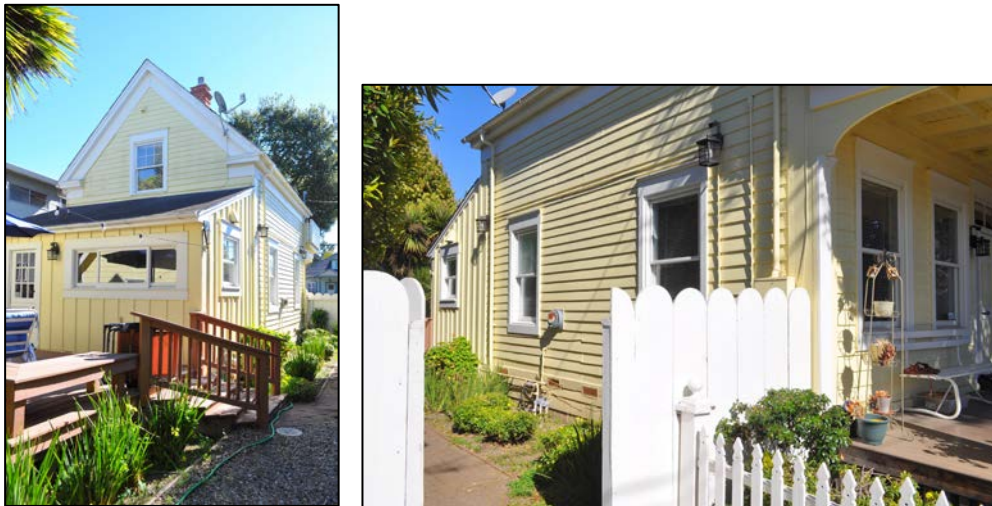
Figures 3 and 4. Left image shows the rear (west) elevation, with shed roofed rear addition. Windows in the rear addition have been replaced in original and new openings. Right image details the south elevation. Original wood sash windows have been replaced.

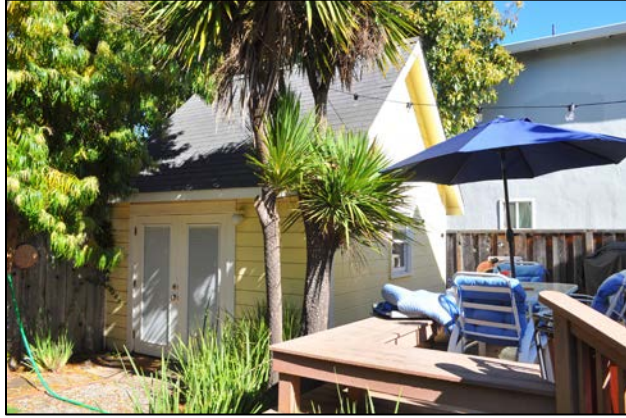
Figure 5. View of 1984 shed outbuilding located in the rear yard.

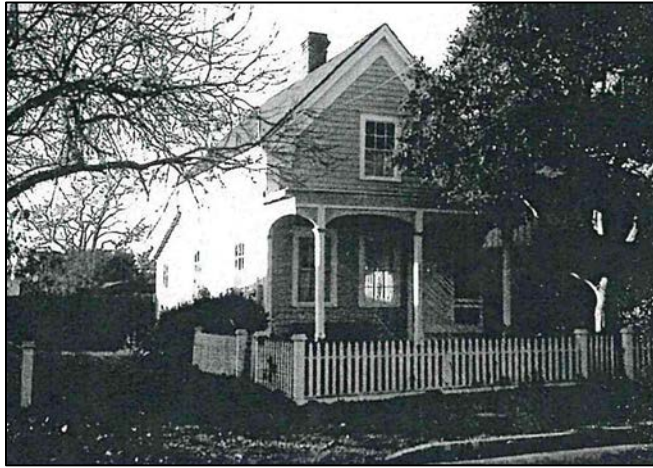
Figure 7. 1975 Assessor's photograph showing the second-story, gable-end window and the replaced front porch.
