P A S T
CONSULTANTS LLC

March 21, 2022

Re: 106 Cliff Ave., Capitola, CA – Final Secretary of the Interior’s Standards Compliance
Review; APN. 036-112-17

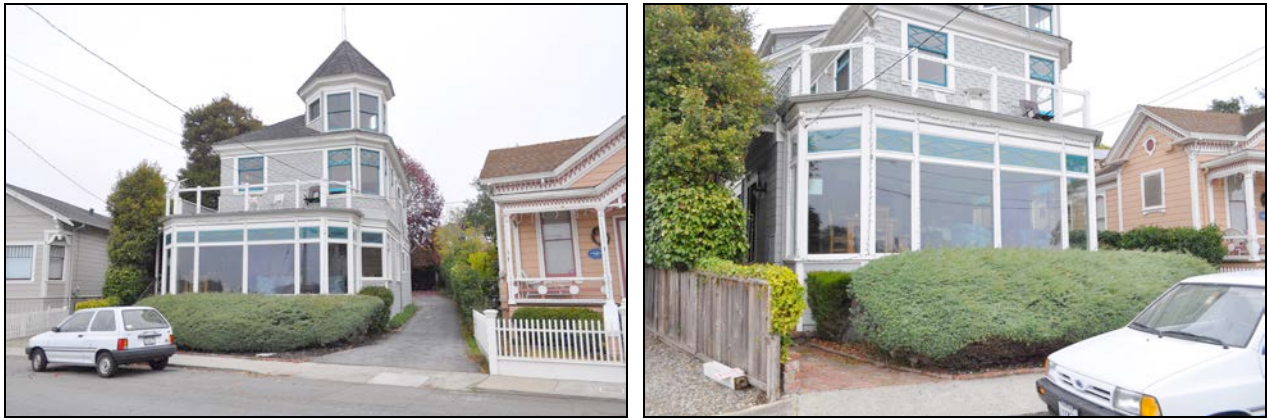
Figures 1 and 2. Left image shows the front (west) elevation, as viewed from the street. Right image details the front porch replacement on the west elevation.

1. The details of the porch replacement and first-floor windows, such as the type/configuration of the windows and the type/style of the wood columns are not detailed on the drawings. It is recommended that the architect provide this information in a proposed porch detail, based on the photographic evidence that exists (see **Figure 9**).
2. Provide dimensions of the rear addition's existing and proposed wood wall cladding, including the proposed upper-floor shingle pattern and the proposed lower-floor wood siding exposure width to ensure it differentiates from the historic house.

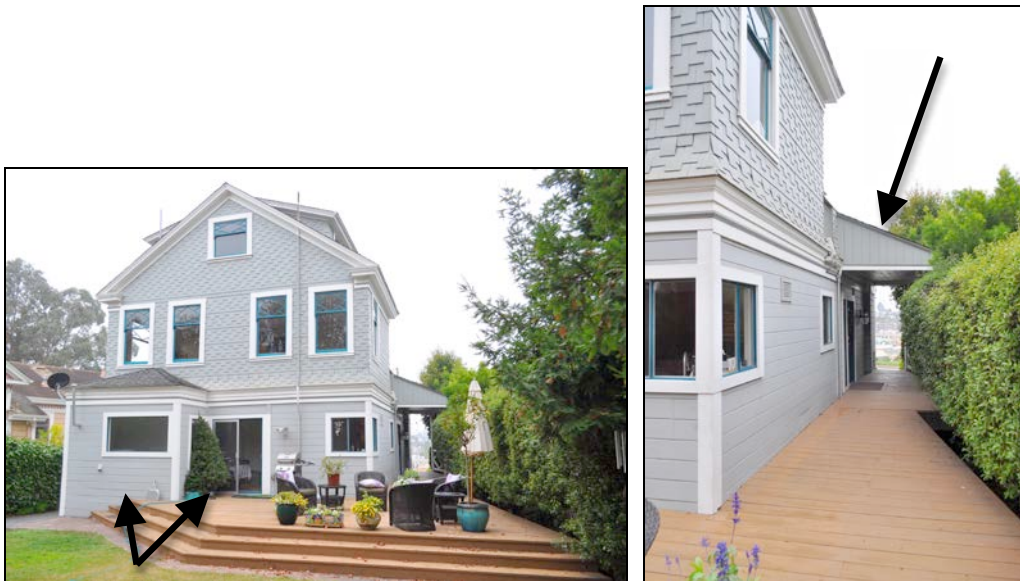
Figures 3 and 4. Left image shows the rear (east) elevation, with arrows indicating a rear addition and circa-1960s aluminum sliding glass doors. The upper-story wood sash windows are original. Right image details the north elevation, with modified entrance beneath the shed roof (arrow).

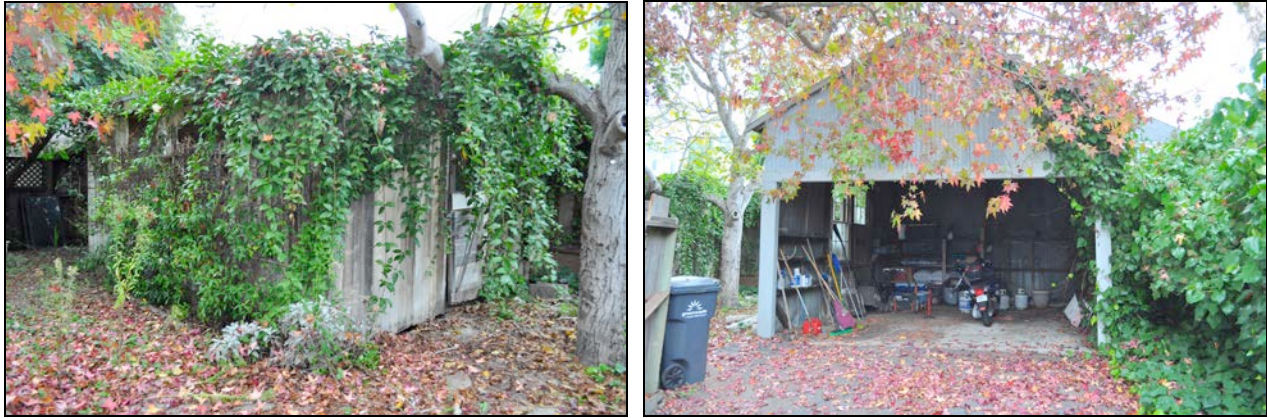
Figures 5 and 6. Left image shows the circa-1949 wood-clad shed outbuilding at the northwest property corner. Right image details the circa-1933 corrugated metal vehicle shed.

The above list indicates the remaining character defining features that are original to the subject house and that communicate the Queen Anne Victorian style. While the two outbuildings appear to be over 50 years old, both outbuildings were constructed out of the period of significance (circa-

1904) of the subject house and in styles and materials that are not in keeping with the Queen Anne-style house. For these reasons, the two outbuildings are not considered to be character-defining features of the site.

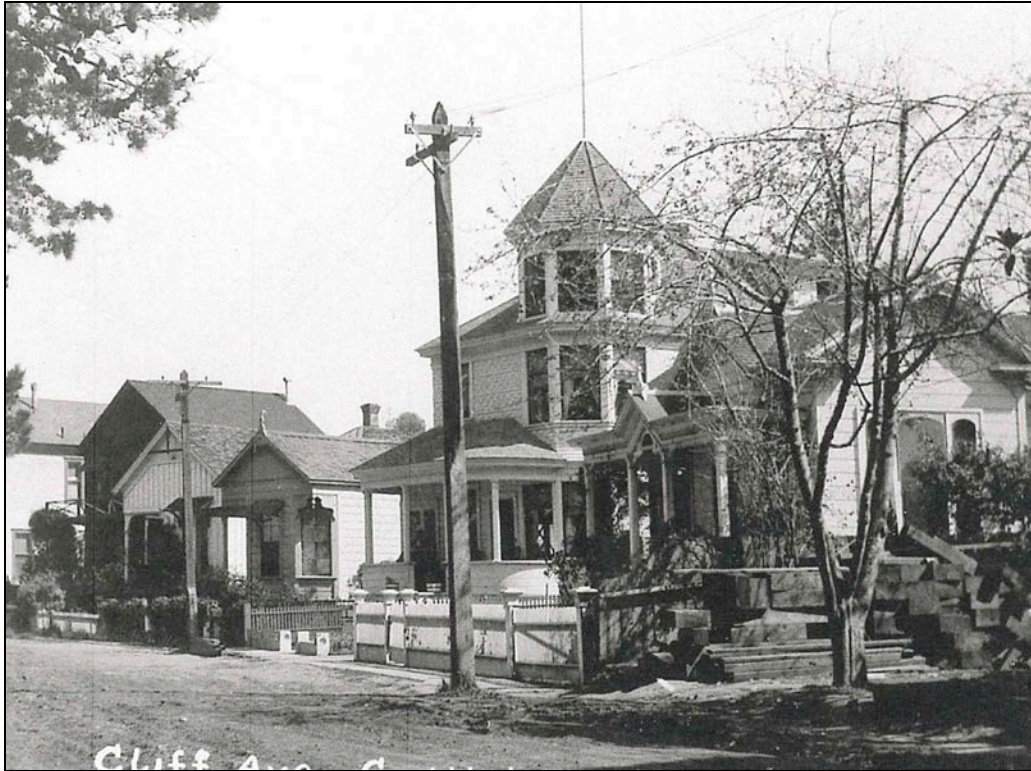
Figure 9. Undated image of the subject property, showing the open porch and entrance on the west elevation.

The undated photograph indicates an open front porch and west-elevation entrance, the patterned upper-story wood shingles and second-floor decorative wood sash windows. The remaining character-defining features are:
