WEISINGER
INCORPORATED

Ref: Water Well No. 01 Motor

Ref: Water Well No. 01 – College Hill

**PUMP INSPECTION REPORT
OIL LUBRICATED**

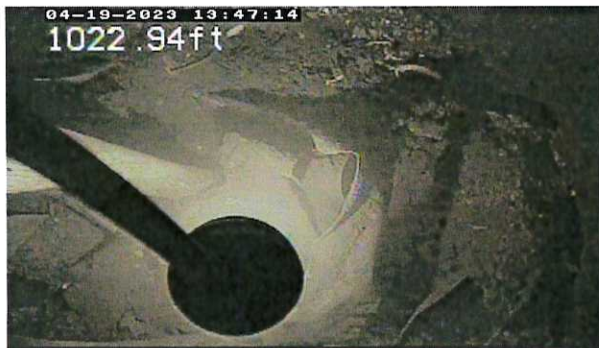
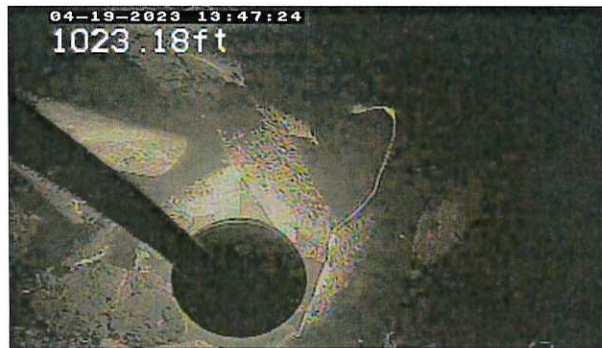
A TV Survey was performed on 04/19/2023 to investigate the conditions of the well after removing the pumping equipment. The static water level was 208' and the total depth viewed was 1023' which we believe is where the top of the 8" lap pipe is covered by debris that the camera could not penetrate. This debris will need to be cleared before permanent pumping equipment is installed and operated. . Our recommendation at this time is to attempt to push through the obstruction with work pipe, jet the fill/debris, and resurvey the well. Please consider the following:

- Install work pipe and airline and attempt to clear material blocking the top of the lap by jetting and/or pushing through the obstruction.
- Lower the work pipe to the bottom of the well and jet any accumulated debris from the bottom of the well under normal removal procedures..
- Re-televis the well after clearing the top of the lap and make a report of findings
