**SUBJECT: PM Environmental – Change Order #3 – PCB Remediation Workplan for Construction Debris**

**PHASE II ENVIRONMENTAL SITE ASSESSMENT  
FORMER HAWORTH PROPERTY**

**200 South Blue Star Highway  
Douglas, Allegan County, Michigan**

**October 2022**

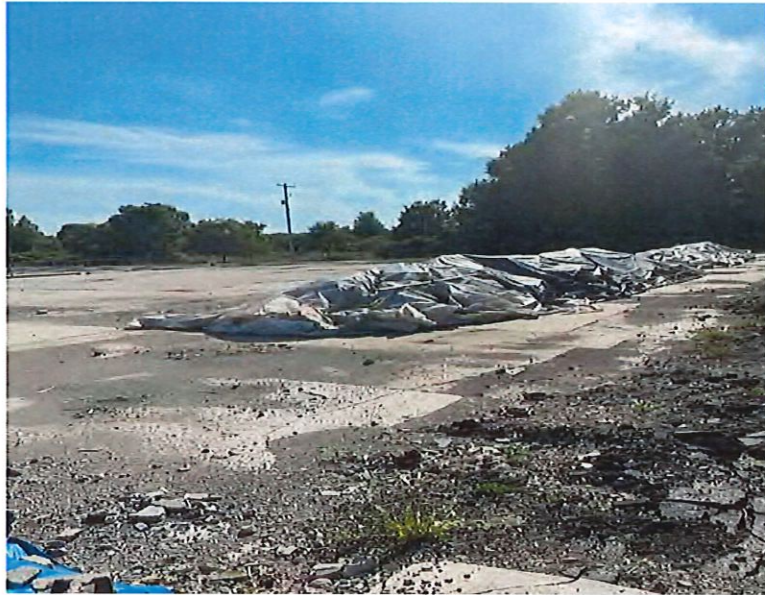
**Description:** East Room with debris piles located in the northern portion of the Site

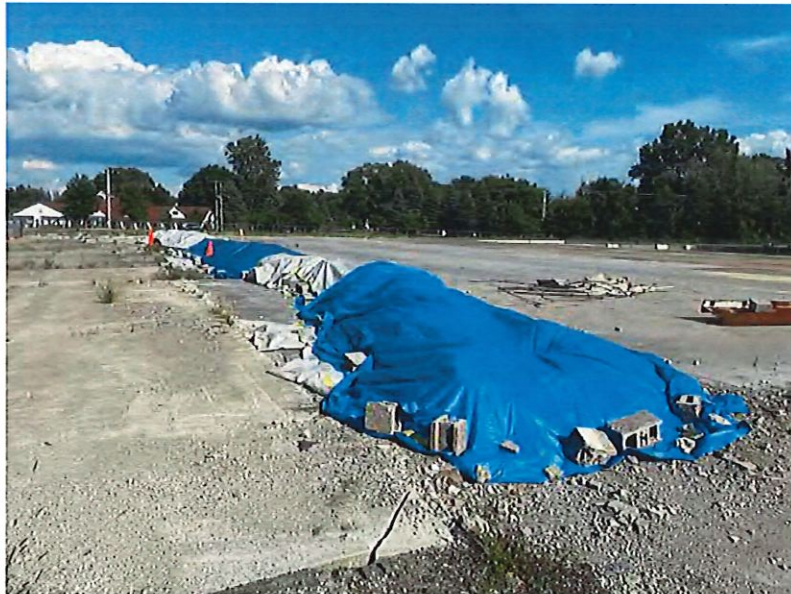
### Photograph No. 2

**Description:** West Room with debris piles in the northern portion of the Site.

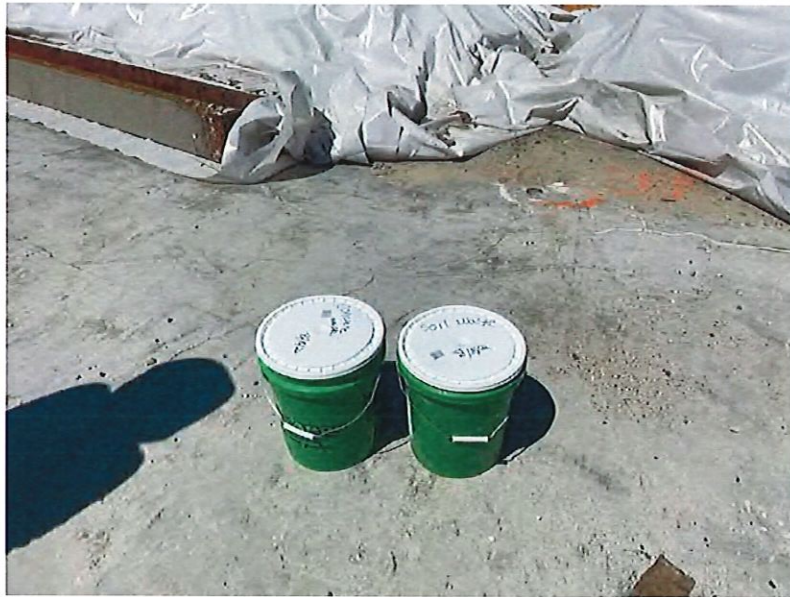
**Description:** Waste material buckets staged onsite awaiting disposal.
