A New Office Building for

Andrea & Ryan Hunt

**602 Old Fitzhugh Road
Dripping Springs, Texas 78620**

Tree Inventory

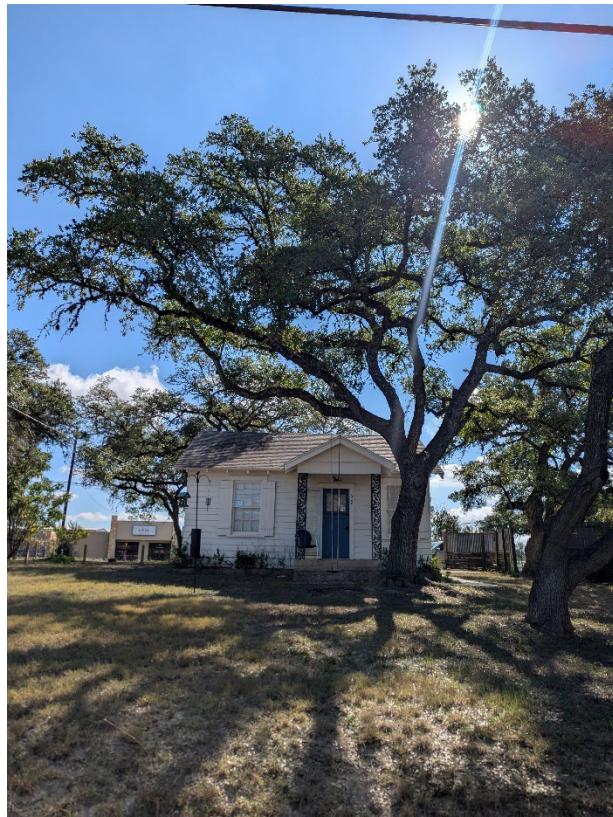
Photo 1: View of site.

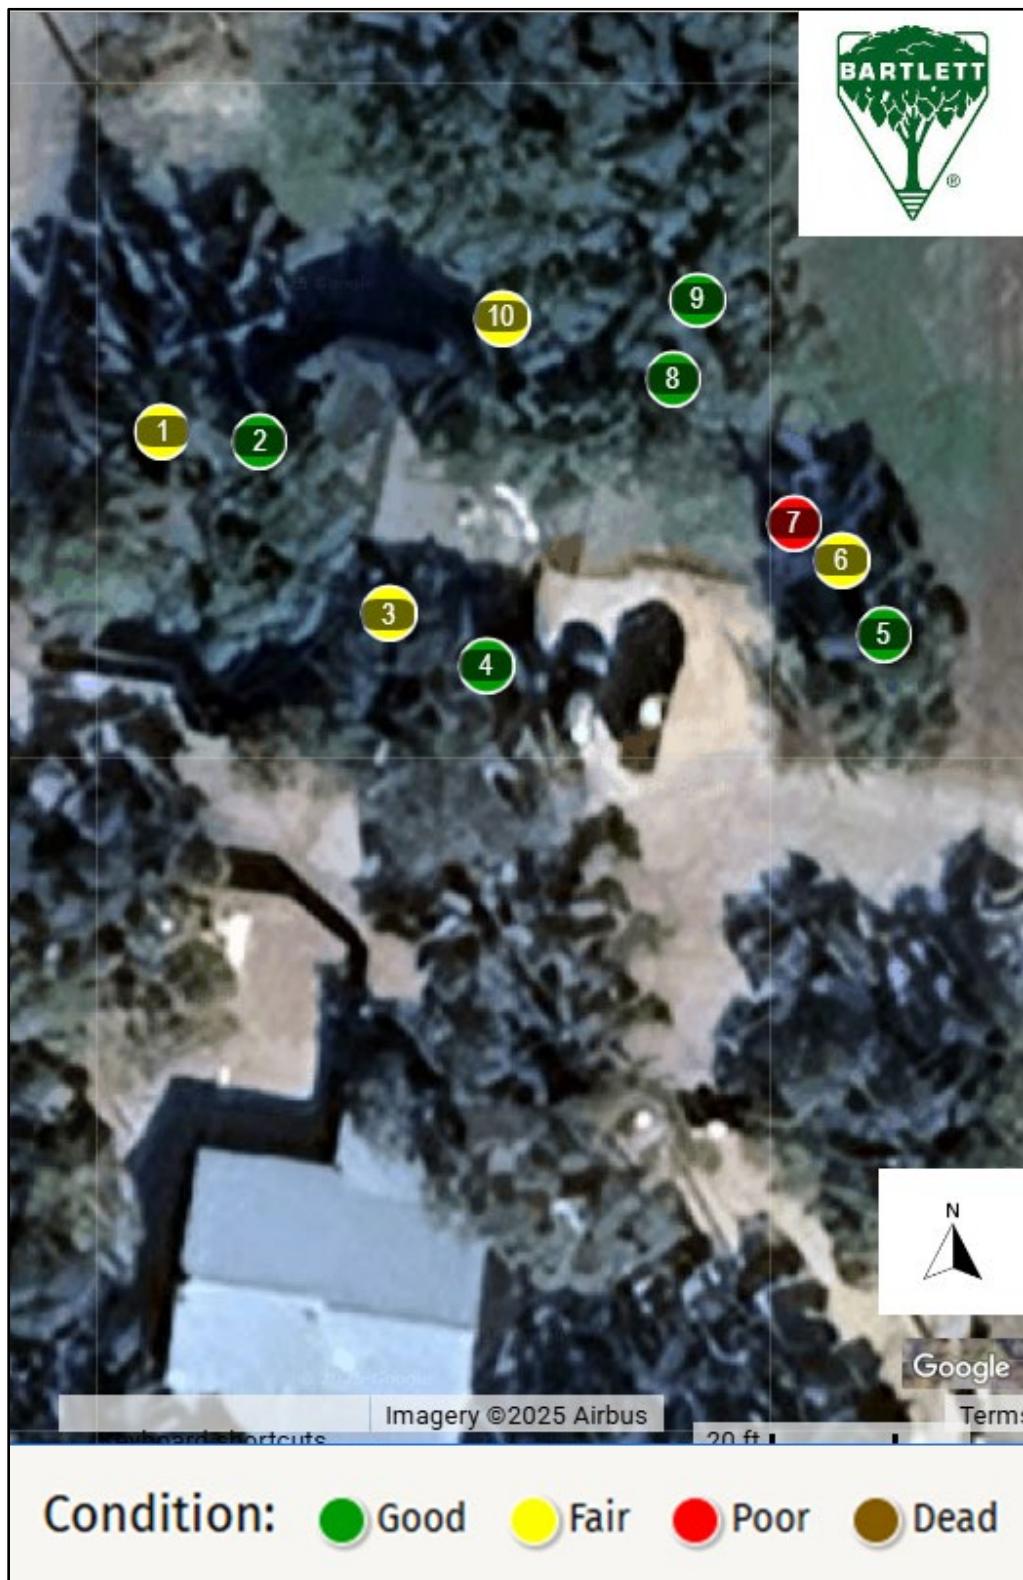
Appendix I – Tree Location Map
Arborscope Image Accessed September 2025

1. The condition ratings for the 10 trees were as follows (see tree location in Appendix I):
 - 5 trees were in good condition
 - 4 trees were in fair condition

- 1 tree was in poor condition
2. All of the observations may be found in **Table 1** (page 5).
3. The estimated mitigation (inches and dollars) is found in **Table 2** (page 6). **Table 3** (page 6) identifies the standard mitigation within Article 28.06 Landscaping and Tree Preservation.

4. Dead branches were noted trees #1, 3, 4, 5, 6, 9, and 10.
5. The lower canopies of trees #1, 4, 6, and 8 were low to the ground. Branches from live oak #1 were touching the service line.

6. Live oak #2 had a swing attached to a limb by rope.
7. Compliance to proposed CRZs is located within **Table 2**. If preserved, Tree Protection Zones (TPZ) will need to be installed on protected trees within the limits of construction if the site is developed.

1. Chinaberry #7 was in poor condition and is recommended for removal. The tree had several large dead branches, as well as a hanger in the canopy.
2. Prune dead branches and remove hangers from trees #1, 3, 4, 5, 6, 9, and 10.

3. Raise the canopies of trees #1, 4, 6, and 8, and provide clearance pruning for the service drop near live oak #1.
4. The rope on live oak #2 should be monitored and loosened to avoid girdling the branch. Girdling will block water and nutrient uptake and eventually lead to the decline of the branch. Switching to a different holding attachment or removing the swing would solve the issue.
