Planning Advisory Notice

FAA Aviation Obstruction Lighting (“Tower Lighting”)

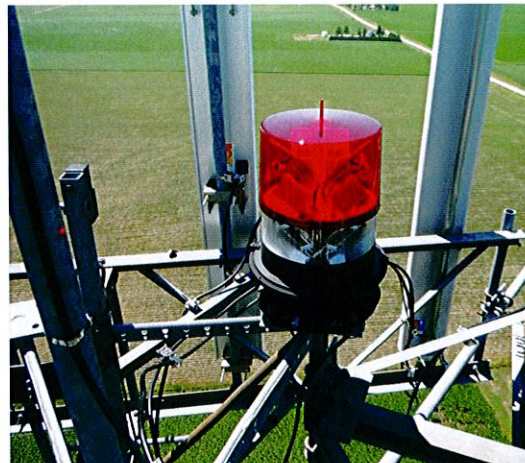
Picture 1: Beacon nested within panel antennas creating an unsafe, obstructed view. Not only is this tower owner subject to a Notice of Violation and forfeiture, the window of liability exposure is wide open if an aircraft incident occurs.

panel antennas, or to add antennas to an existing structure and obstruct the view of the tower lighting. Unobstructed view is iterated throughout the AC 70/7460-1K Chg 2. The top beacon on the tower must not be obstructed or a second beacon must be added (see Picture 1). Lower level beacons and markers must exhibit a 360 degree unobstructed view (see Pictures 2, 3). Failure to follow this procedure creates an unsafe condition.

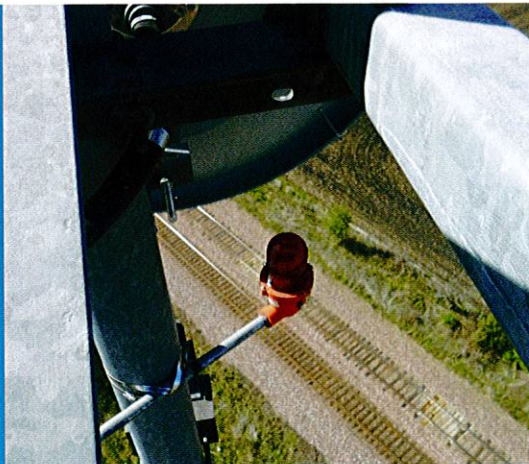
Picture 2: L-810 side marker light mounted behind antenna, creating an obstructed view.

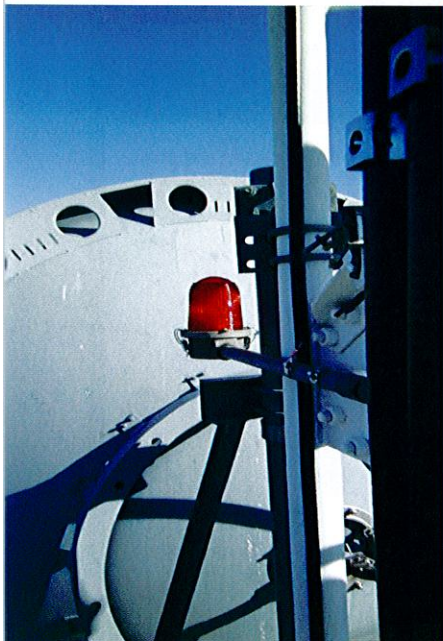
Picture 3: The FCC will allow an adjustment in the placement of an antenna with the proper filing, or the FAA (see AC70/7460-1K Chg 2) allows an adjustment in the placement of the lighting tiers by up to 10'. It is critical to understand that this is a 10' measurement from ground level, not to the base of the tower. Counting tower sections is not a safe means of measurement. All lighting must have an unobstructed view.

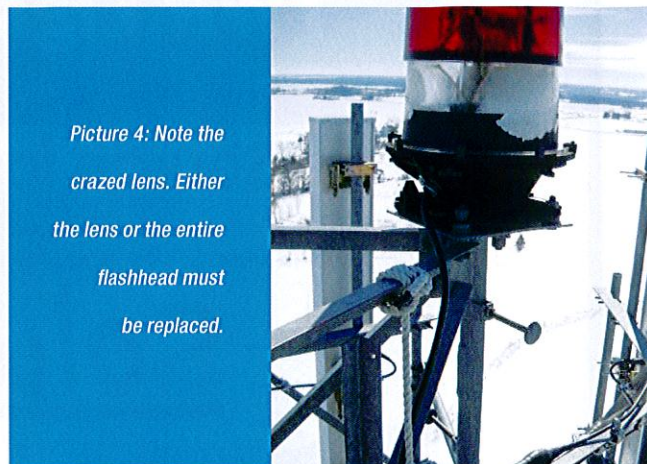
and cleaning of lenses on the lighting system at the tier levels. Crazed lenses (damage from UV rays and other sources creates tiny cracks in the lens that inhibit the output of the light) must be replaced.

Picture 4: Note the crazed lens. Either the lens or the entire flashhead must be replaced.

Respected tower lighting service companies can often save tower owners substantial expenditures (and headaches) through a long-term maintenance plan. PMs (Preventative Maintenance) by qualified service companies will not only include necessary repairs, but replacement of parts that are at the end of their life cycle. A full inspection of the system and, when applicable, the orange and white paint bands with full documentation should include a list of parts replaced and photographs of the system components. It is important to understand replacement of the lamps or tubes in the lights is not the only consideration. Crazed lenses must be addressed (see picture 4). The FCC requires an annual inspection
