Staff Report
(with attachments)
Presented to the
Historic Preservation Commission
July 17, 2024

STAFF REPORT Historic Preservation Commission	July 17, 2024
---	---------------

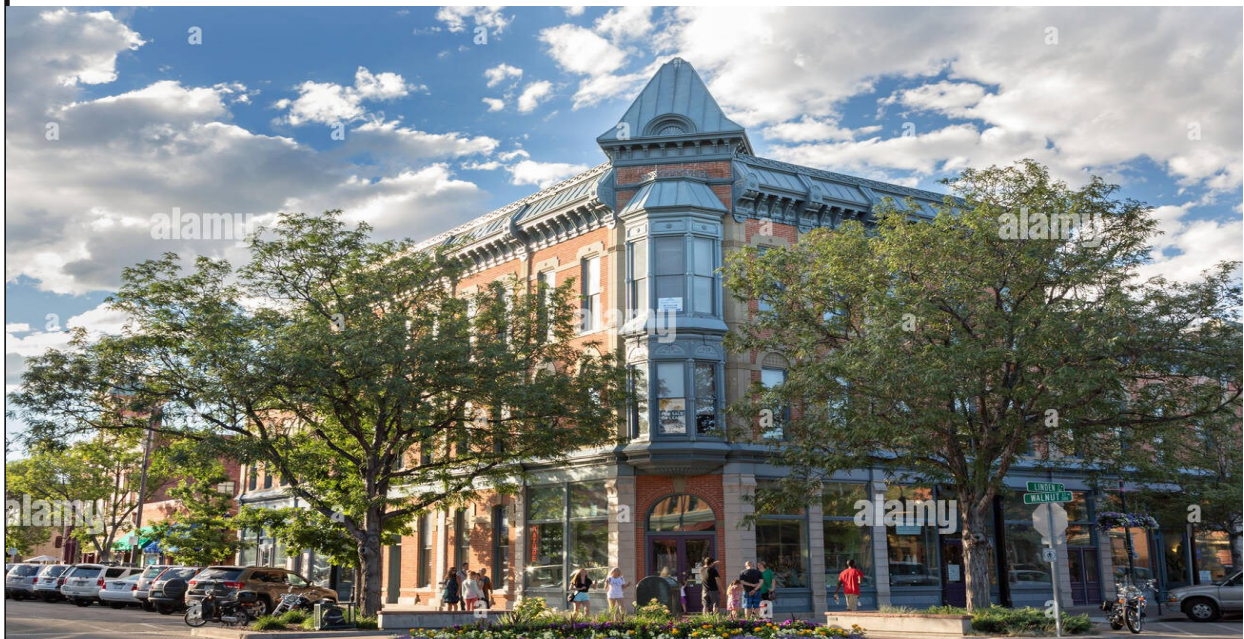
201 Linden Building Window Information, Past Repairs and Proposed Replacement

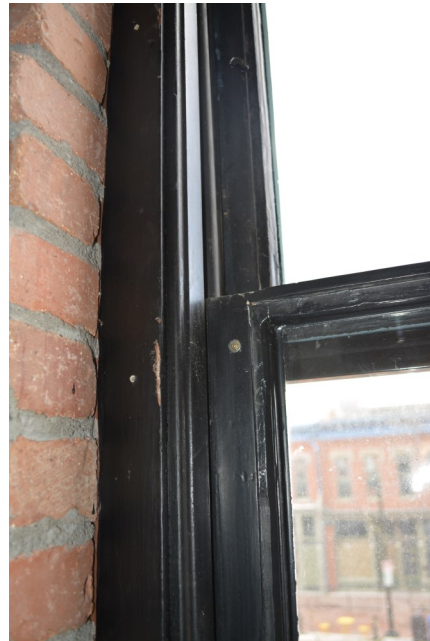
Sash Screwed Together

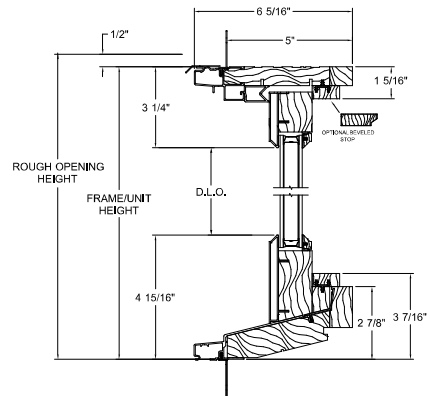
NOTE: Drawings are not to scale. Brickmould is shown factory-applied. Brickmould may be shipped loose for field application. Some units are shown with optional drip cap or nailing fin. For Ultra accessory or application drawings, see pgs. 206-212. Additional and the most current drawings are available at www.kolbewindows.com.

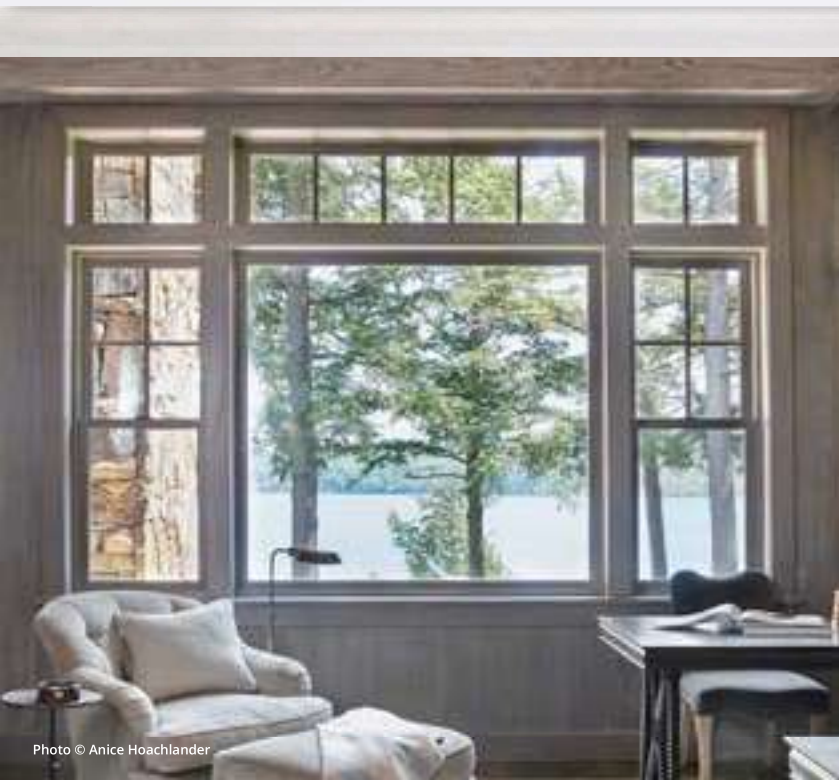
Photo © Anice Hoachlander

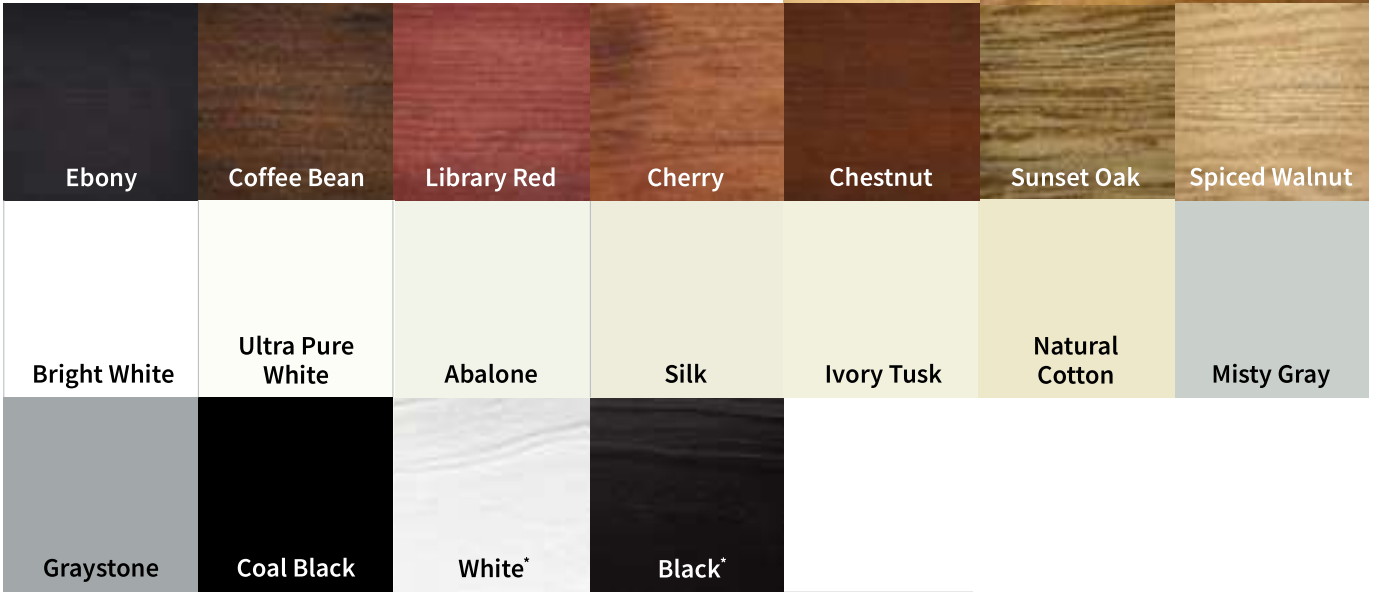
For units that are ready to install upon delivery, Kolbe's Ultra Series windows and doors can be prefinished on the interior with one of the water-based stains or paints shown. Stained units are given two coats of satin clear finish. Because our interior finishes are water-based, low-VOC stains and paints, you can rest assured you've made an environmentally conscious decision. Custom colors may be requested as well.

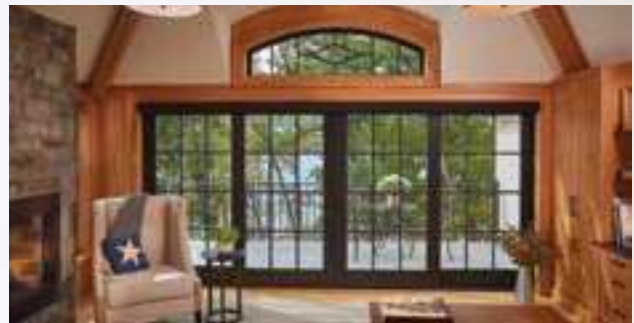
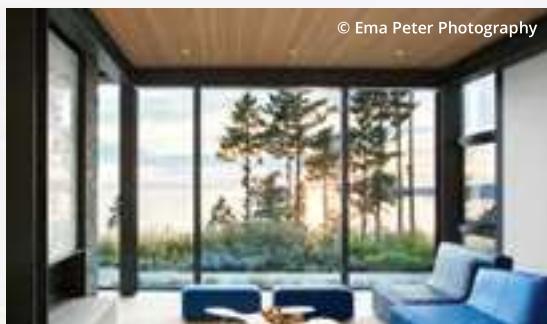
We're for possibilities.

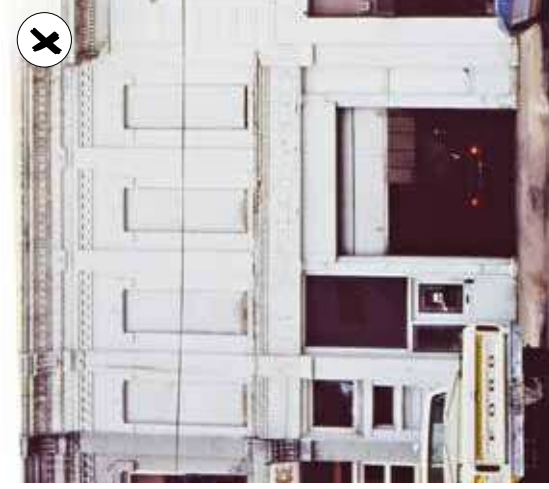
Before rehabilitation: historic windows are missing.

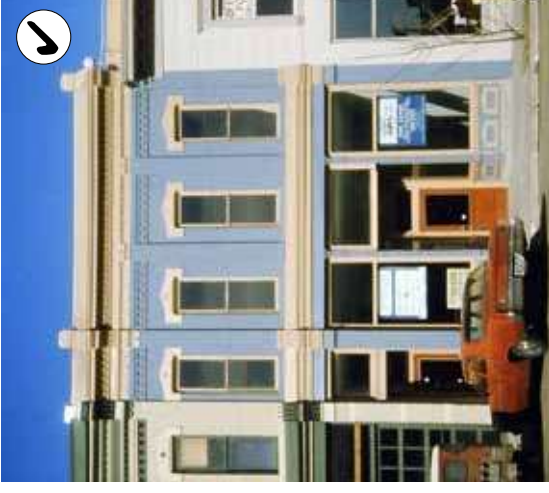
After rehabilitation: historic openings are restored.

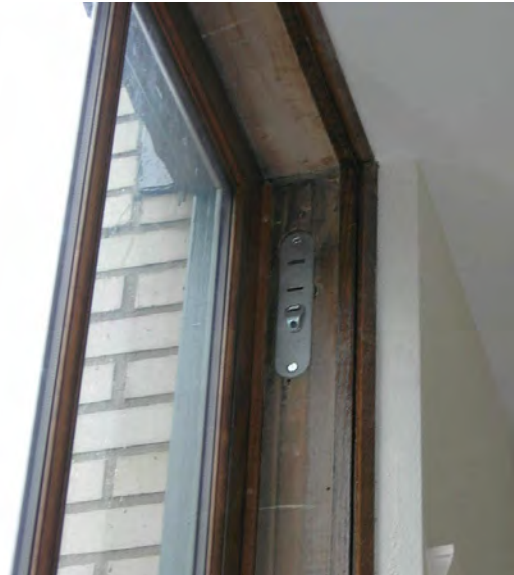
Image 3: Pullman balance installed in place of a window pulley. Photo courtesy of the Pullman website

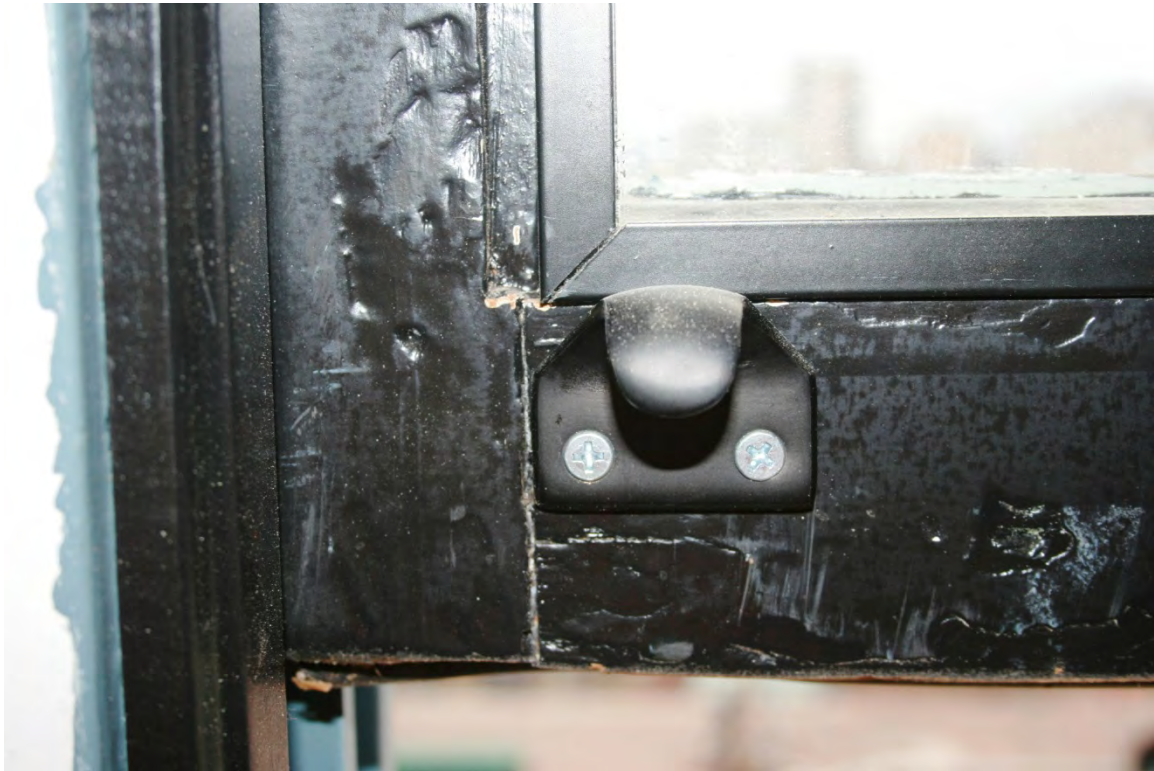
Image 8: Note that glass panel does not fit tight in groove

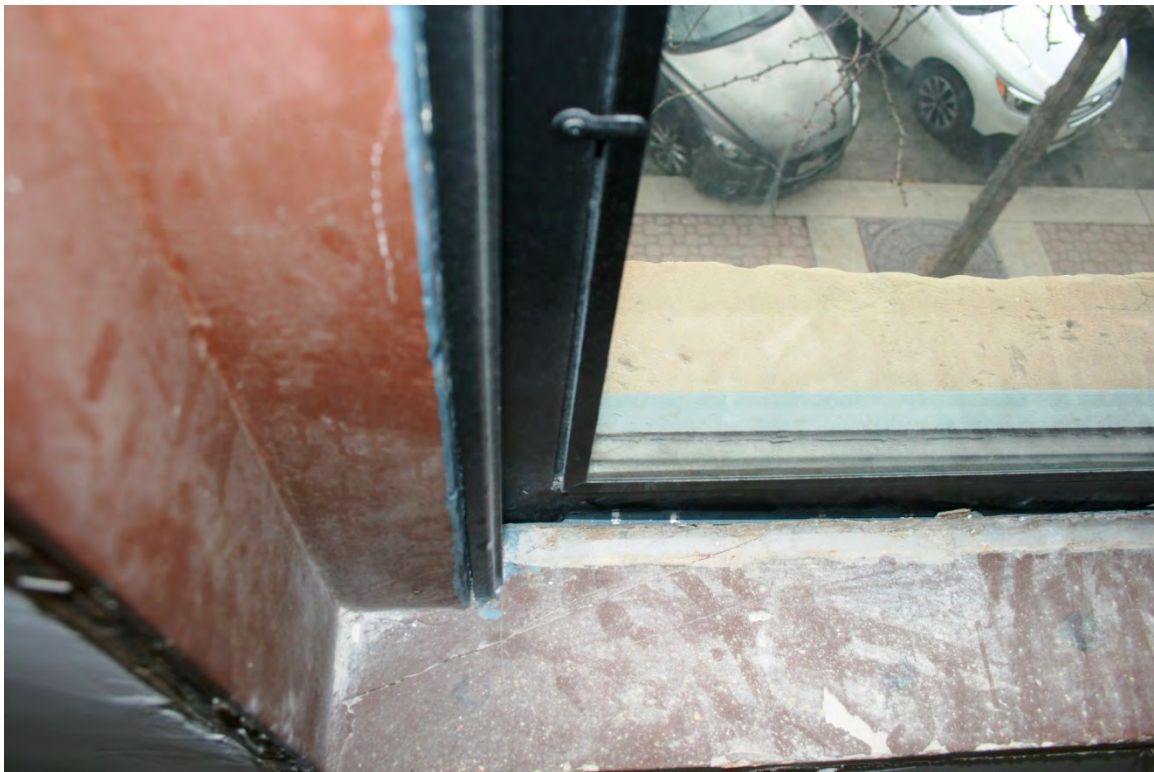
Image 9: Glass panel is slipping. Fit is loose

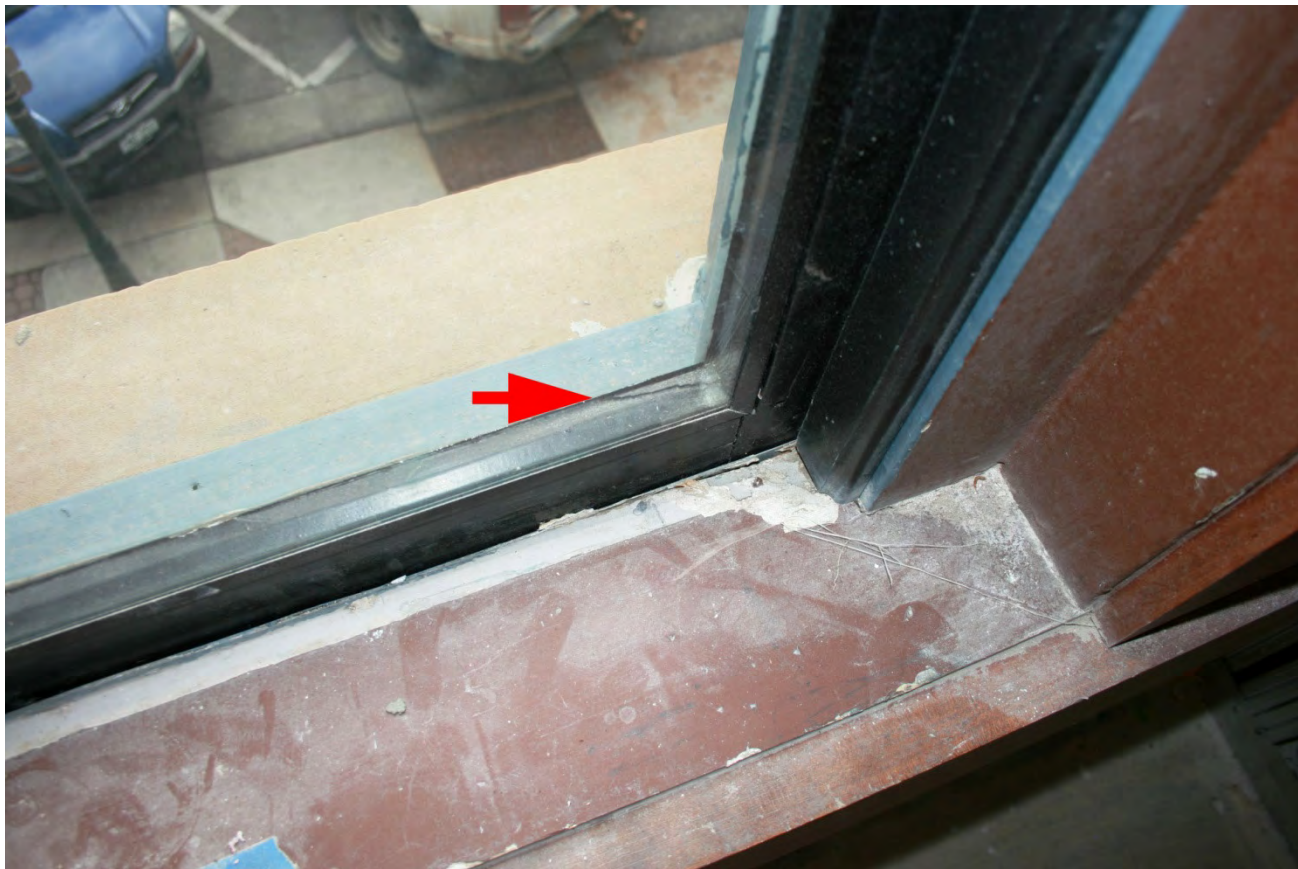
Image 19: Window 002-6, note crack in lower rail

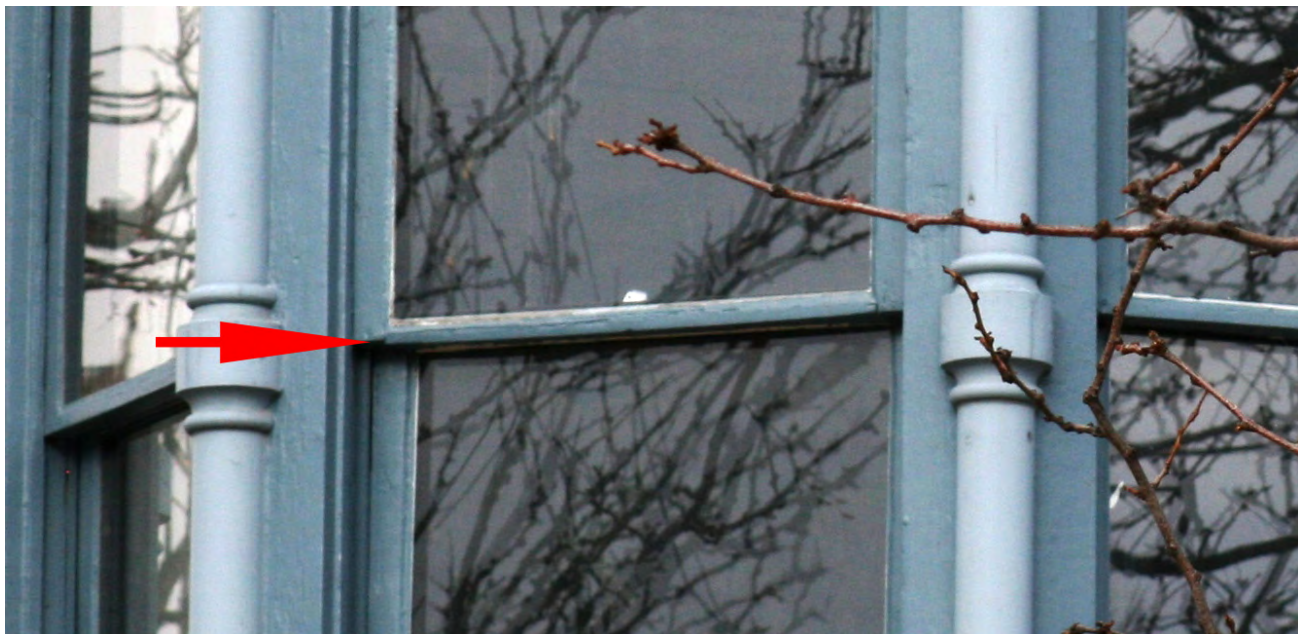
Image 20: Window 002-11, note meeting rail slipping down

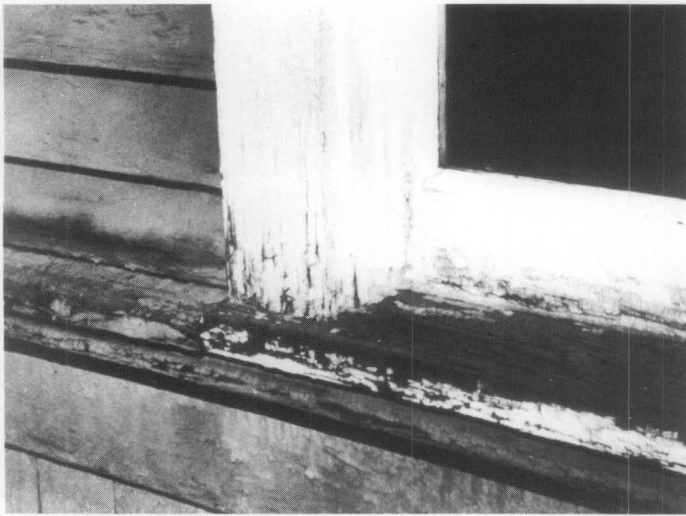
Figure 3. Deterioration of poorly maintained windows usually begins on horizontal surfaces and at joints where water can collect and saturate the wood. The problem areas are clearly indicated by paint failure due to moisture. Photo: Baird M. Smith, AIA

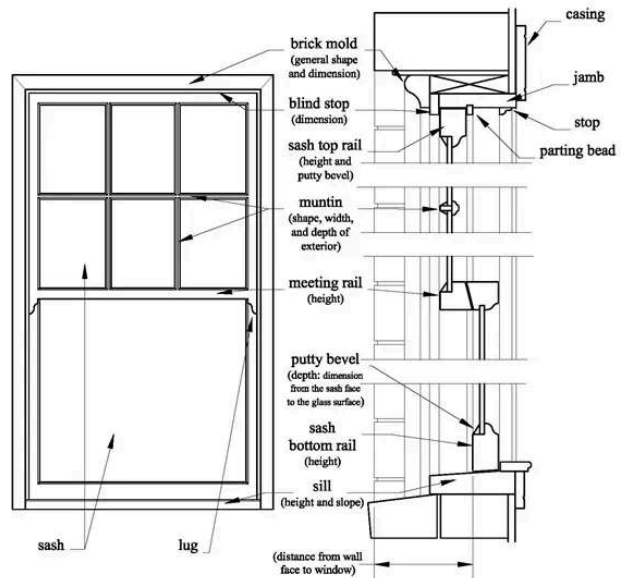
Elevation and sections of a wood window.

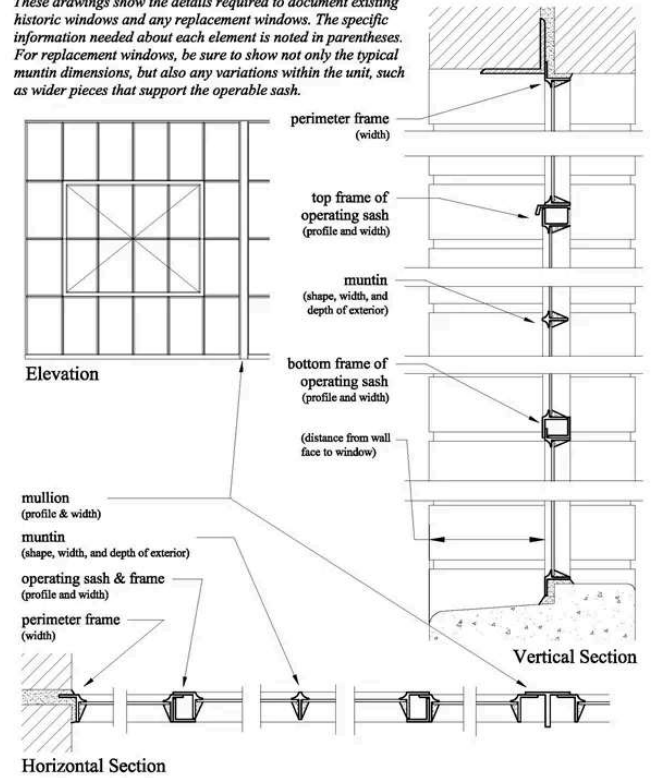
Elevation and sections of an industrial steel window
