**TO:** Township Board & Department Heads

**FROM:** Deby Henneman, ADAC - Township Coordinator

**DATE:** April 9, 2025

**AGENDA ITEM TOPIC:** ADA Transition Plan – 2025 Updates for Budgeting Purposes

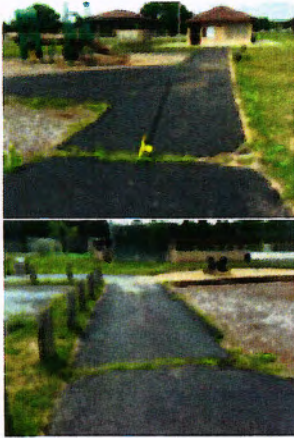
There are 4 large gaps around the playground walkways.	ADAAG 302.3	Fill in or replace section of asphalt sidewalk to provide a flush transition or an opening no greater than 1/2 inch.	1		\$
