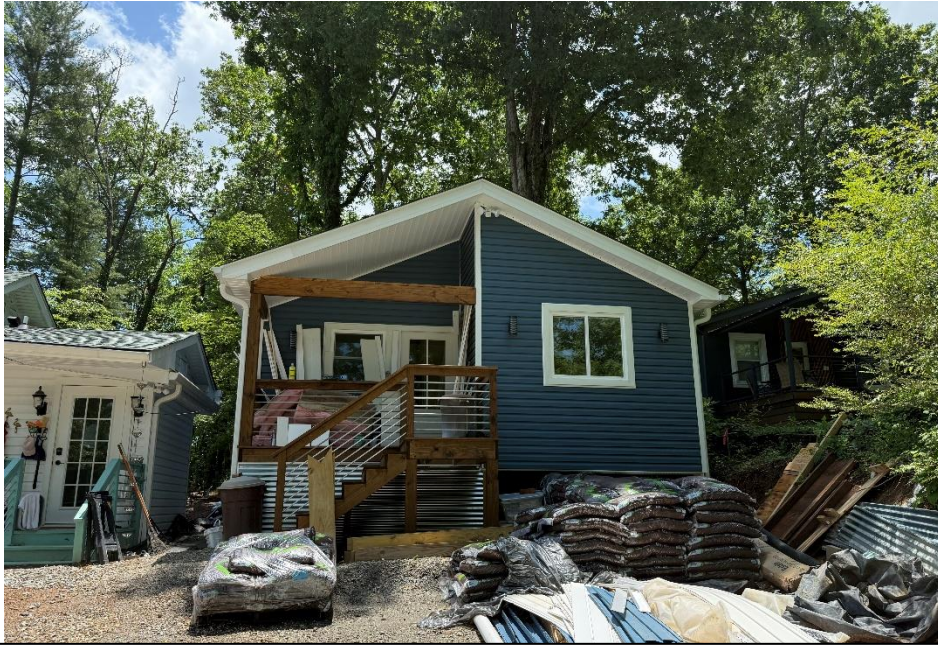
Front view of subject property. The right side of the structure is encroaching into the setback by two feet. Provided by staff.

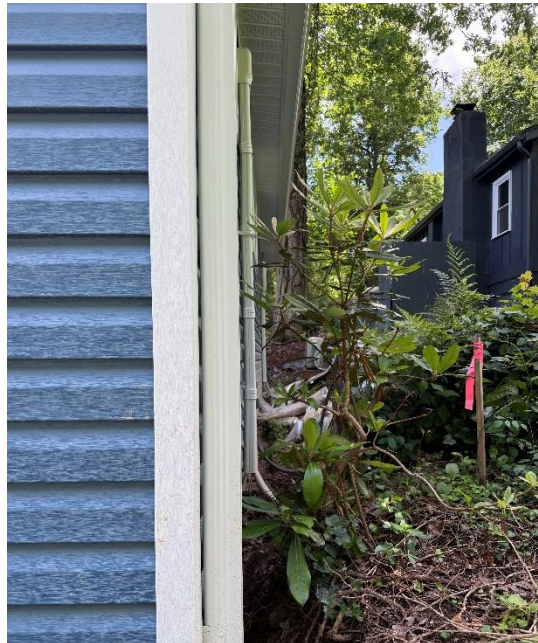
View of front corner of building to property line stake. Provided by staff.

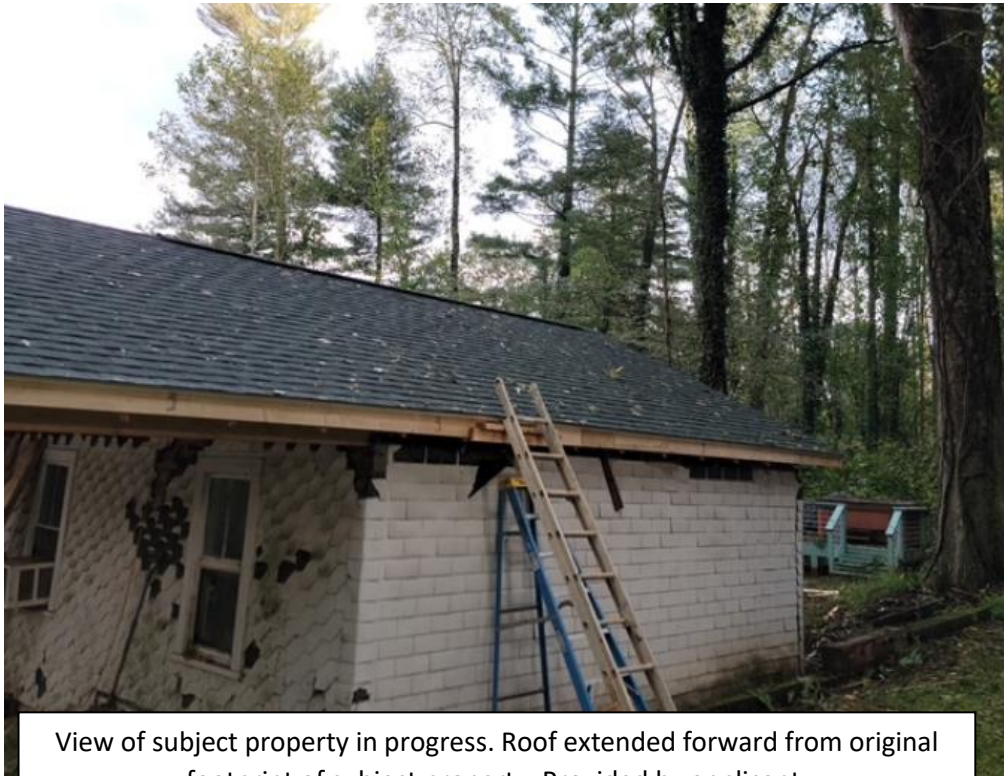
View of subject property in progress. Roof extended forward from original footprint of subject property. Provided by applicant.
