1015 N MAIN STREET – Siding Replacement, Window Replacement, Rear Addition (25-82-COA)

CITY OF HENDERSONVILLE - COMMUNITY DEVELOPMENT - HISTORIC PRESERVATION
COA STAFF REPORT

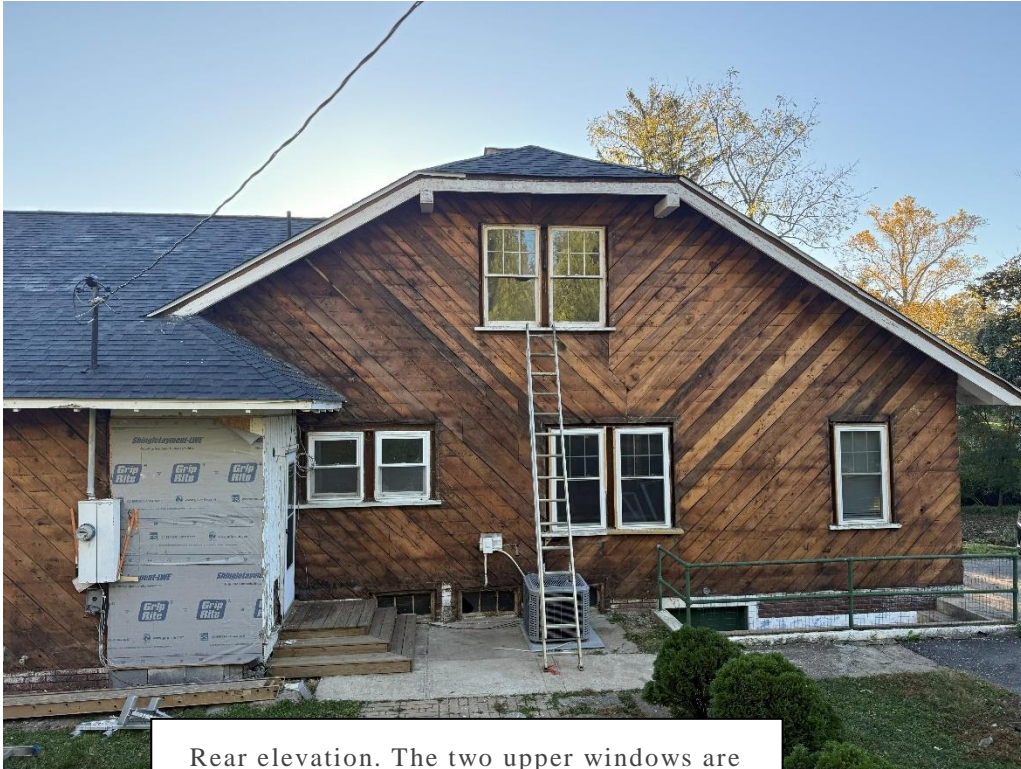
Rear elevation. The two upper windows are proposed for replacement.

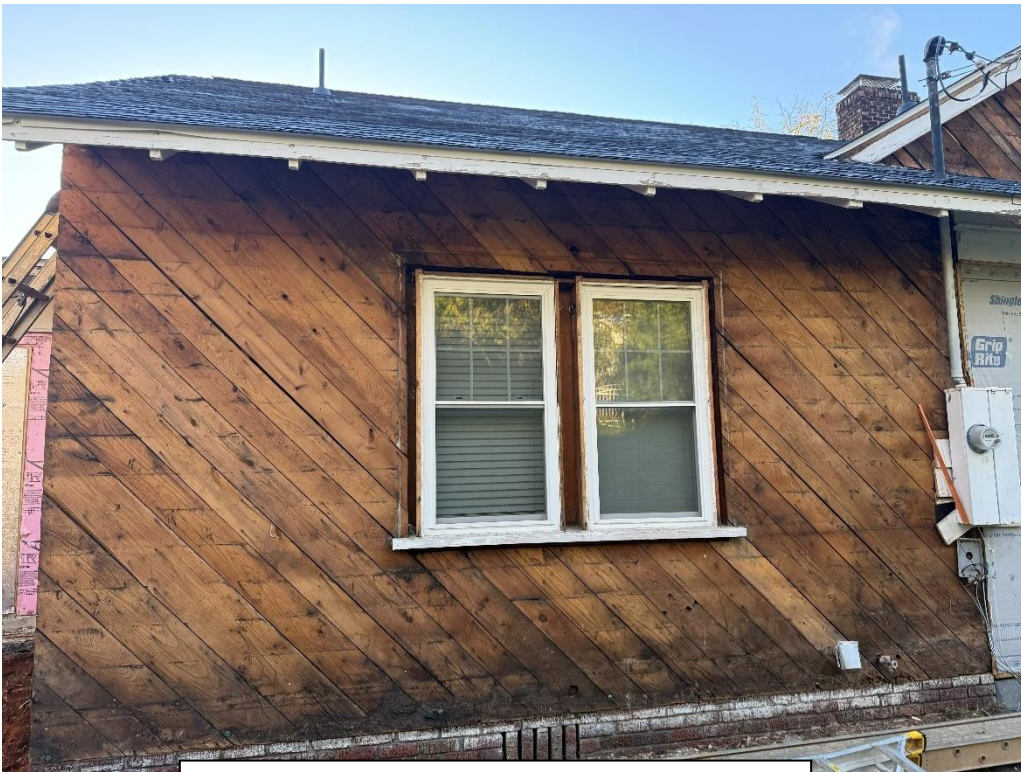
Rear elevation.

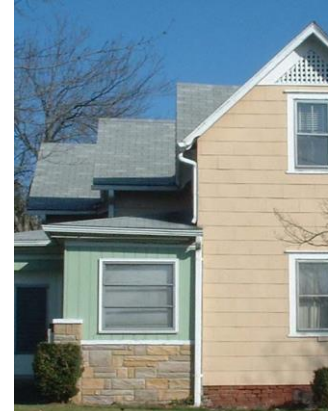
The siding material and windows on this addition are not appropriate for this building.
