1420 RIDGECREST DR. – After the Fact Approval of Windows

(H24-021-COA)

CITY OF HENDERSONVILLE - COMMUNITY DEVELOPMENT - HISTORIC PRESERVATION
COA STAFF REPORT

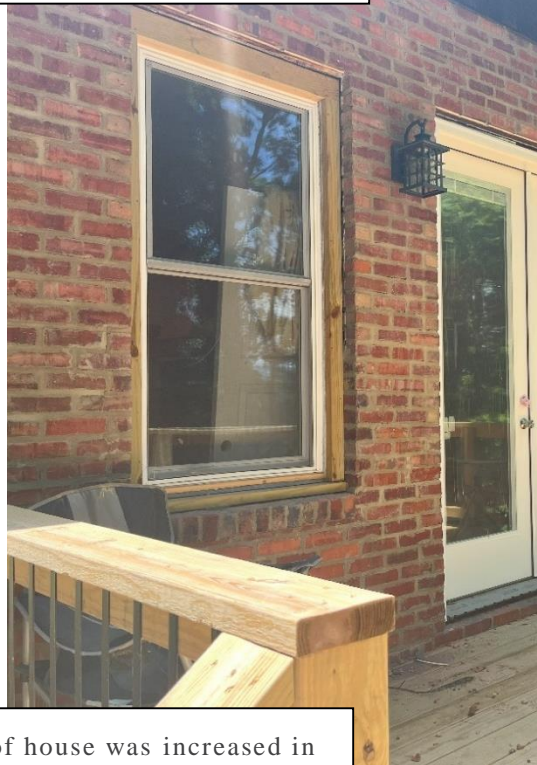
Left window opening on rear of house was increased in size to allow for a larger window.
