# 1420 RIDGECREST DR. – Replacement Front Door, After-the-Fact Rear Double Doors (H24-049-COA)

CITY OF HENDERSONVILLE - COMMUNITY DEVELOPMENT - HISTORIC PRESERVATION  
COA STAFF REPORT

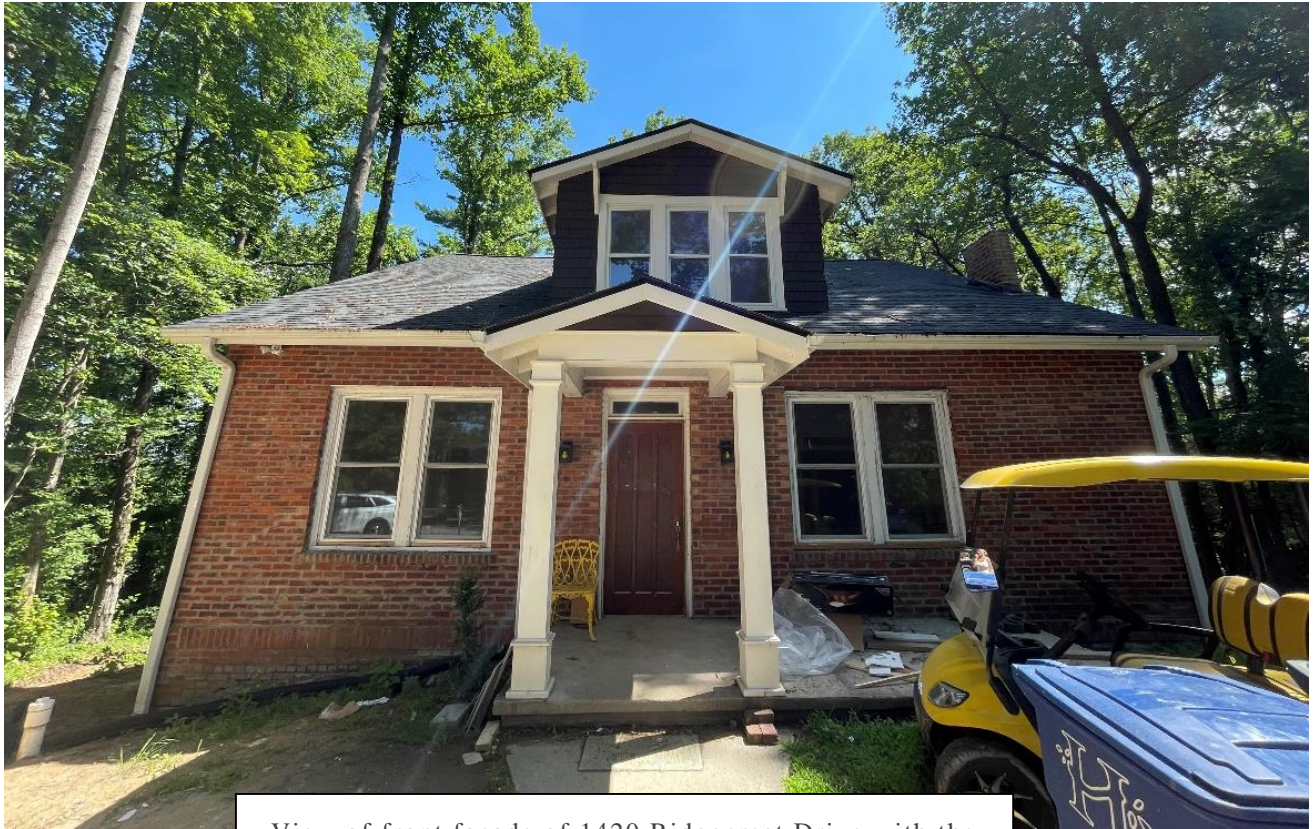
View of front façade of 1420 Ridgecrest Drive with the existing front door.

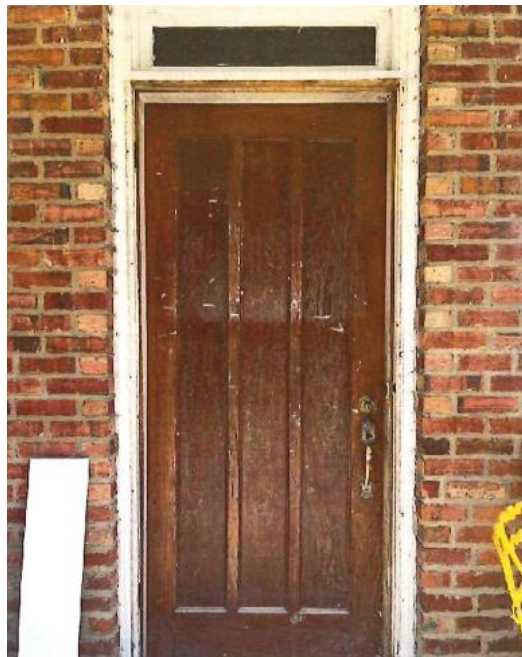
Close up of front door.

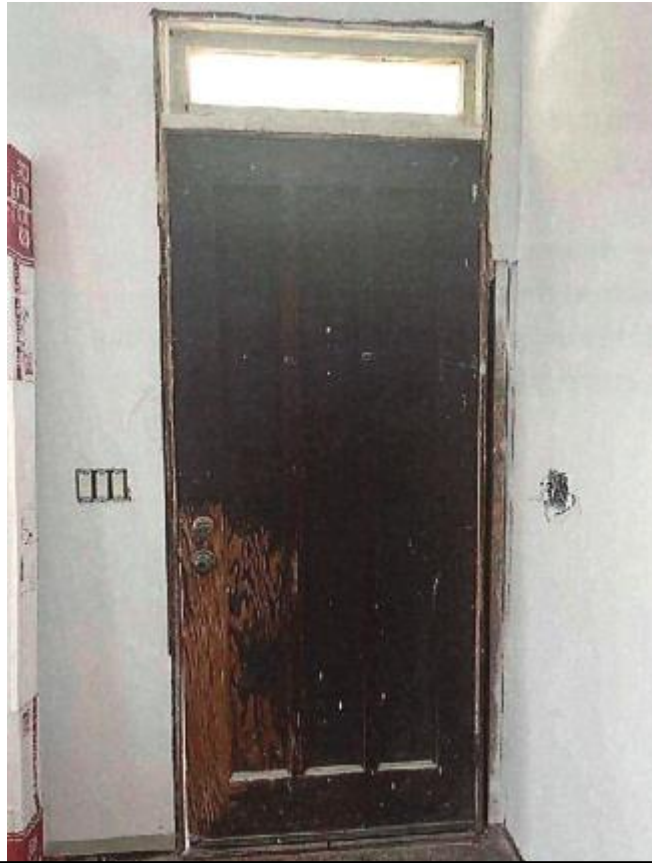
Damage to interior of front door.

**REQUEST I: Replacement Front Door.** The applicant is seeking approval for a new front door, to be based on the current front door's design.

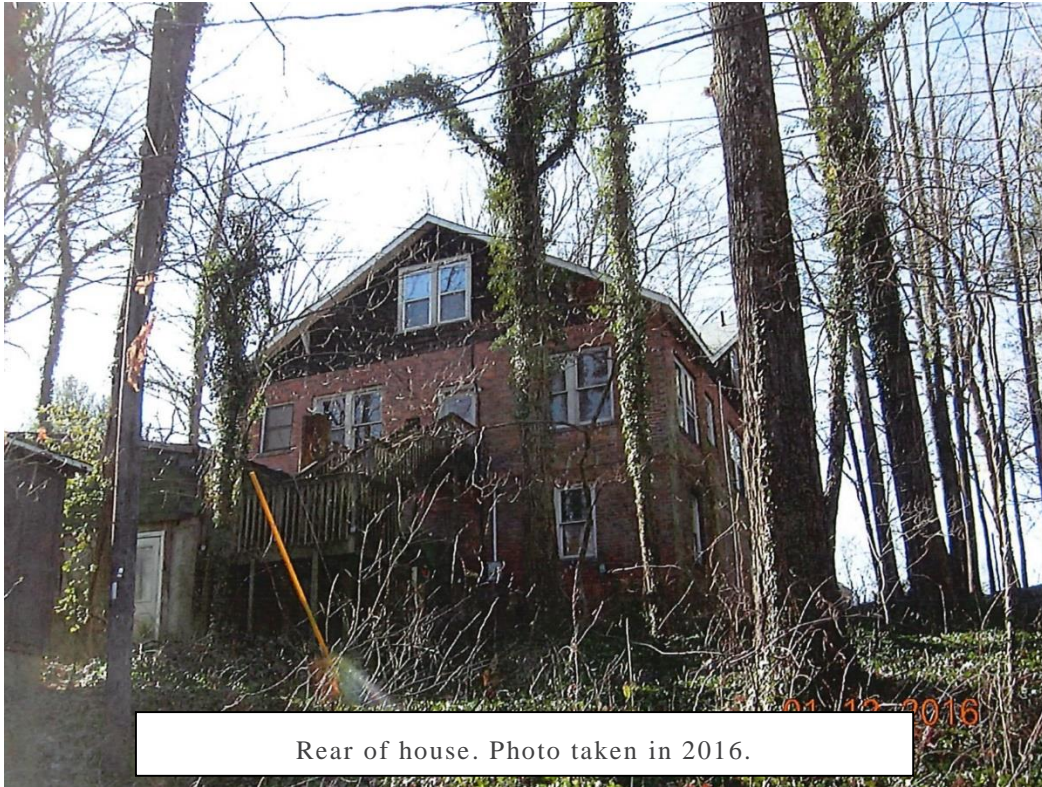
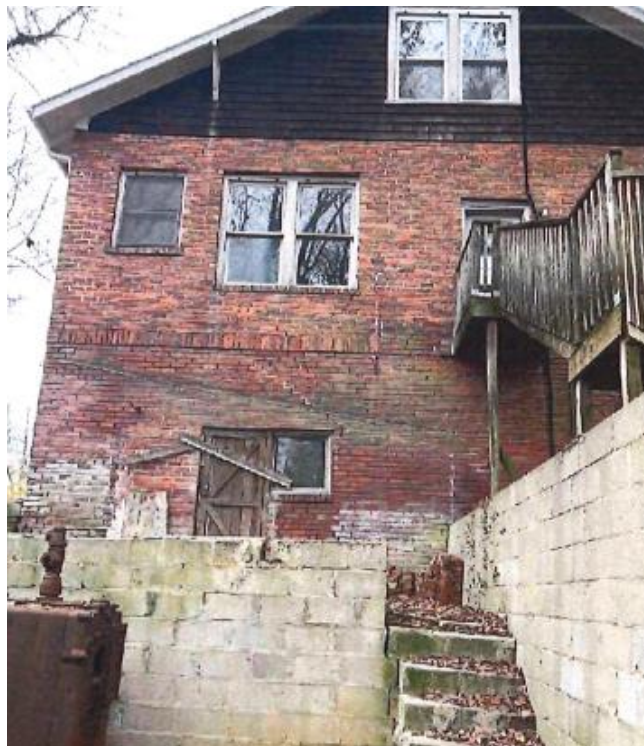
Rear of house before double windows were replaced with double doors.

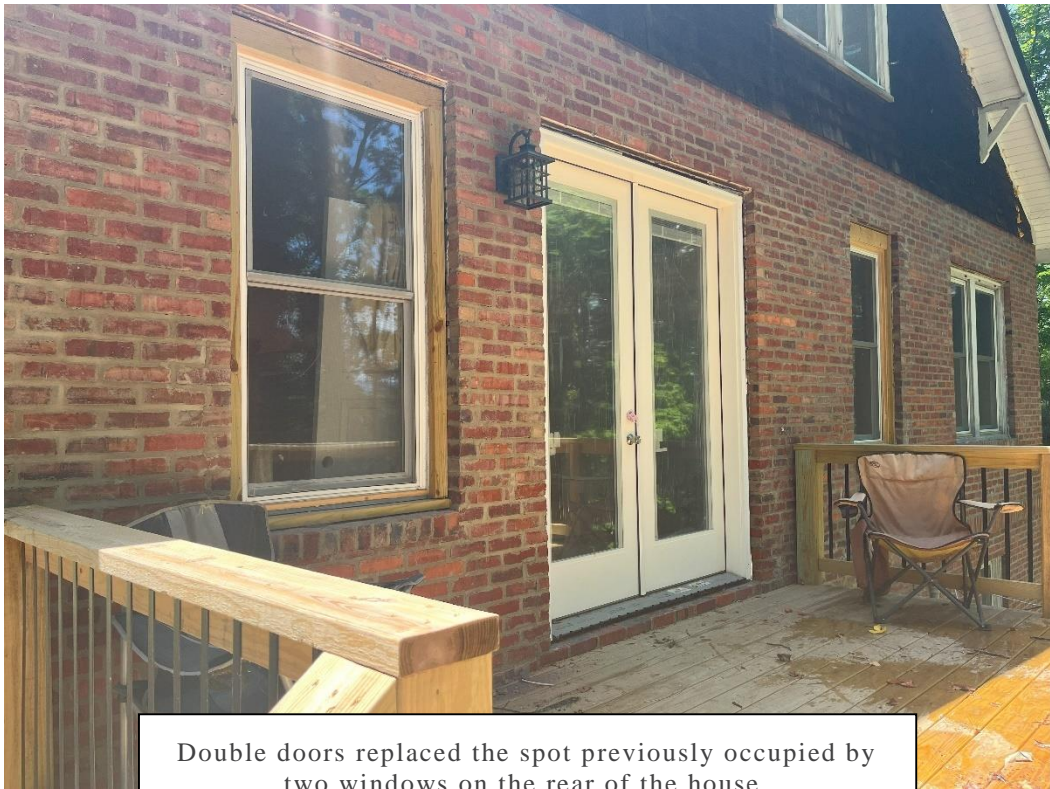
Double doors replaced the spot previously occupied by two windows on the rear of the house.
