**Electric Utility System Hardening and Reliability Improvement
Project**

**Western Circuits - 26B1W13 Update and
26B6001, 26B6003, 26B6004 Hooper Construction \$2.4 Million
Project**

**System Hardening and Reliability Improvement
Hooper Construction \$2.4 Million Project
26B6001, 26B6003, 26B6004**

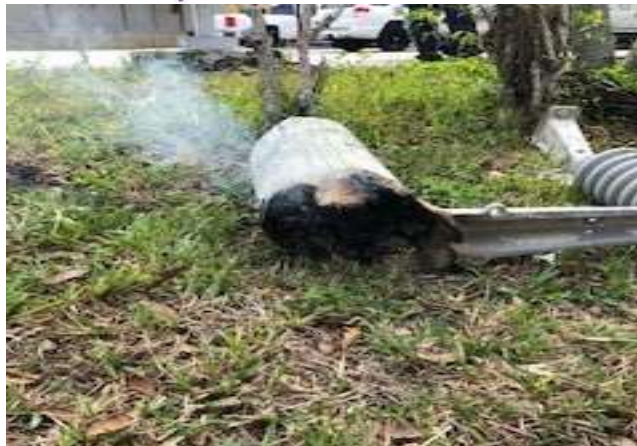
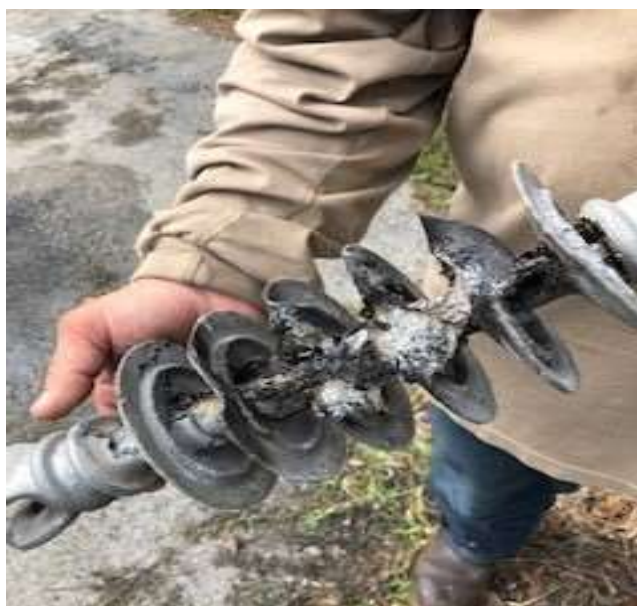
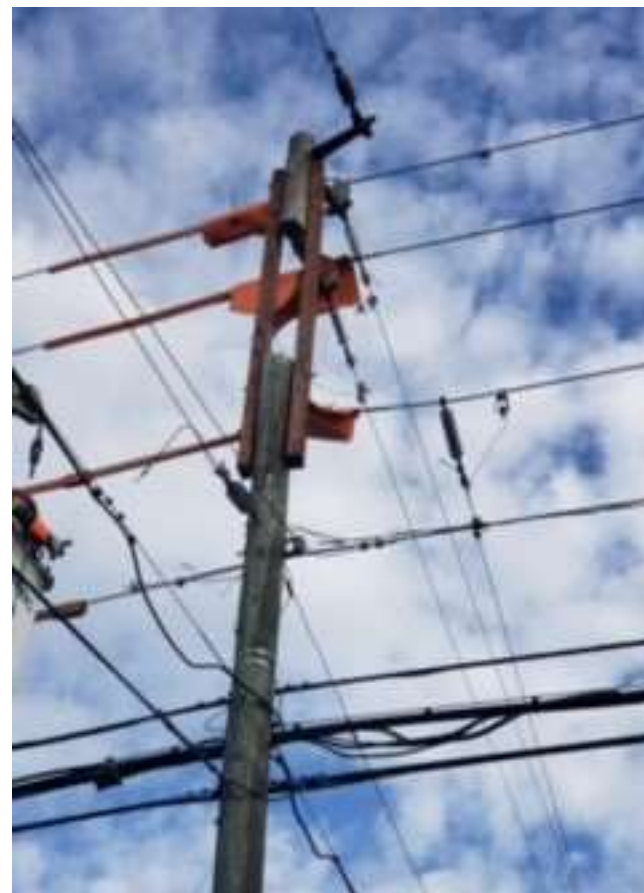
- Images of what happens if the Identified Issues are not Addressed
- Early Morning February 17th 2021 Pole Fire - causing 2 Breaker reclosing events affecting 1373 customers - sustained outage for 174 customers for 2 hours – extended outage for 20 customers for 7 hours
