CITY HALL ANNEX

Lake Worth Beach, Florida

Building Condition Assessment

March 3rd, 2025

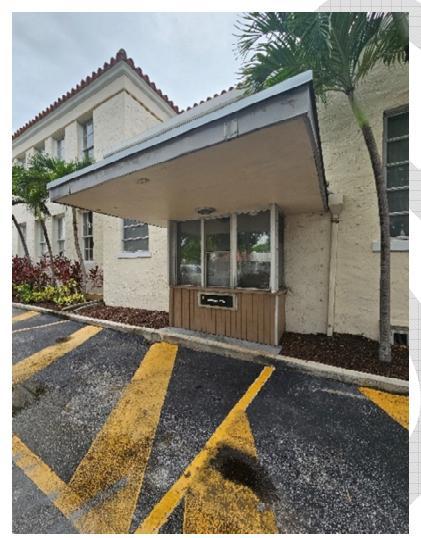
Figure 1: Customer Service Window

The customer service window is intact but has some major wind and water damage to be repaired at the roof, storefront systems, and base of the structure. The roof fascia is bent out of place and the electrical receptacle located on the soffit shall be replaced to meet the necessary codes. The wood siding is slightly warped, and all associated components are aged.

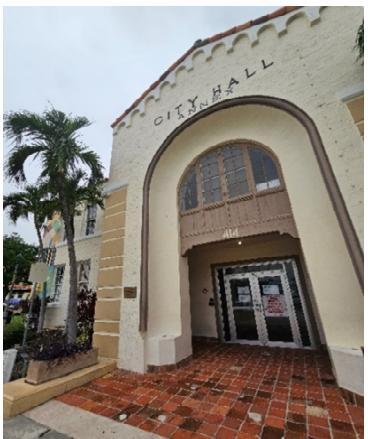
Figure 2: South Entrance

The main entry into the building previously included a public drop box that is now boarded. It will need to be removed and sealed according to code. Existing bike rack, also located in entry, may deter access into the building. Final location shall be coordinated with city at time of design. All plaques and signage installed on the building appear in good condition and can be reinstalled in existing locations.

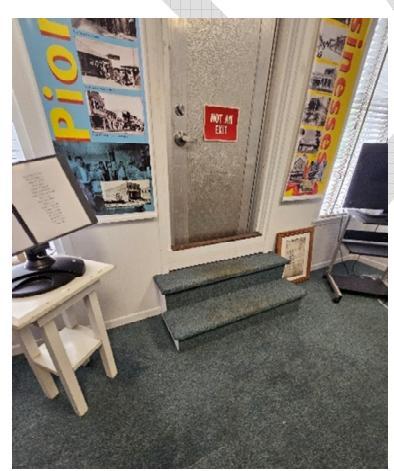
Figure 3 Roof Access

Existing interior doors appear to be in good condition but may require a level of refinishing to achieve and maintain historical aesthetic, but there is a possibility of reuse for interior doors. Some of the door openings require widening for ADA accessibility. Interior glass appears to have been painted or superficially covered in some locations. Top floor roof access is a trip hazard as well as a water infiltration concern because the bottom of the door is flush with the top of roof.

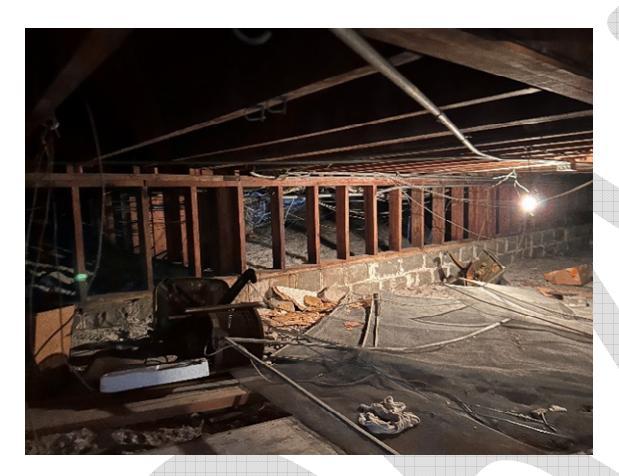
There is a crawl space under the first-floor framing where floor framing is exposed. The floor is framed with wood joists that bear on a wood-framed stem wall. The wood stem wall sits on top of an 8-inch masonry stem wall that is supported by a continuous concrete foundation wall. The

Photo 1. Floor joist bearing on Wood Stem wall at the crawl space

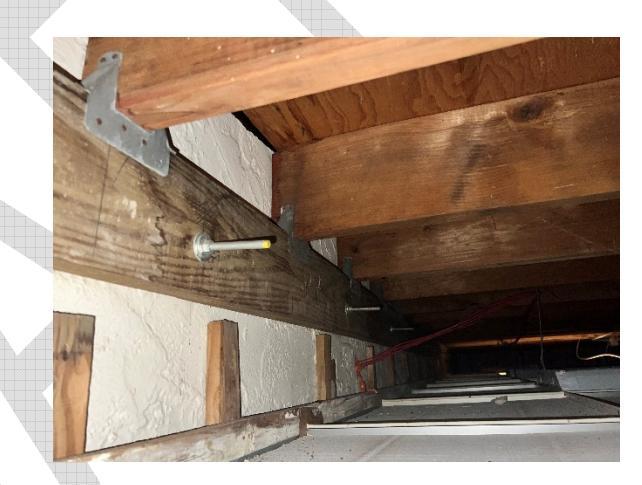
The majority of the first-floor area is framed with 2x14 wood joists spaced at 12" on center and some areas are framed with 2x8 wood joists at 12" on center. This is confirmed with the drawings prepared by Botkin and Associates. The floor joist spans from the 8-inch exterior concrete masonry unit (CMU) wall to the interior wood stem wall. The second floor is framed similar to the first floor. The floor joist is secured with one 16d toenailed to the top plate of the wood stem wall and bearing wood framed interior wall. At some locations, the top plate is a single 2x6, and in some locations is a double 2x6. The joist is supported on the 2x4 wood ledge bolted to the exterior CMU wall. The joist is secured with a Simpson-strong type connection. The exact model and capacity cannot be confirmed.

Photo 2. Floor joist to exterior CMU wall

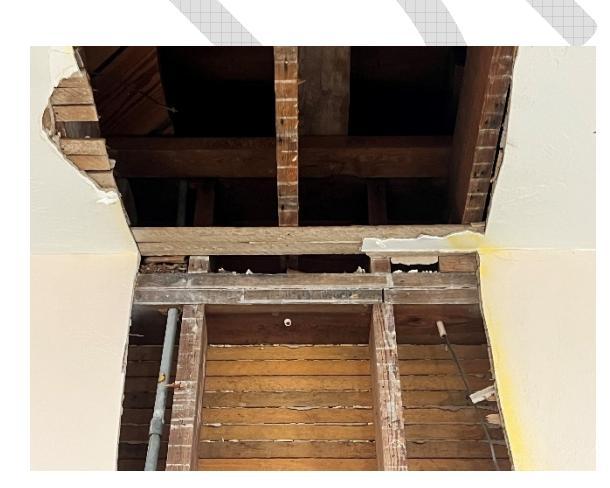
Photo 3. Floor joist bearing on the wood framed wall

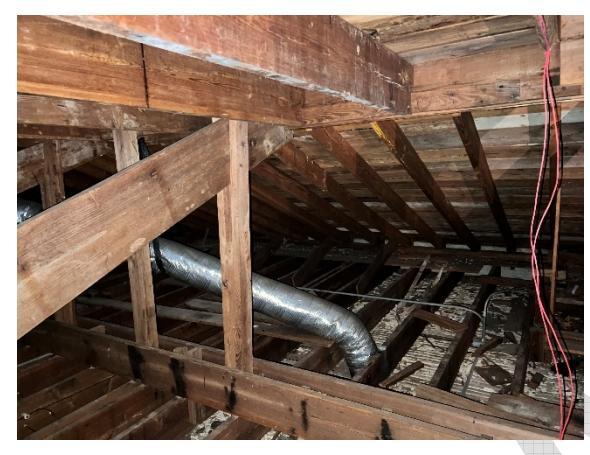
The roof has an attic space with approximately 5 feet of clear height from the finish floor to the bottom of the roof joist. The roof consists of a flat roof with a mansard on the perimeter edges of the roof. The attic floor is framed with 2x10 wood joist spaced 16" on center. The attic floor currently houses the HVAC unit. The flat portion of the roof is framed with 2x6 wood spaced at 24" on center and 2x6 wood joists at 16" on center for the mansard portion.

Photo 4. Roof framing view from attic space

The attic floor is framed with 2x10 with spacing at 16 inches on center and can hold a maximum of 10 PSF dead load and 50 PSF live load. The member reaches the maximum deflection allowed per FBC and this controls the capacity.

Bringing the building to the current building code will require strengthening the existing foundation, floor framing, roof framing, and CMU wall. The strengthening of these elements will require further engineering analysis, design, and constructability considerations on logistics and details. At a minimum, Appendix A lists the structural members, connections, and items required to strengthen the building.
