# CAPITAL IMPROVEMENT PLAN UPDATE

2023 Pavement Plan

07.13.23

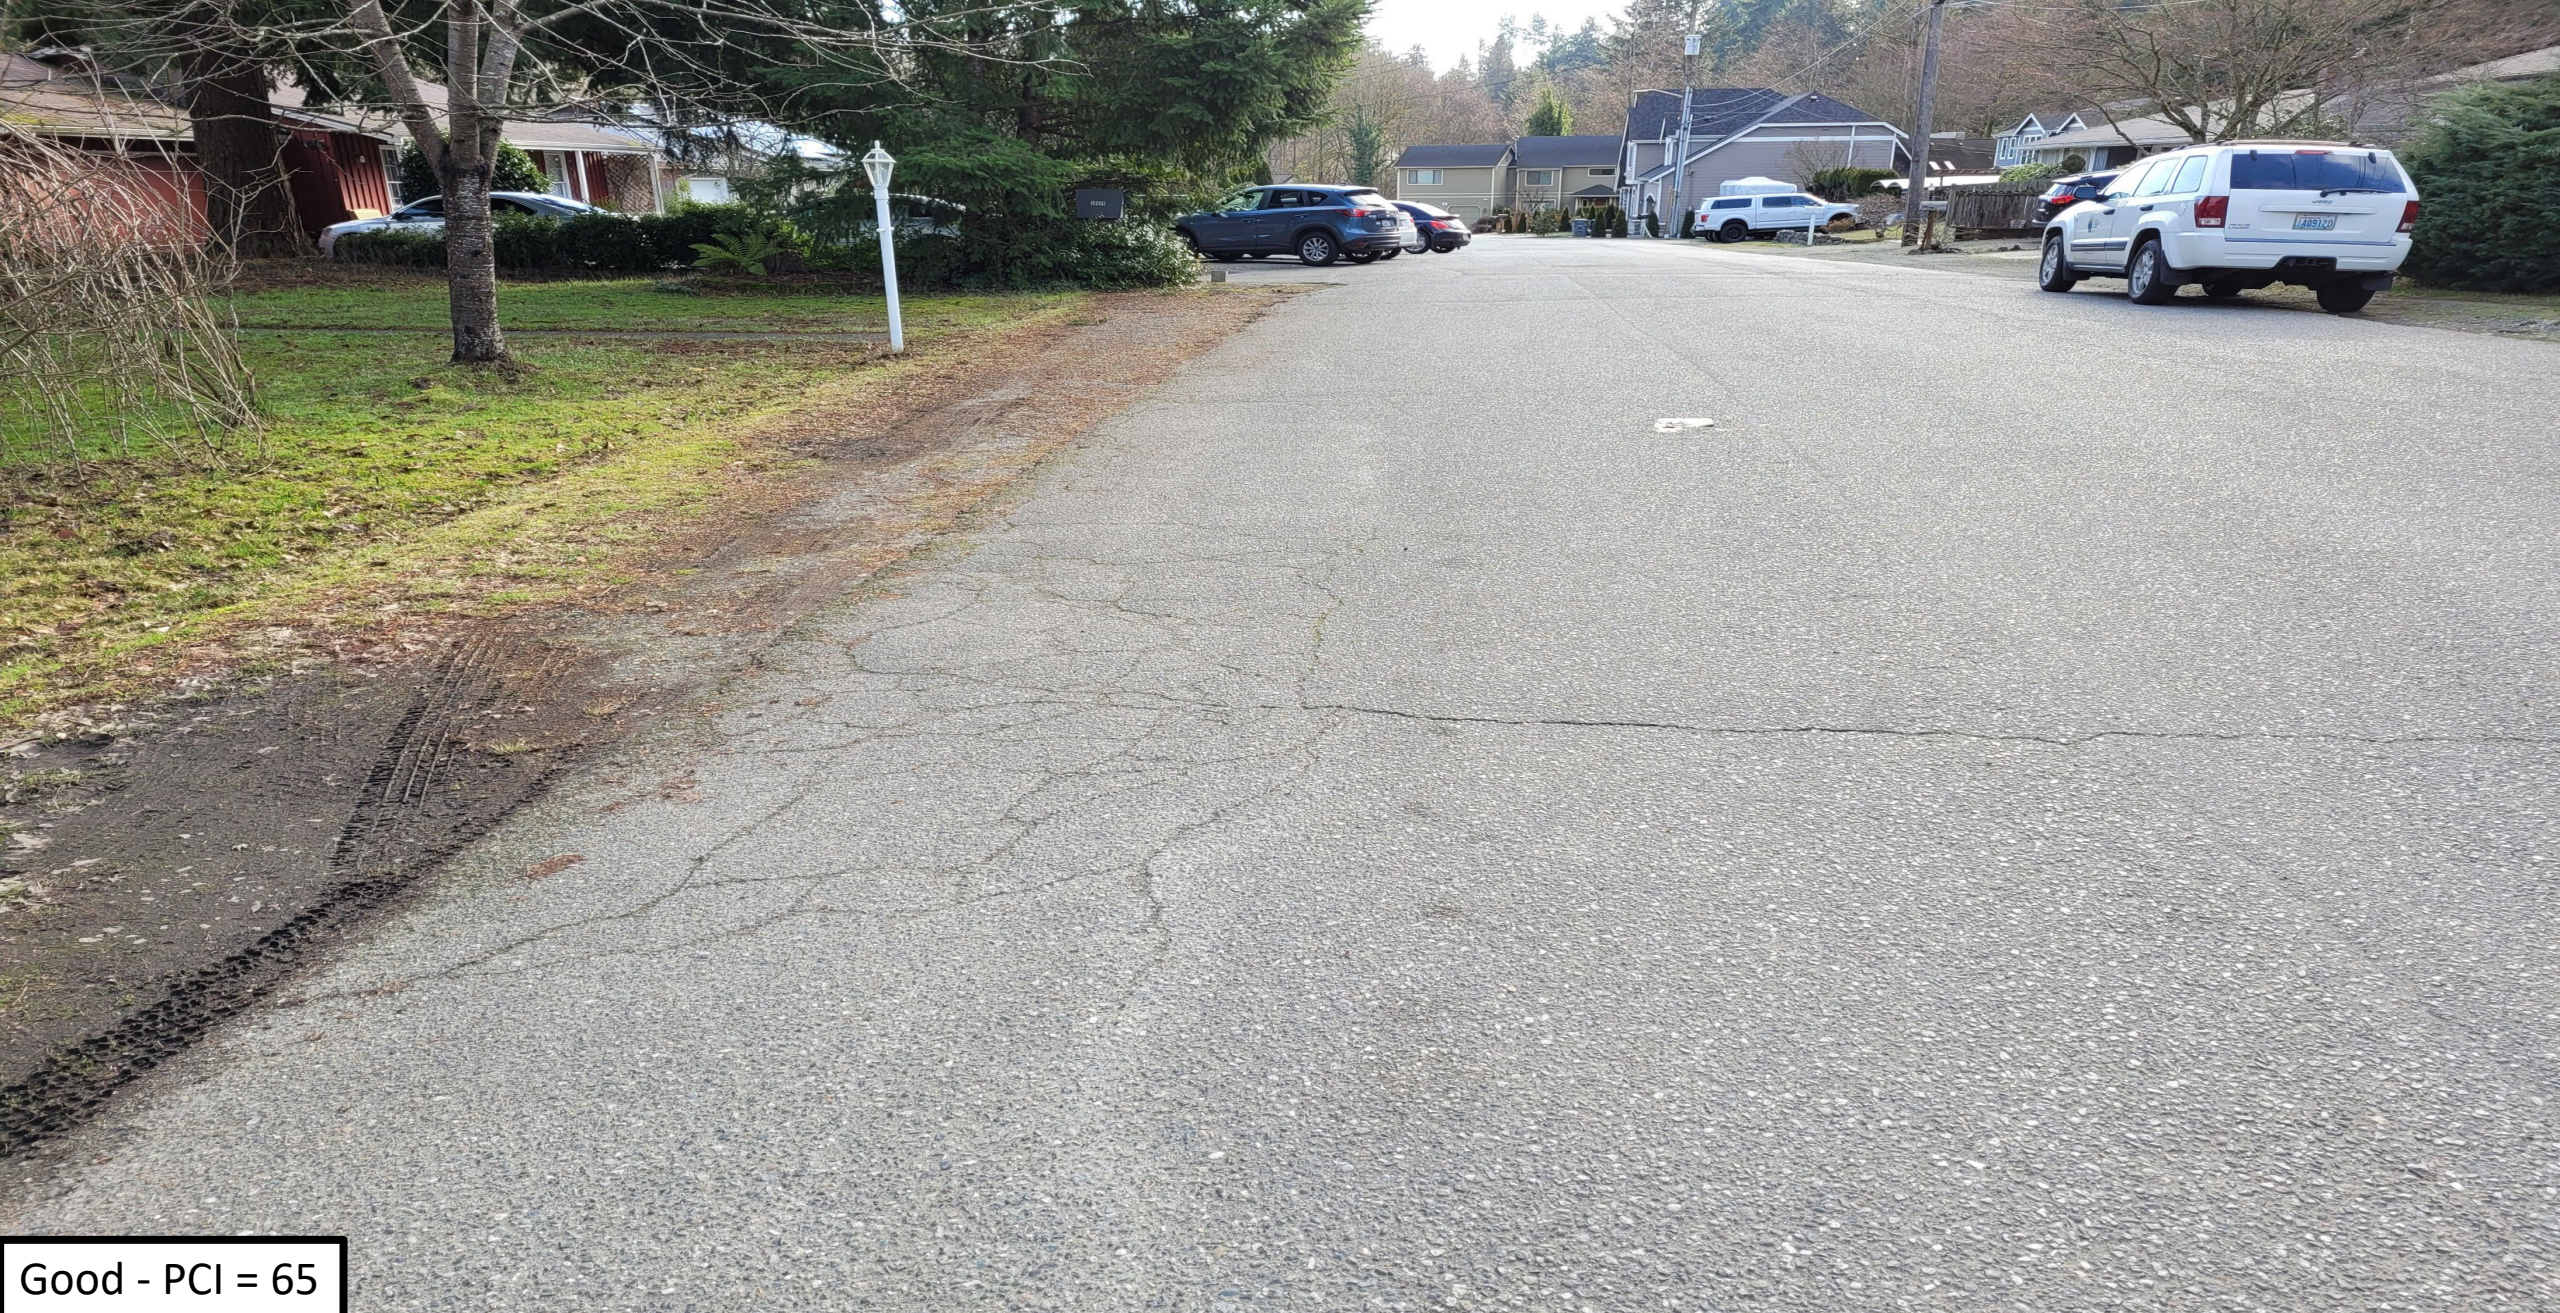
Good - PCI = 65

Generally stable, **minor areas of structural weakness evident**. **Cracking is easier to detect**, patches evident, patched but not excessively. Deformation more pronounced and easily noticed. **Ride qualities are good to acceptable**.

Alligator Cracking

Numerous Patches

Utility structures misaligned  
leading to poor ride quality

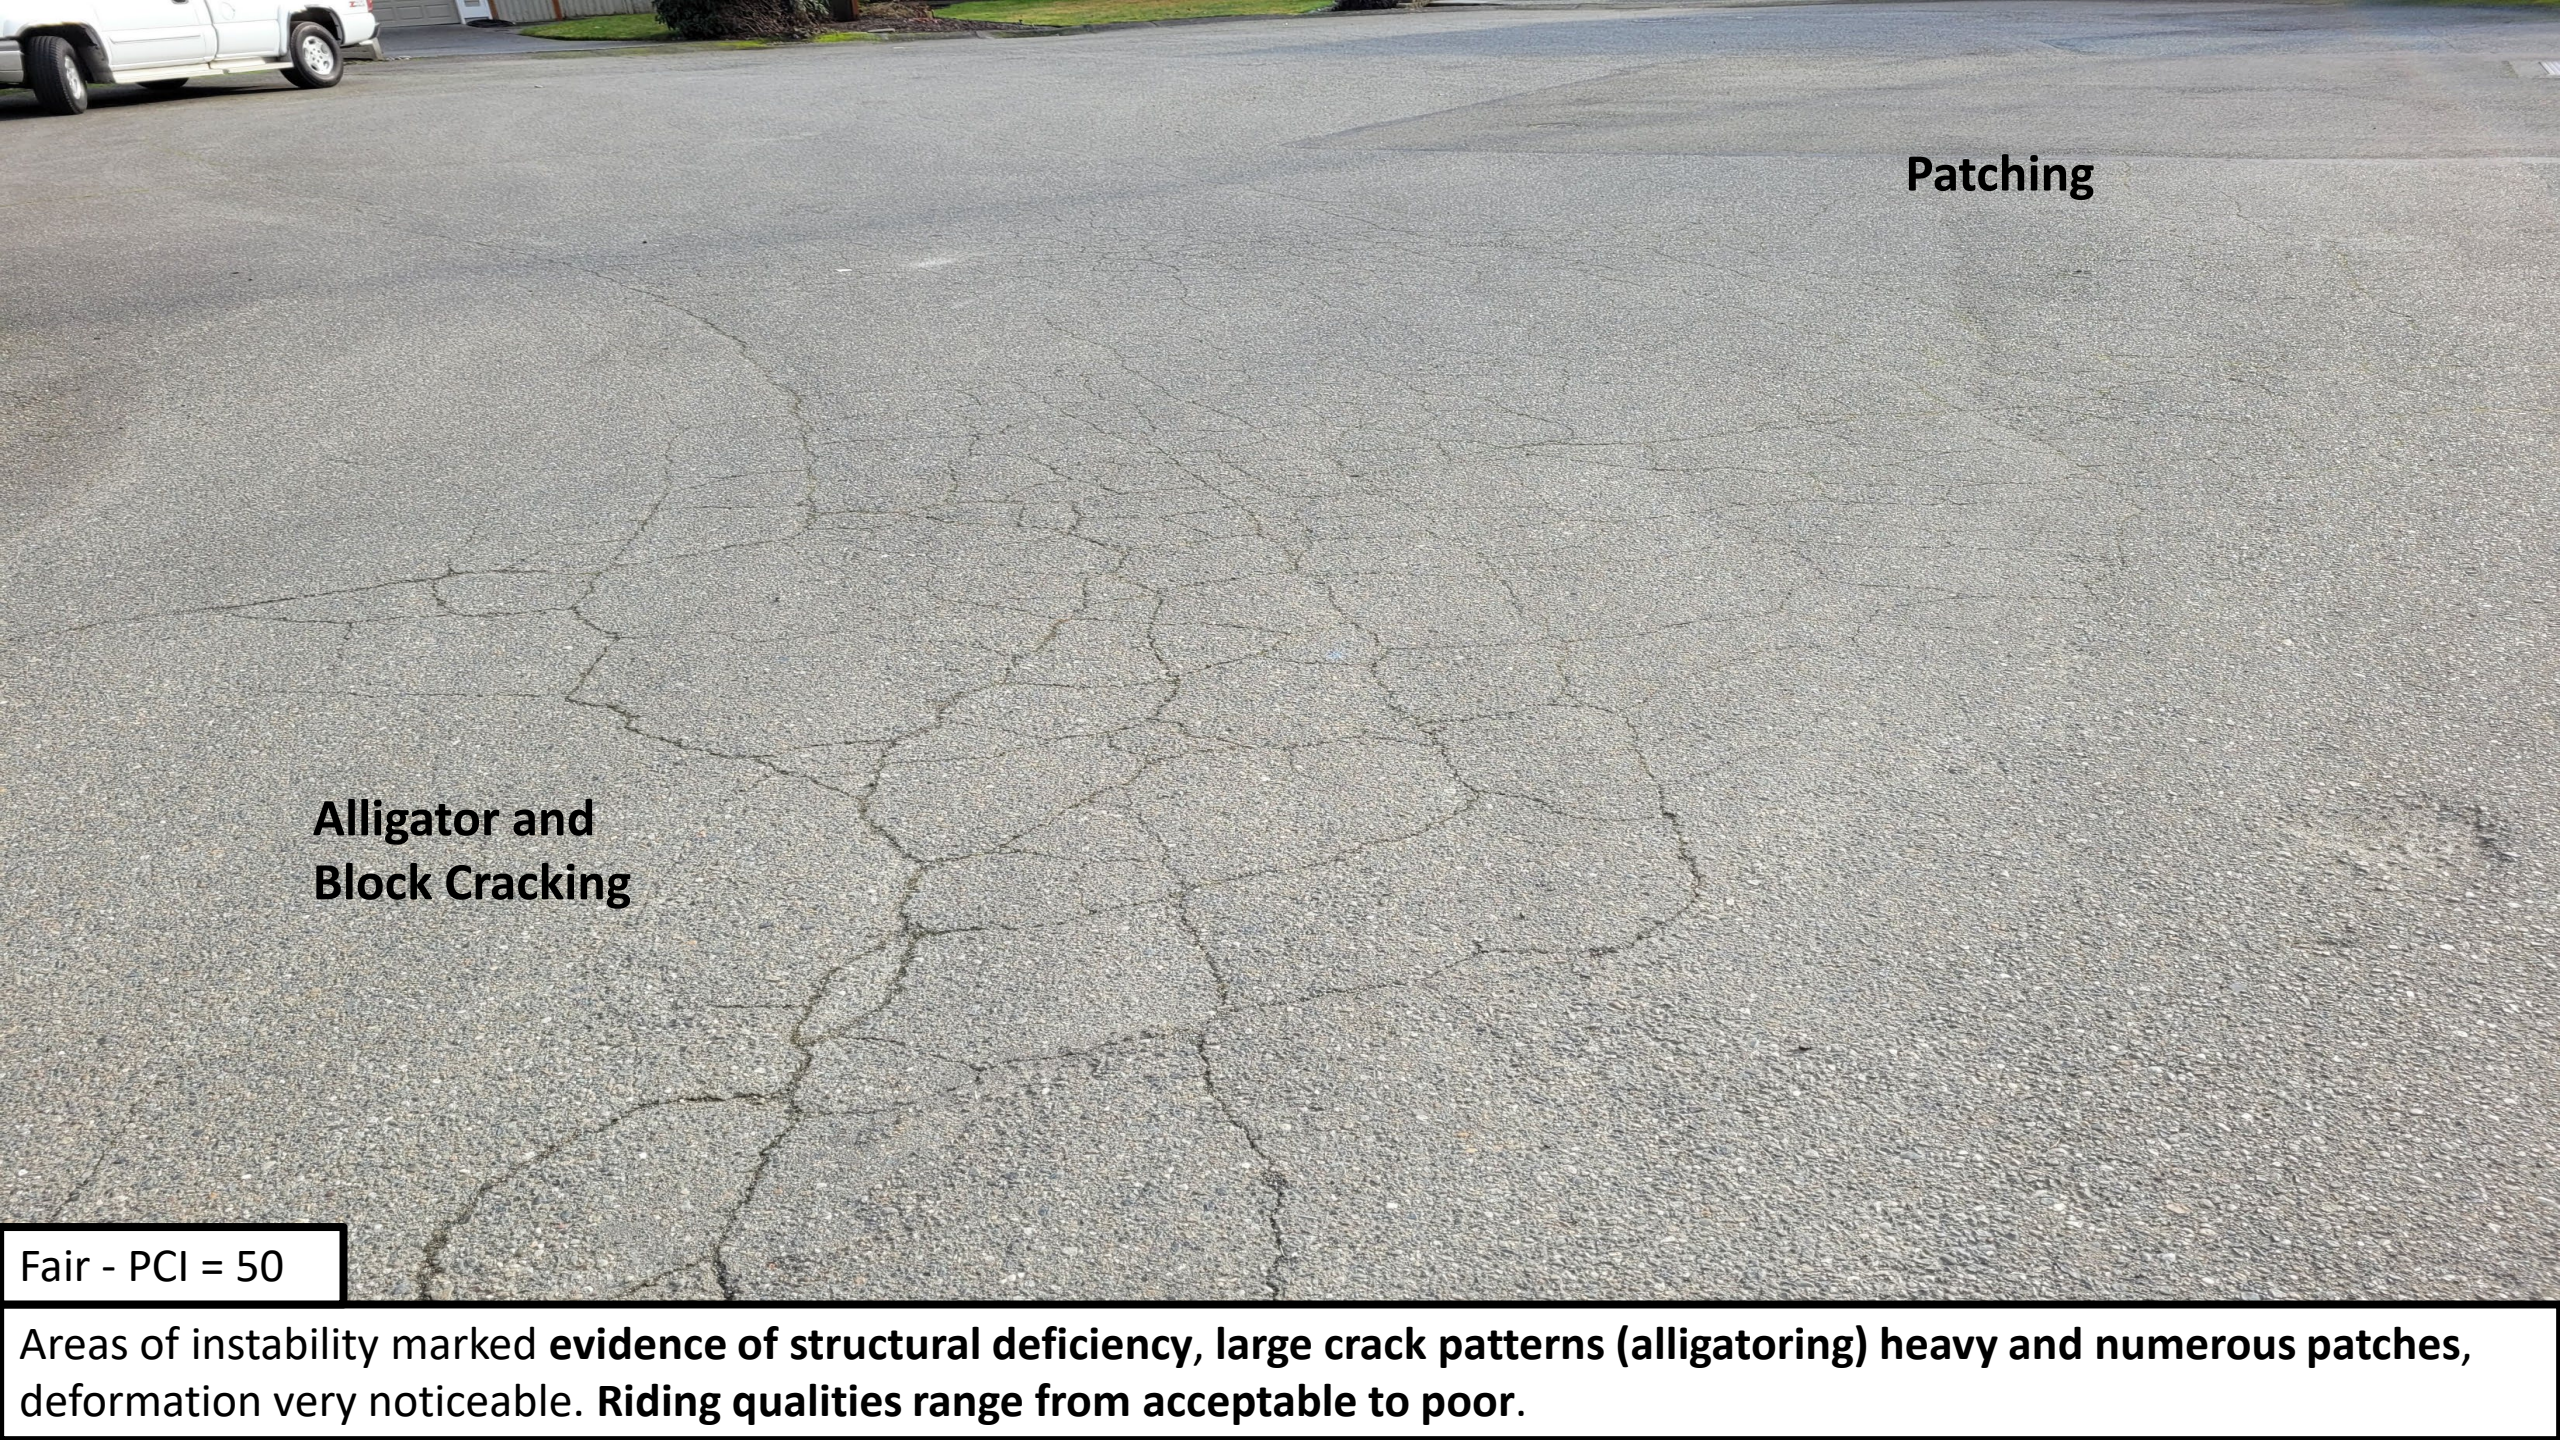
Patching

Alligator and  
Block Cracking

Fair - PCI = 50

Areas of instability marked **evidence of structural deficiency**, large crack patterns (alligatoring) heavy and numerous patches, deformation very noticeable. **Riding qualities range from acceptable to poor.**

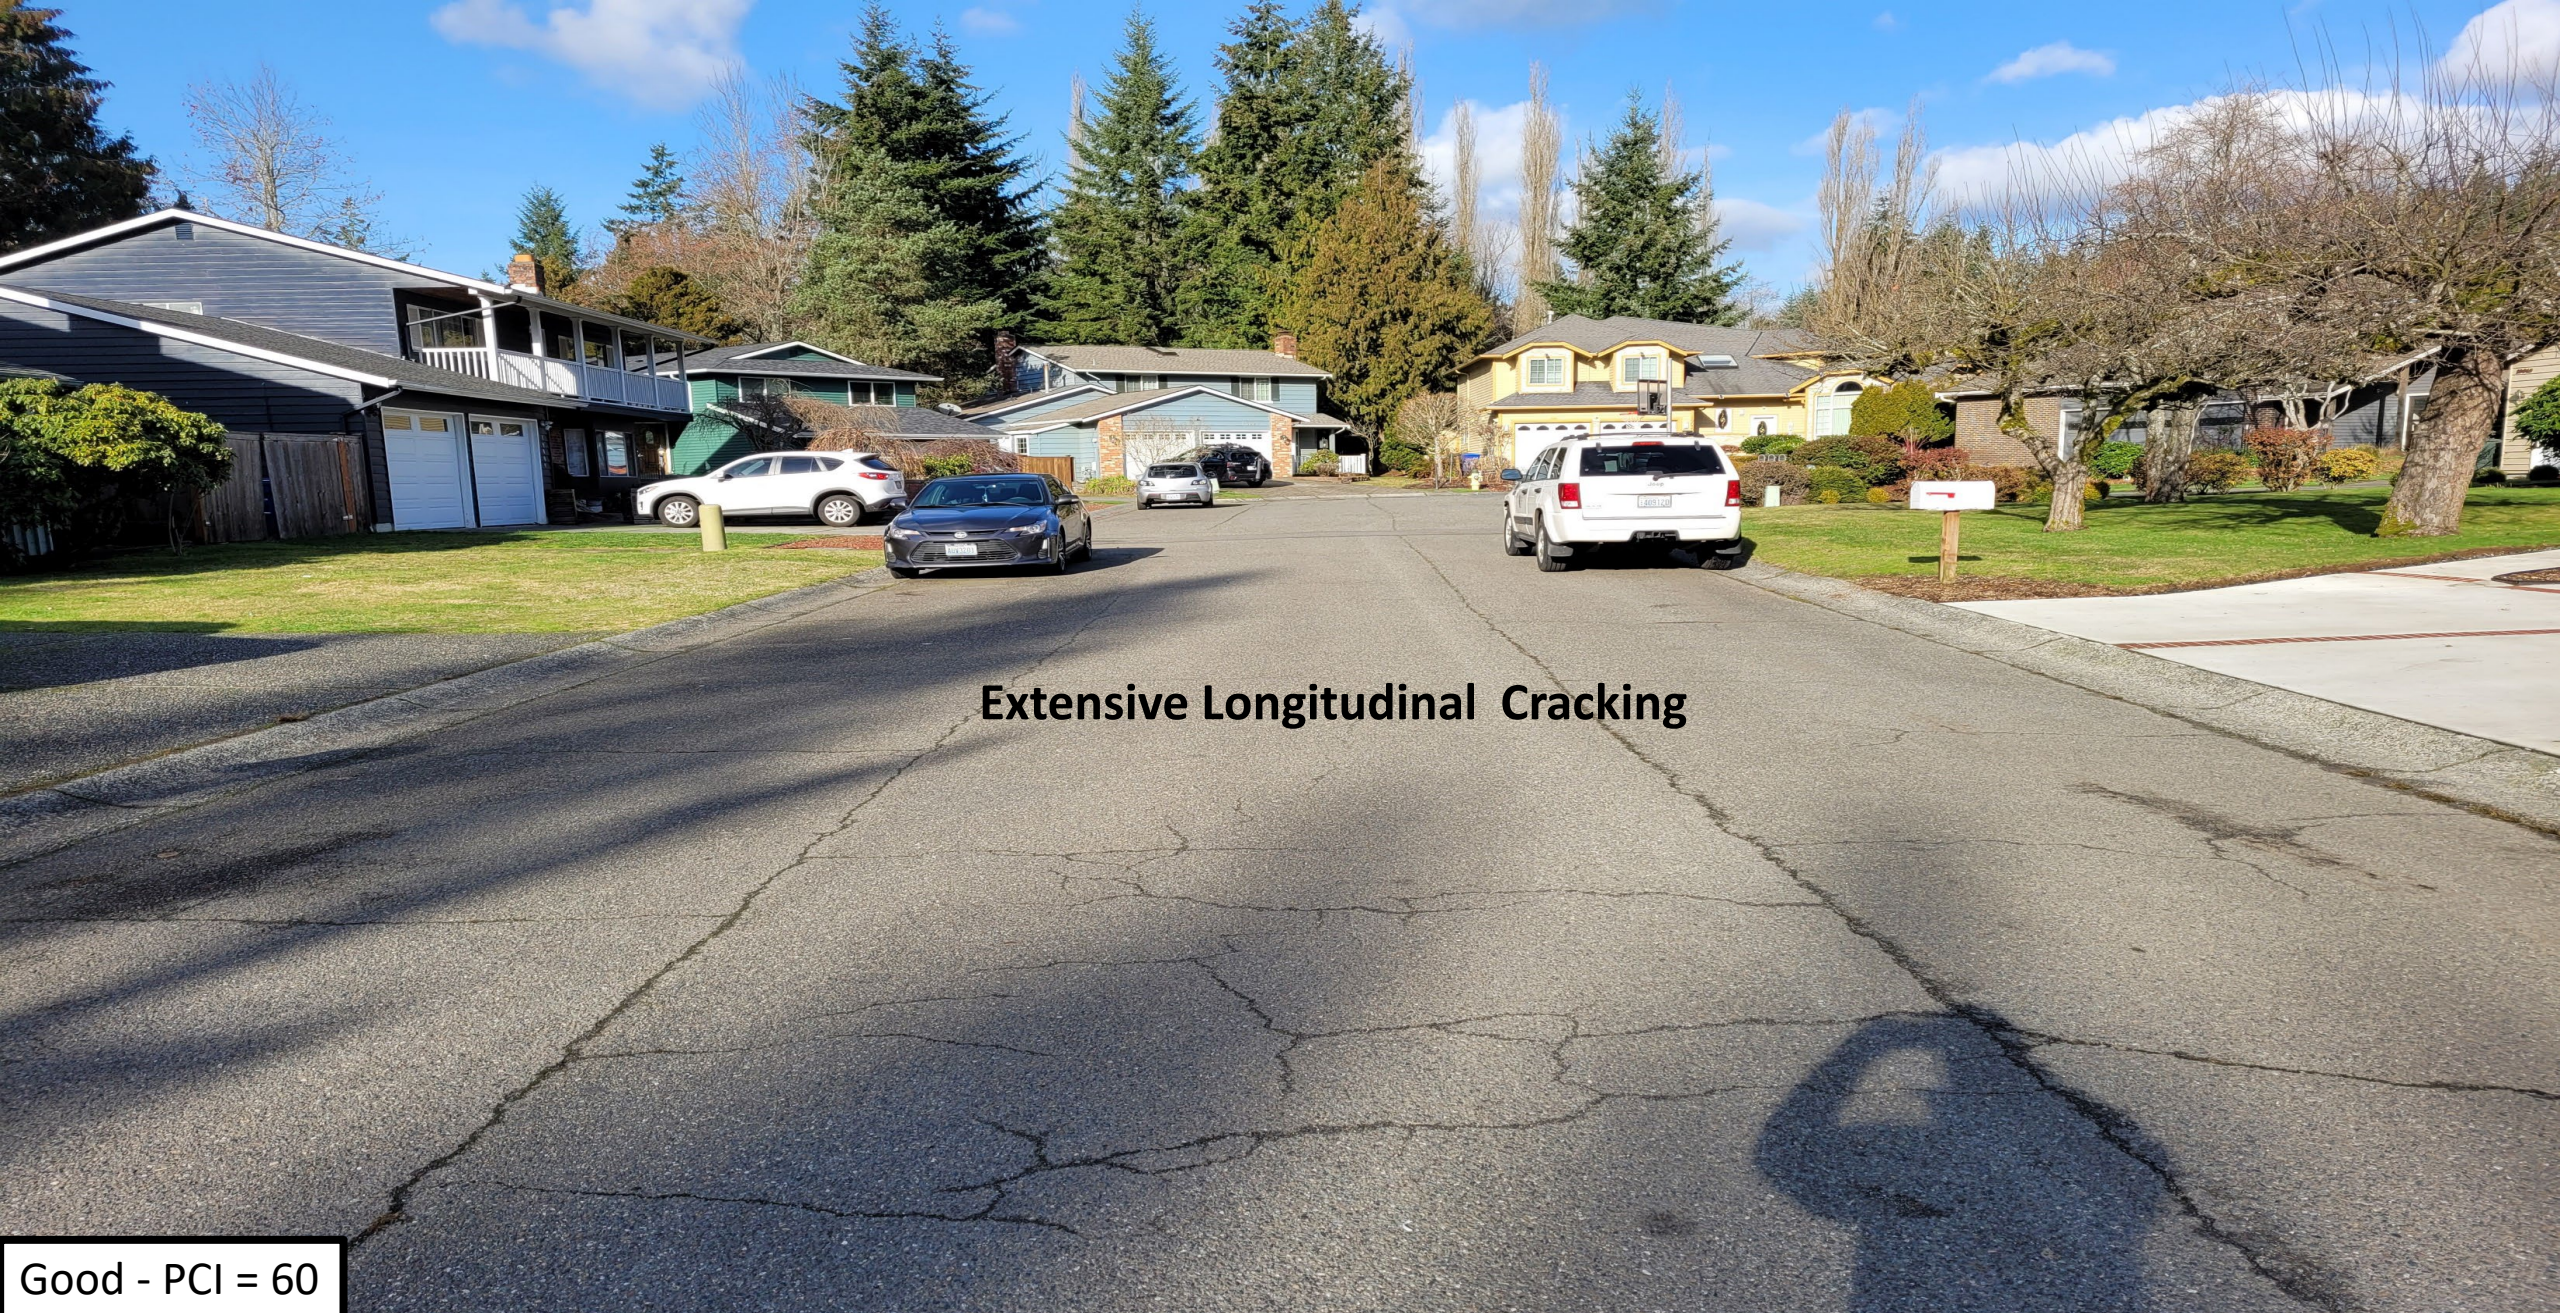
## Extensive Longitudinal Cracking

Good - PCI = 60

Generally stable, **minor areas of structural weakness evident**. **Cracking is easier to detect**, patches evident, patched but not excessively. Deformation more pronounced and easily noticed. Ride qualities are good to acceptable.

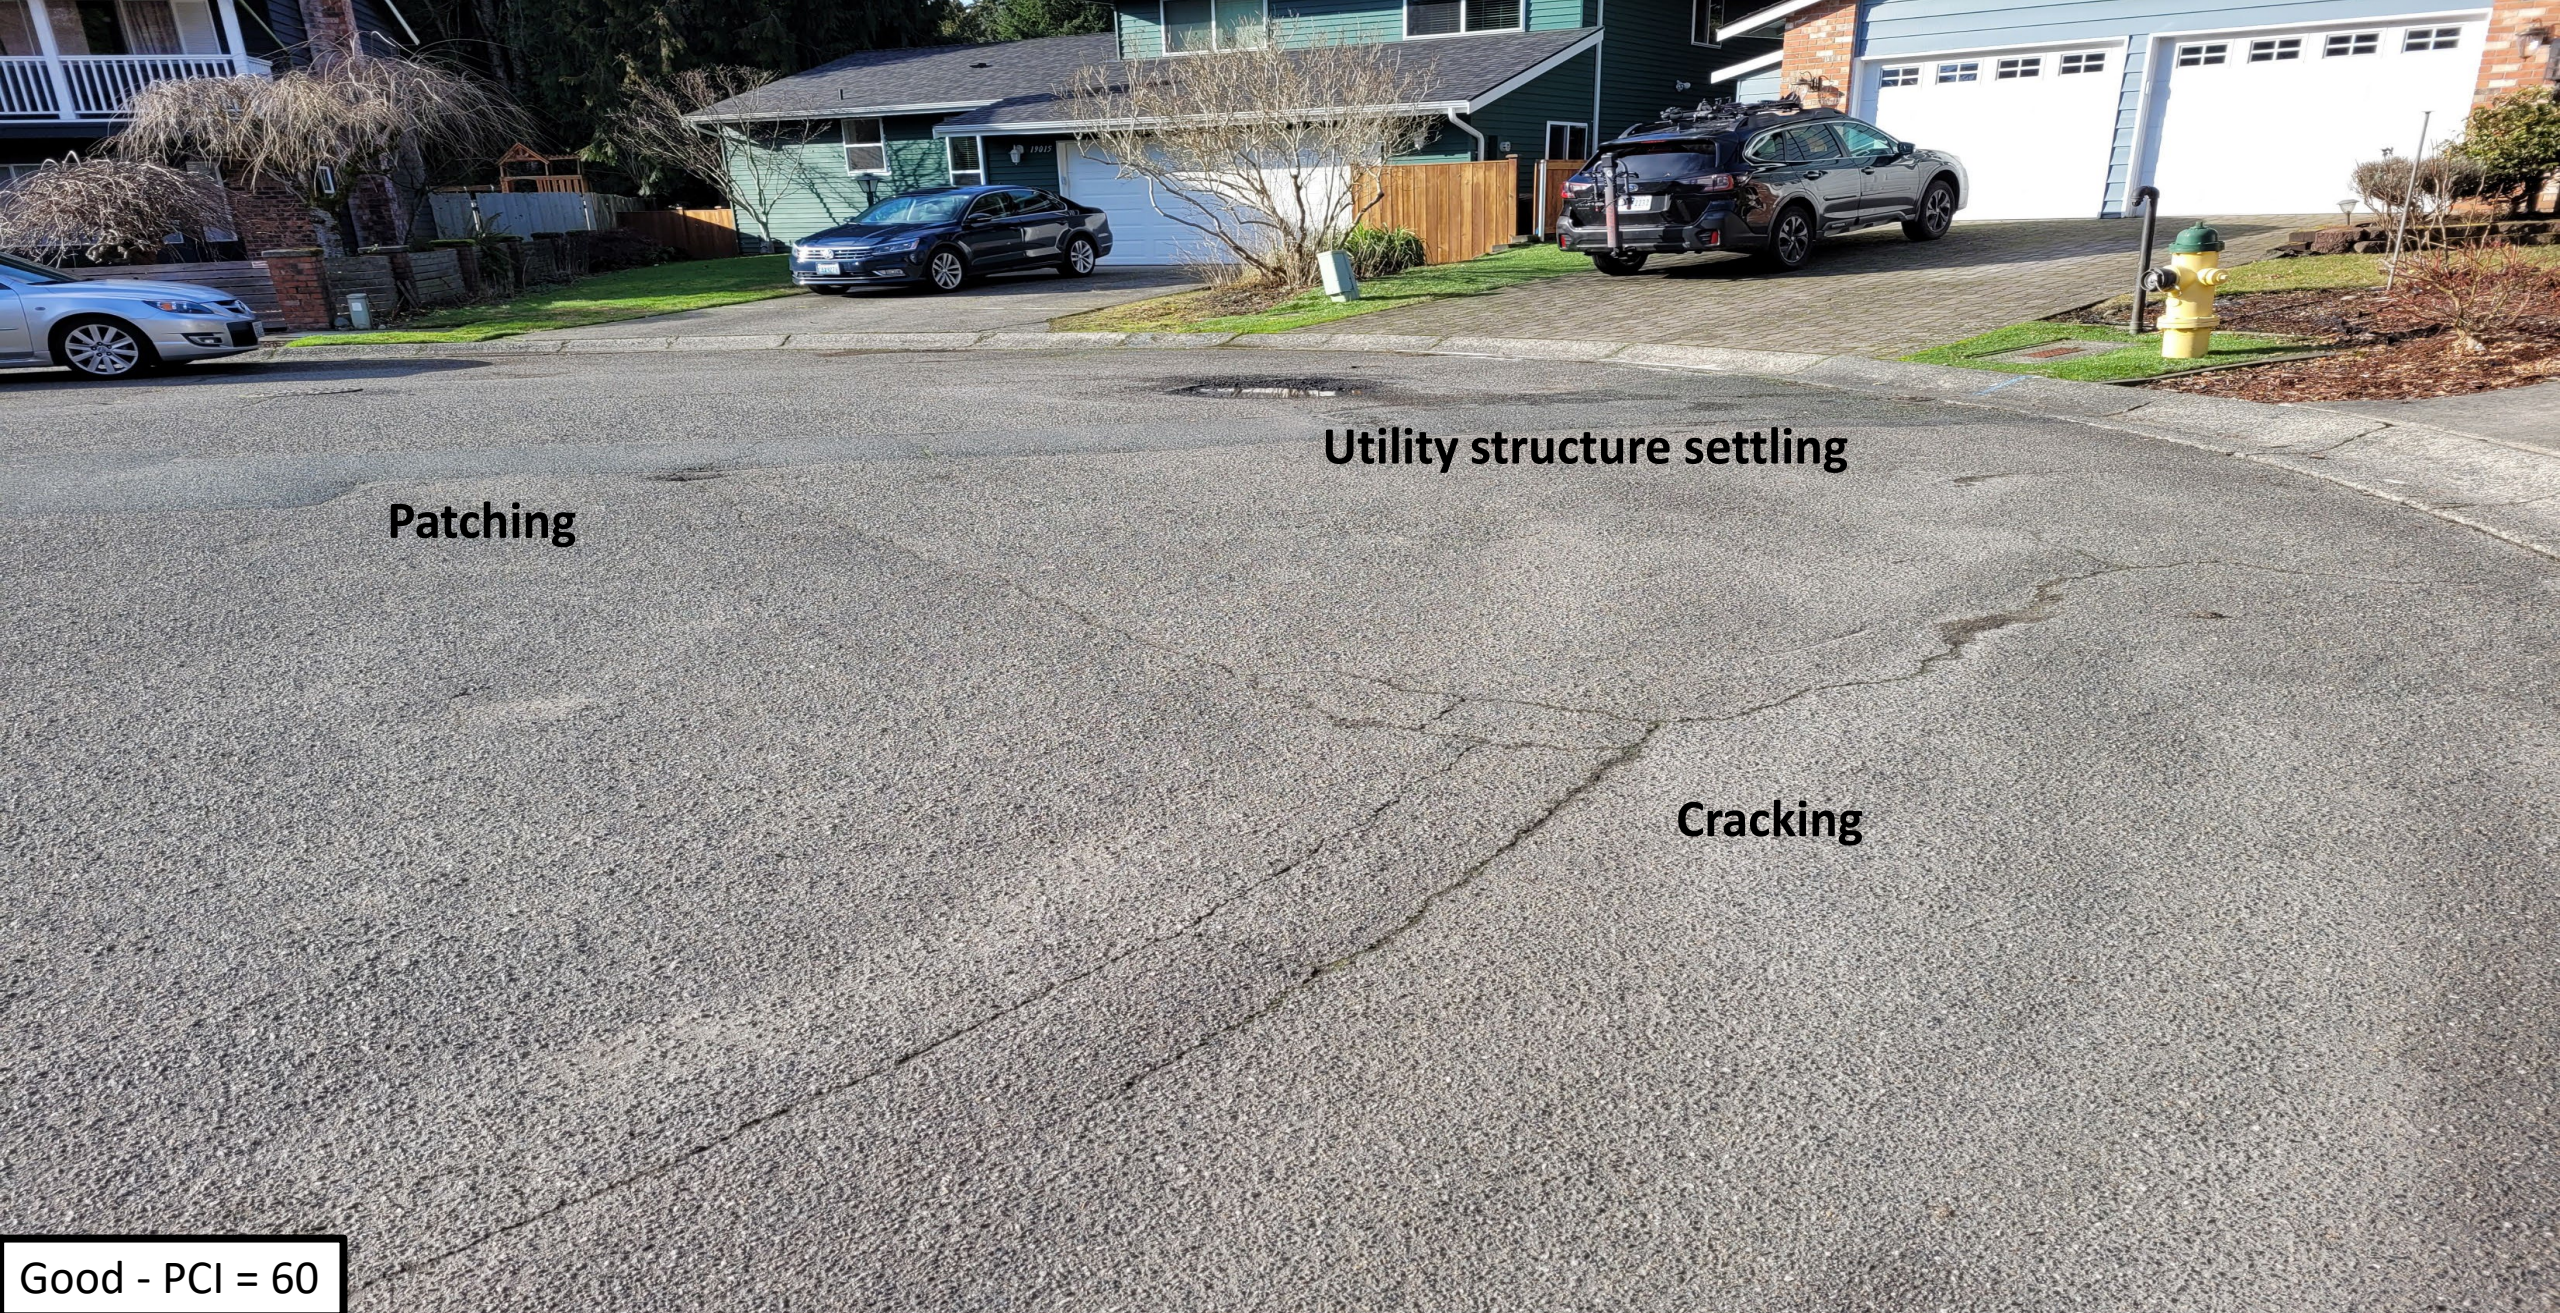
Patching

Utility structure settling

Cracking

Good - PCI = 60

Generally stable, **minor areas of structural weakness evident**. **Cracking is easier to detect, patches evident**, patched but not excessively. Deformation more pronounced and easily noticed. Ride qualities are good to acceptable.

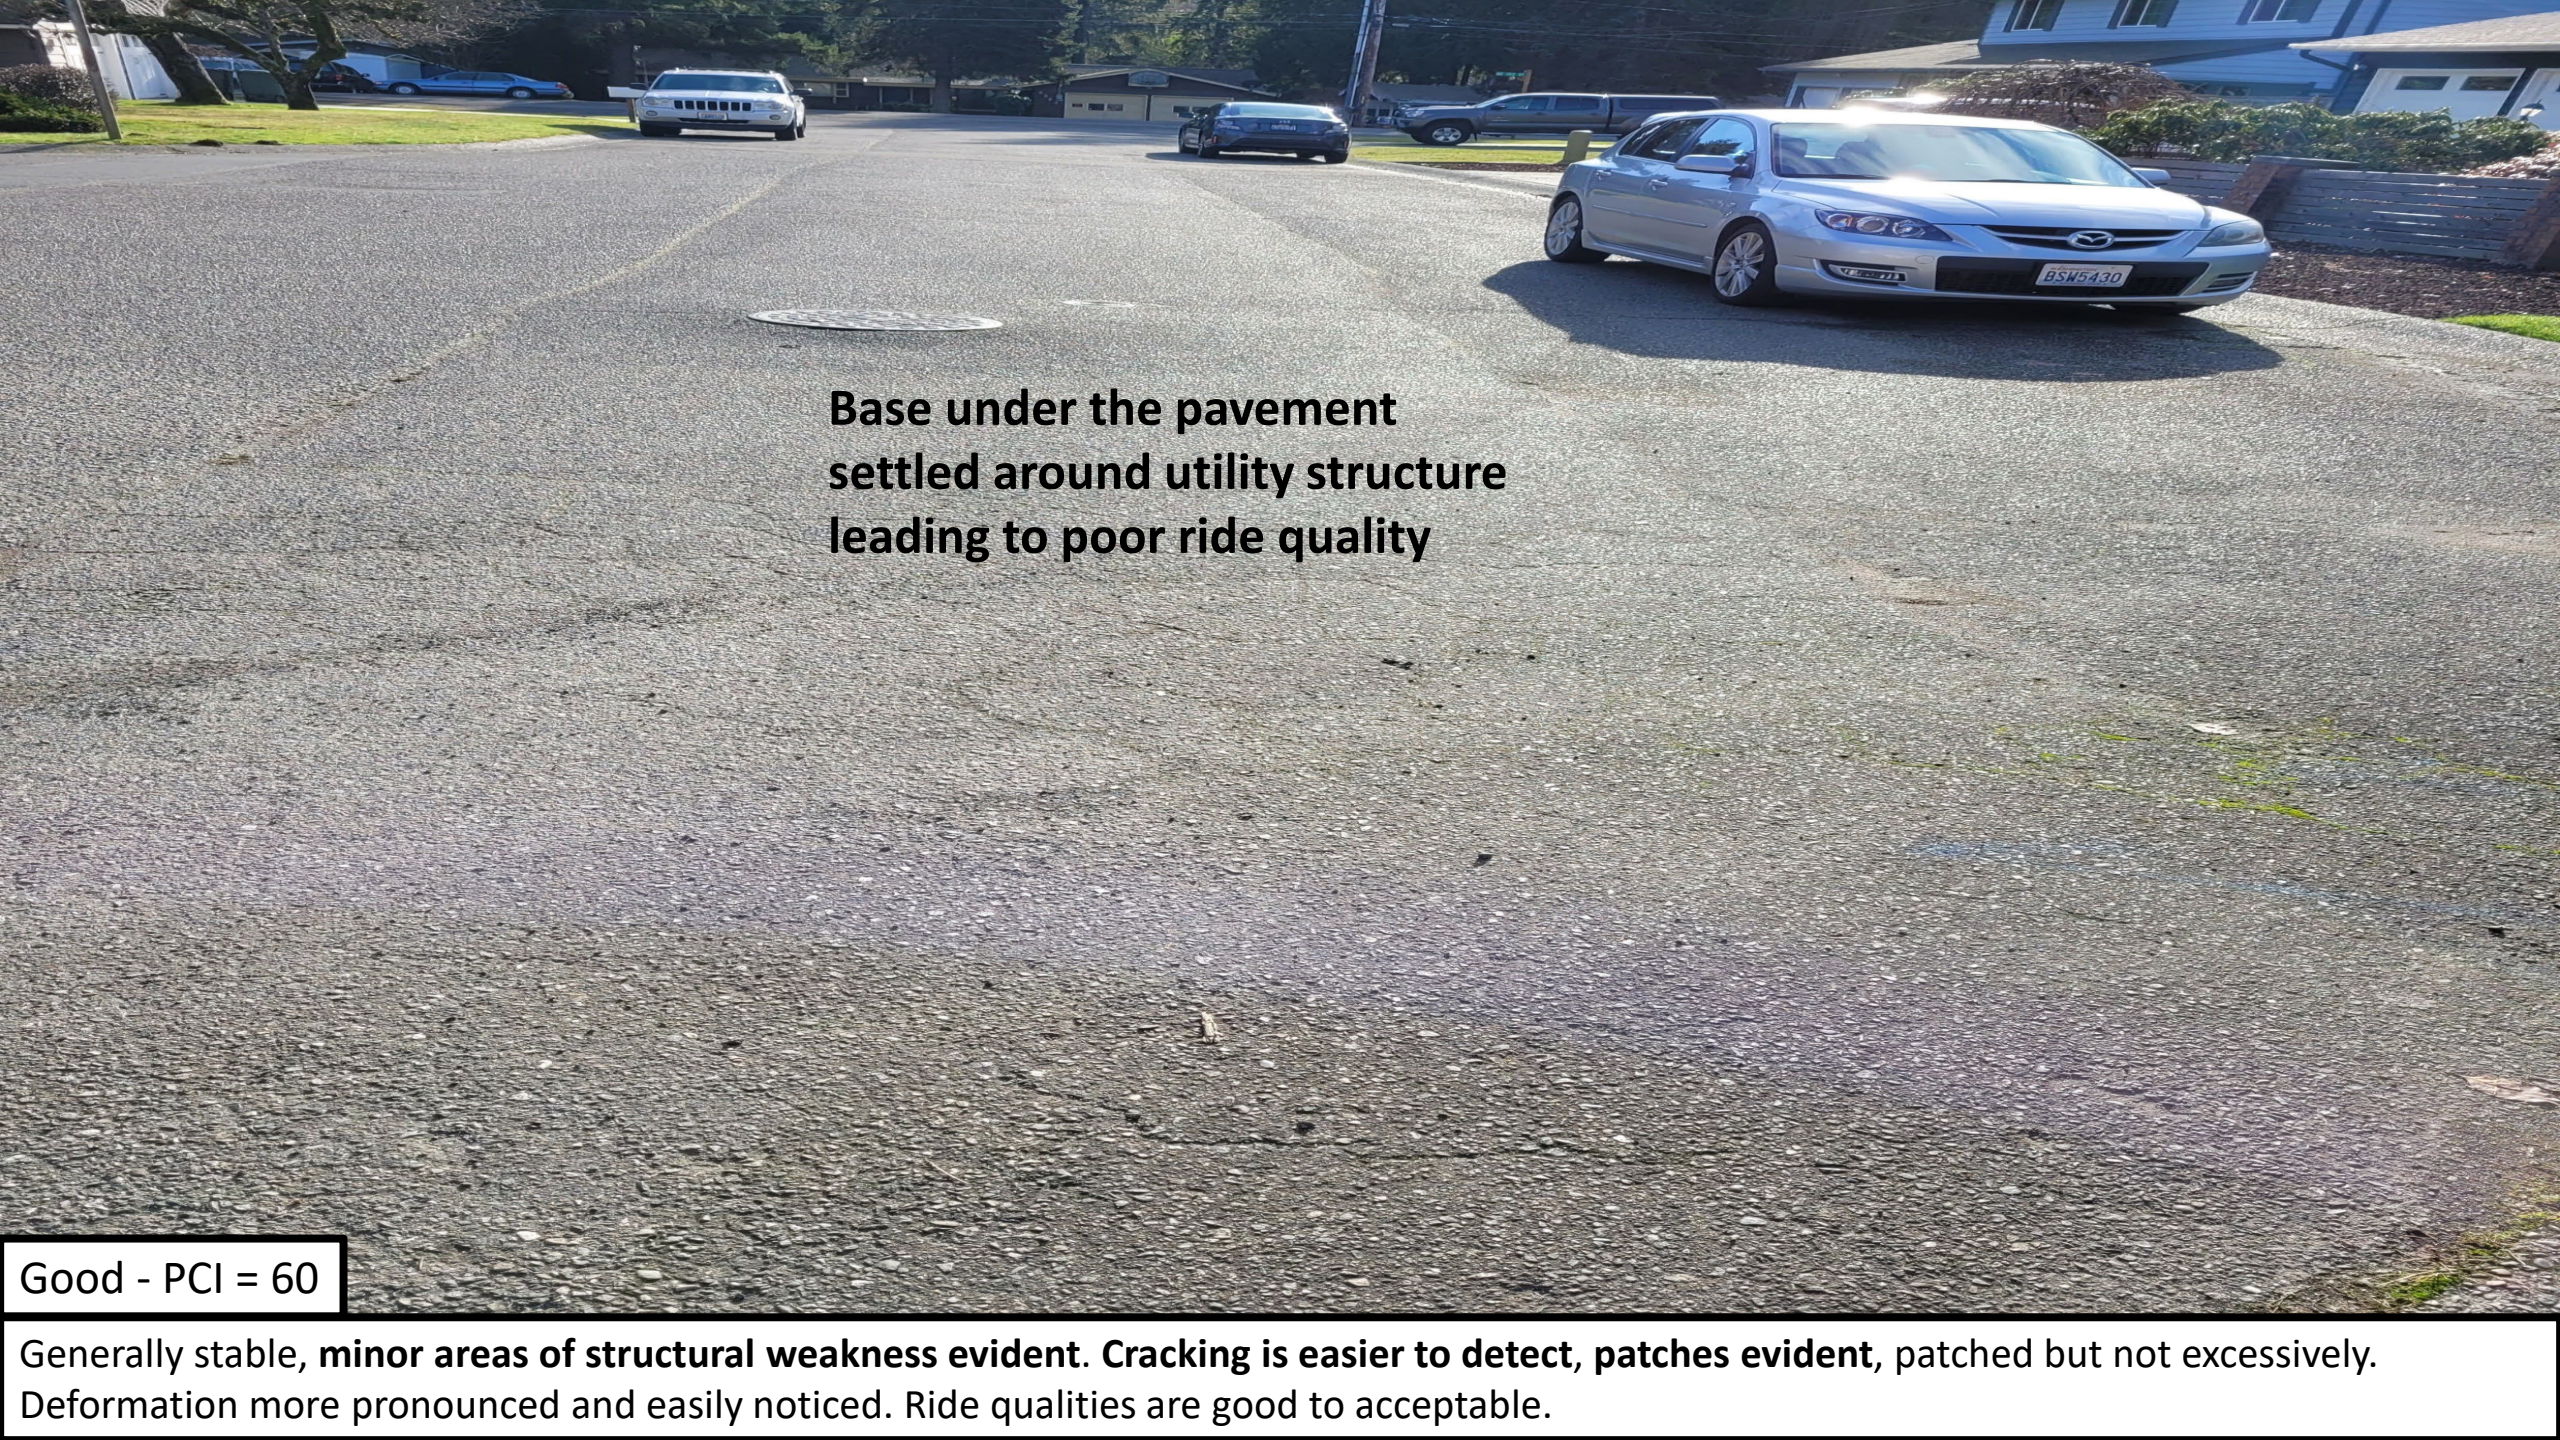
Base under the pavement  
settled around utility structure  
leading to poor ride quality

Good - PCI = 60

Generally stable, **minor areas of structural weakness evident**. **Cracking is easier to detect, patches evident**, patched but not excessively. Deformation more pronounced and easily noticed. Ride qualities are good to acceptable.

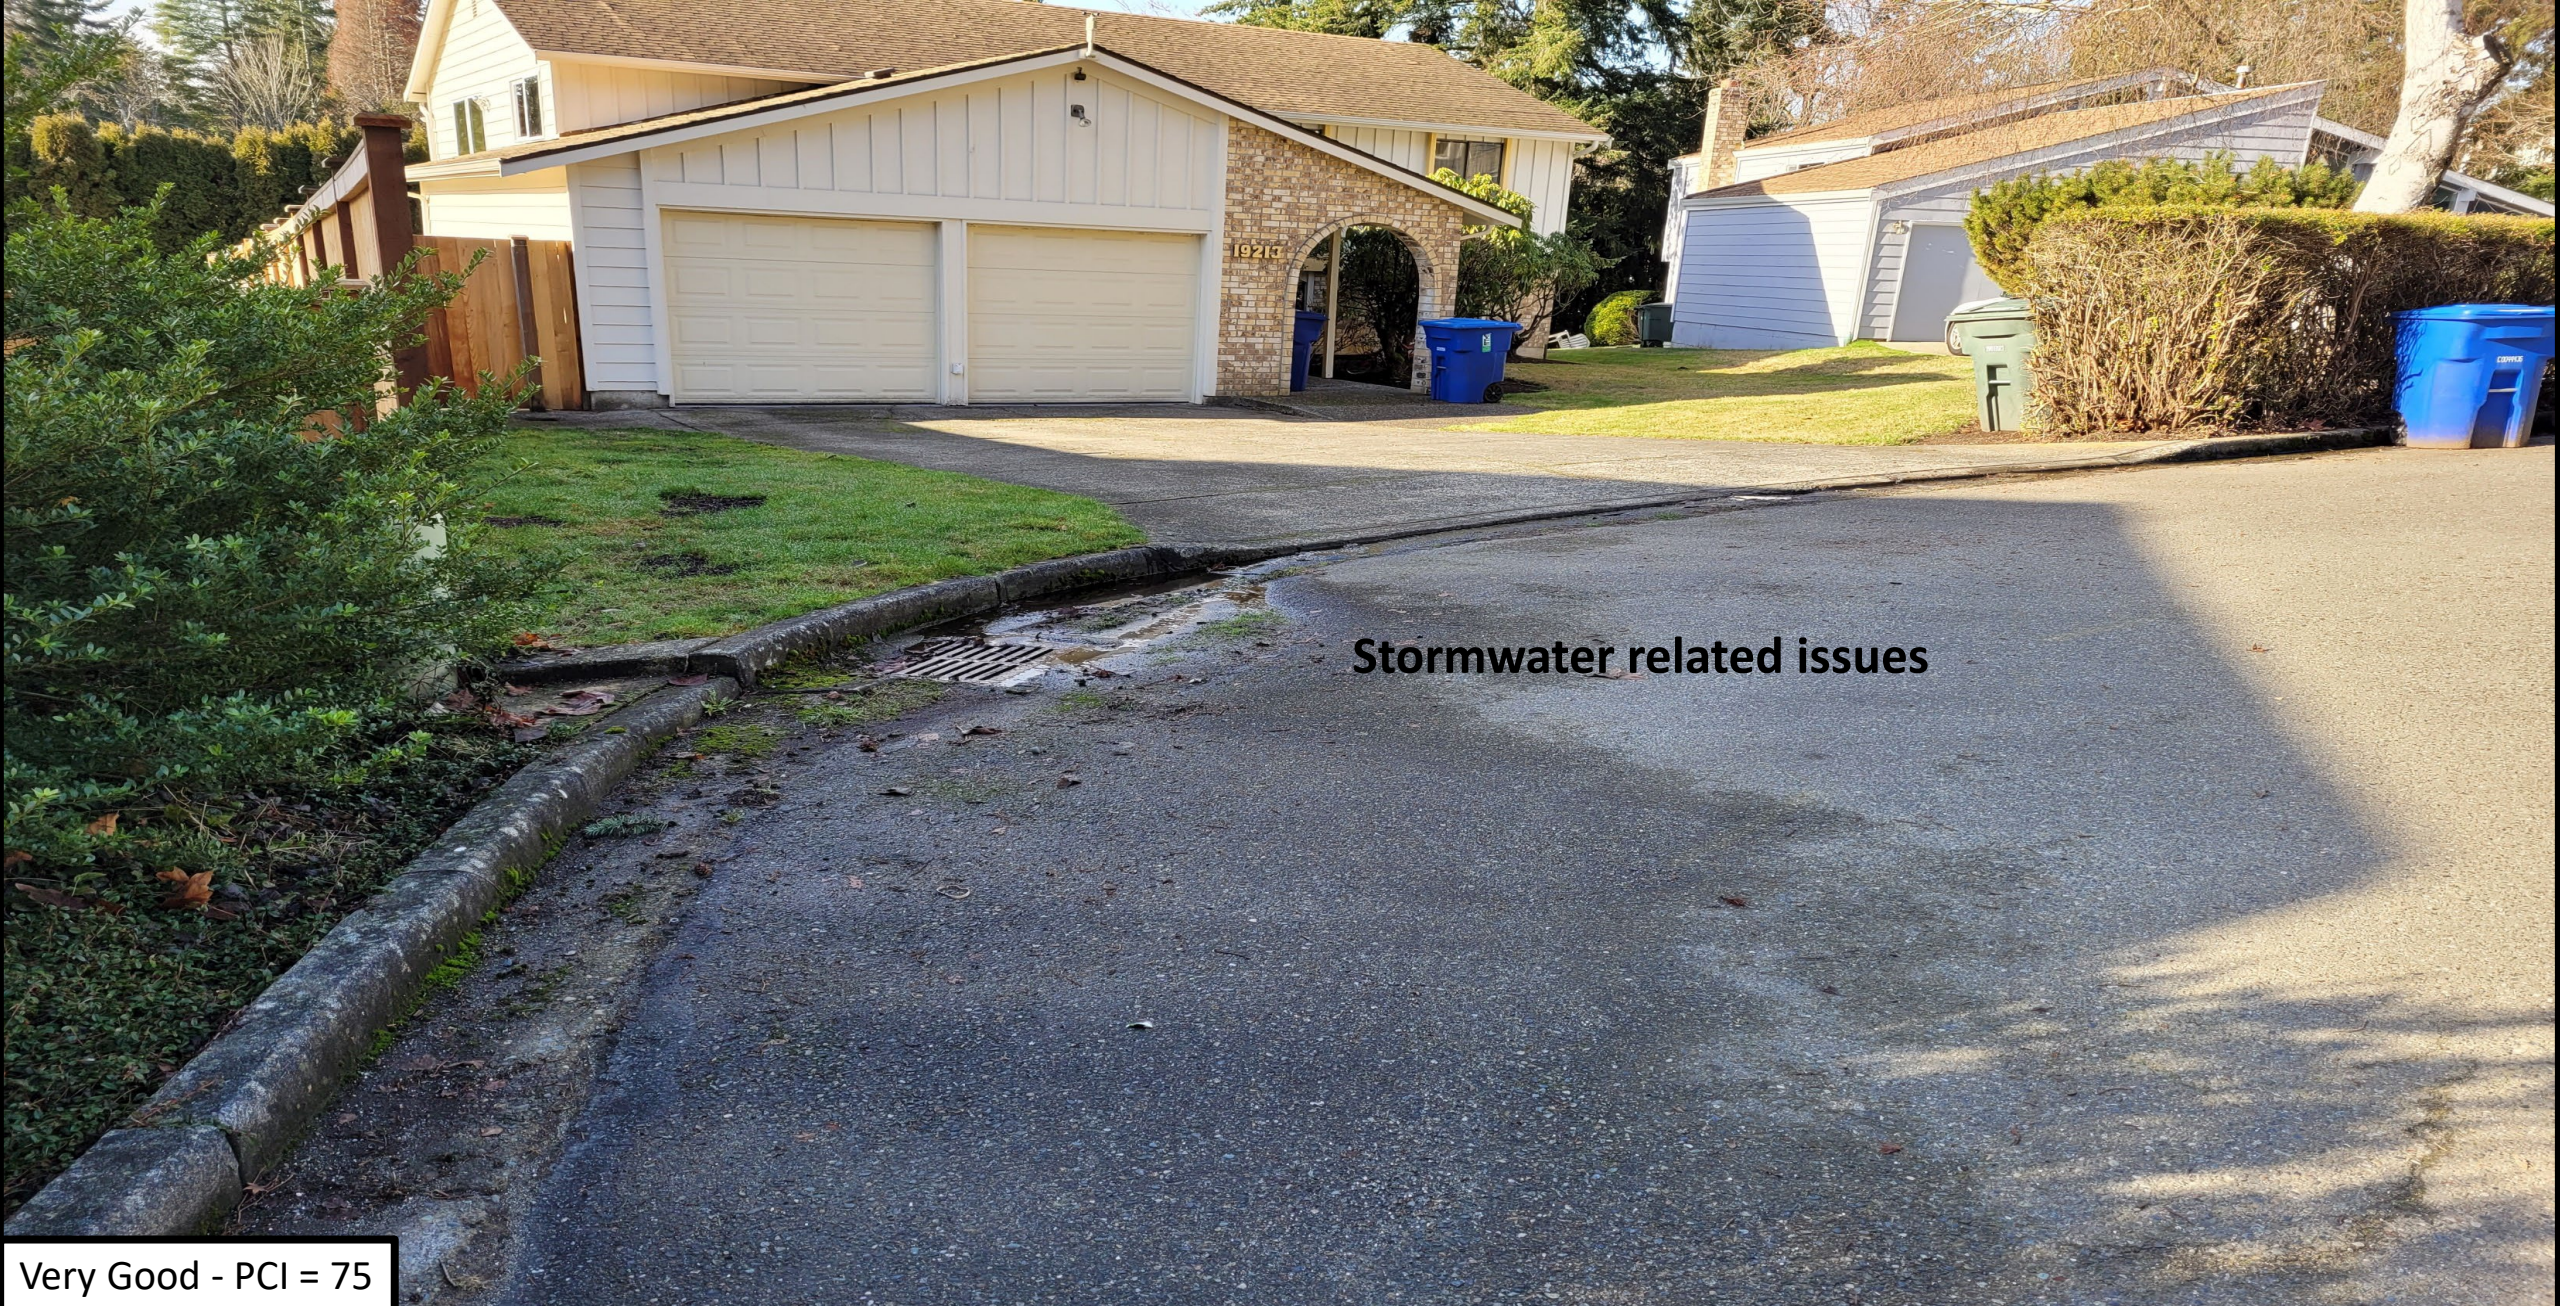
Stormwater related issues

Very Good - PCI = 75

**Stable, minor cracking**, generally hairline and hard to detect. **Minor patching** and possibly some minor deformation evident. Dry or light-colored appearance. **Good riding qualities. Rutting less than ½".**
