# CAPITAL IMPROVEMENT PLAN UPDATE

2023 Pavement Plan

07.13.23

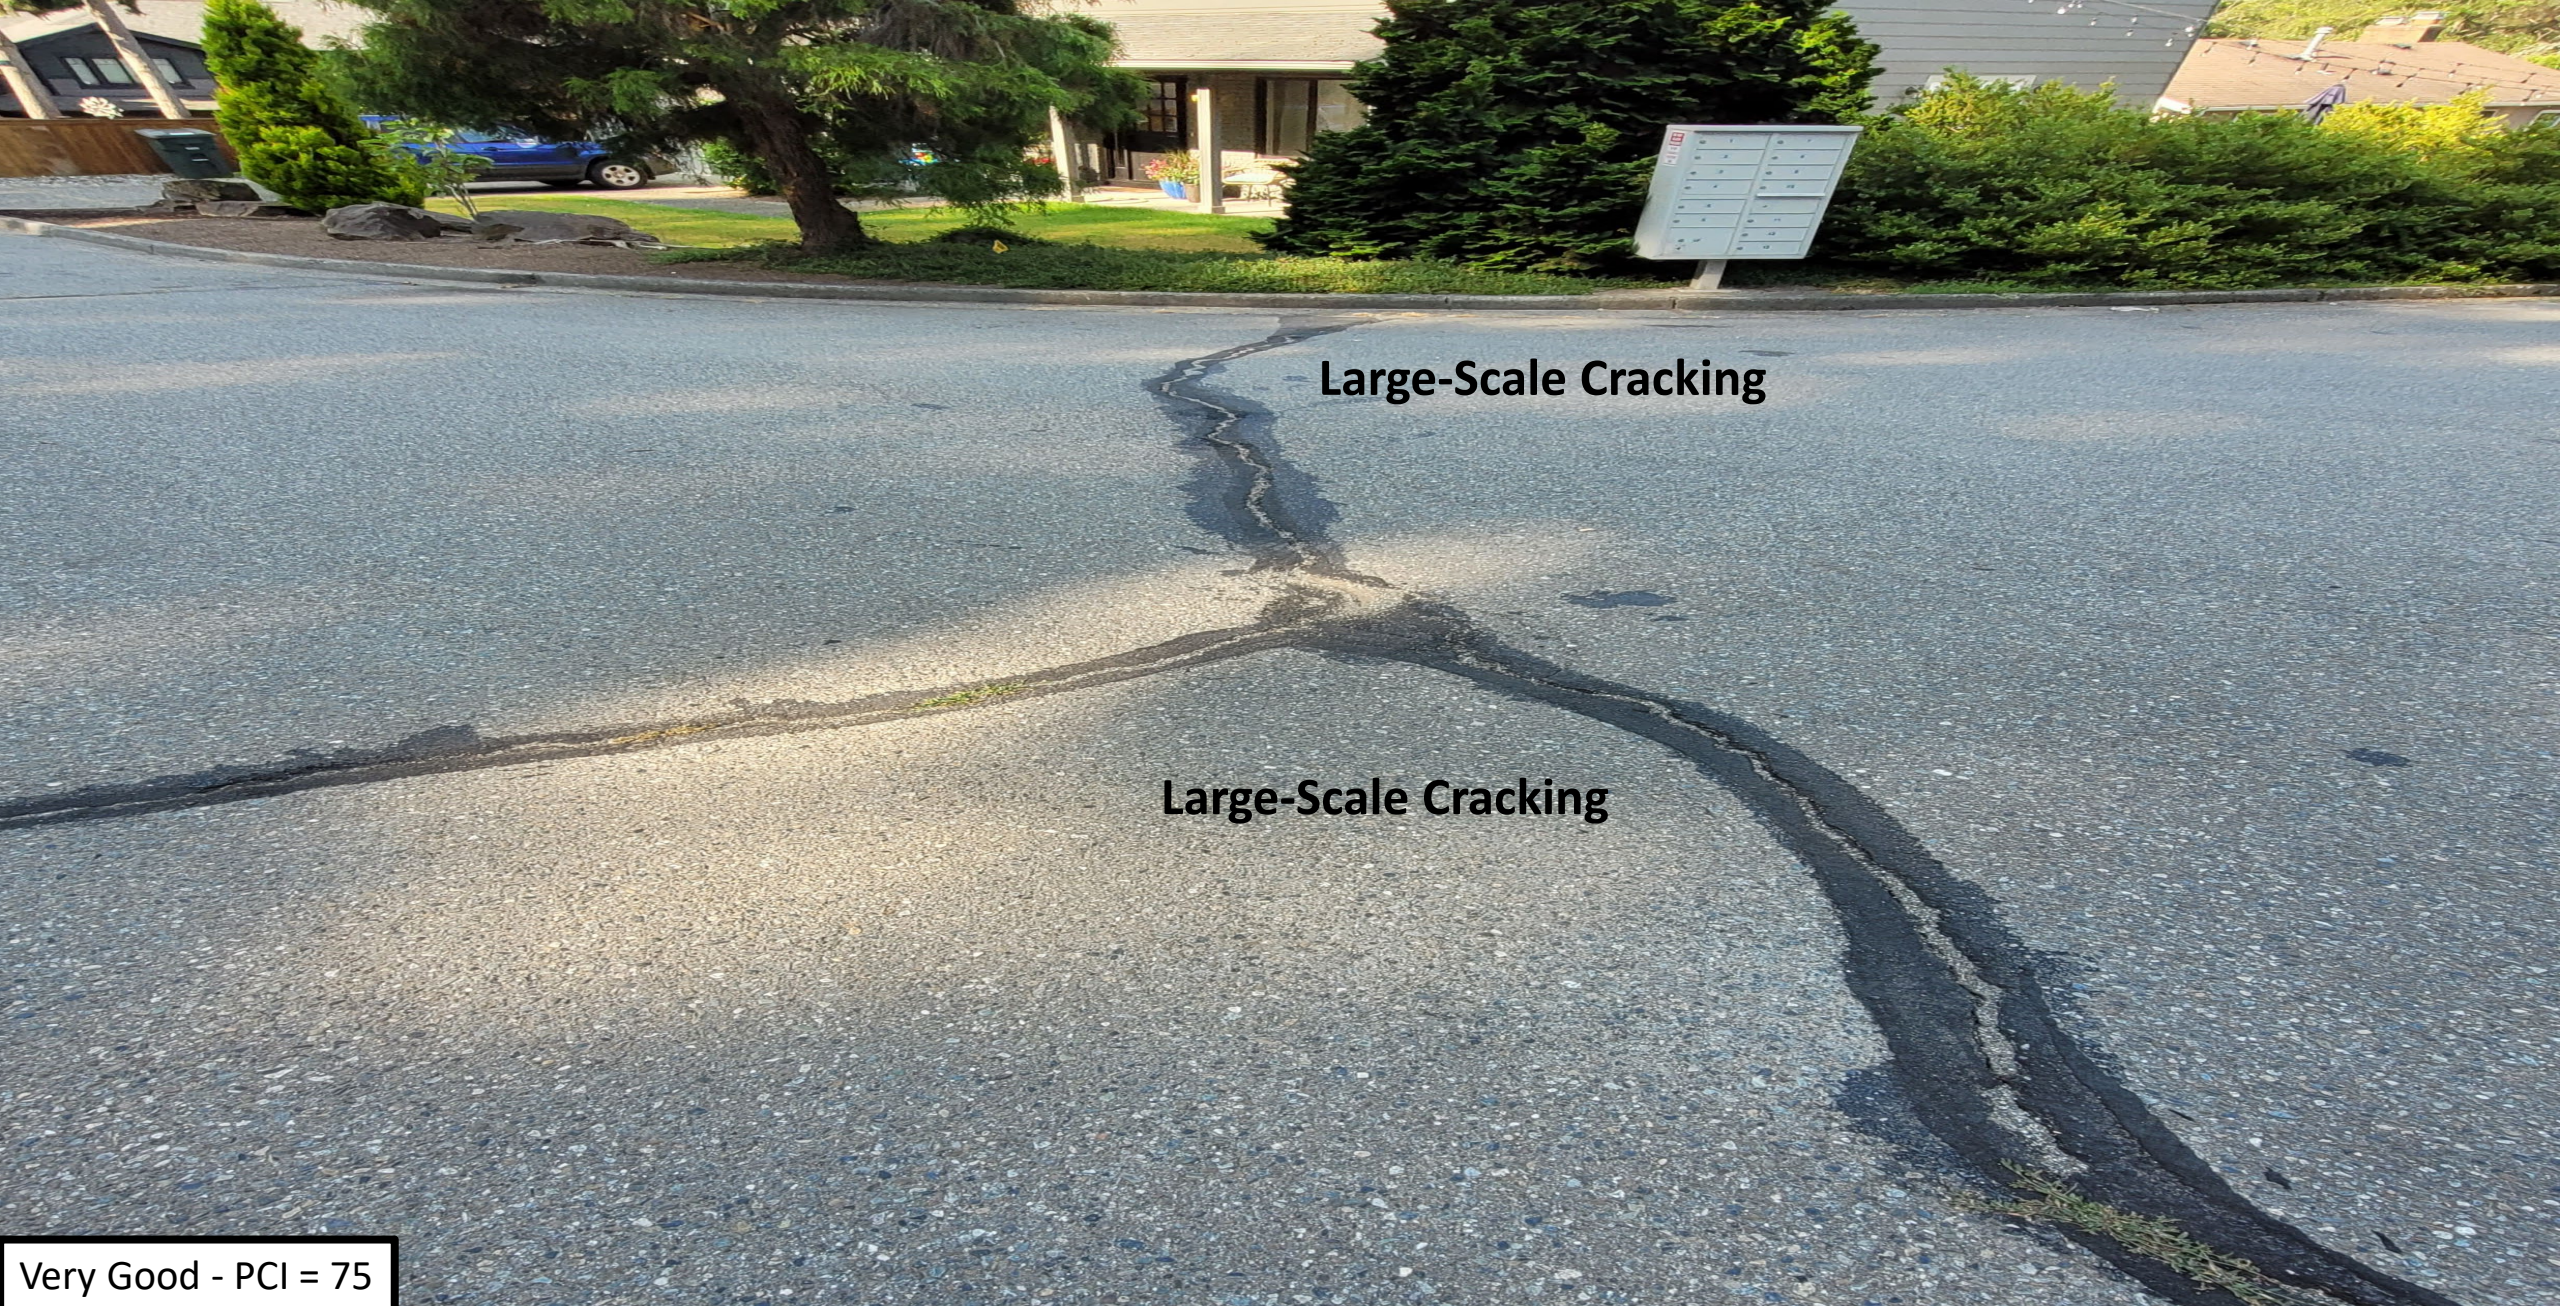
Large-Scale Cracking

Very Good - PCI = 75

**Stable, minor cracking**, generally hairline and hard to detect. **Minor patching** and possibly some minor deformation evident. Dry or light-colored appearance. **Good riding qualities. Rutting less than ½".**

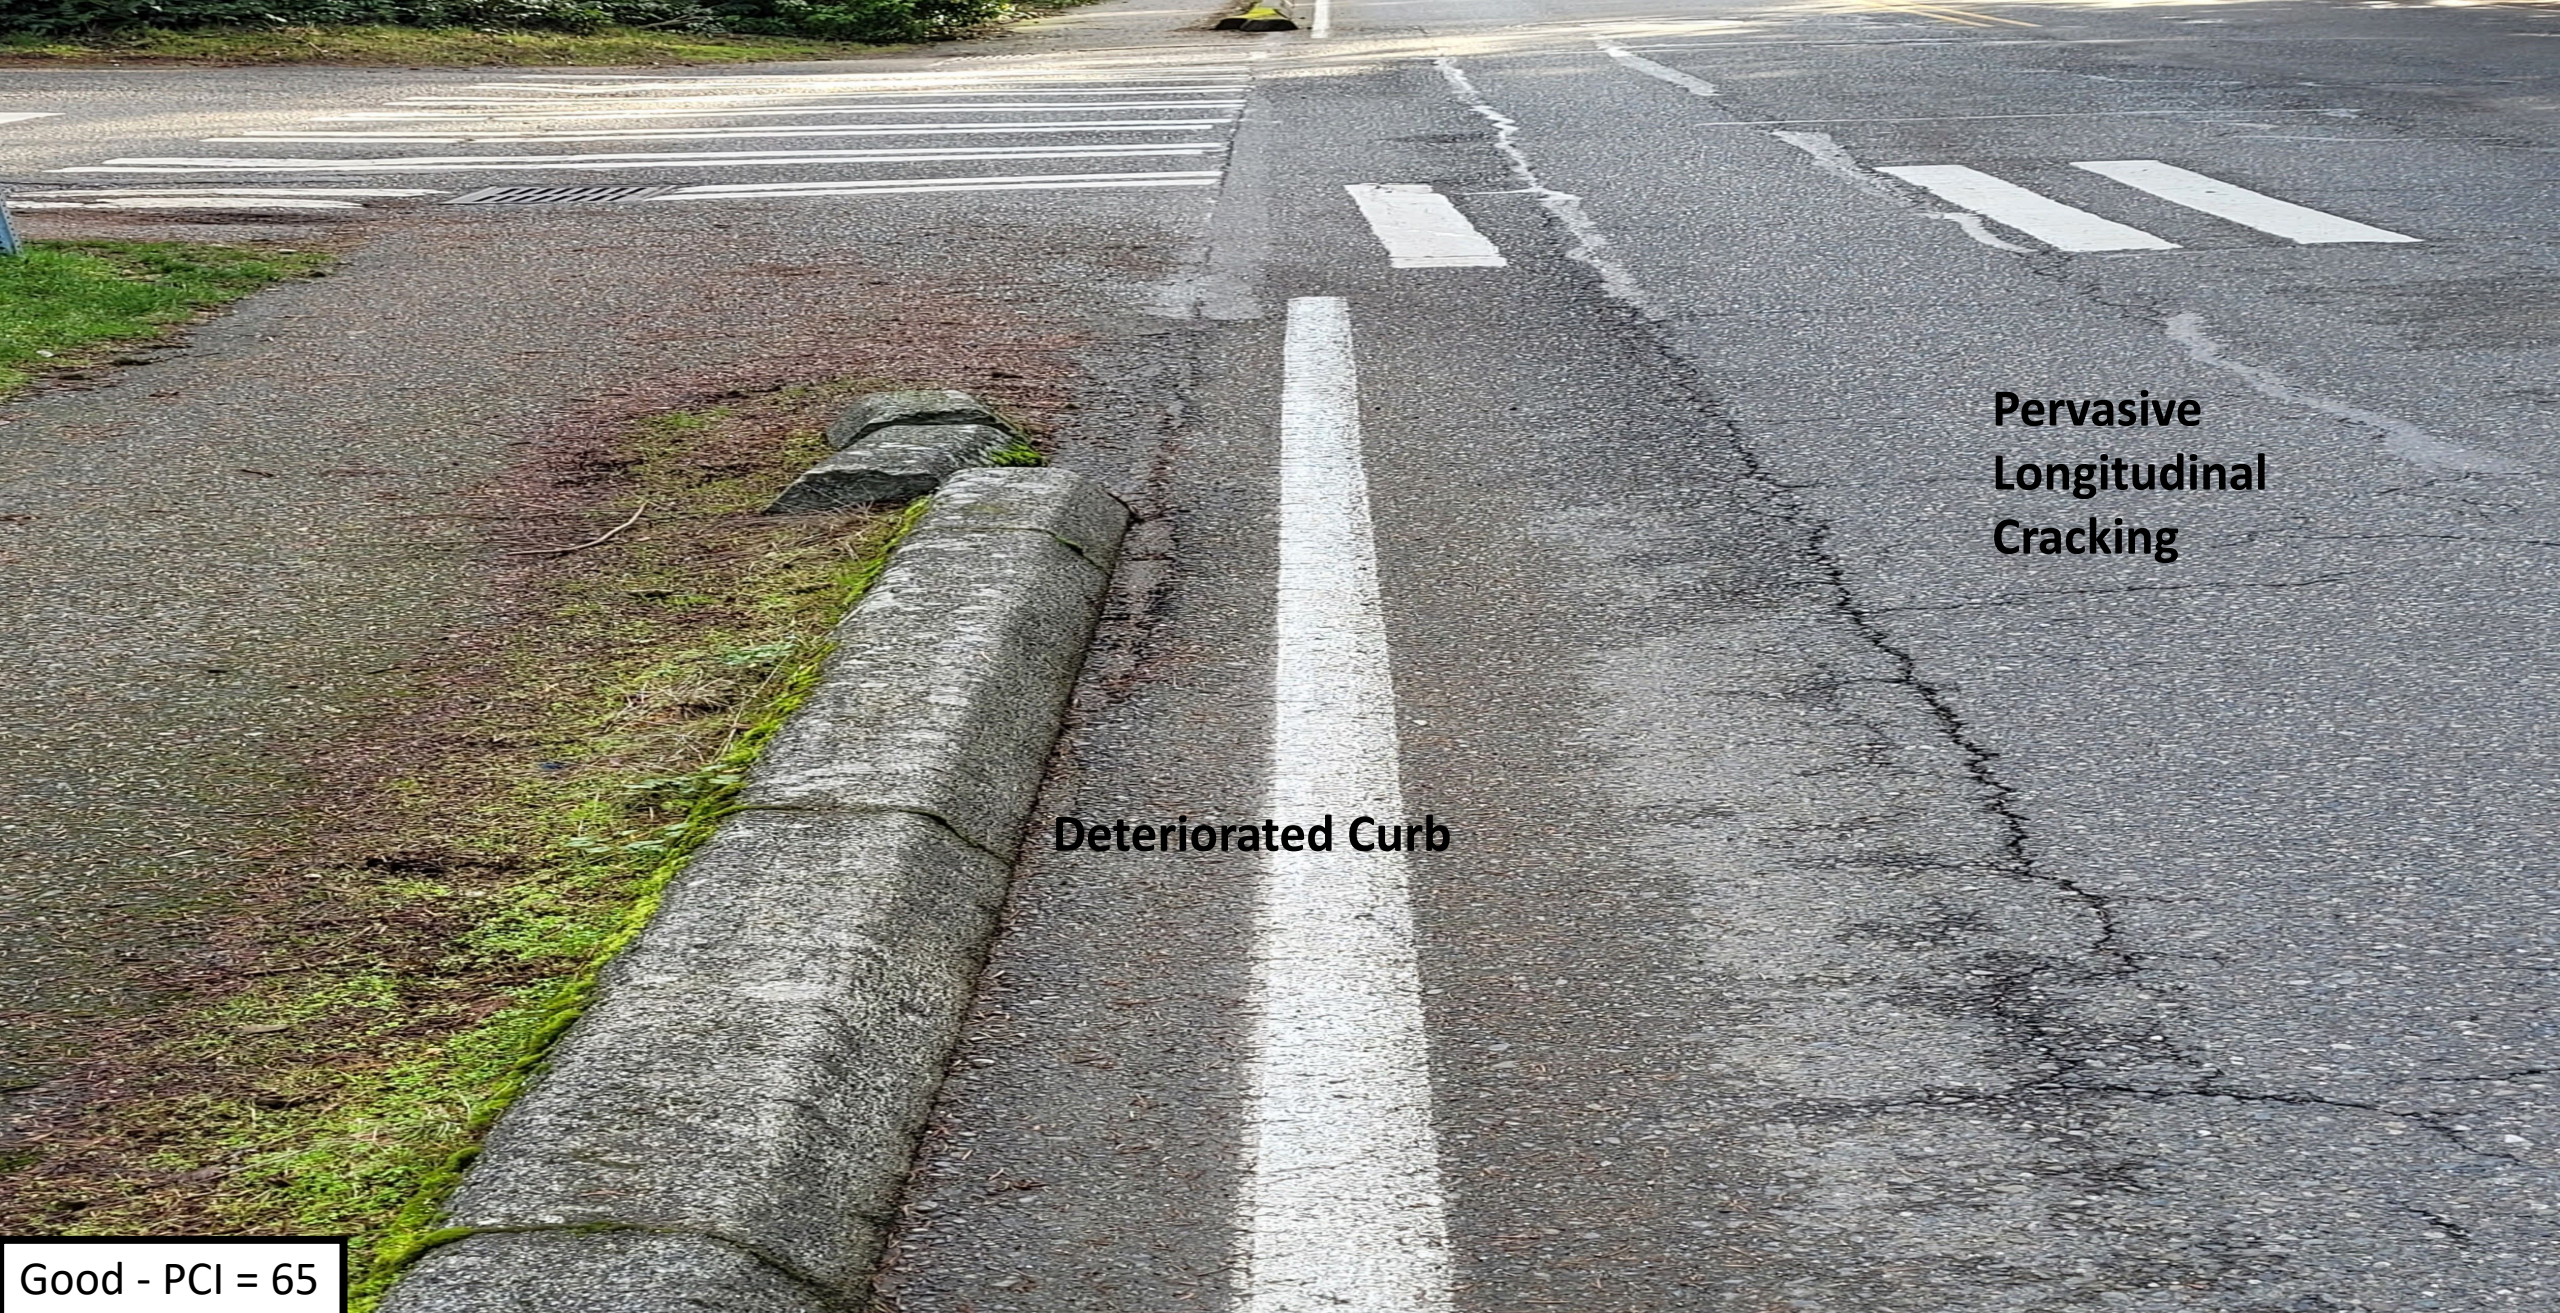
Pervasive  
Longitudinal  
Cracking

Deteriorated Curb

Good - PCI = 65

Generally stable, **minor areas of structural weakness evident**. **Cracking is easier to detect**, patches evident, patched but not excessively. Deformation more pronounced and easily noticed. **Ride qualities are good** to acceptable.

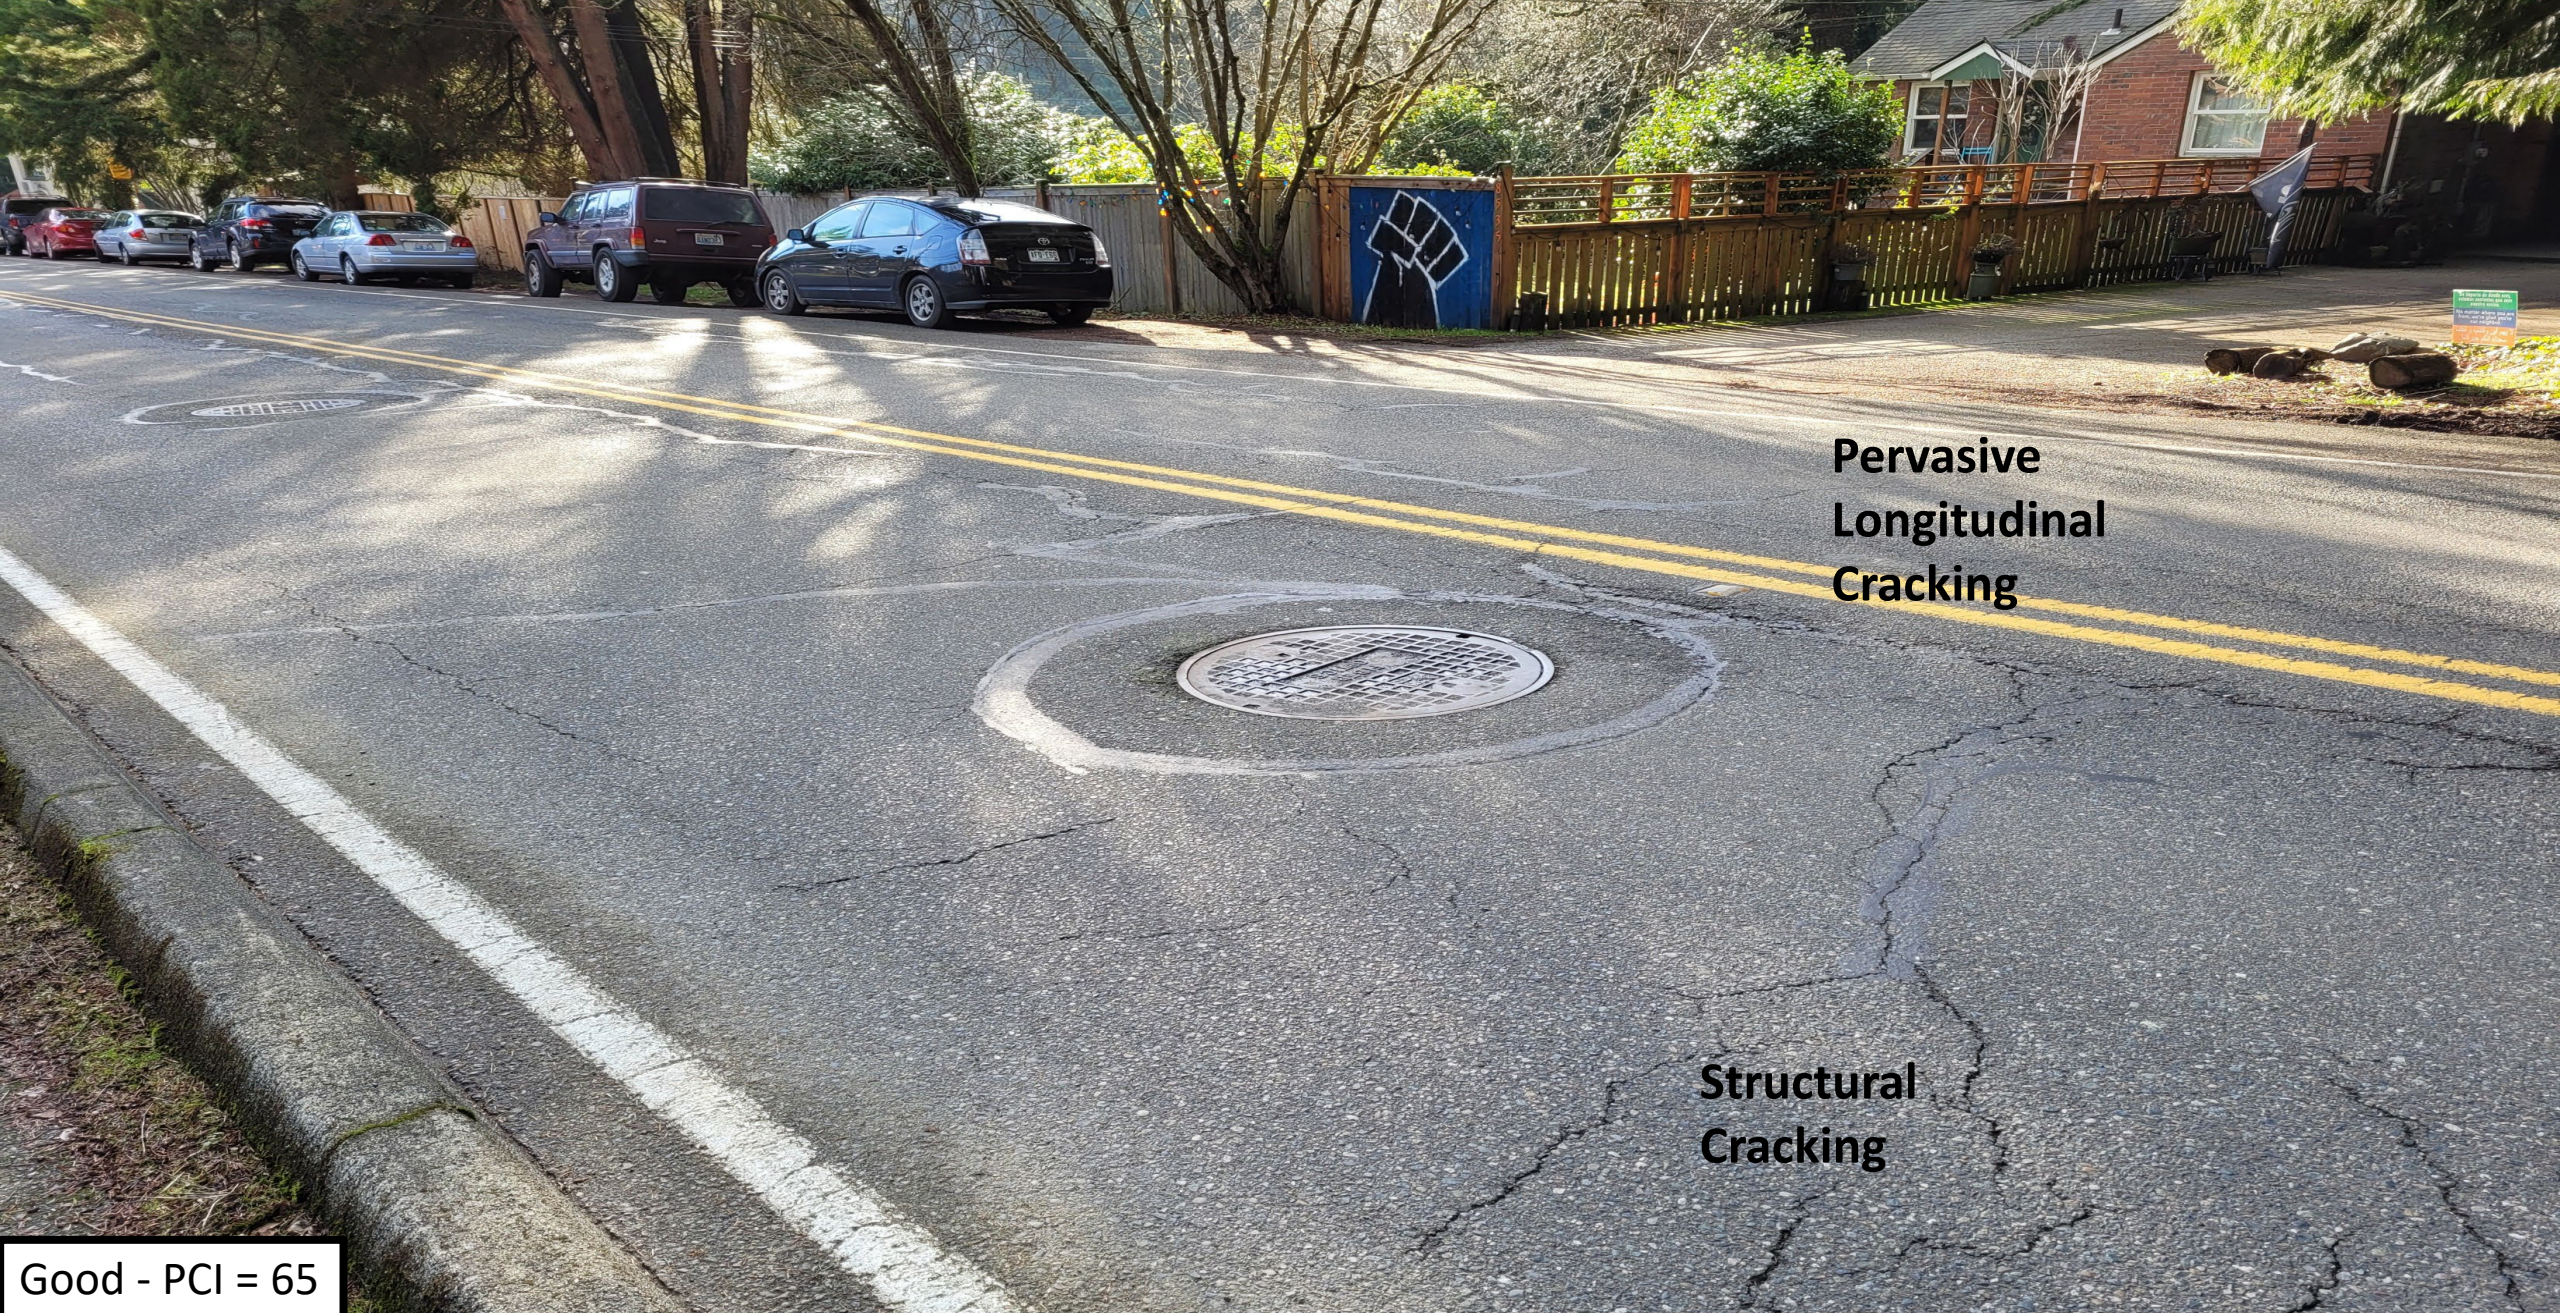
Pervasive  
Longitudinal  
Cracking

Structural  
Cracking

Good - PCI = 65

Generally stable, **minor areas of structural weakness evident**. **Cracking is easier to detect**, patches evident, patched but not excessively. Deformation more pronounced and easily noticed. **Ride qualities are good** to acceptable.

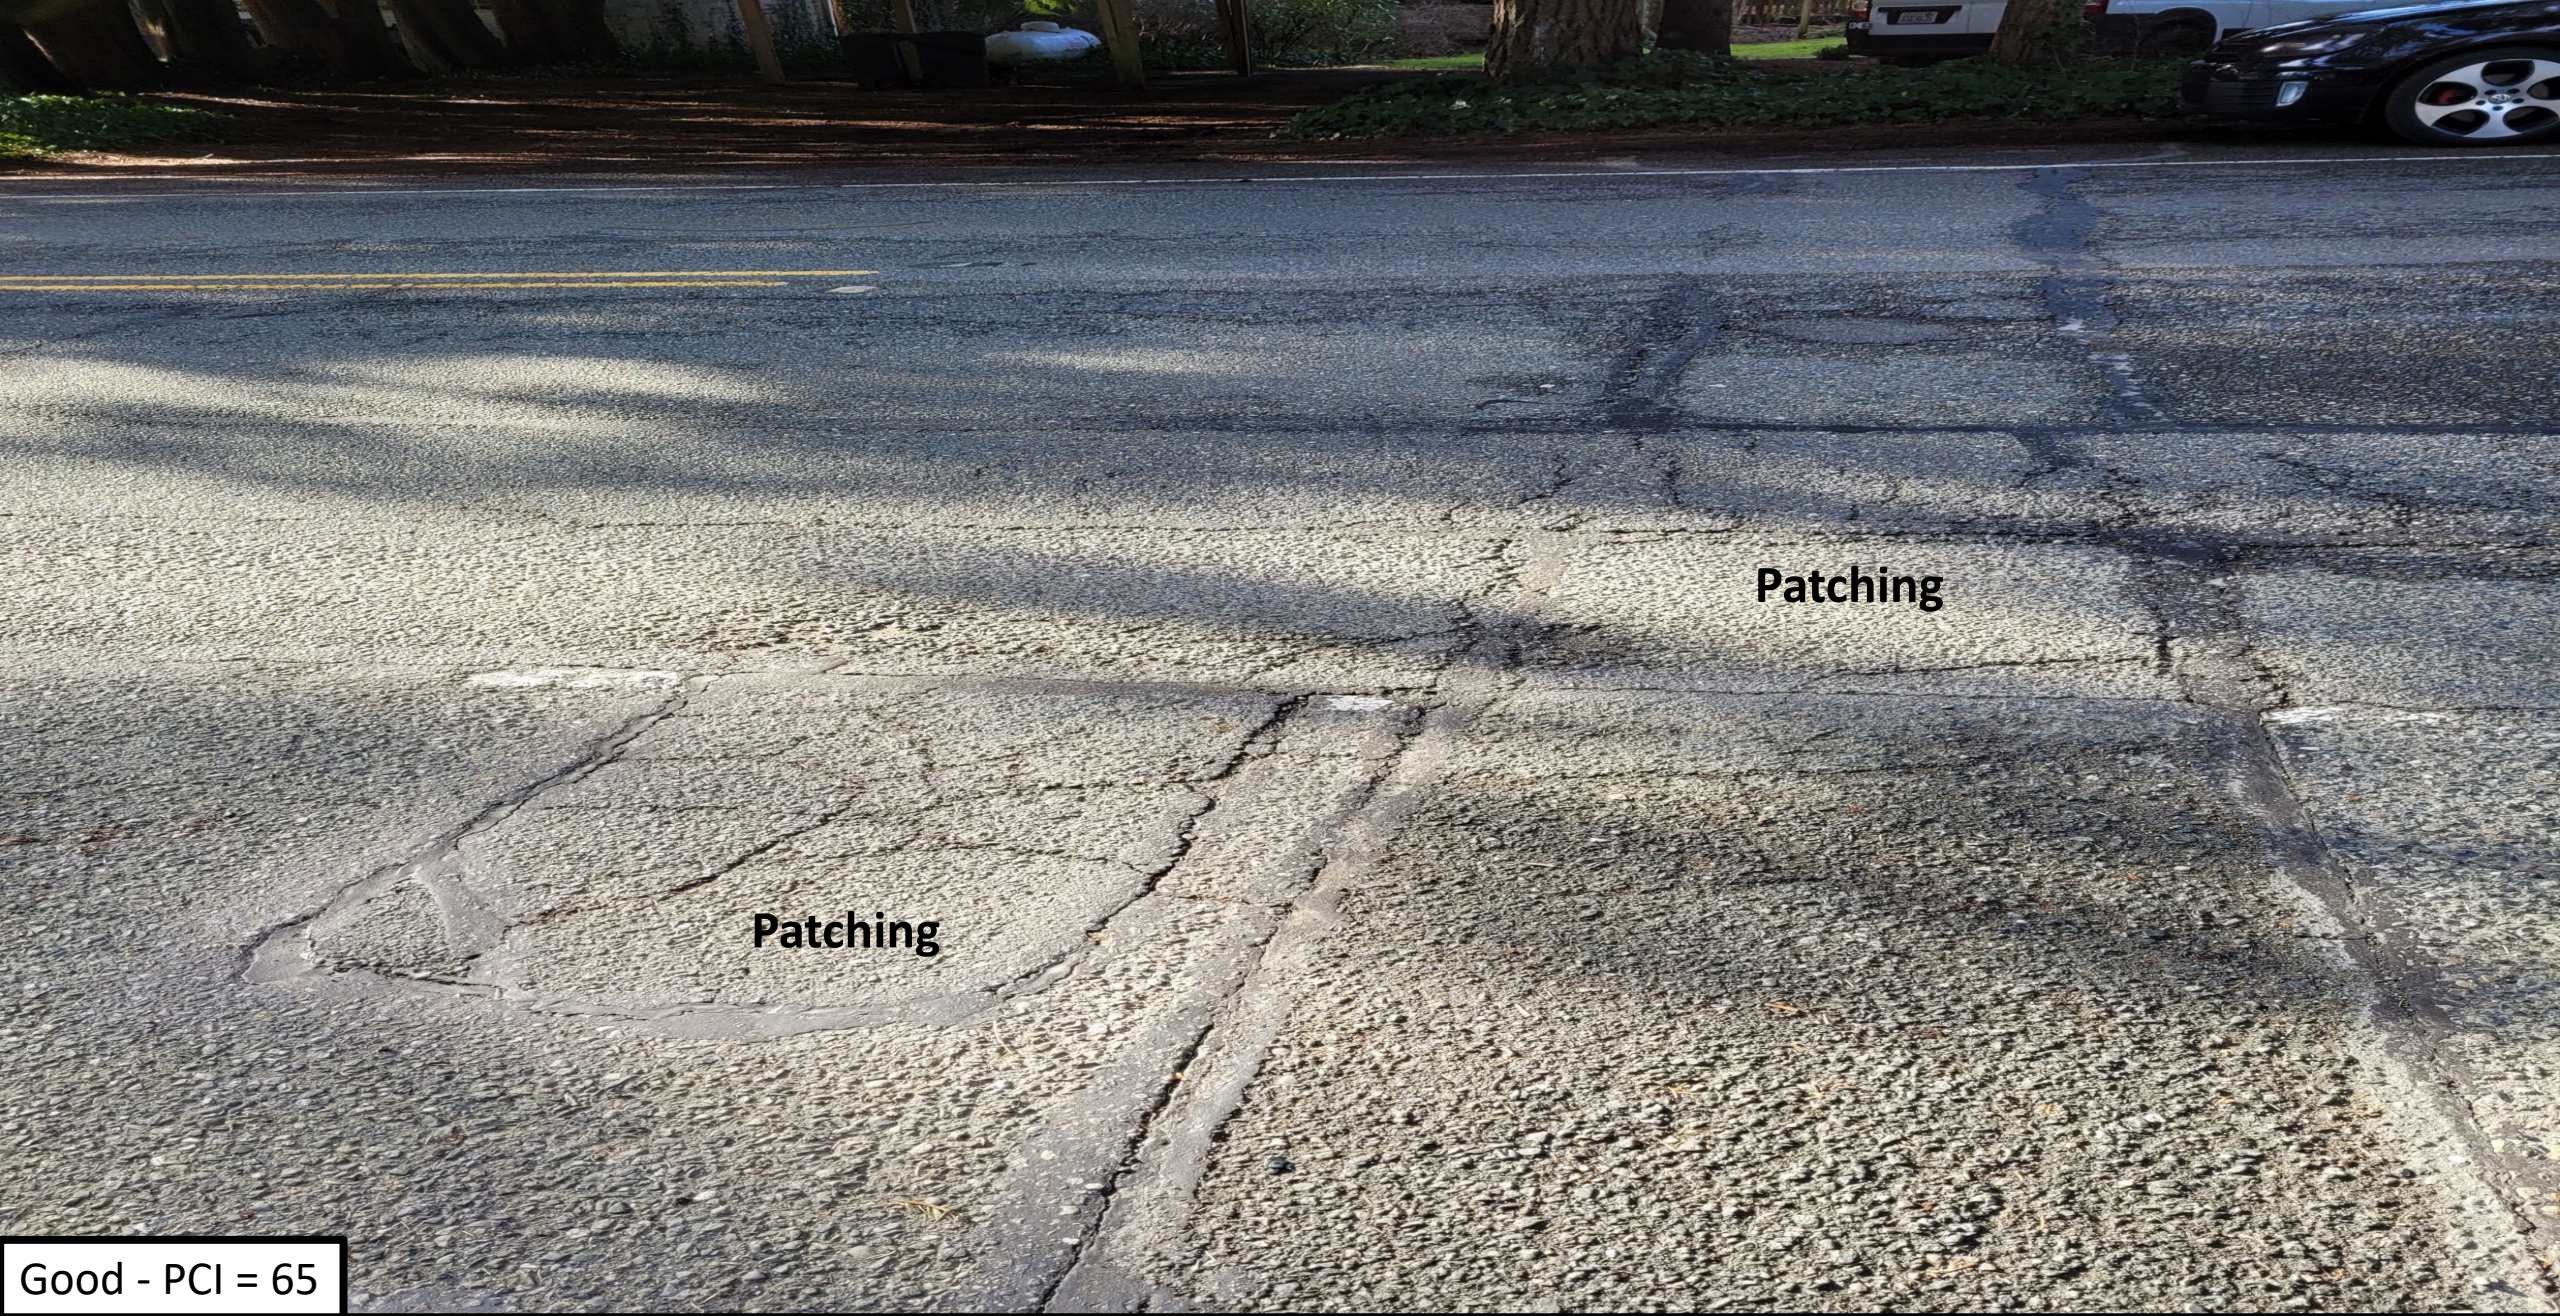
Patching

Good - PCI = 65

Generally stable, **minor areas of structural weakness evident**. **Cracking is easier to detect, patches evident**, patched but not excessively. Deformation more pronounced and easily noticed. Ride qualities are good to acceptable.

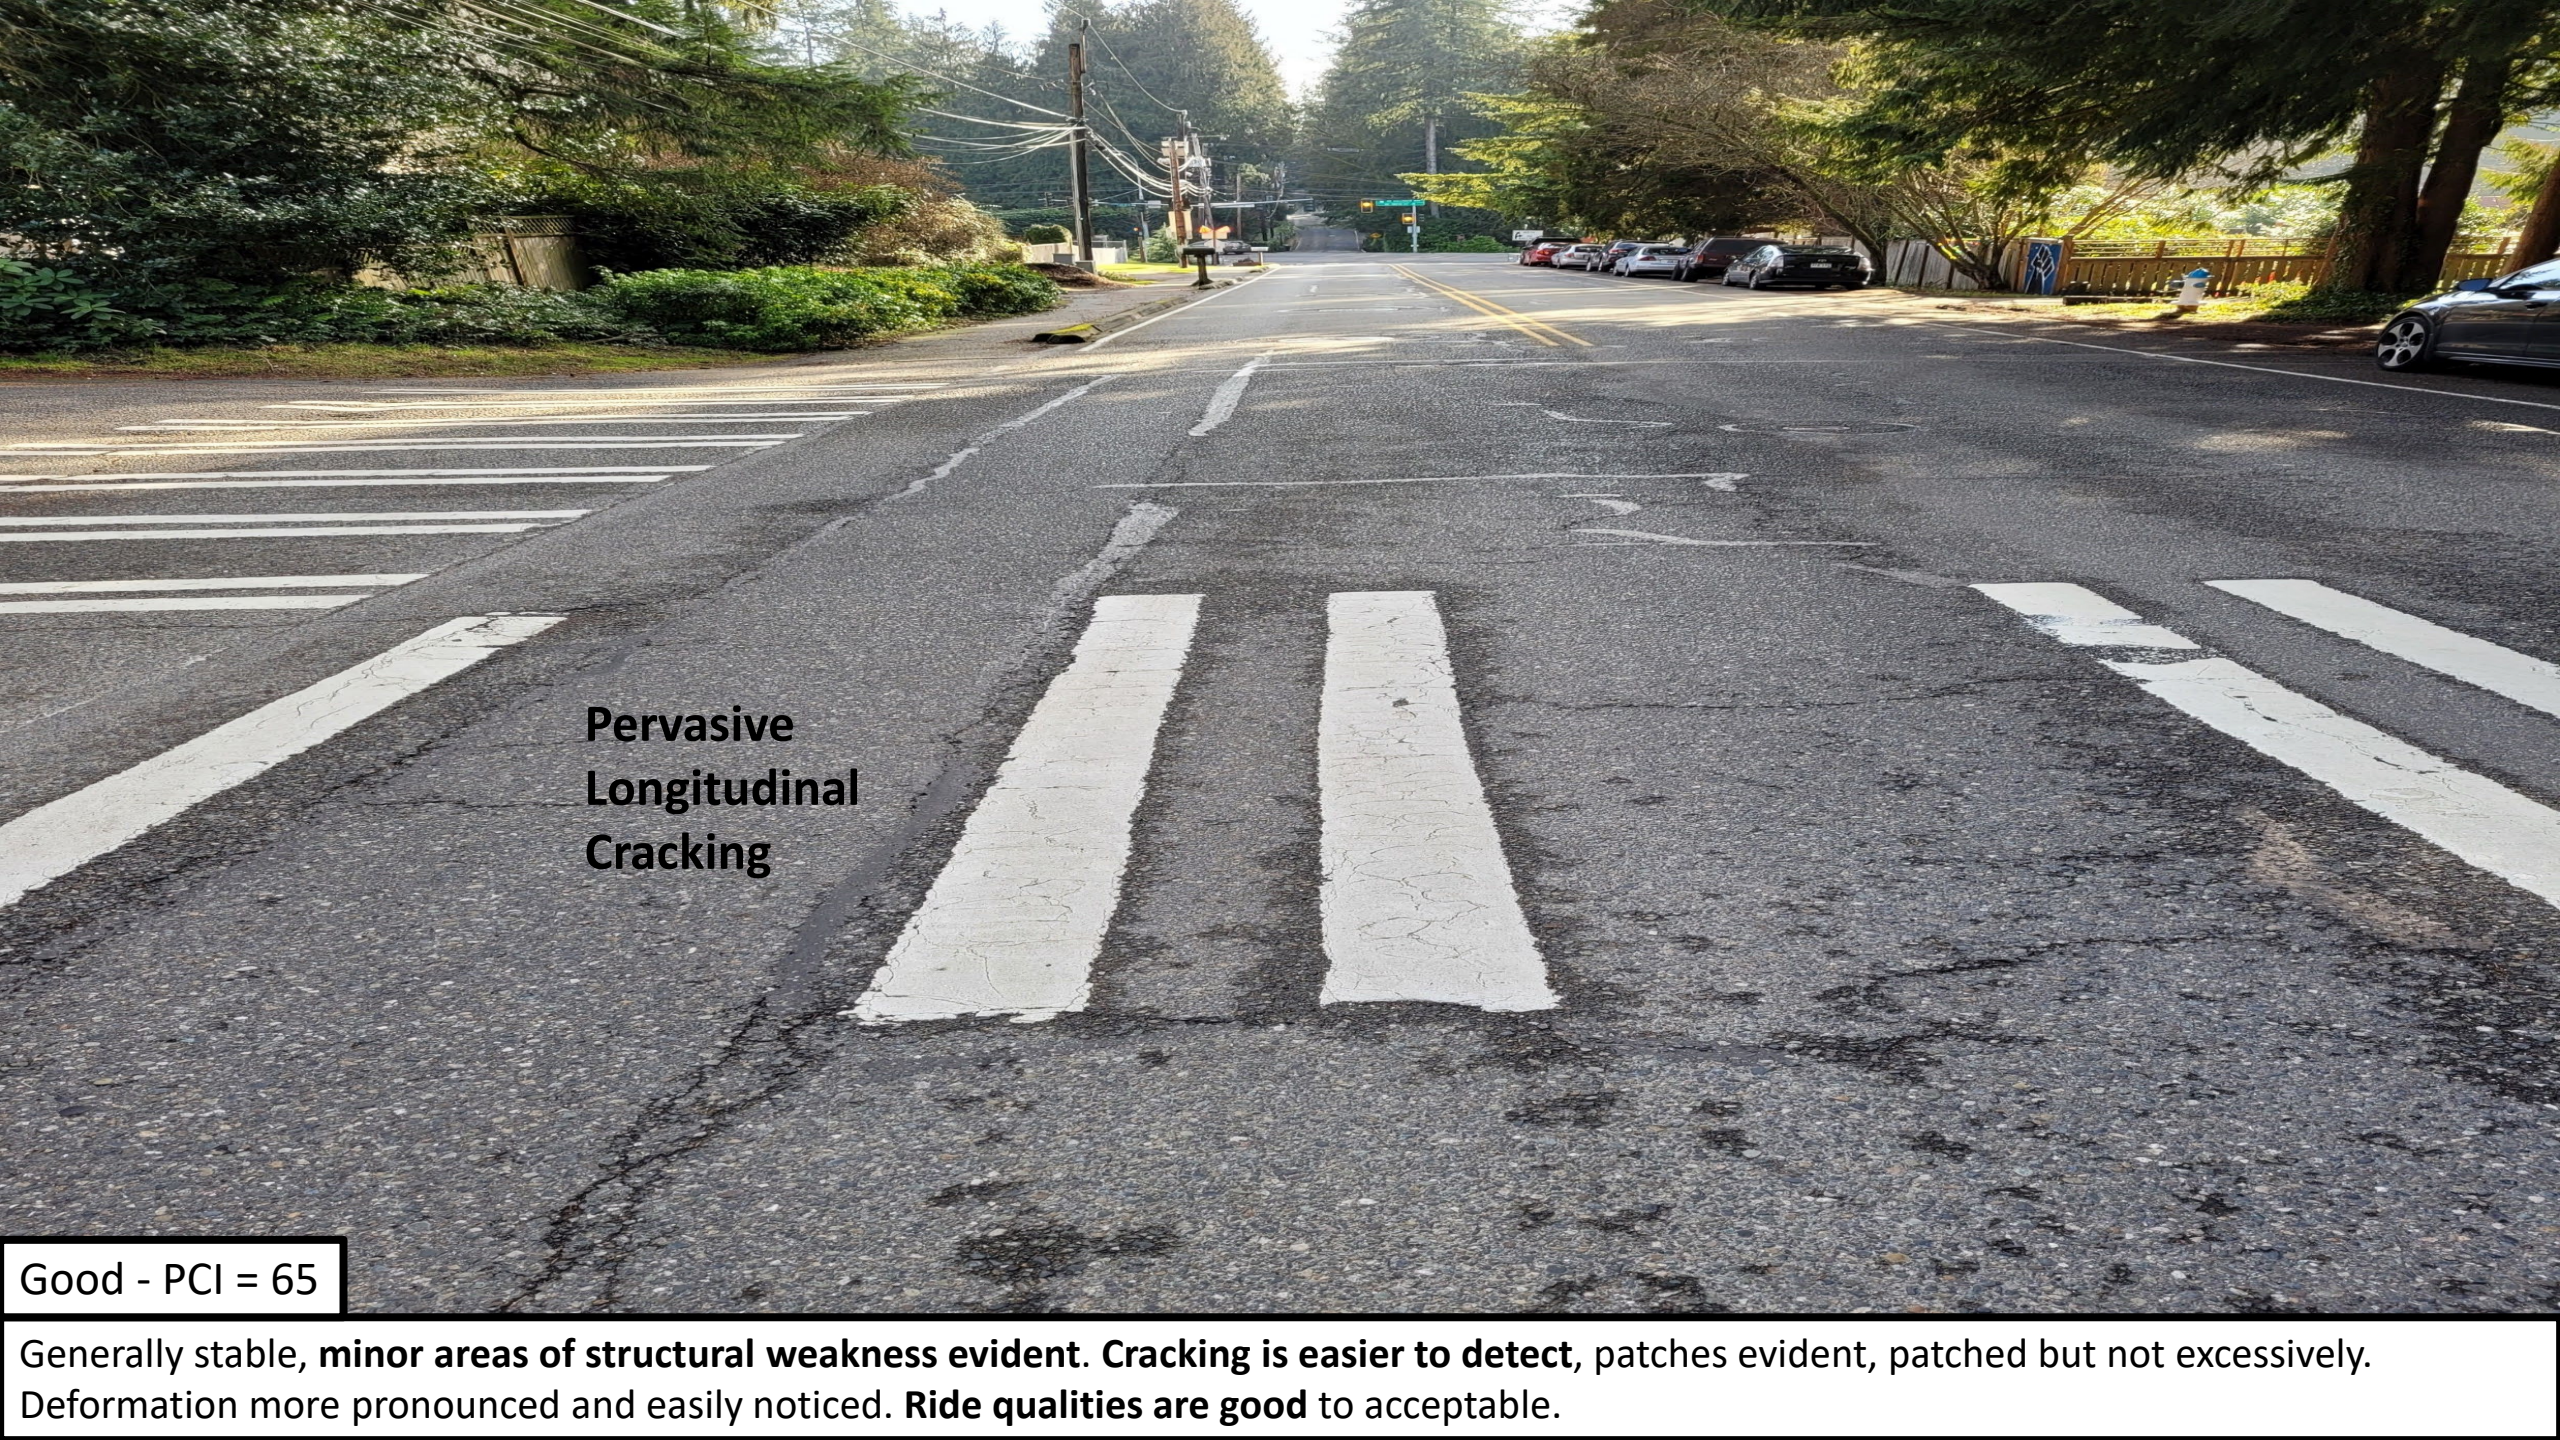
Pervasive  
Longitudinal  
Cracking

Good - PCI = 65

Generally stable, **minor areas of structural weakness evident**. **Cracking is easier to detect**, patches evident, patched but not excessively. Deformation more pronounced and easily noticed. **Ride qualities are good** to acceptable.

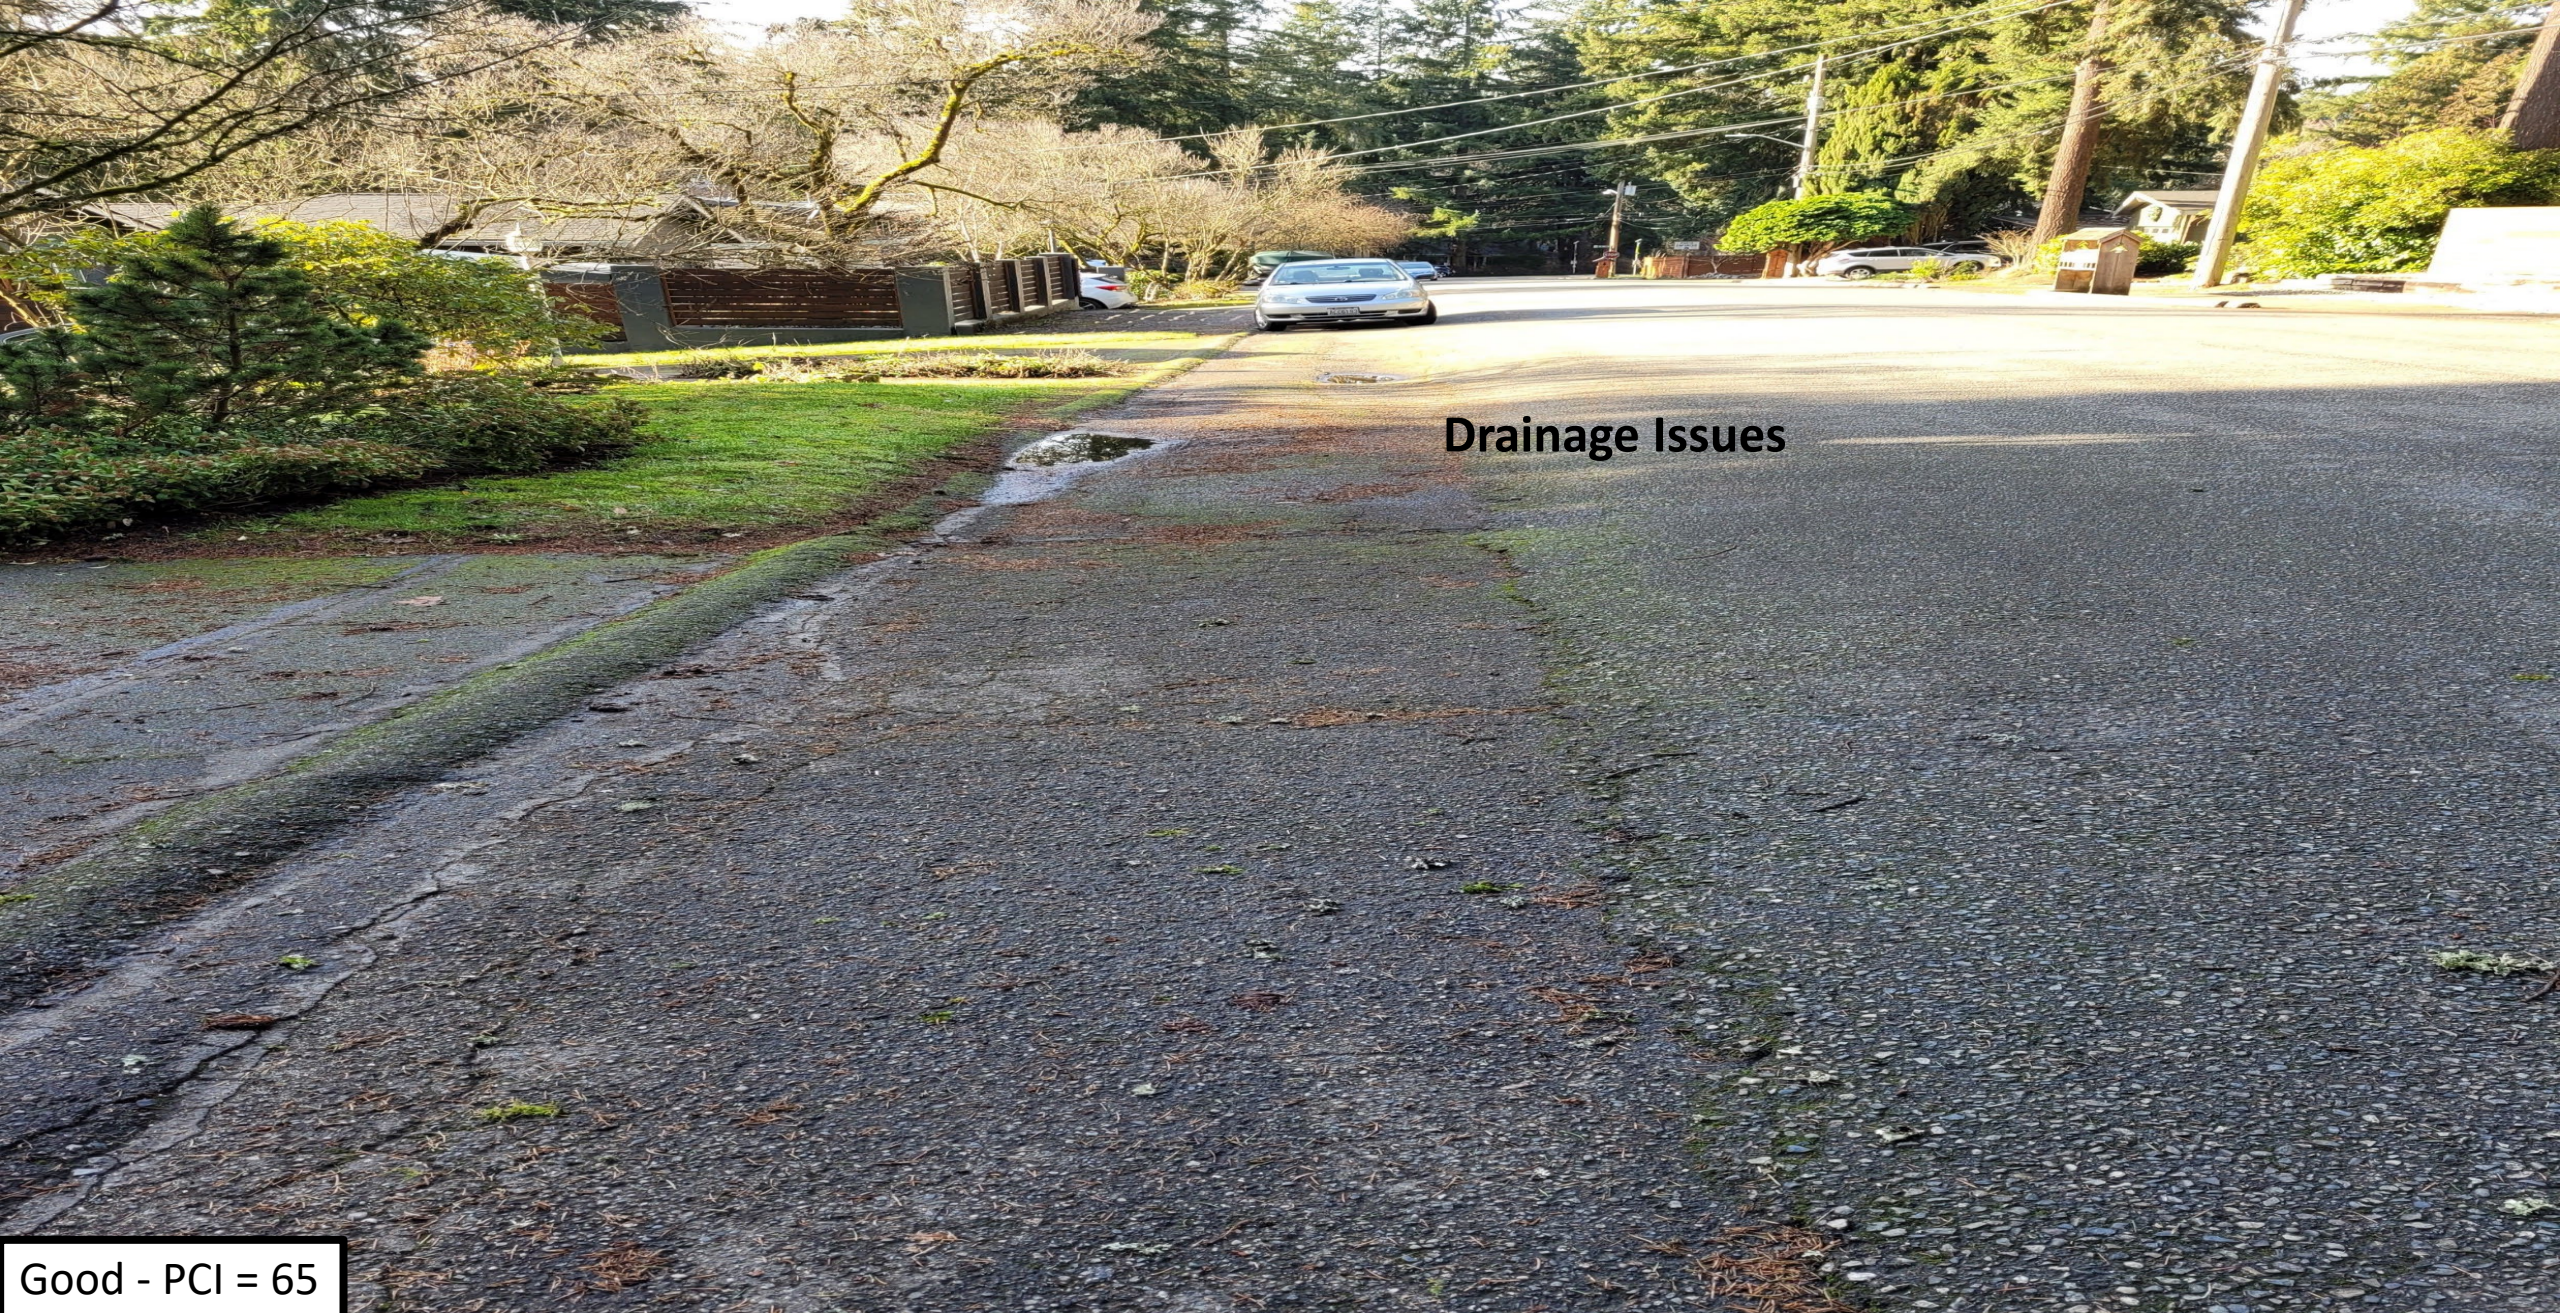
## Drainage Issues

Good - PCI = 65

Generally stable, **minor areas of structural weakness evident**. **Cracking is easier to detect, patches evident**, patched but not excessively. Deformation more pronounced and easily noticed. **Ride qualities are good** to acceptable.
