# CAPITAL IMPROVEMENT PLAN UPDATE

2023 Pavement Plan

07.13.23

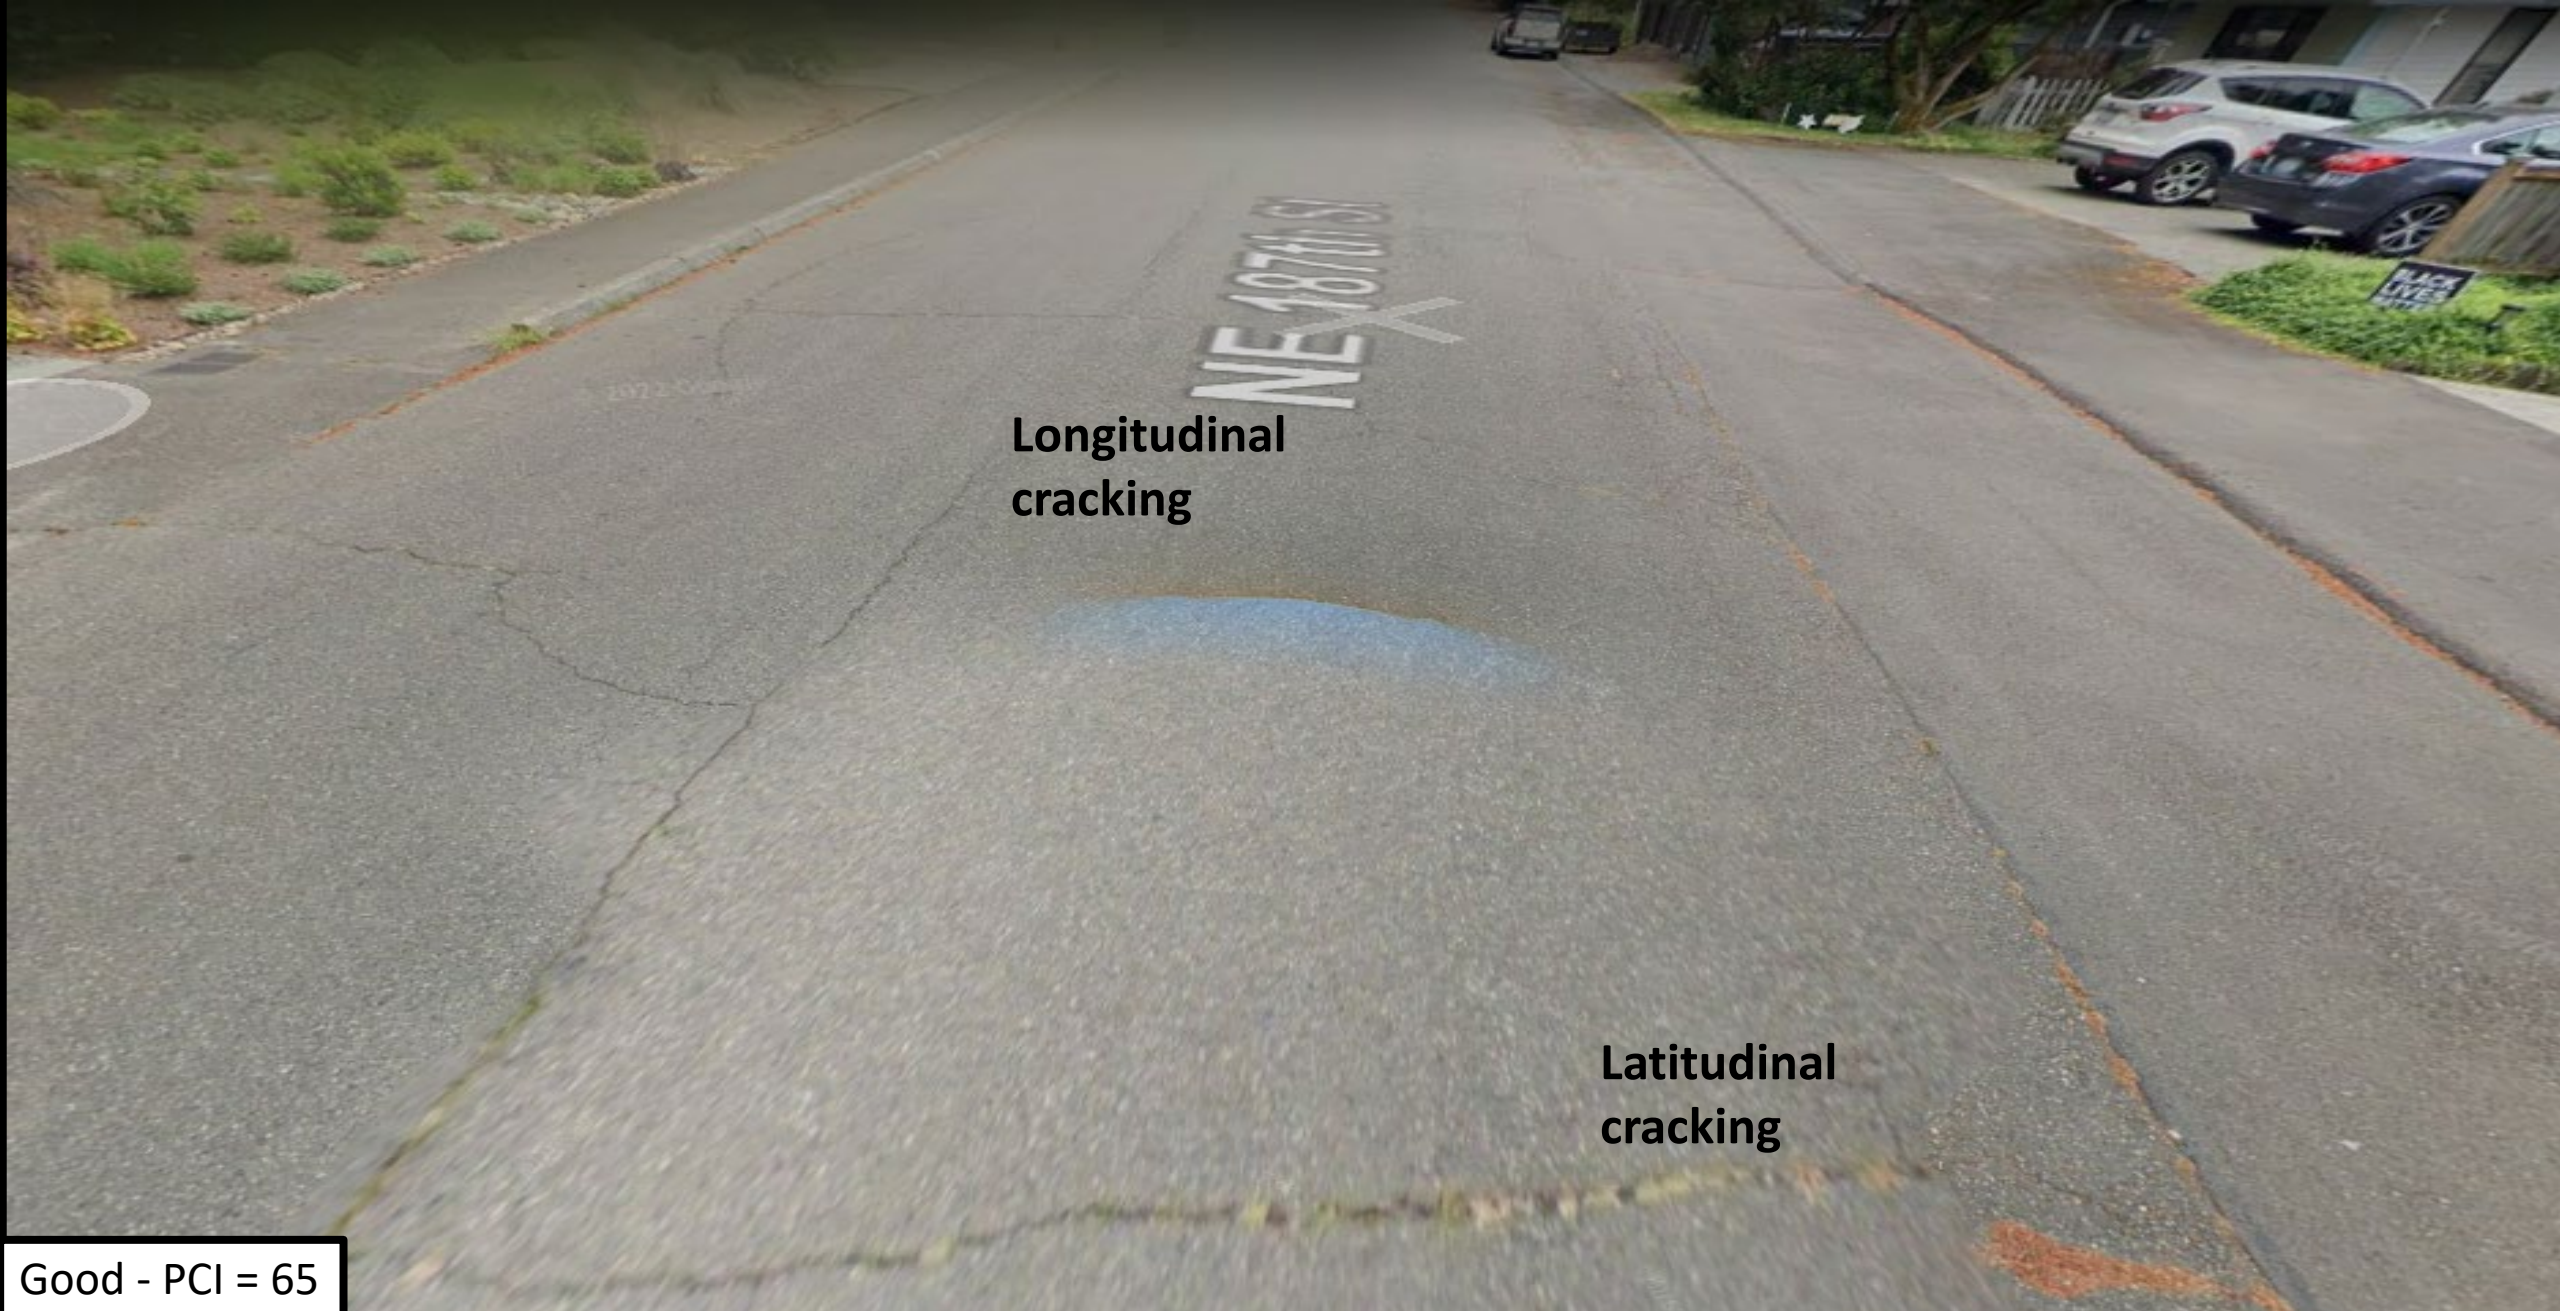
Longitudinal  
cracking

Latitudinal  
cracking

Good - PCI = 65

Generally stable, **minor areas of structural weakness evident**. **Cracking is easier to detect, patches evident**, patched but not excessively. Deformation more pronounced and easily noticed. **Ride qualities are good** to acceptable.

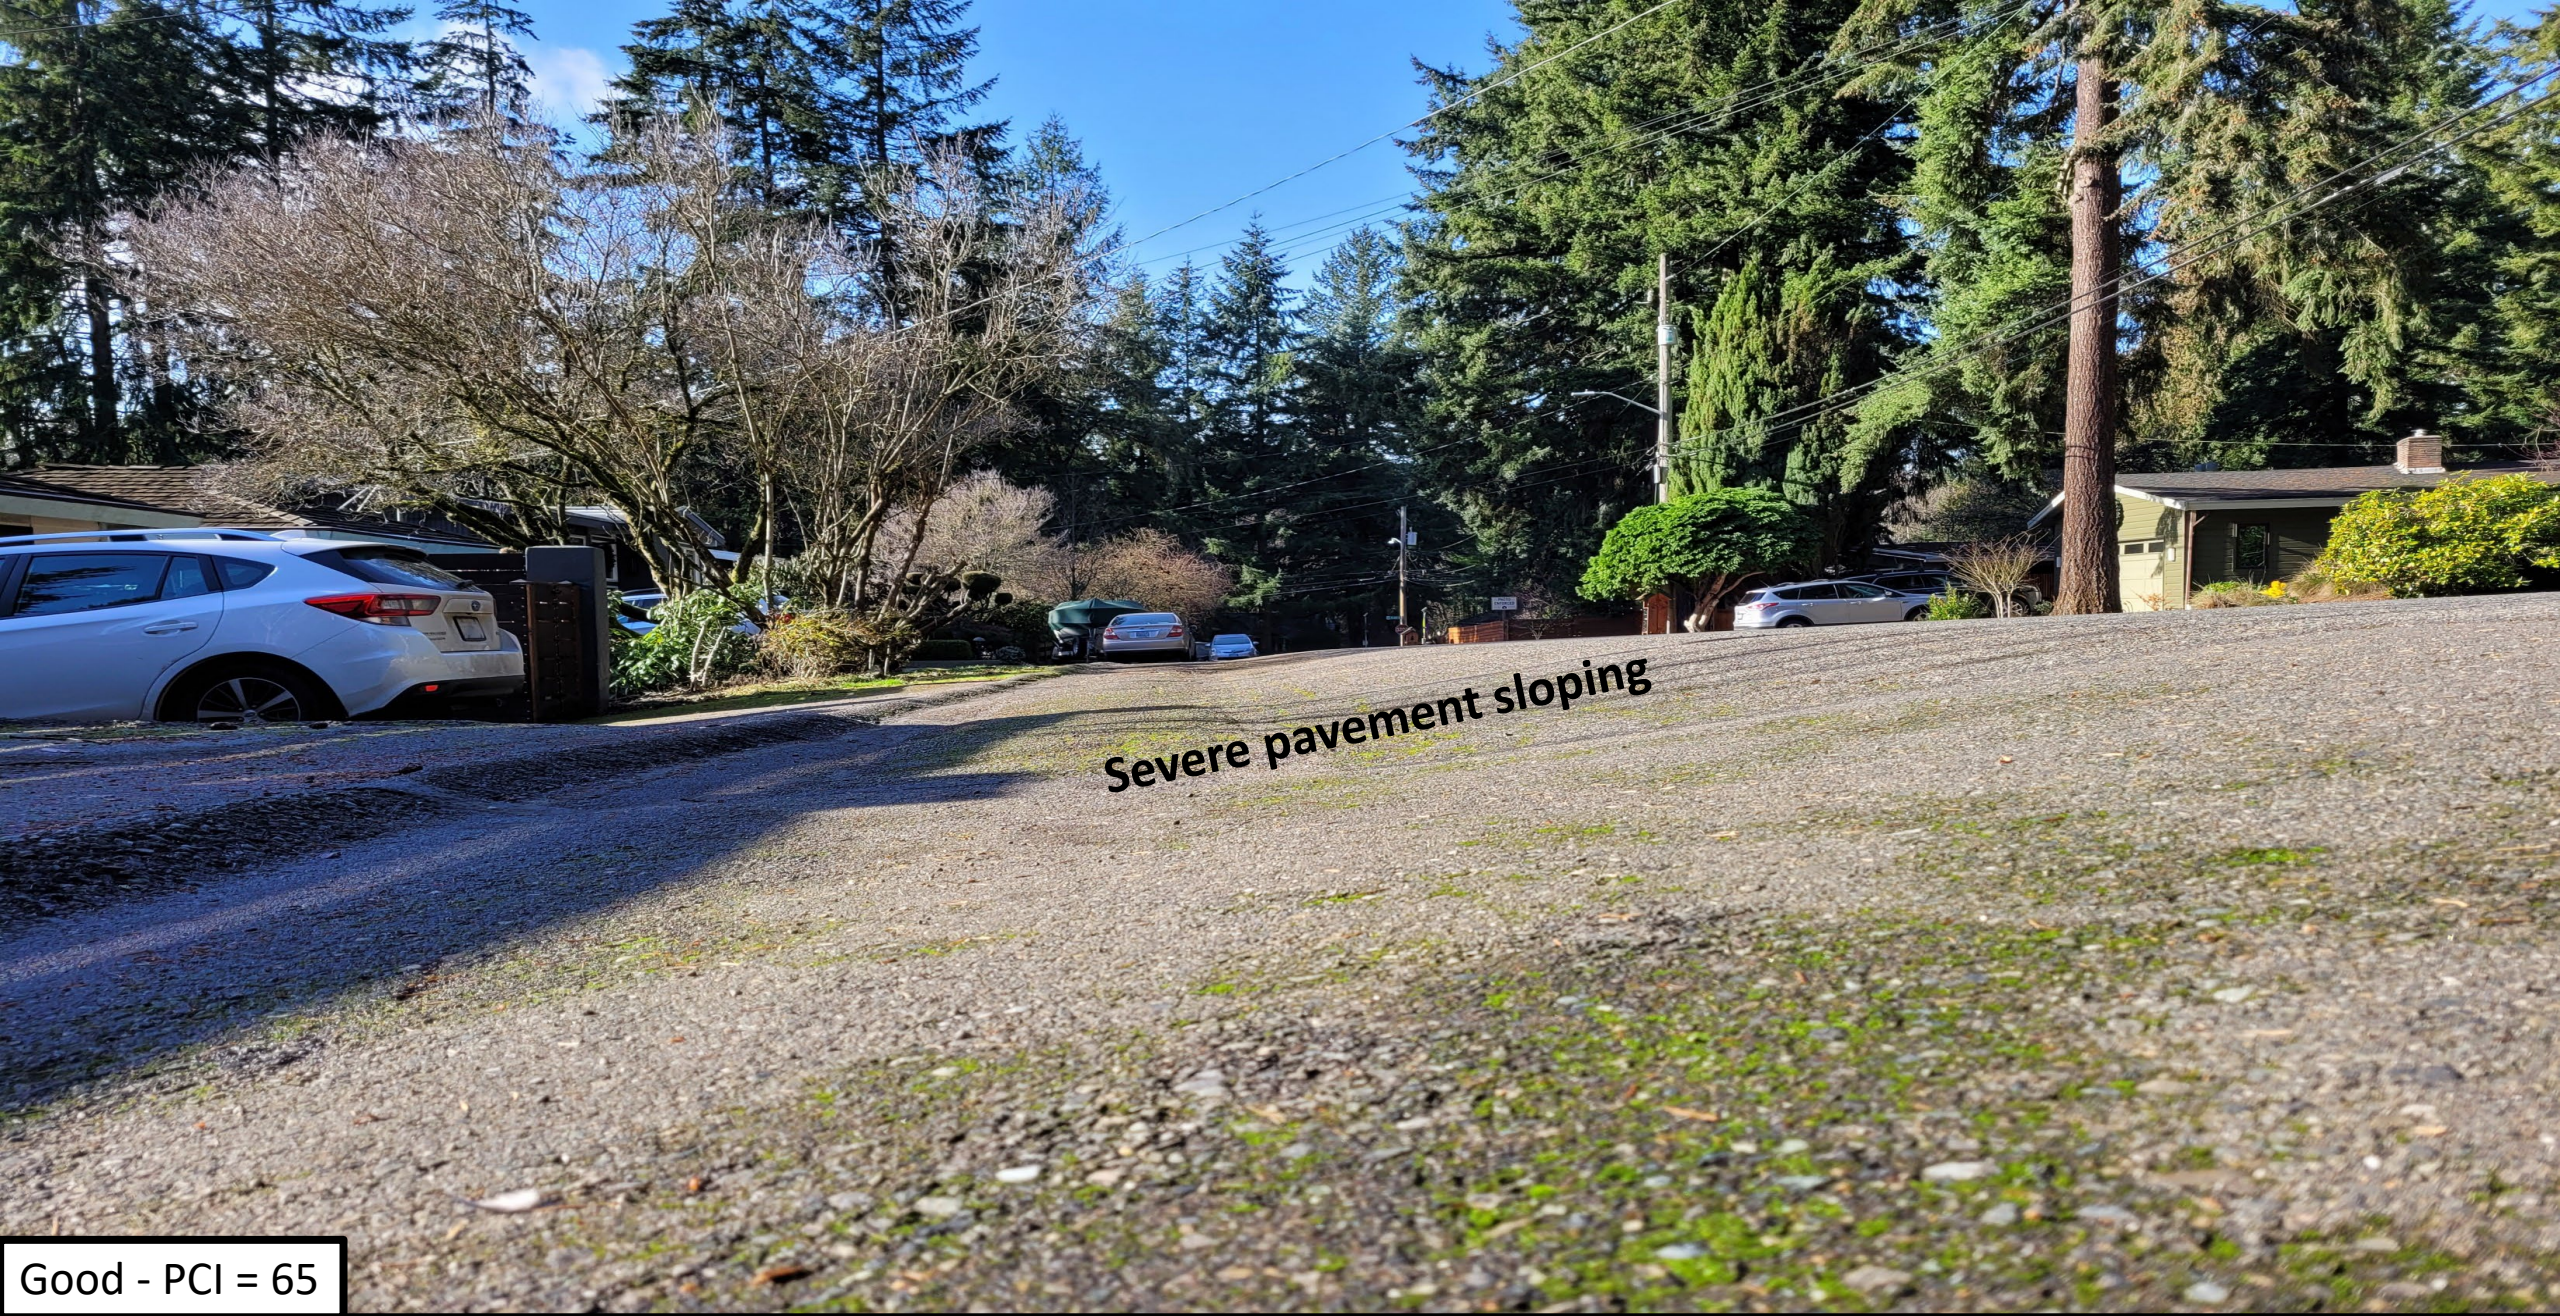
Severe pavement sloping

Good - PCI = 65

Generally stable, **minor areas of structural weakness evident**. Cracking is easier to detect, patches evident, patched but not excessively. Deformation more pronounced and easily noticed. **Ride qualities are good** to acceptable.

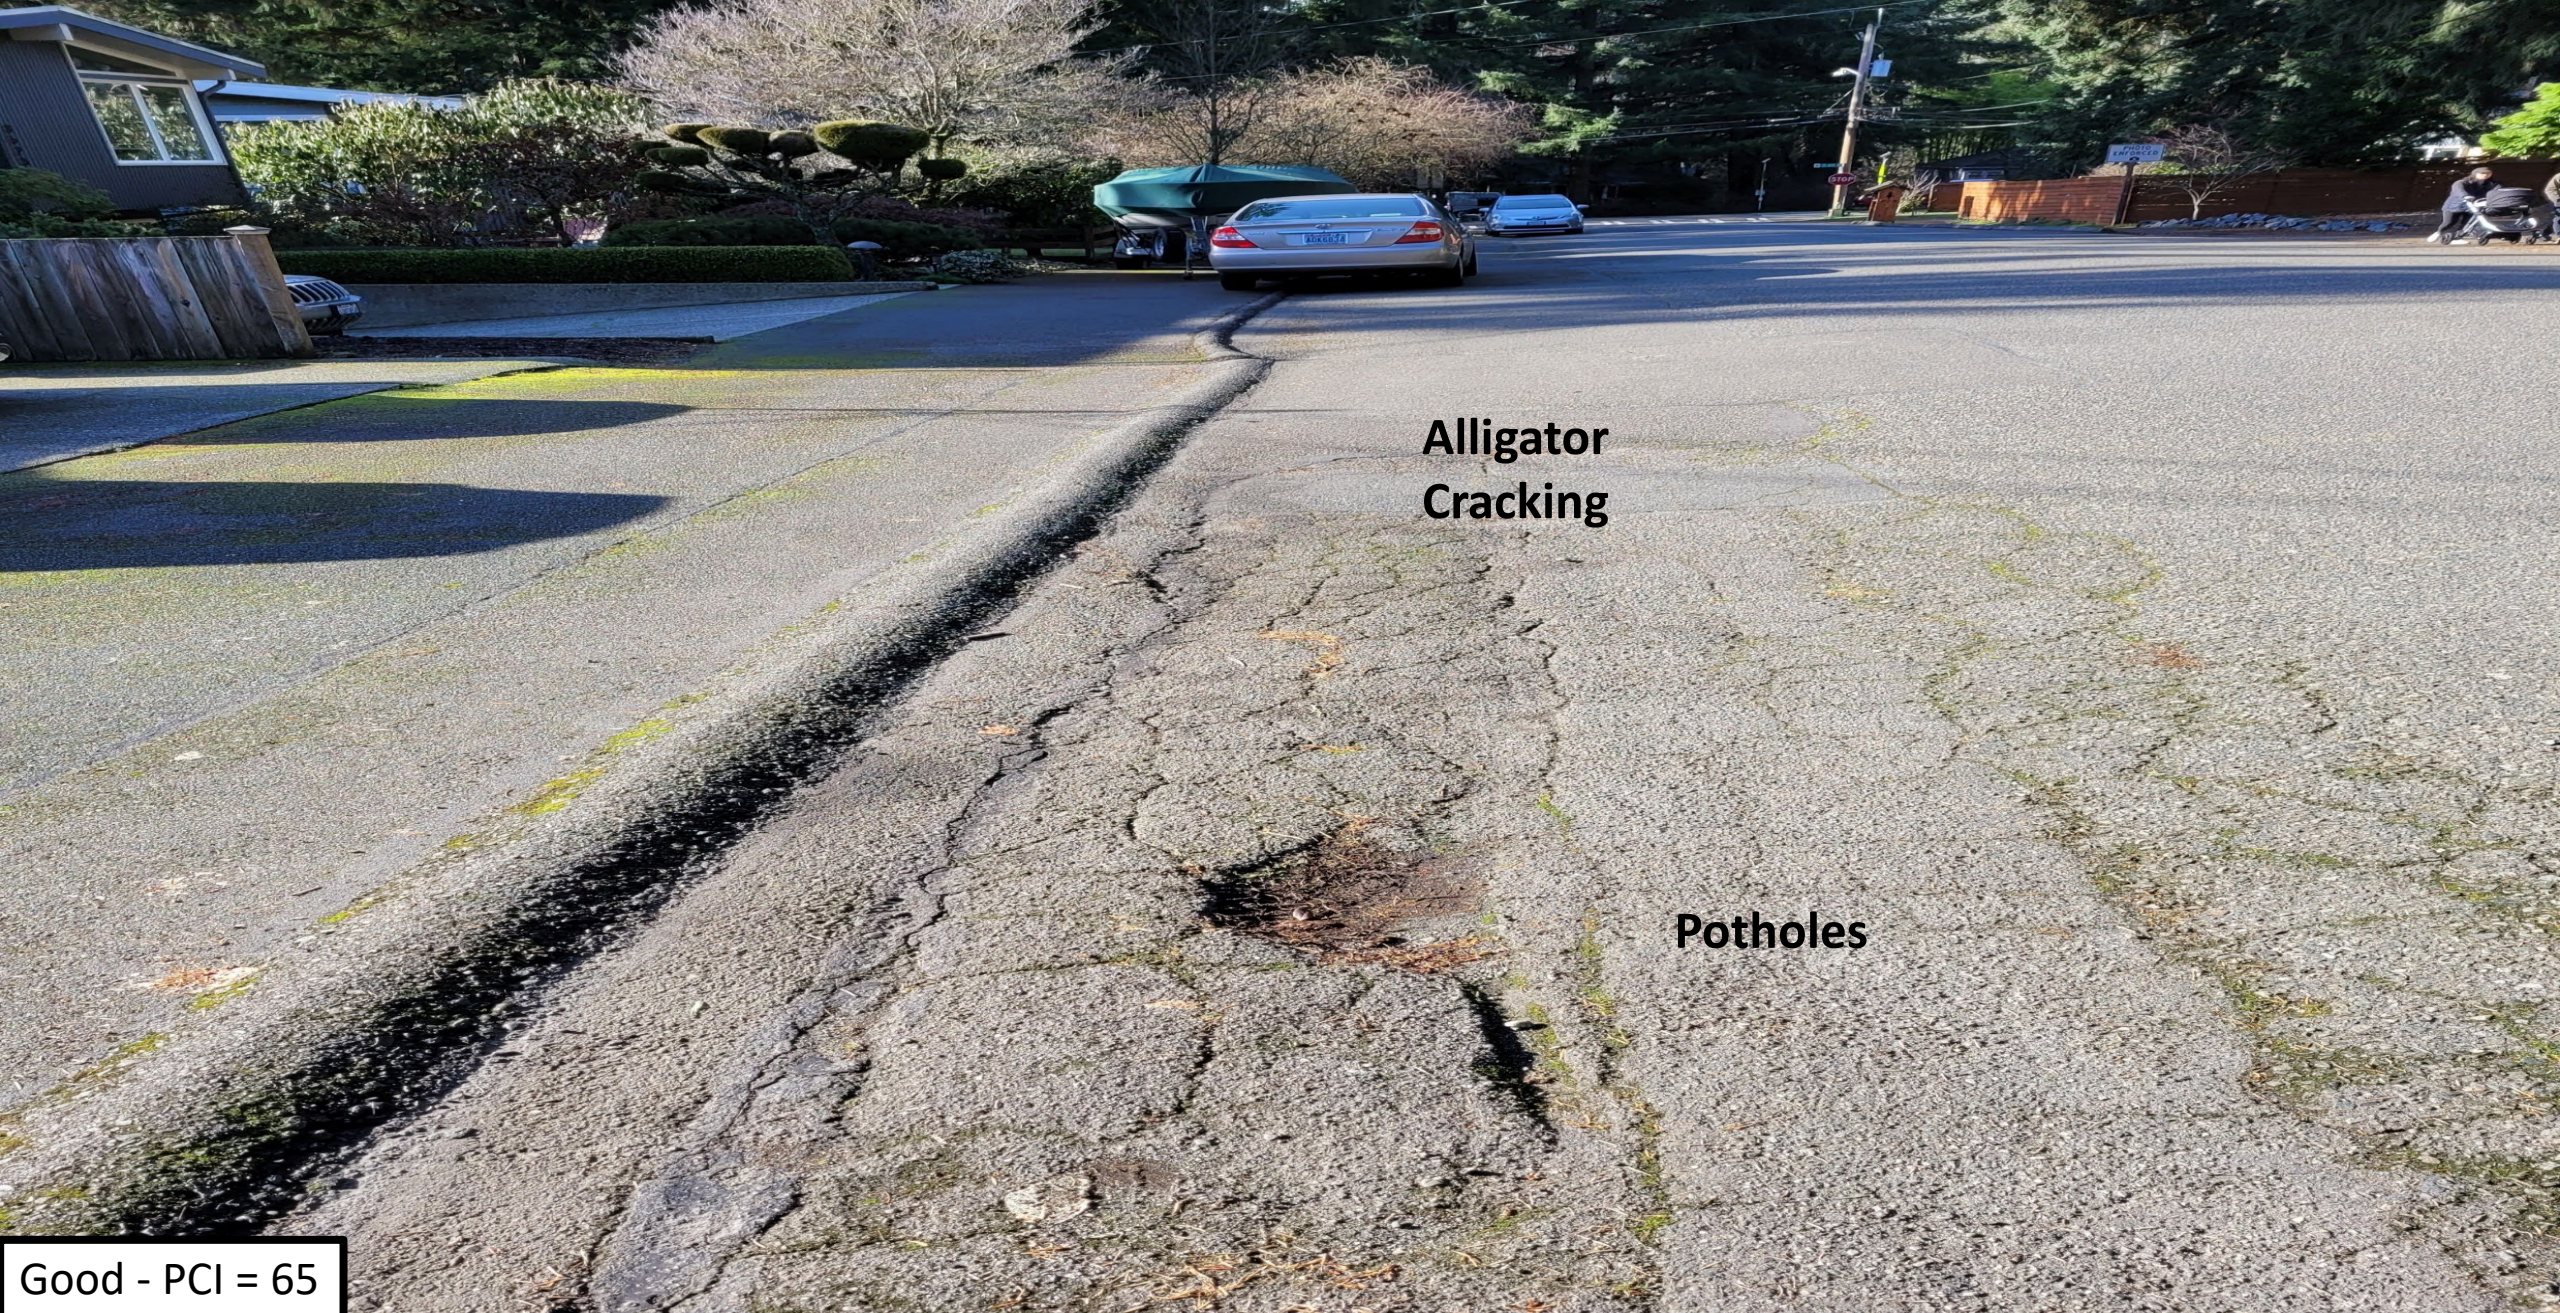
Alligator  
Cracking

Potholes

Good - PCI = 65

Generally stable, **minor areas of structural weakness evident**. Cracking is easier to detect, patches evident, patched but not excessively. Deformation more pronounced and easily noticed. **Ride qualities are good** to acceptable.
