Advanced Tree Care

1248 Via Huerta, Los Altos

October 20, 2022

Tree Survey

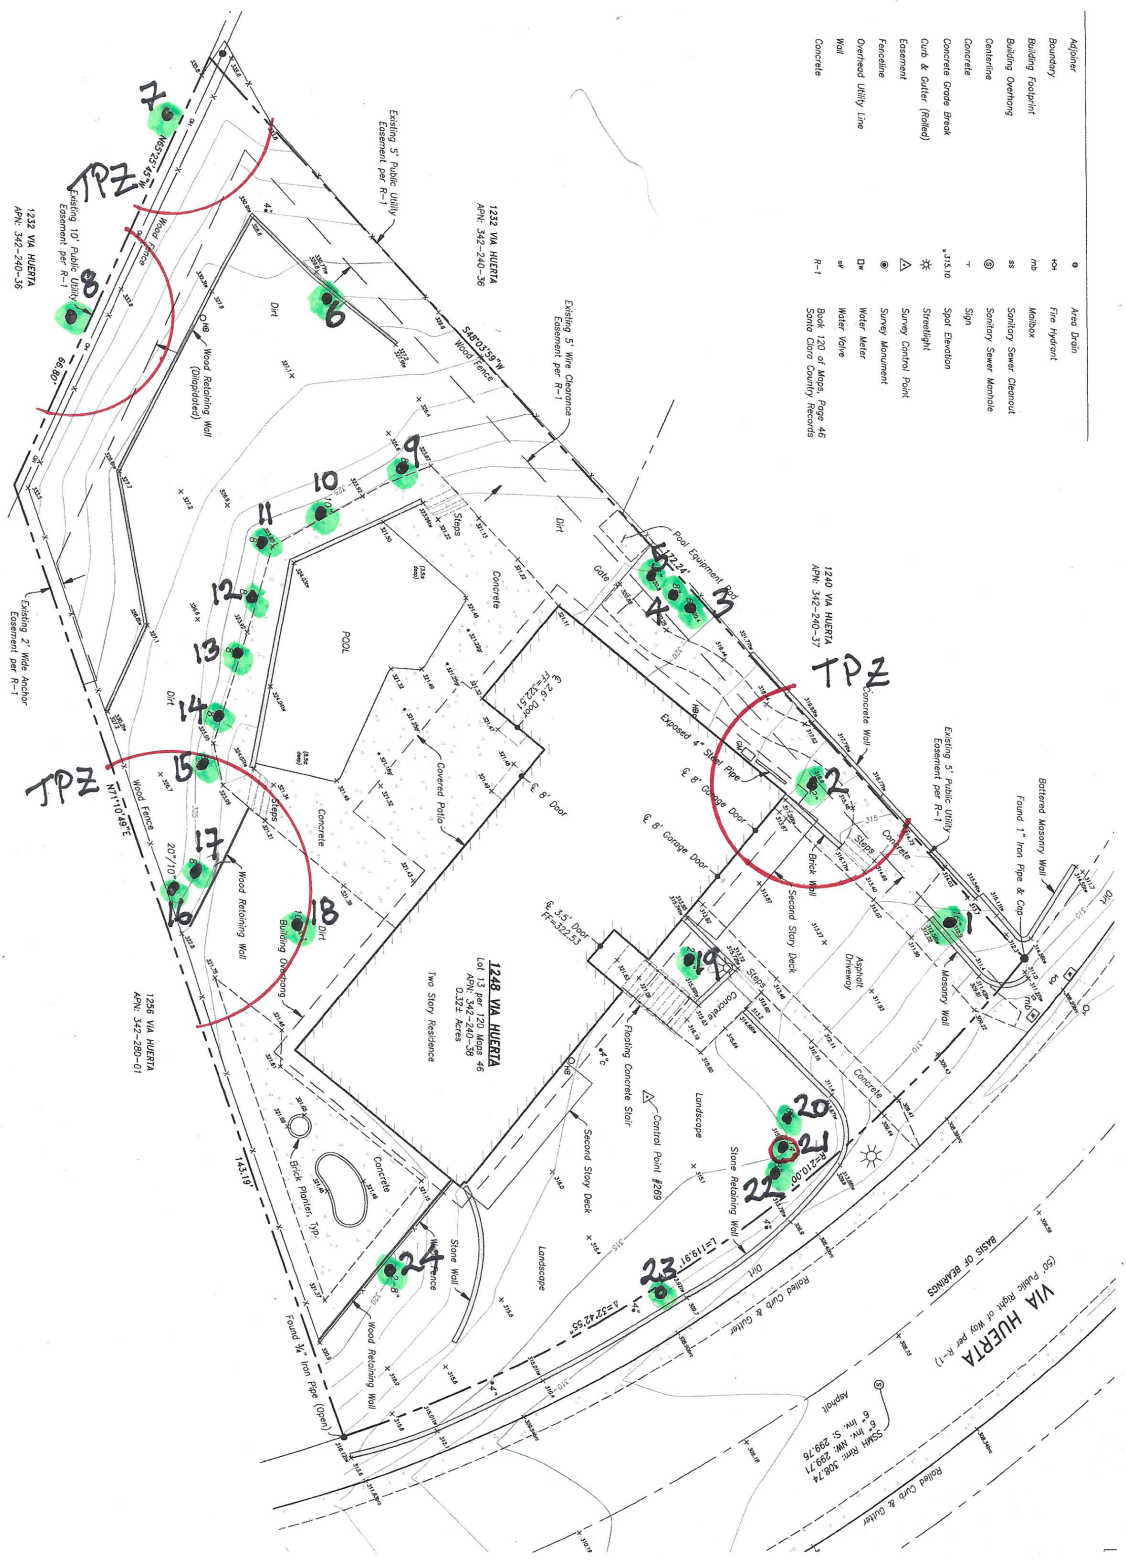
Location of existing home, protected trees and their Tree Protection Zones

Tree #s 2, 16 and 21 are Regulated trees on this property and should be protected during construction.

There are 2 trees on adjacent properties, Tree #s 7 and 8, both are Regulated trees that should be protected during construction.

Tree # 2: TPZ should be at 13 feet radius from the trunk of the tree closing on the fence line in accordance with Type I Tree Protection as outlined and illustrated in image 2.15-1 and 2 ⁽⁶⁾ .

Tree #s 7 and 8: TPZ should be at 13 feet from the trunk closing on the fence line in accordance with Type I Tree Protection as outlined and illustrated in image 2.15-1 and 2 ⁽⁶⁾ . Shown as a thick red line.

Tree # 16: TPZ should be at 18 feet radius from the trunk of the tree closing on the fence line in accordance with Type I Tree Protection as outlined and illustrated in image 2.15-1 and 2 ⁽⁶⁾ .

Tree # 21: Should be protected with Type III TPZ fencing as outlined and illustrated in image 2.15-4 ⁽⁶⁾ .

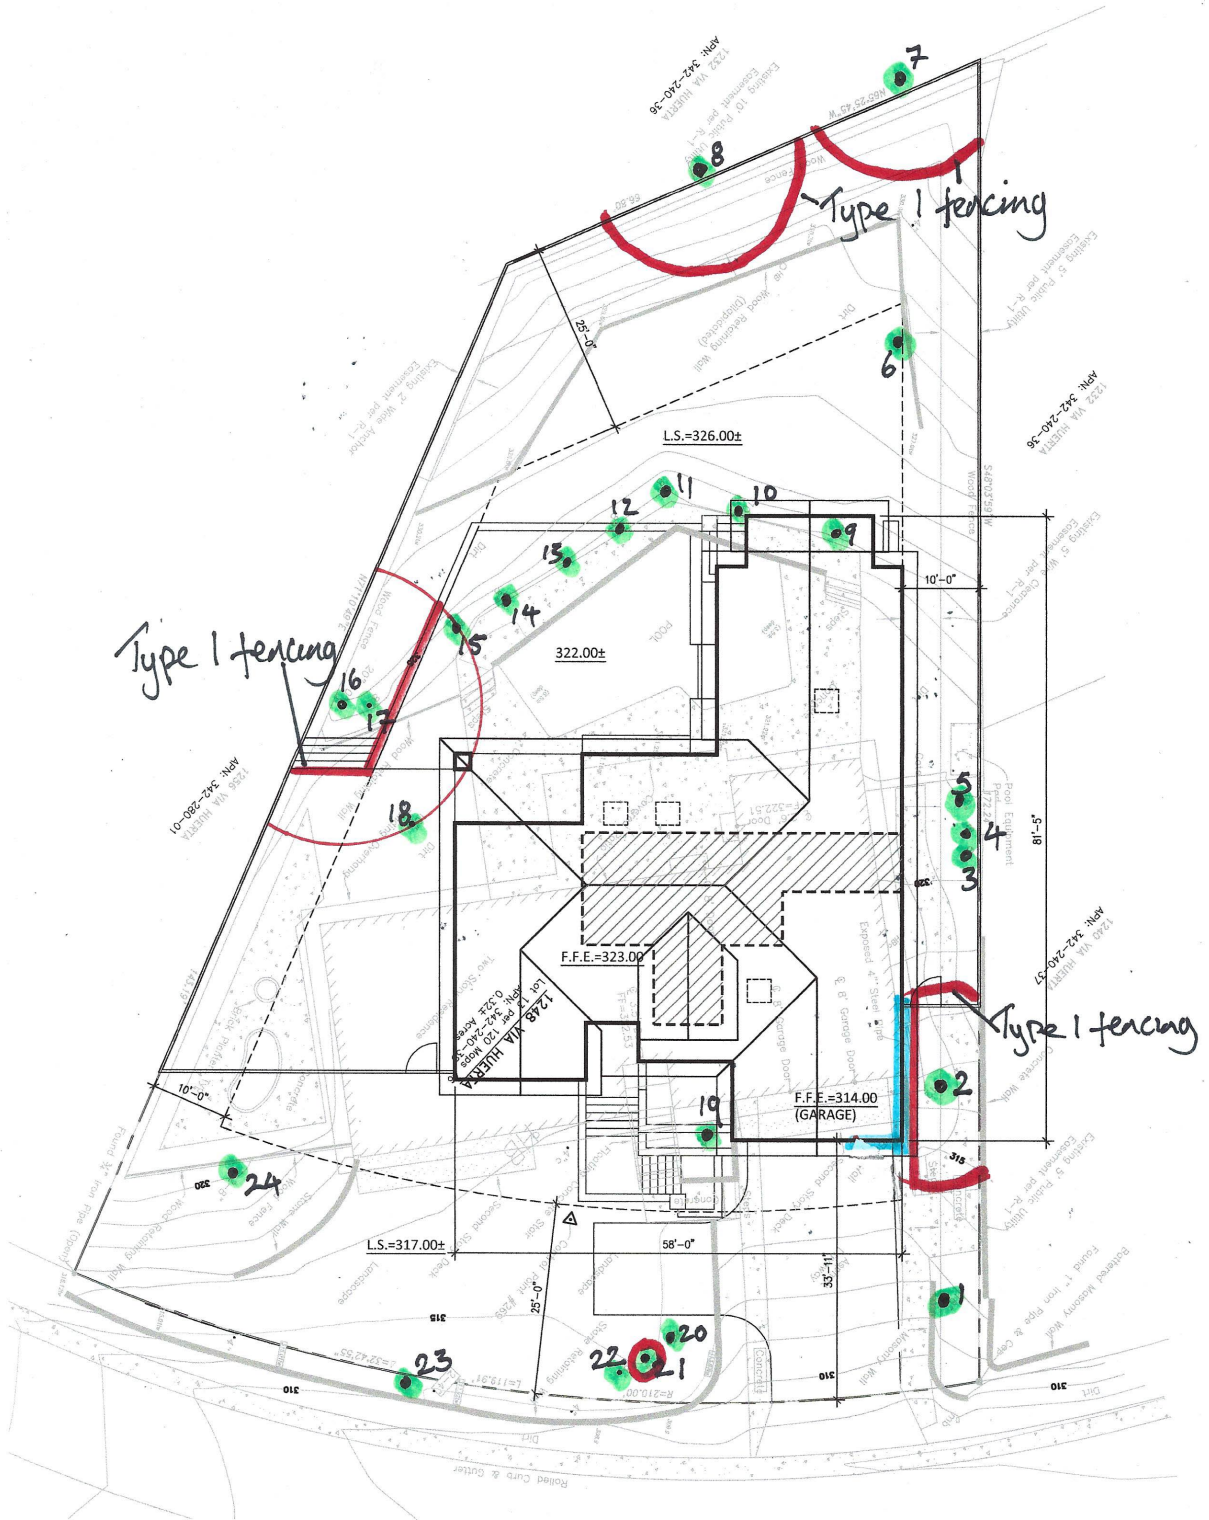
Location of proposed new home and Tree Protection Fencing

The tree is located on top of a steep grade. This grade will be supported with a retaining wall in the new landscape. The retaining wall is outside the grade and so there will be very little root disturbance in the construction of the retaining wall. The tree protection fencing can be placed at edge of retaining wall, shown as a thick red line.

The TPZ for Tree # 2 can be reduced to edge of existing home and proposed construction to allow for demolition and construction. Shown as a thick red line.

The proposed new home is in a very similar footprint to the existing home. Excavation for the proposed foundation within the TPZ should be dug by hand. Area shaded in blue. Any roots encountered should be cut cleanly with handsaw or pruners.
