MEMO

Subject: 236 Eleanor Avenue-Response to comments on the Historic Report DPR and Review of Rehabilitation Plans

Date: April 12, 2023

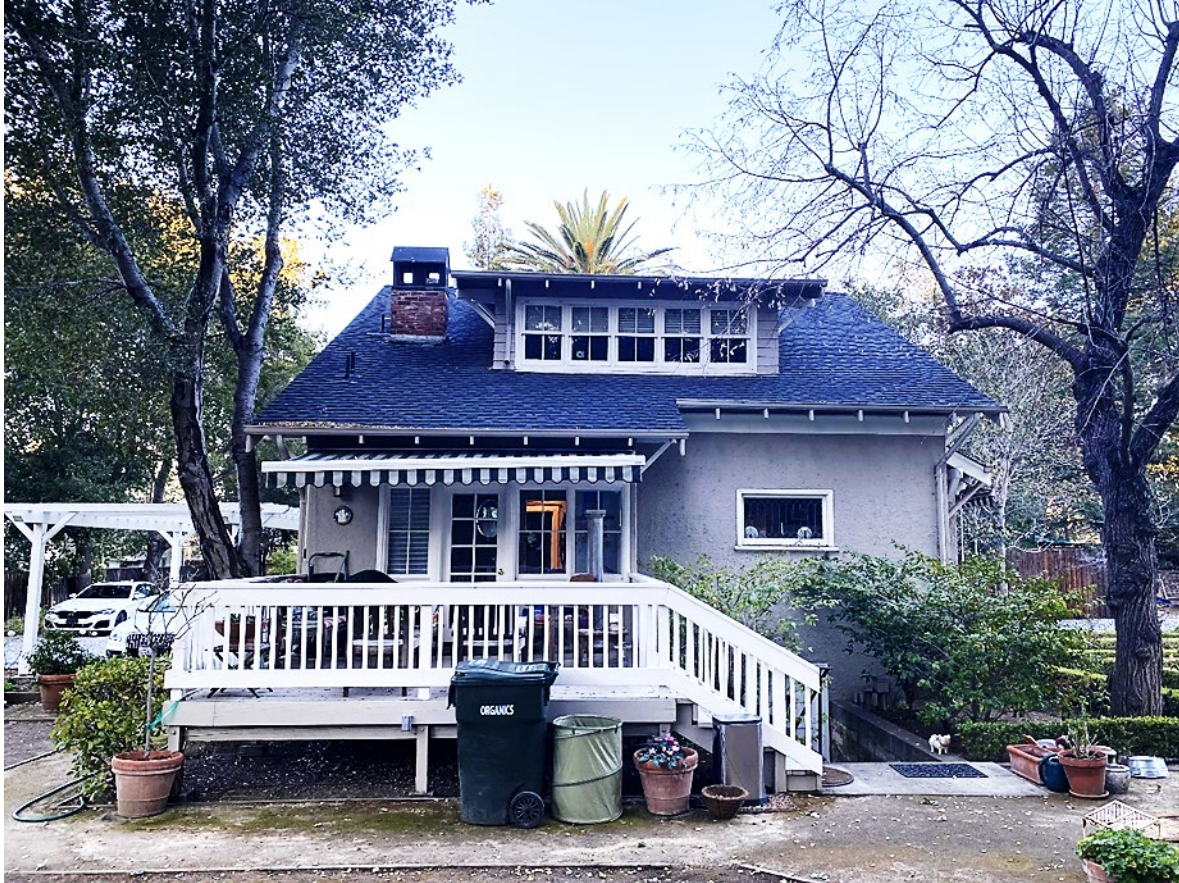
Rear Façade Historic materials and Character-defining

The rear façade has been significantly altered from the original design of a farmhouse in a variation of the Craftsman style.

Alterations that previously removed historic material include the protruding section that has a multi-pane glass door and three wood windows that are not original to the location and probably not to the building. The rear facade of an orchard would have the utility porch with a wood back door that might have had a glass panel in the top. Stairs usually were to the side. This is the pattern of the existing foundation. Windows would be small and plain frames. All windows appear to be from a previous remodel. The rear of the house was not used for recreation but was utilitarian with, clotheslines, a barn and other ancillary buildings behind. Windows on the rear were also less formal, but operable.

Although this may be the original style roof framing it would be unusual. Typically the roof was straight across and a second shed roof covered the utility portion. The roof appears to have been extended over the protruding section carrying the design of exposed rafter tails.

While the Craftsman style may include a shed dormer, the style seen on the front would have dictated a cross gable or gable dormer would have occurred on this house. The shed dormer is out of proportion with the rest of the house. It appears to have been installed to create a bedroom in the attic storage area. Although the shed roof incorporates exposed rafter tails and a knee brace - Craftsman elements- these are not original to the building. Looking to the front and sides of the house, a dormer would have had a gable and not a shed roof. The shed roofed dormer is not original and because of the scale it has not gained significance, and is not a character defining feature of this house.

The windows in the protruding section are not original to the location and not likely the house. Recycling windows during a remodel is not a new concept and may have happened although the frames do not appear early twentieth century. The small, almost square windows (rear of the house) may or may not be an original frame and lugsil. Prior to central heat and ventilation was important and kitchen windows particularly would have been operable to expell kitchen odors and circulate air into the kitchen. The fixed pane kitchen window may have been relocated to this area or is a feature of remodeling. It is not a character defining element.

The deck has also been added and is not a character defining feature of the house.

In summary, the rear of this house has been remodeled with original materials and style changed. The characteristic elements to be removed are; roof slope with exposed rafter tails is a defining element of the Craftsman style and siding on half the rear wall appears to be original and is typical of the Craftsman Style and this house.

The rehabilitation plan shows these elements will be removed. This will change the design and rear character of the house.
