RE: Variance request for 899 Madonna Way

Kielty Arborist Services

Site: 899 Madonna Way, Los Altos, CA

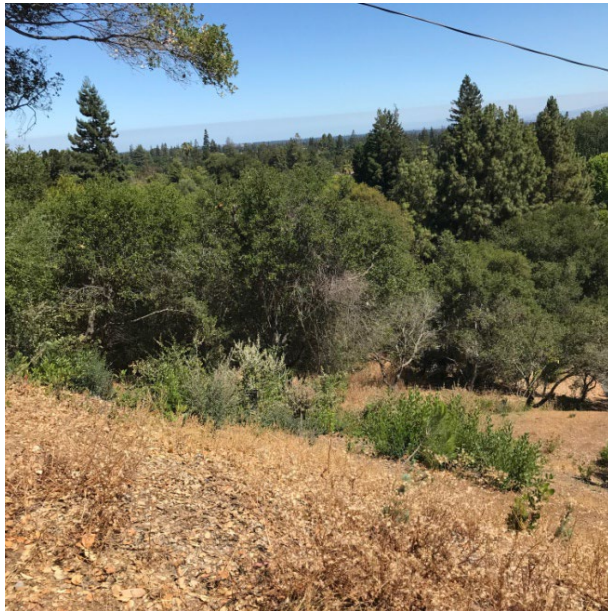
The property at 899 Madonna Way is an undeveloped lot with 13 native coast live oak trees surveyed. The lot is heavily sloped with no recent upkeep. Most of the trees are in fair to good condition with a few exceptions.

Showing existing site conditions

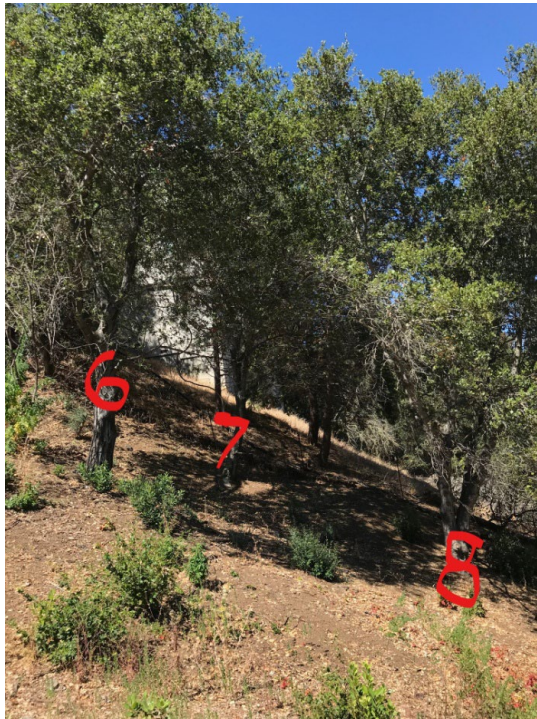
Showing Oaks #6-8

Protected oak trees #2, 3, 6 and 8, are proposed for removal to facilitate construction of the proposed residence. Due to the slope of the lot a large retaining wall is needed so that a driveway can be constructed. The retaining wall is too close to Oak trees #2 and #3. Large roots are expected to be encountered at the proposed retaining wall cut and would impact the stability of the trees. Oak tree #2 is codominant at grade with two large leaders leaning heavily away from each other. The form of the tree is poor and risk of a limb/leader failure is high. Removal is recommended.

Protected Oak trees #6 and #8 are also within the area of proposed work. The trees are either within the building footprint or too close to the building. Protected Oak trees #2, 3, 6, and 8 fall into the following criteria for tree removal:

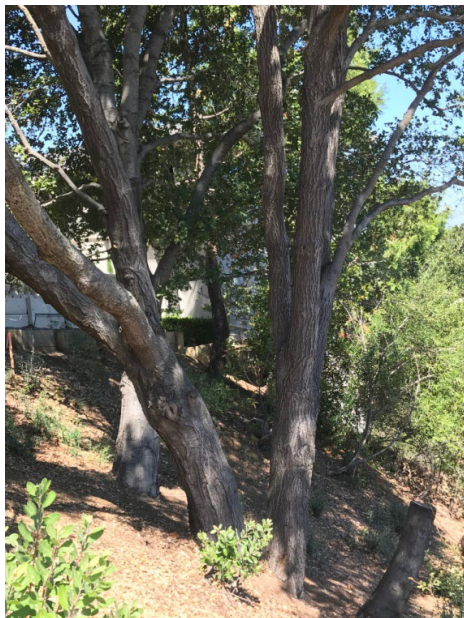
Showing Oak tree #2 with leaning codominant leader
