May 19, 2020

**RE: 62 Ellenwood Avenue**

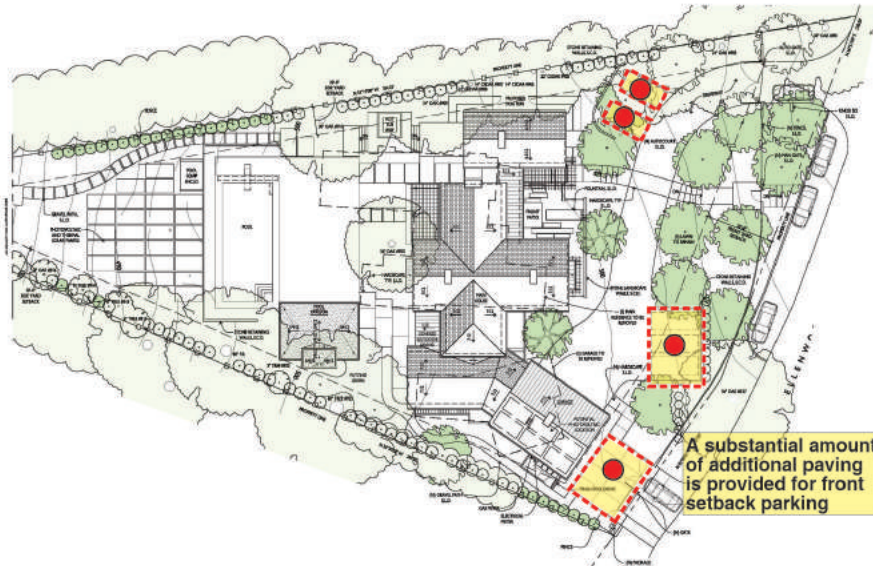
1. The additional landscaping in the front setback will be a welcome feature to integrate the home into the surrounding neighborhood, but the substantial additional paving proposed to provide at least six additional parking spaces seems out of character with the immediate neighborhood.

**Recommendation:** Remove some of the additional paving.

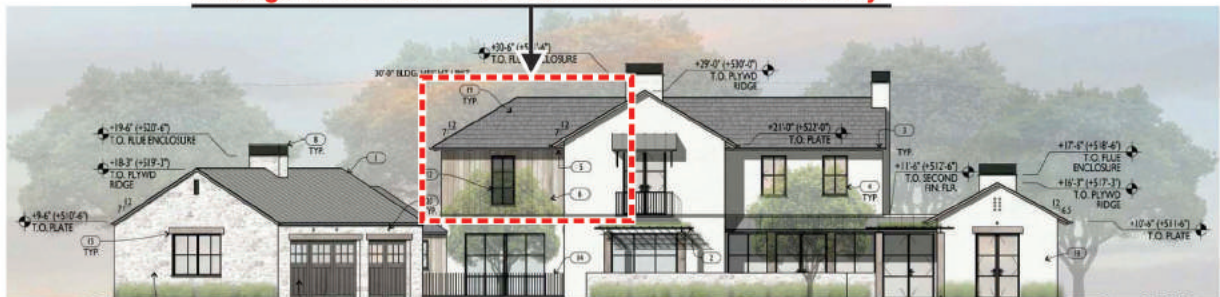
2. The change in roof form and wall materials on the second floor south wing of the house seems arbitrary, and an unwelcome change from the traditional forms and simplicity of the house style.

**Change in roof form and wall material seems arbitrary**

**Recommendation:** Match the roof form and wall material of the other second floor masses.

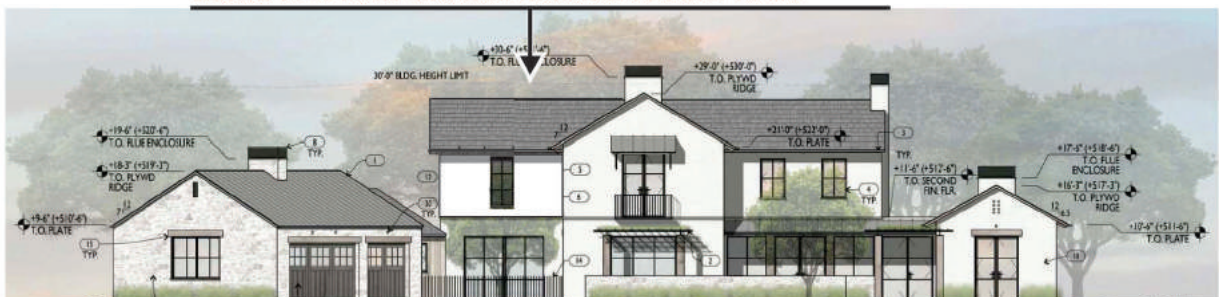
**Match roof form and wall material of other roofs**

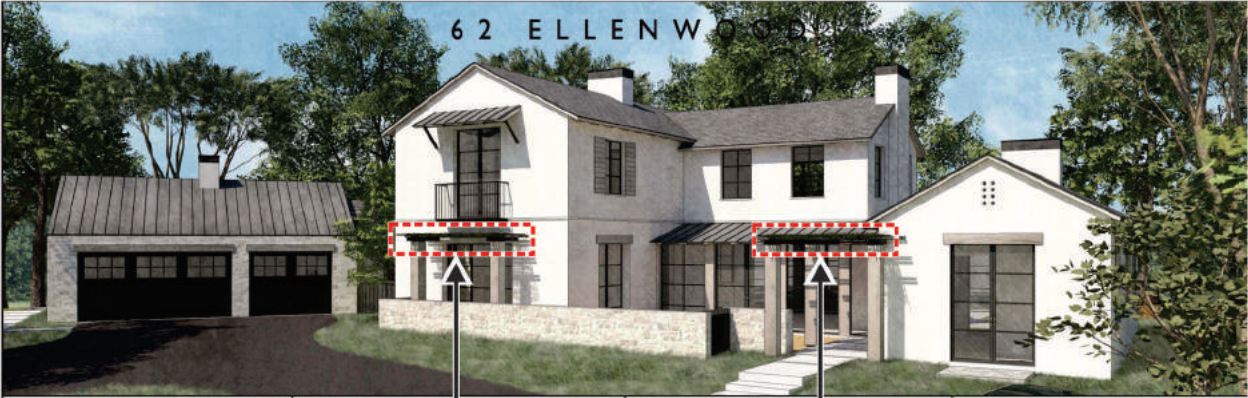
3. The metal trellis elements seem too small for the large cedar wood columns.

**Trellis seem small in scale compared to large wood columns**

**Recommendation: Consider adjusting the scale of the trellis and/or the columns - see examples below.**

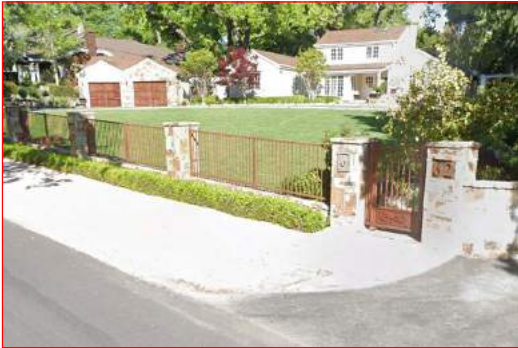
*Existing parcel fence*

4. The proposed fencing along the Ellenwood Avenue edge has some stone features at auto and pedestrian entries, but appears to be a uniform picket fence without additional elements or buffer landscaping along the remainder of the edge as is common on other nearby properties.

**Front fence is taller and lacking in visual variety compared to other nearby homes**

Recommendation: Revisit the design of the front property line wall - see nearby neighboring examples below.
