**Re:** New Garage – 69 Hernandez Avenue

Pursuant to our site meeting on July 27, 2026, please find the attached drawings and application to replace the Upper Level siding at 69 Hernandez Avenue for your review.

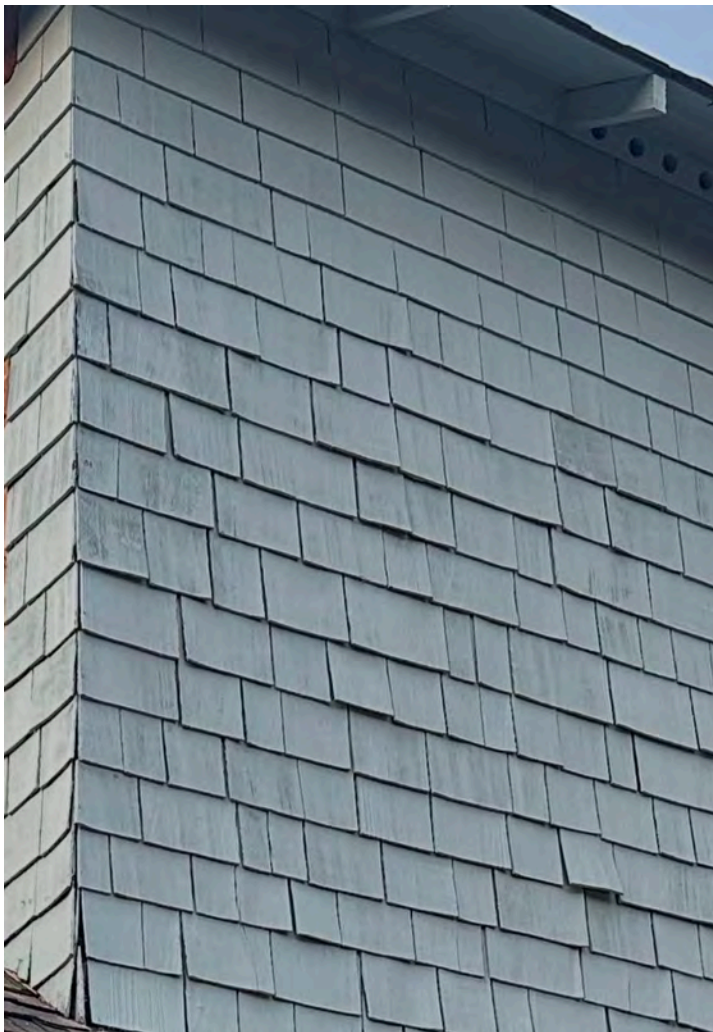
The Upper Level was an addition approved by the Town under permit number B-9441 in 1981. The shingle siding and flashing have not been maintained over the years and have fallen into a state of disrepair. Photo attached.

View of Upper Level addition from South. The top 2 rows under the eaves are how the shingles are supposed to look. Once the shingles get below the protection of the roof, they have become splayed. Particularly at the building corners

This property is located in the “Very High” Fire Hazard Area according to the Fire Hazard Severity Zones Map dated June 17, 2025. The exterior siding is required to be ignition resistant. We have selected Hardie Board and Batten by James Hardie to match, as closely as possible, the existing shingle siding.

The Hardie shingle siding allows for the outside corners to be woven together so we can match the existing edge profile of the structures. No corner trim is proposed.

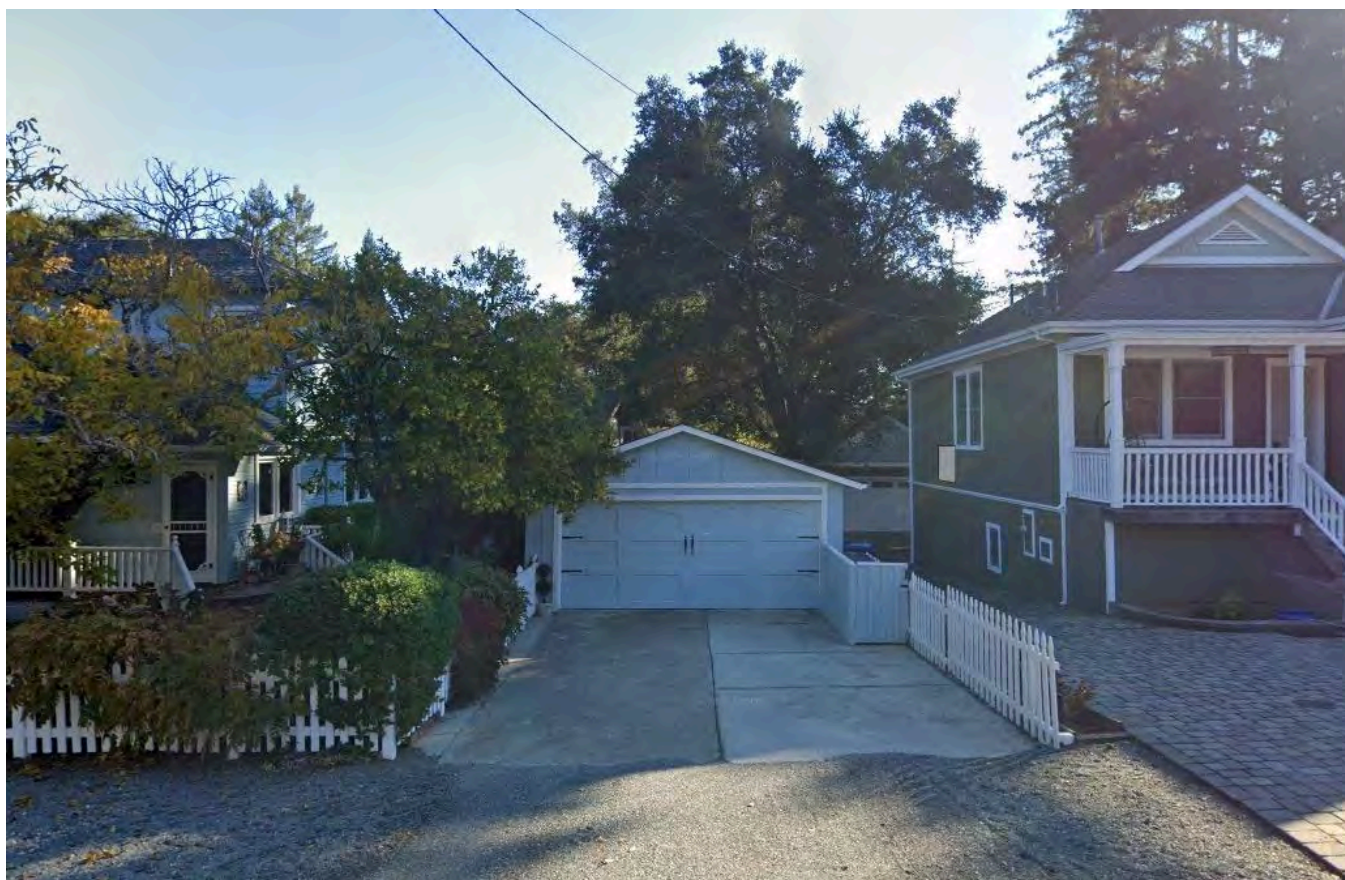
The rear porch has also fallen into a state of disrepair and rot. We are proposing to replace the wood porch with a stone porch and steps of a smaller scale in order to be more in scale with the backyard and site.

View of rear porch from Walnut Ave.

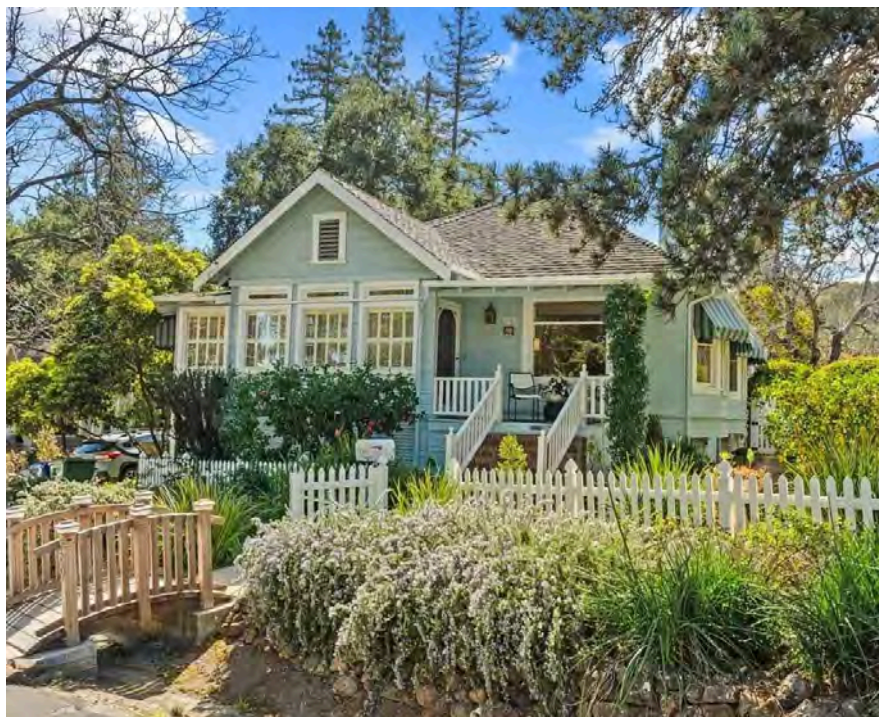
View of non-original front door location. Street view from Hernandez Ave

In keeping with the historic fabric of the neighborhood, we are proposing to relocate the front door so that it faces the street, centered on the front porch steps. According to a photograph in the historic research, the original door faced the street prior to being moved to its current location when the front porch was enclosed at some unknown date. The door will be a solid wood door with two 12” wide full height sidelights.
