TECHNICAL MEMORANDUM

Date: November 4, 2019

From: Chris D. Kinzel, P.E.
Vice President

Subject: **16 Chestnut Driveway Analysis**

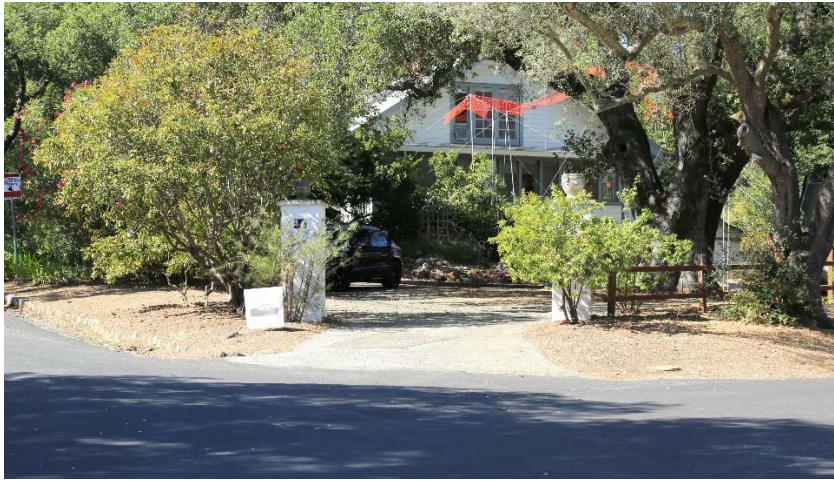
Photo 1 – This shows the existing driveway at 16 Chestnut. The house is in the rear. Two pillars define the driveway; 12 feet of pavement is available.

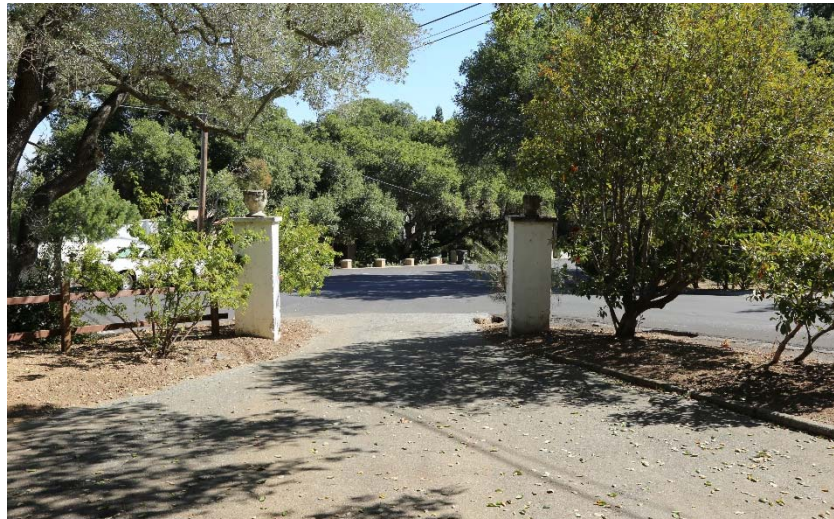
Photo 2: The same driveway looking from the inside of the property to the intersection. In the distance is the eastern section of Hernandez Avenue.

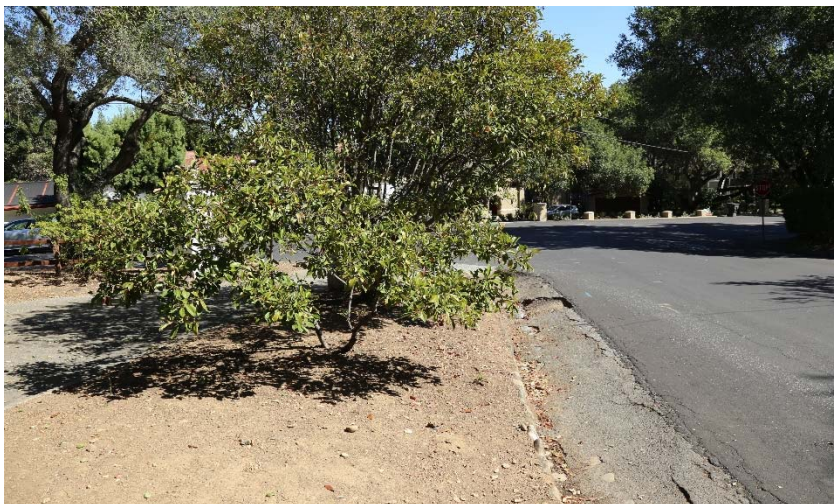
Photo 3: This is the approximate location of the driveway if it were placed about 50 feet from the intersection on the west side of Chestnut Avenue.

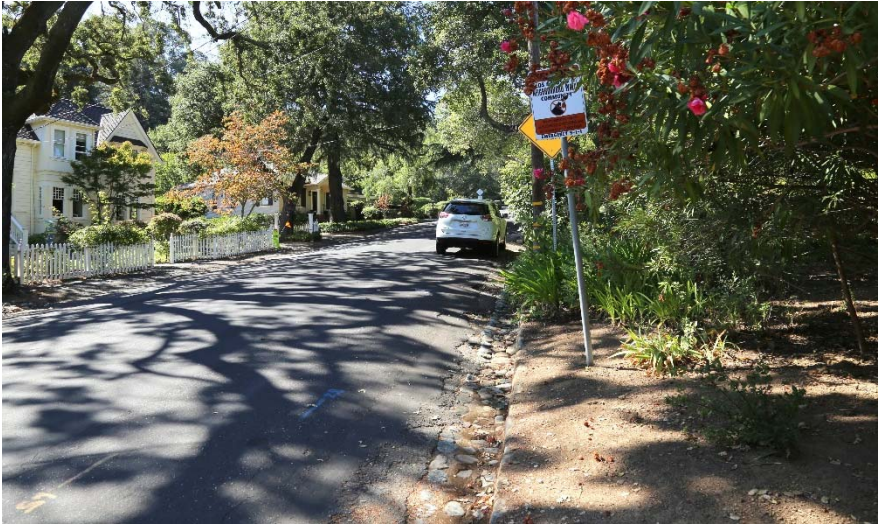
Photo 4: Looking south on Chestnut Avenue from the approximate location of the driveway if located 50 feet south of the intersection.

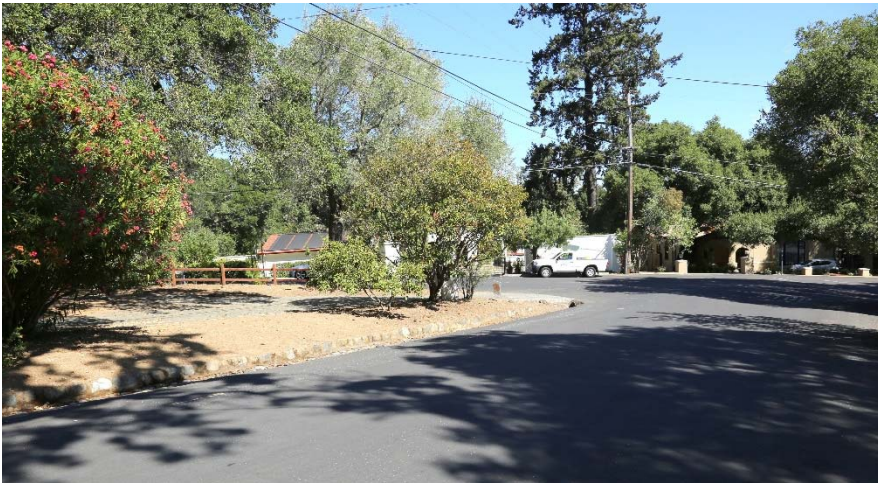
Photo 5: Looking north on Chestnut Avenue with 16 Chestnut located to the left. The gap in vegetation shows the approximate location of a driveway located 50 south of the intersection.

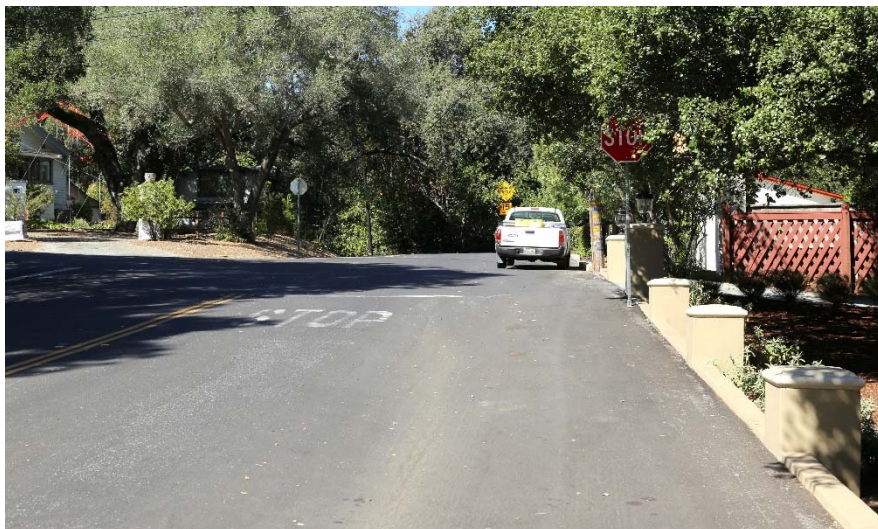
Photo 6: Looking west on Hernandez. The 16 Chestnut location is on the far left. The pickup is near a driveway in the intersection; a second driveway is in mid-photo opposite the painted STOP marking.

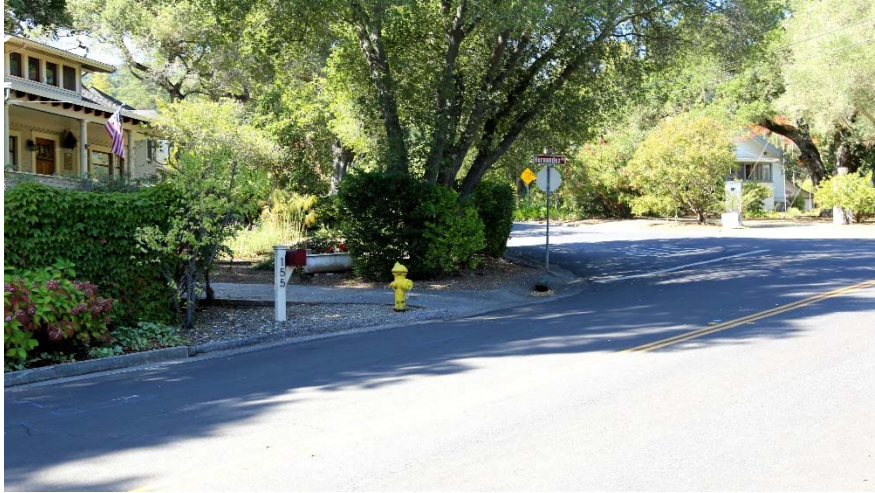
Photo 7: Looking north on Hernandez. The 16 Chestnut access is located on the right side of the photo. Driveway on left near fire hydrant requires backing into the street.

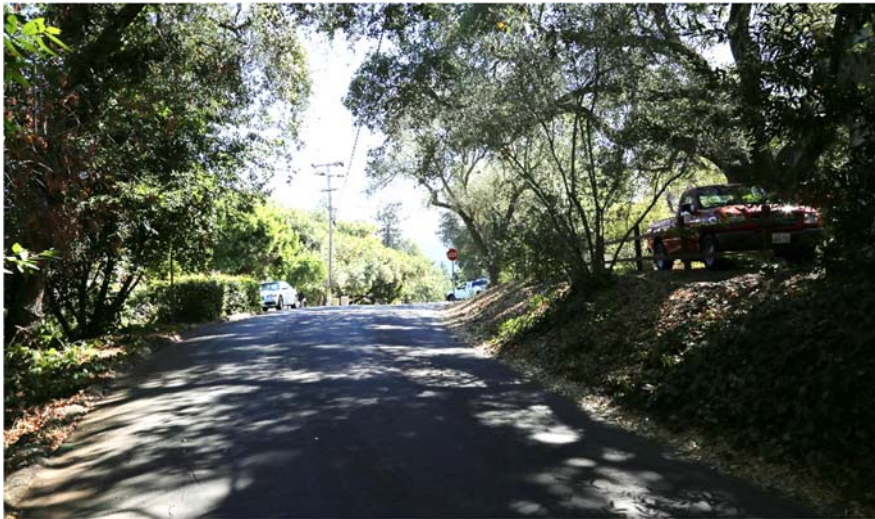
Photo 8: Looking east on Hernandez toward intersection. The vehicle on the right is parked near the guest house of 16 Chestnut.

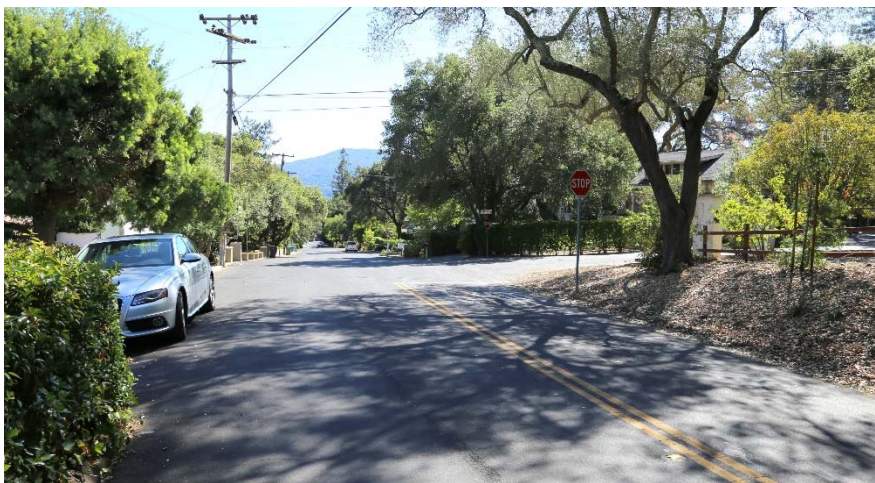
Photo 9: Looking east on Hernandez toward intersection. 16 Chestnut is on the right; the driveway is between the two bushes on the right.

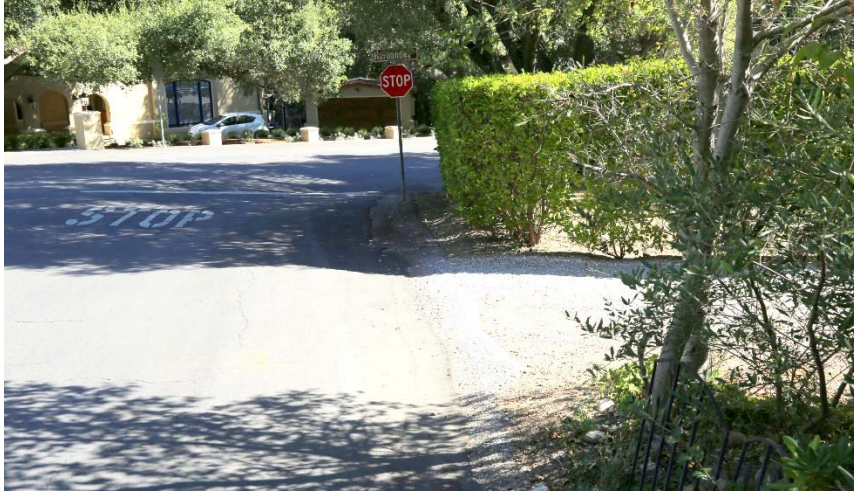
Photo 10: Looking north on Chestnut. The driveway is directly across the street from 16 Chestnut. This requires backing into the street.

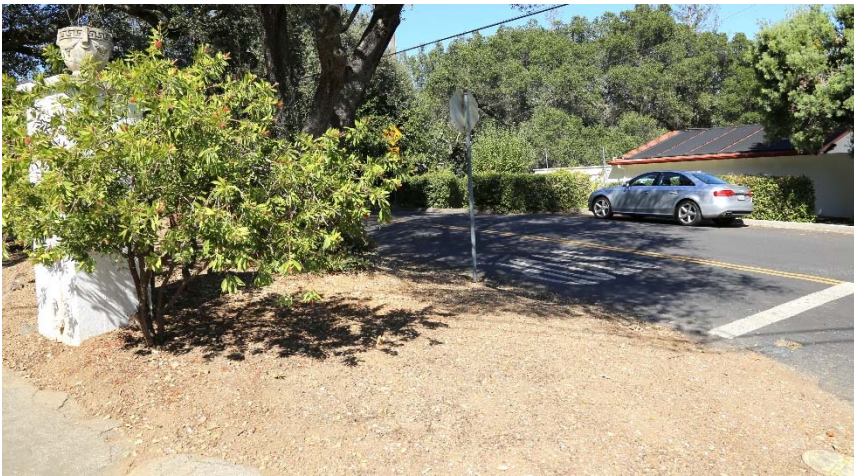
Photo 11: Looking northwest on Chestnut. The Pillar shown is for the 16 Chestnut driveway.

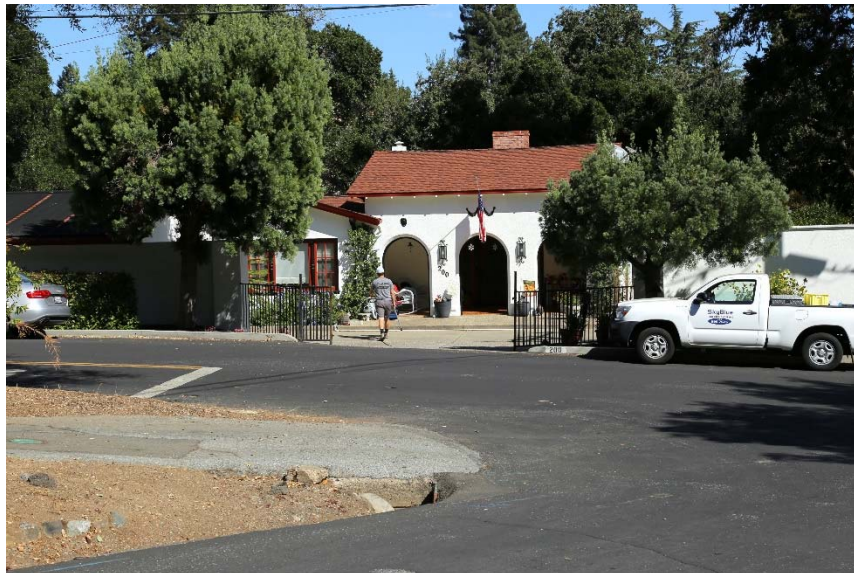
Photo 12: Looking north on Chestnut into the intersection. The 16 Chestnut driveway is shown (in lighter color) on the left.

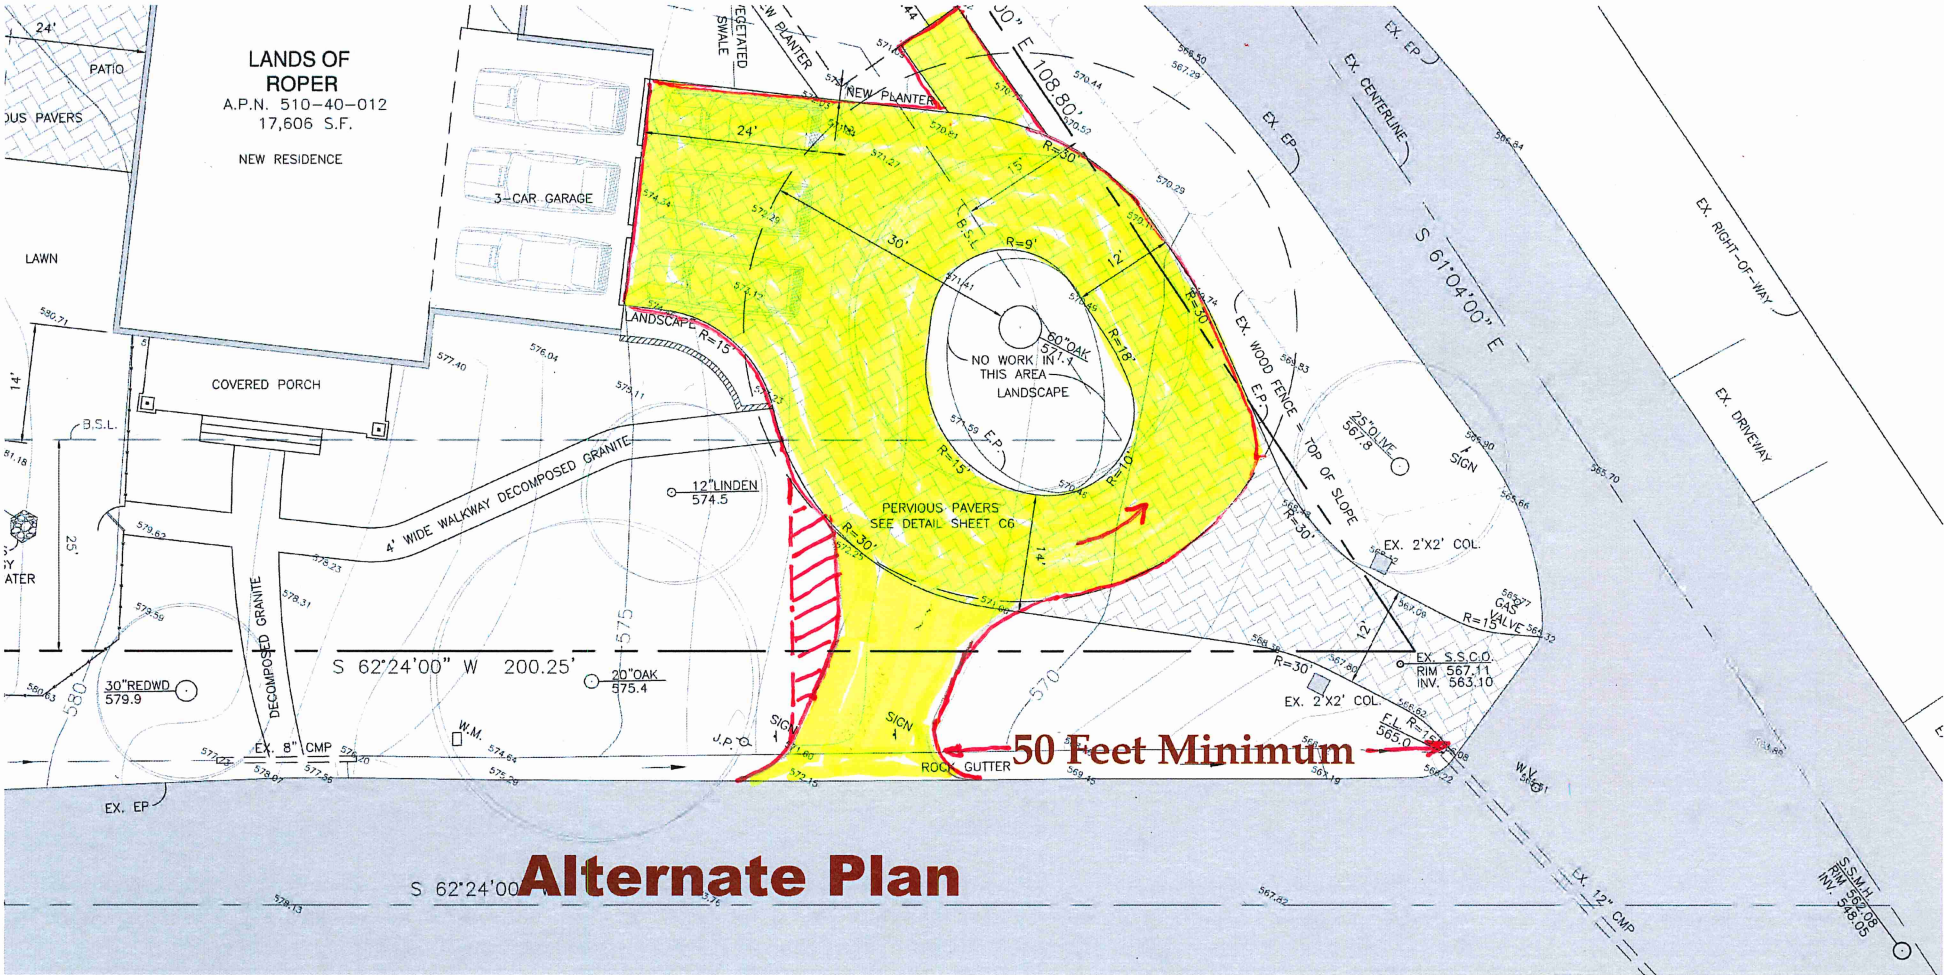
Alternate Plan

The drawings on the following page shows the proposed site plan. A second drawing, prepared by TJKM, shows an alternative plan that shifts the existing driveway approximately 50 feet to the south where it will be more compliant with Town standards. In addition to allowing for a 14 foot wide driveway instead of the current 12 feet, this configuration also creates a 90 degree connection with Chestnut Avenue, instead of the current approximately 30 degrees.

The Alternate Site Plan is conceptual in that has not considered grades or utilities or other factors. It is intended to demonstrate that a variation of the proposed plan can function on site with few changes. The plan allows those entering the site to have convenient access to the garage area by circling the center oak tree. The new driveway would require removal of more shrubbery than the proposed plan, resulting in the house having less landscape screening from Chestnut Avenue.

If the driveway that meets the Town's standards is chosen, the area with reduced vegetation should extend about 25 feet (one car length) on either side of the new driveway.
