February 25, 2020

**RE: 15 Loma Alta Avenue**

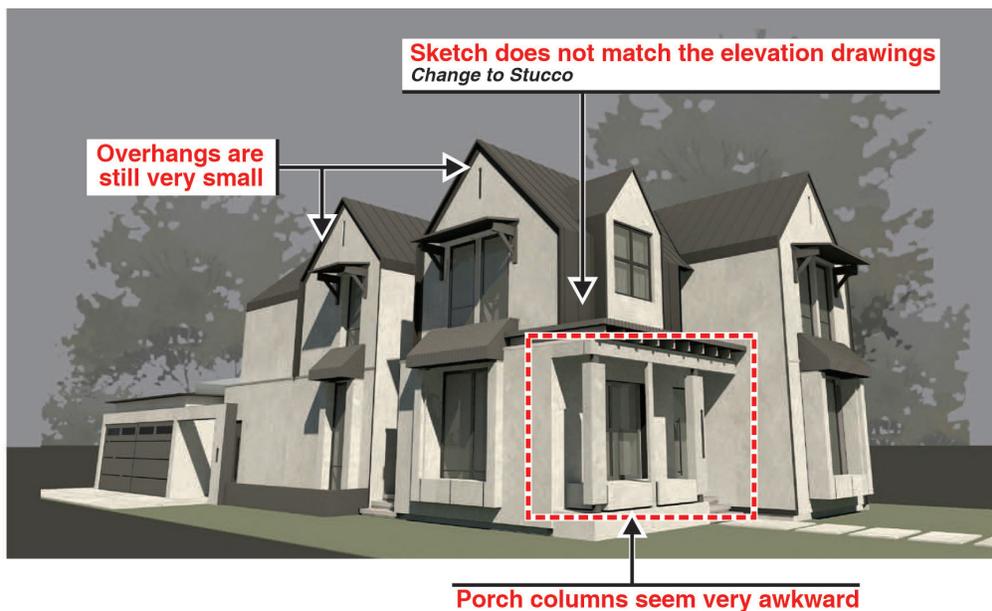
1. The perspective sketch still shows metal panelling on the walls.
2. The roof eave and gable overhangs are still very small.
3. The porch columns are very awkward.

**Wall material does not match the B & W elevation drawings**

*Change to Stucco*

1. Update and coordinate the drawings to show stucco rather than metal panels on all walls of the house.
2. Extend eave and gable overhangs more, and add wall caps at the flat roof portions of the house.
3. Simplify the porch columns and eliminate the center support.
4. Resolve the issue of the metal strips shown at some building corners. Smooth stucco corners would be the preferred solution.
5. Provide more substantial bellybands.
6. Add windows to the tall walls on the right side elevation.
7. Resolve the issue of recessing the garage door.

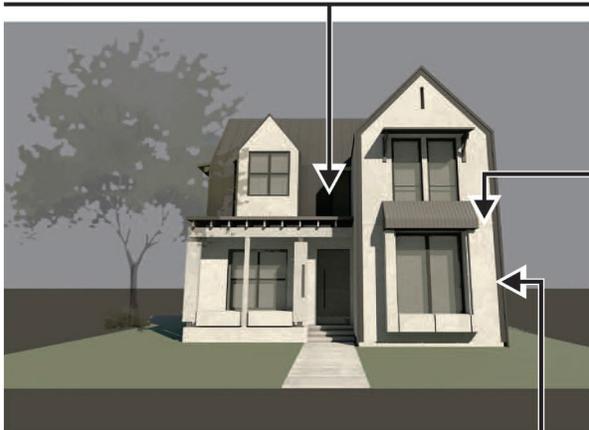
**Bellybands are too weak to make a difference in apparent wall height**

**Unclear why metal runs down facade and the extent does not match the black and white elevations**

4. It is unclear why a metal strip appears to be run down the corners of some walls. In any event, there are conflicts among the drawings as to the extent of the metal strips.
5. Bellybands have been added to break up tall walls, but they are too weak to make a visual difference in the apparent wall height, and are not robust enough to satisfy the intent of the Residential Design Guidelines.
6. The tall two-story wall on the right side elevation is very blank, and the front portion will be seen from the street and sidewalk.

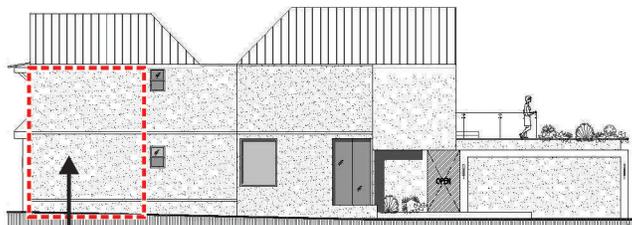
**This blank two-story wall will be visible from street and sidewalk**

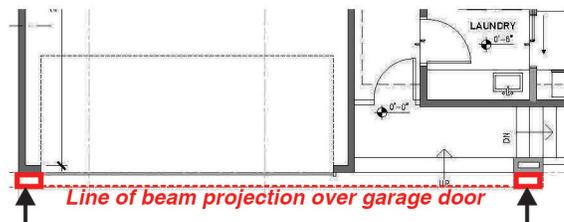
7. The applicant stated in their response letter that the garage door had been recessed by one foot, but the drawings do not clearly show that - see illustration below. The general solution of a projecting frame at the edges and over the garage door shown on the perspective sketch could work, but would require additional encroachment into the side setback or moving the garage back from the side street.

**Surround supports would need to be here to satisfy garage inset recommendation**  
*This would require more encroachment into the setback*
