**SURVEYOR'S NOTE**

08/30/2023

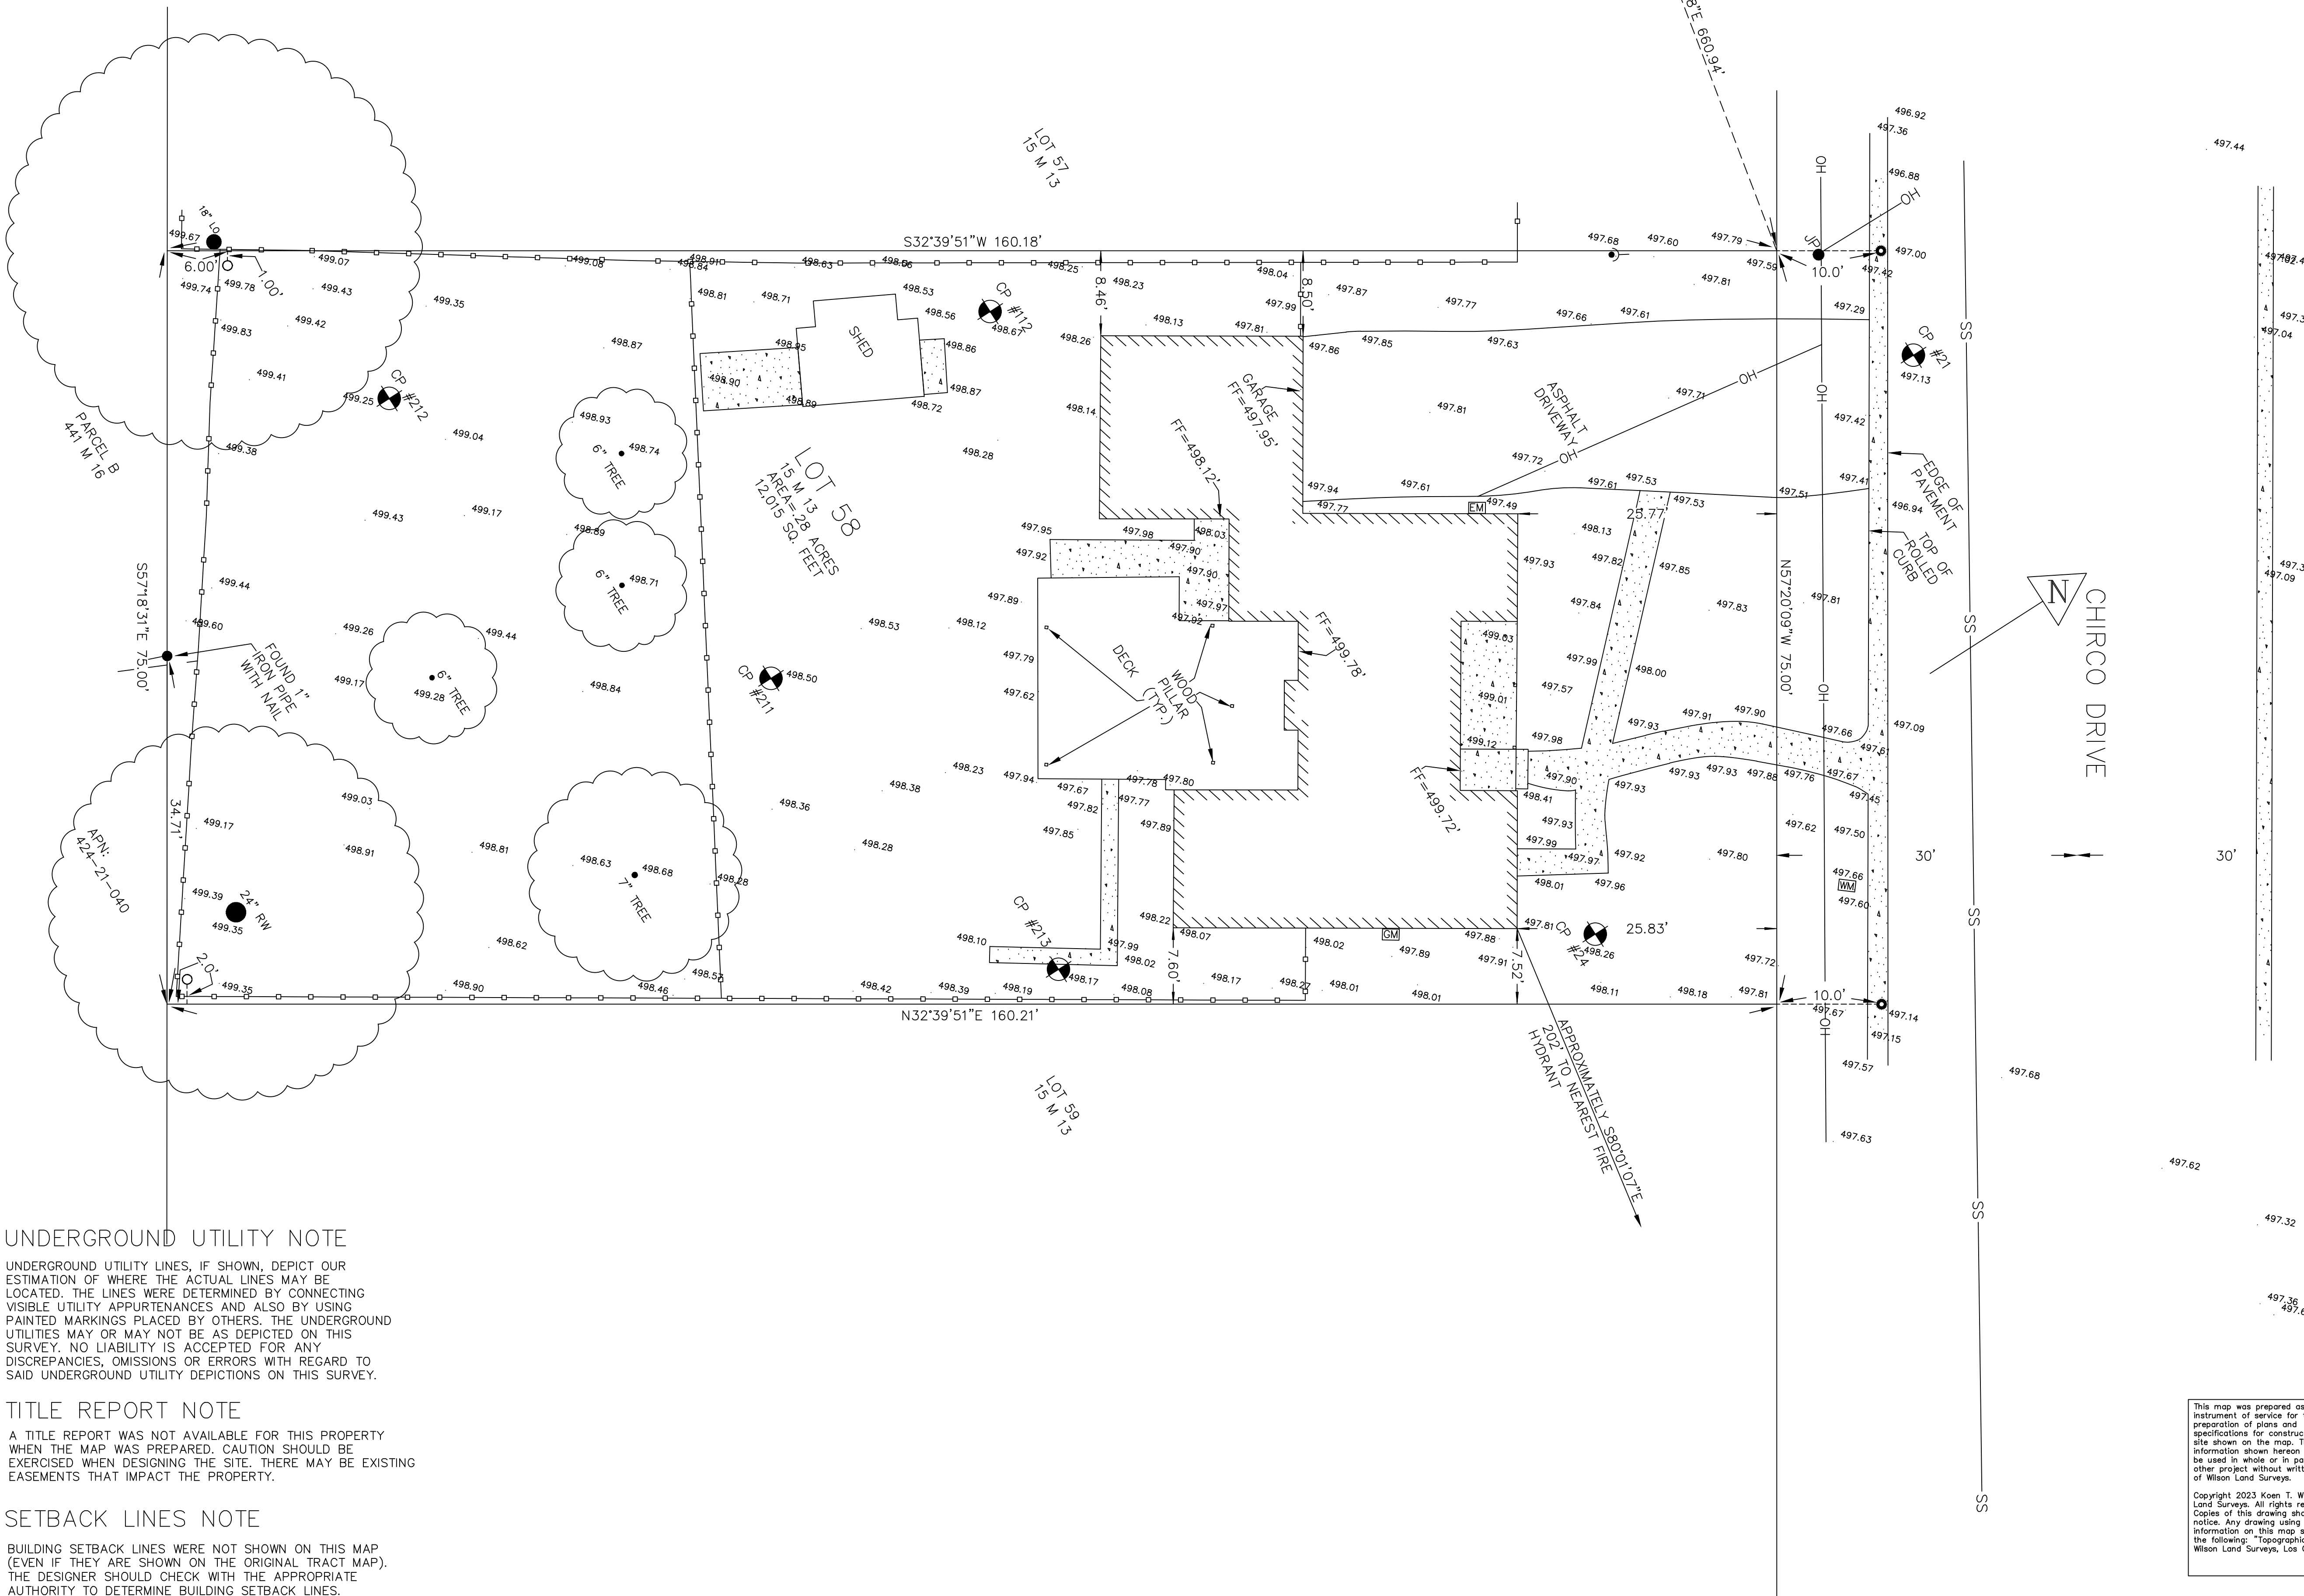
- LEGEND**
- FOUND 1" IRON PIPE OPEN IN MONUMENT WELL UNLESS OTHERWISE NOTED
  - SET 5/8" REBAR WITH PLASTIC CAP "WILSON L 9440"
  - SET NAIL AND 1" BRASS TAG "WILSON L 9440" IN CONCRETE

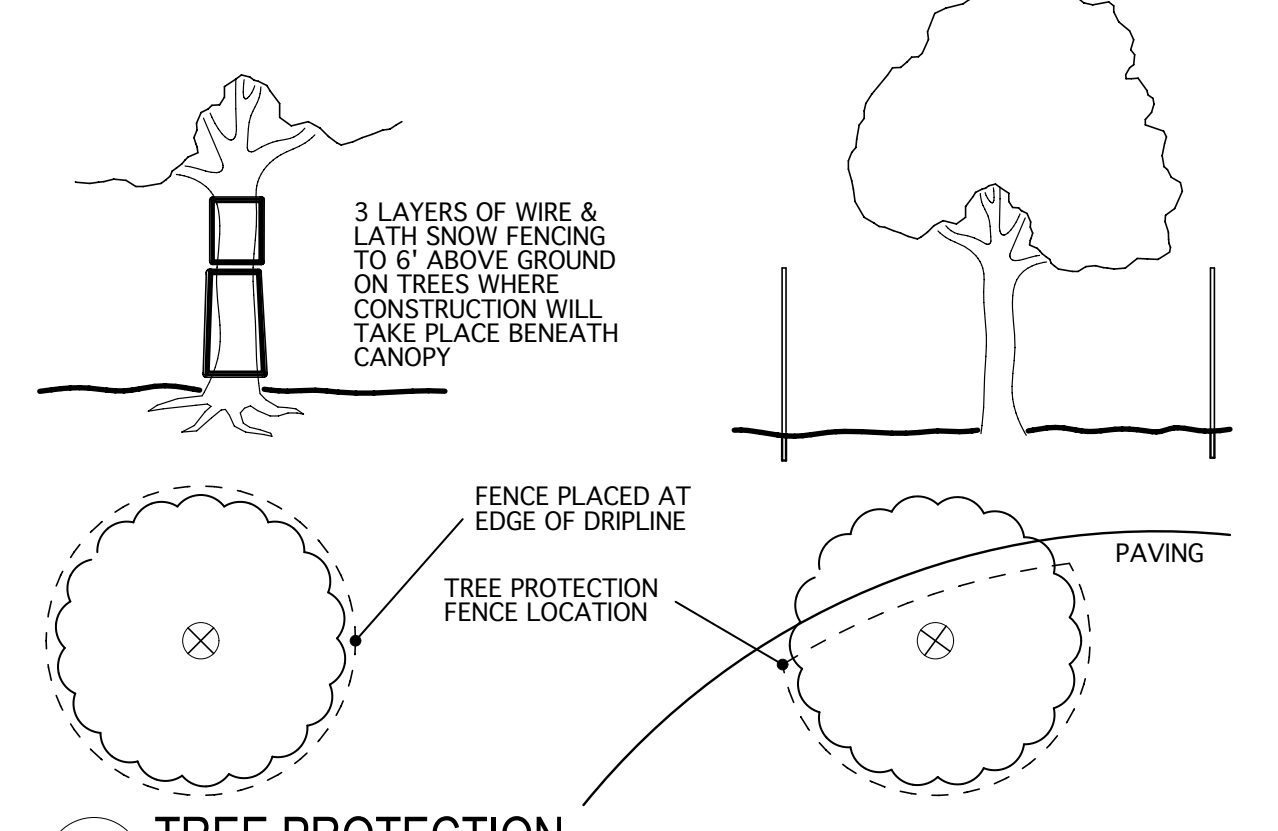
**1 TREE PROTECTION**  
For Reference Only. See Arborist Report NOT TO SCALE

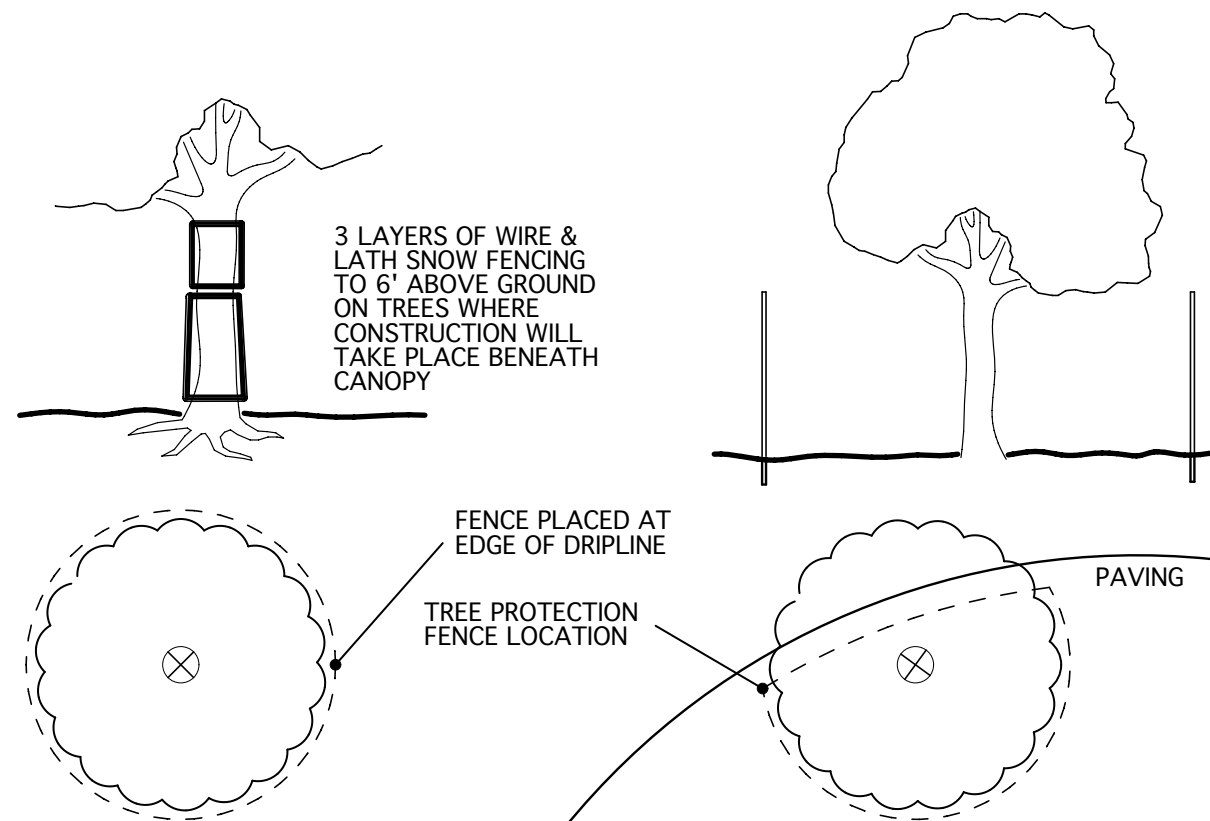
**1 TREE PROTECTION**  
 For Reference Only. See Arboist Report NOT TO SCALE

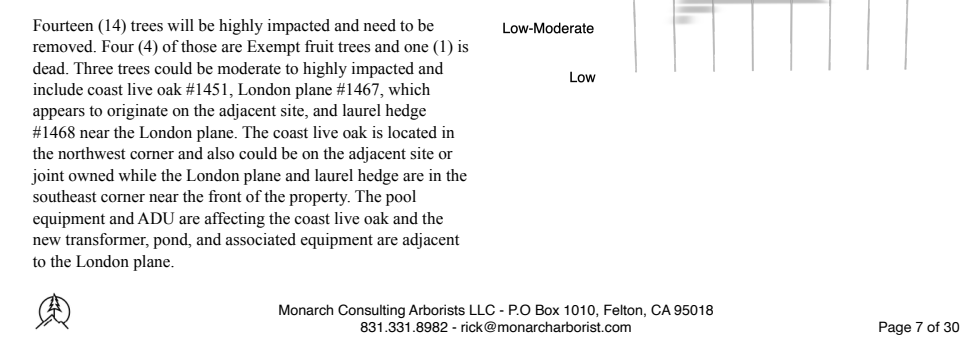
**16724 Chirco Avenue** Tree Inventory, Assessment and Protection Report February 25, 2025
