# Tree Permit Activity Report

## August 2026

### By Andy Crossett

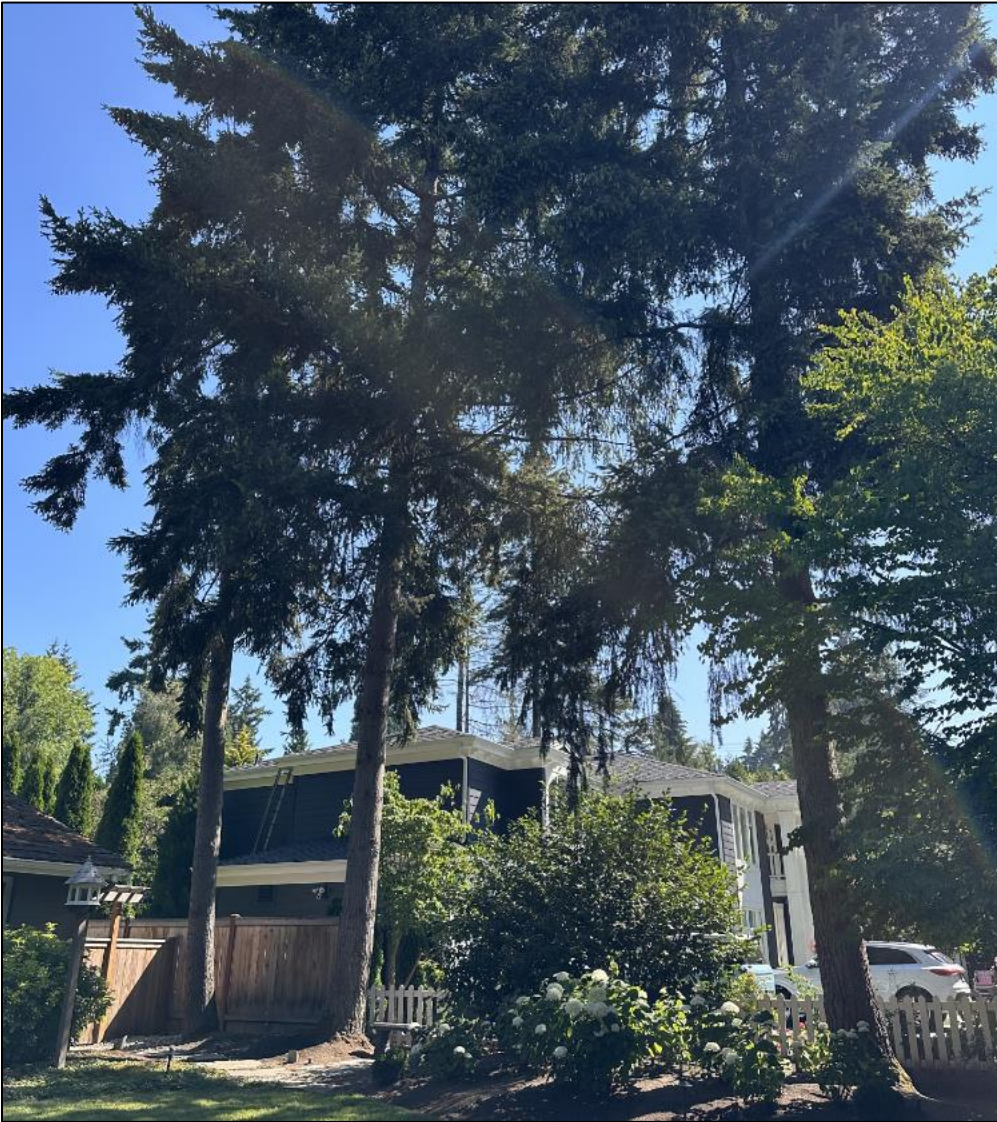
| Issued Non-Development Tree Permit Activity Table | | | | | | |
|---|---|---|---|---|---|---|
| 1 | TREE-PERFORMANCE | 8214 NE 8TH ST | 3 Douglas fir | 14, 16, 18" | N/A | No supplemental trees required. |

**Picture 1. 8214 NE 8TH ST:** Three Douglas Firs were removed under a Tree Performance Permit. The subject property had an excess of required tree units; therefore, no supplemental planting was required.

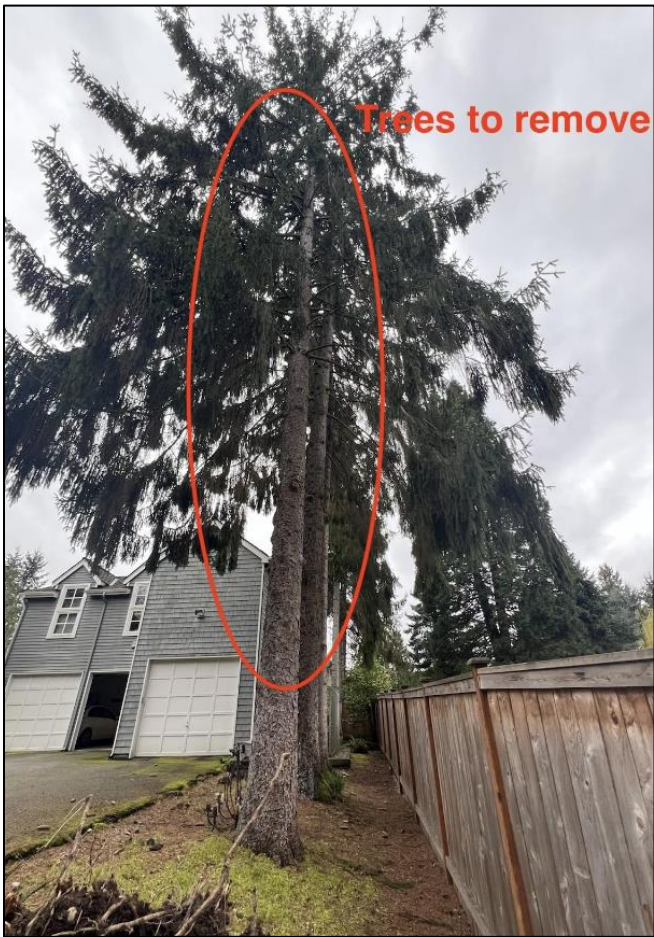
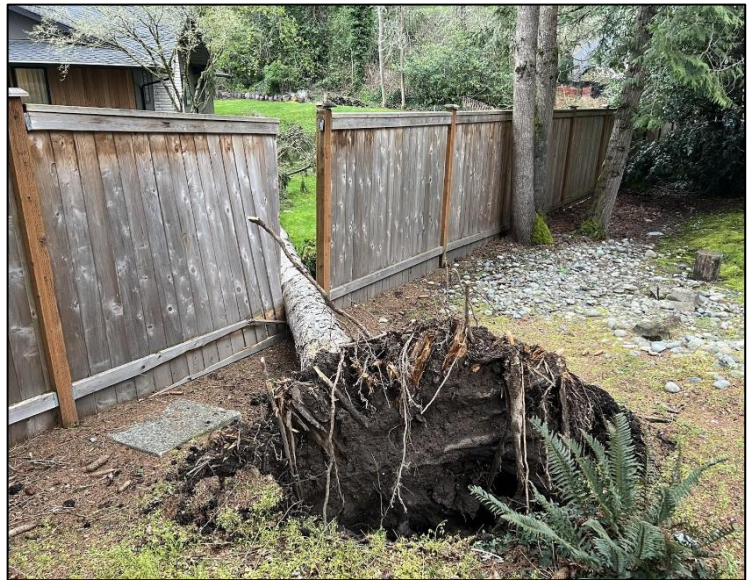
| Issued Non-Development Tree Permit Activity Table | | | | | | |
|---|---|---|---|---|---|---|
| 2 | TREE-PERFORMANCE | 8210 Overlake Dr W | 1 Silver Birch, 3 Norway Spruce | 31, 18, 22, 20" | N/A | No supplemental trees required. |

**Picture 2. 8210 Overlake Dr W:** One Silver Birch was in poor condition, with crown dieback consistent with Bronze Birch Borer infestation and large branches overhanging the home. A Norway Spruce on the property had previously experienced catastrophic root failure during a storm, likely associated with poor root development in heavy clay soils. The resident was concerned about the remaining trees due to their similar growing conditions. No supplemental planting was required, as the site exceeded minimum tree unit requirements.

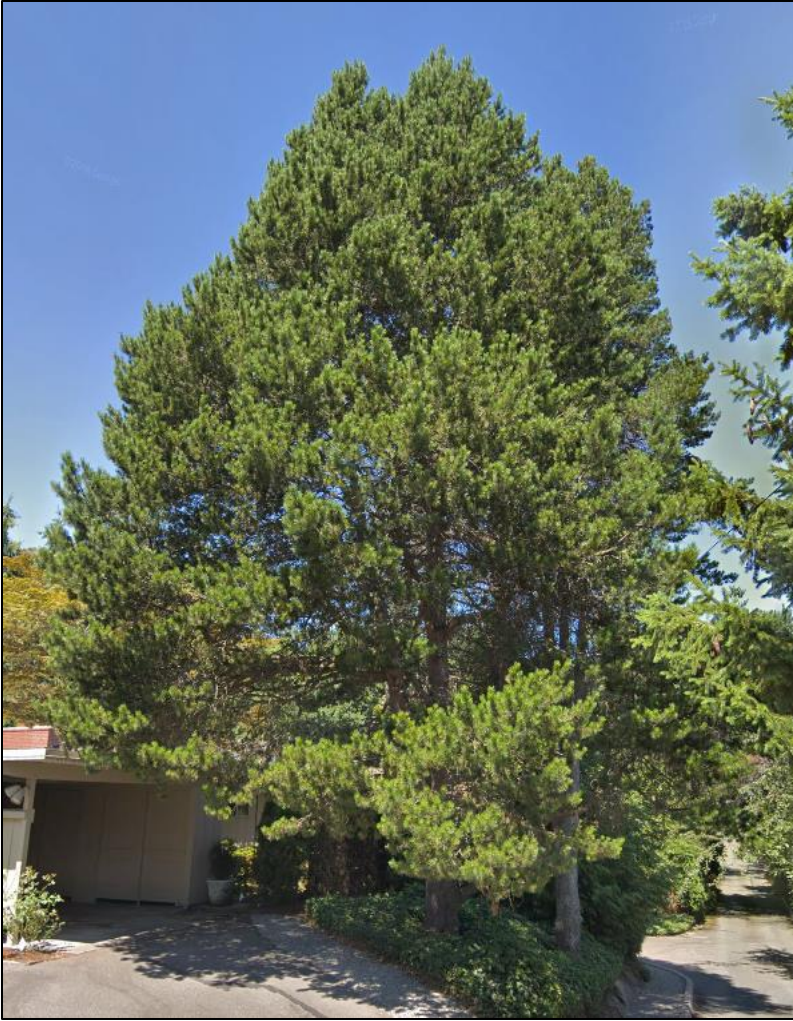
| Issued Non-Development Tree Permit Activity Table | | | | | | |
|---|---|---|---|---|---|---|
| 3 | TREE-PERFORMANCE | 7620 NE 12 <sup>TH</sup> ST | 1 Pine | 19" | N/A | No supplemental trees required. |

**Picture 3. 7620 NE 12TH ST:** One Pine tree was removed. No specific reason for removal was provided, but removal may have been related to the tree's limited growing space and proximity to the garage. No supplemental planting was required, as the property exceeded minimum tree unit requirements.

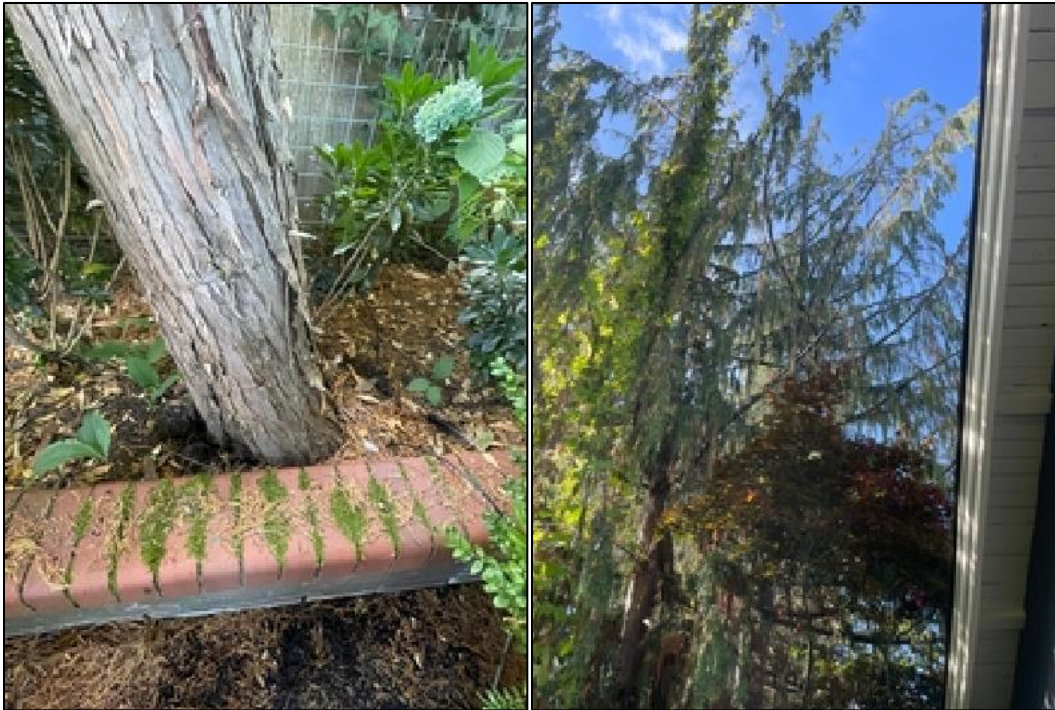
| Issued Non-Development Tree Permit Activity Table | | | | | | |
|---|---|---|---|---|---|---|
| 4 | TREE-RESTORATION | 522 86TH AVE NE | 1 Alaskan Cedar | 14" | 1 | The tree was beginning to uproot and had developed a lean toward the home. |

**Picture 4. 522 86TH AVE NE:** Three Alaskan Cedars were planted in close proximity to one another. The central tree had begun to uproot and developed a lean toward the home, potentially related to poor planting practices. The other two trees appeared healthy and showed no signs of instability or failure.

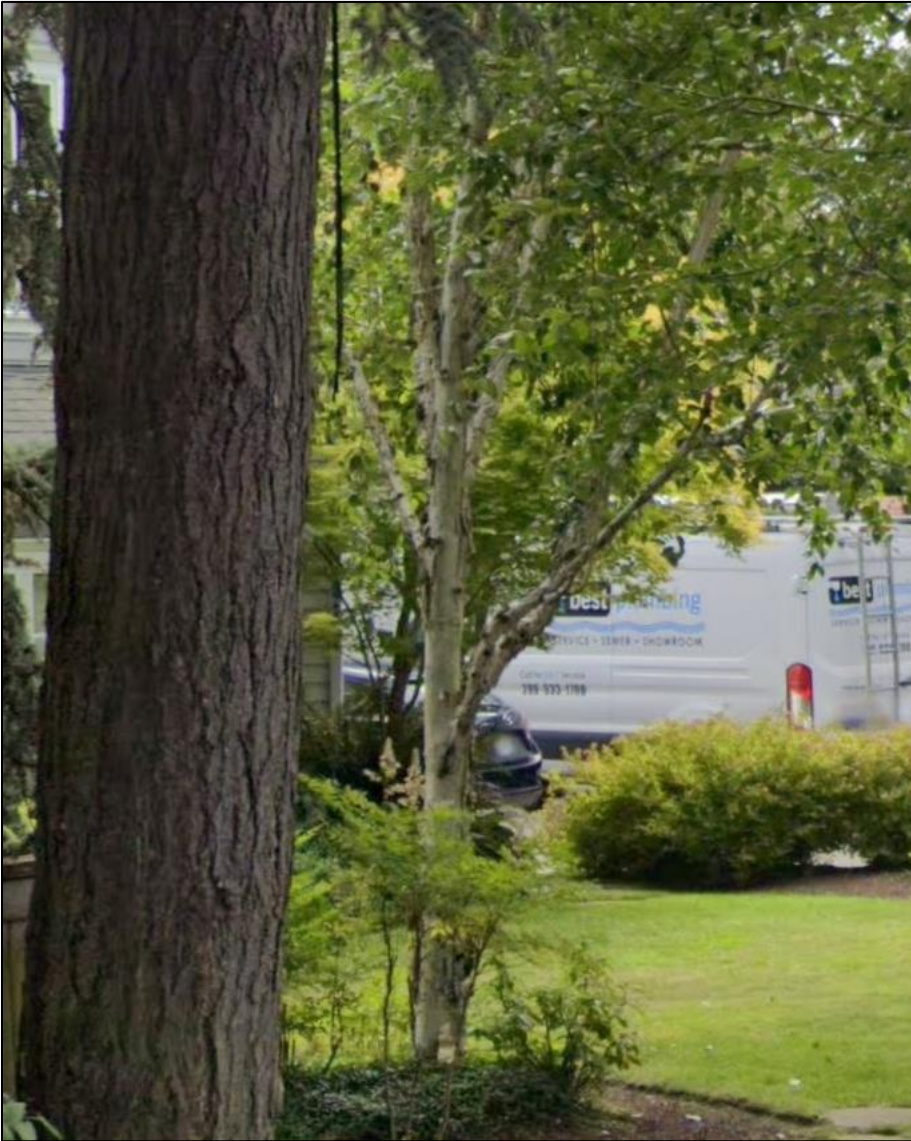
| Issued Non-Development Tree Permit Activity Table | | | | | | |
|---|---|---|---|---|---|---|
| 5 | TREE-PERFORMANCE | 8611 NE 6th St | 1 Silver Birch | 9" | 2 | The site was deficient in required tree units. Two supplemental trees were required. |

**Picture 5. 8611 NE 6th St:** A small Silver Birch with suppressed growth. The site was deficient in required tree units and, as a result, two supplemental trees were required.
