# Administrative Tree Activity Permit

Steve Burnstead  
116 Overlake Dr. E  
Medina, WA 98039

**Property Map: 116 Overlake Dr. E, Medina 98039.**

## Shoreline Tree Hazard & Mitigation:

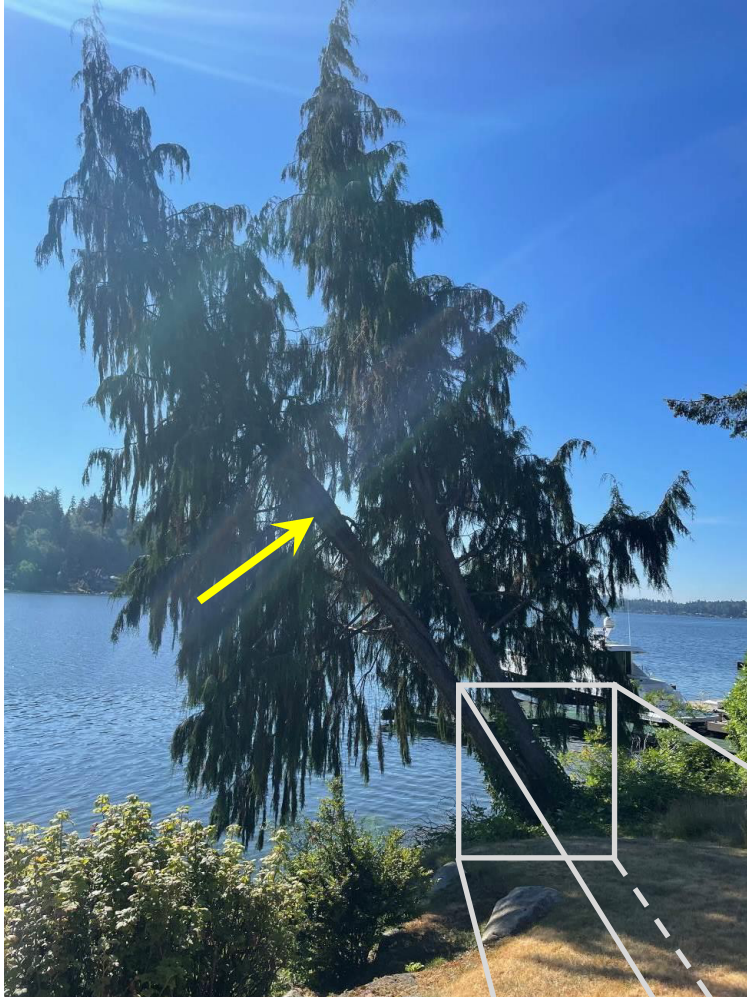
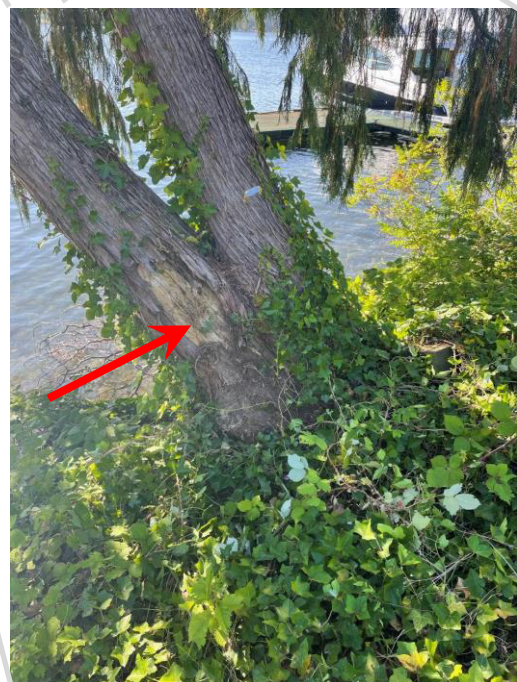
Alaskan cedar T1 is within the shoreline setback and poses a hazard to neighboring property and may cause bulkhead damage. Cedar T1 has increased its severe lean with little canopy correction for the past few years under my routine inspections. The tree is experiencing active root failure. Other health factors put the tree at high risk. Pictures and ISA Hazard Assessment Form describes the tree's condition on the following pages.

The Alaskan Cedar T1 is pictured on the left, taken at time of inspection July of 2022. The cedar leans to the neighboring property at 30-35 degrees. It targets the neighboring shoreline and dock. Tree failure at the root crown may damage the bulkhead.

The bottom picture is a close-up of the tree's trunk. The red arrow shows the large open wound and dead wood that extends into the root collar. Live wood around the wound has low vigor. The root plate has signs of upheaval on the opposite side of the lean.

In addition to the pruning to alleviate leverage load, new tree plantings are recommended near the subject tree to ensure future canopy coverage. For example, three new Alaskan weeping cedars (*Chamaecyparis nootkatensis*) of minimum height for replacement should Cedar T1 eventually fail.

Cedar T1 will require removal if topping the lower trunk cannot be accepted. A tall portion of the trunk will need to remain to act as a “wildlife snag” if removal is the preference. New Alaskan weeping cedars continue to be the preferred replacement trees.

Removal of the lower, southeast trunk (yellow arrow) will reduce the risk of whole tree failure.
