Tree Permit Activity Report
May 2026
By Andy Crossett

TreePlotter Tree Inventory Update: Zone 1 (everything east of 84th Ave NE), covering the southeast portion of Medina, has been completed. Fieldwork has now transitioned into Zone 2 (area west of 84th Ave NE and south of NE 12th St).

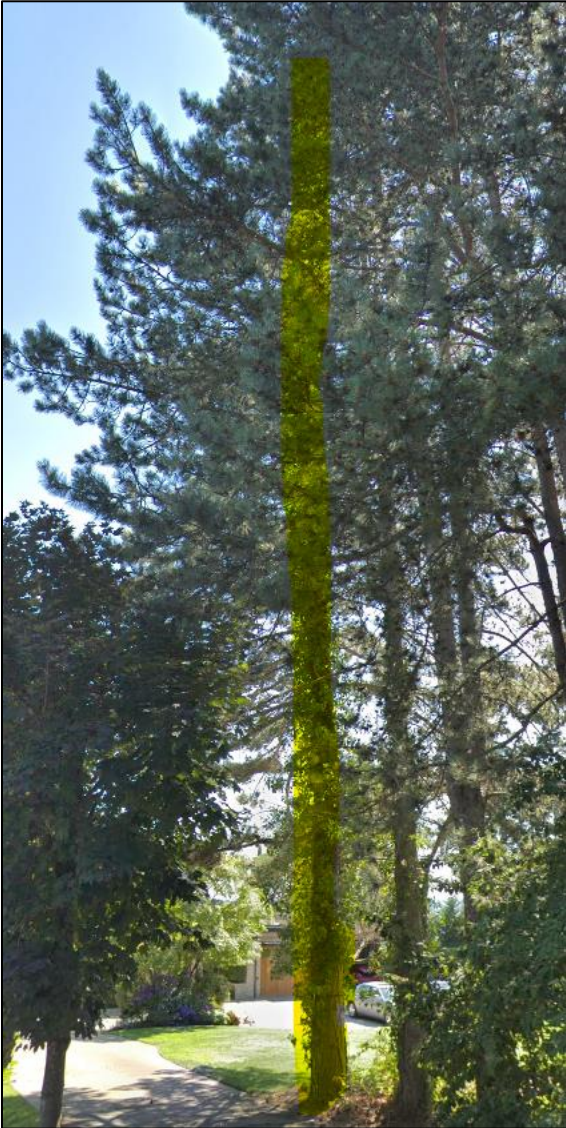
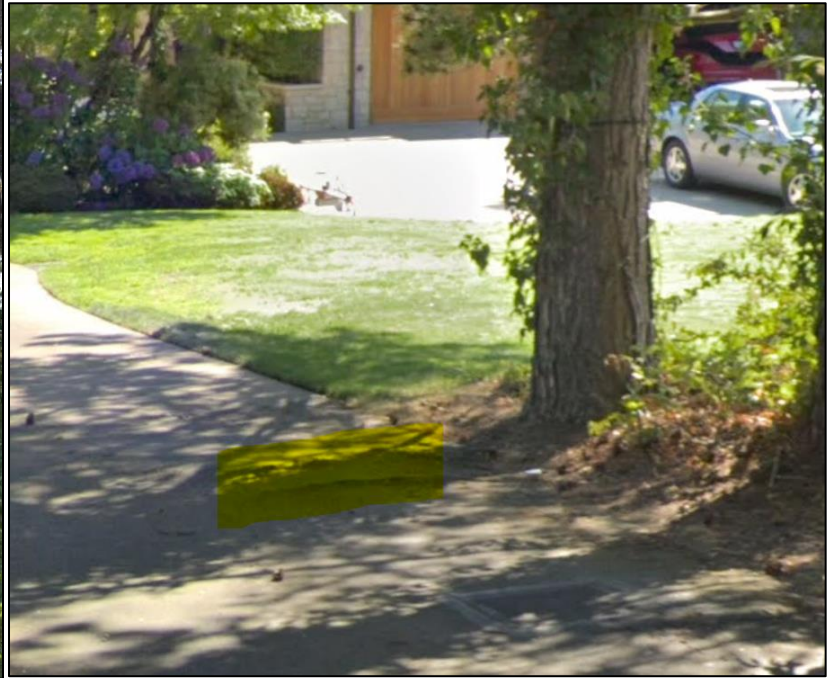
Issued Non-Development Tree Permit Activity Table						
Picture #	Permit Type	Address	# Trees Removed	Removed Tree (Size)	Supplemental Required	Description
1	TREE-RESTORATION	7747 Overlake Dr West	1 Austrian pine	25"	3	Private property tree removal. Tree roots are damaging the adjacent asphalt driveway.
N/A	TREE-PERFORMANCE	8428 NE 10 TH ST	1 Hornbeam, 1 Paper Birch	35", 32"	N/A	Private property tree removal. Minimum tree unit requirements have been met; therefore, no supplemental replacement trees are required.

Picture 1. 7747 Overlake Dr West: Pine roots are causing heaving and cracking of the adjacent private asphalt driveway. Removal of this tree will require three supplemental replacement trees.

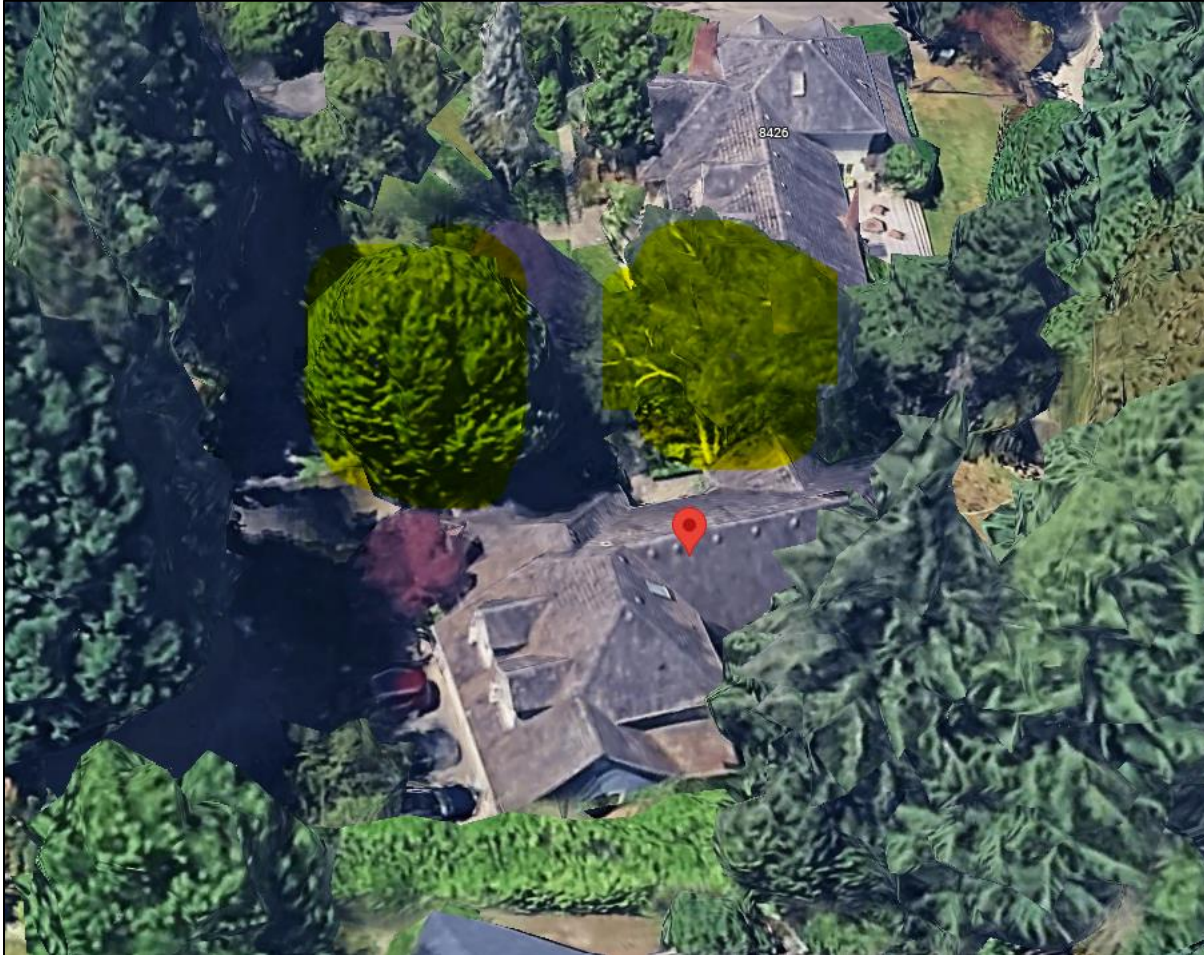
Picture 2. 8428 NE 10TH ST: Hornbeam (left) and birch (right). I met with the applicant to confirm that the application materials were accurate. The applicant believes the trees have outgrown the available planting space and are no longer well-suited to their location. No supplemental planting is required, as the lot will continue to meet the minimum tree unit requirements following removal of these trees.

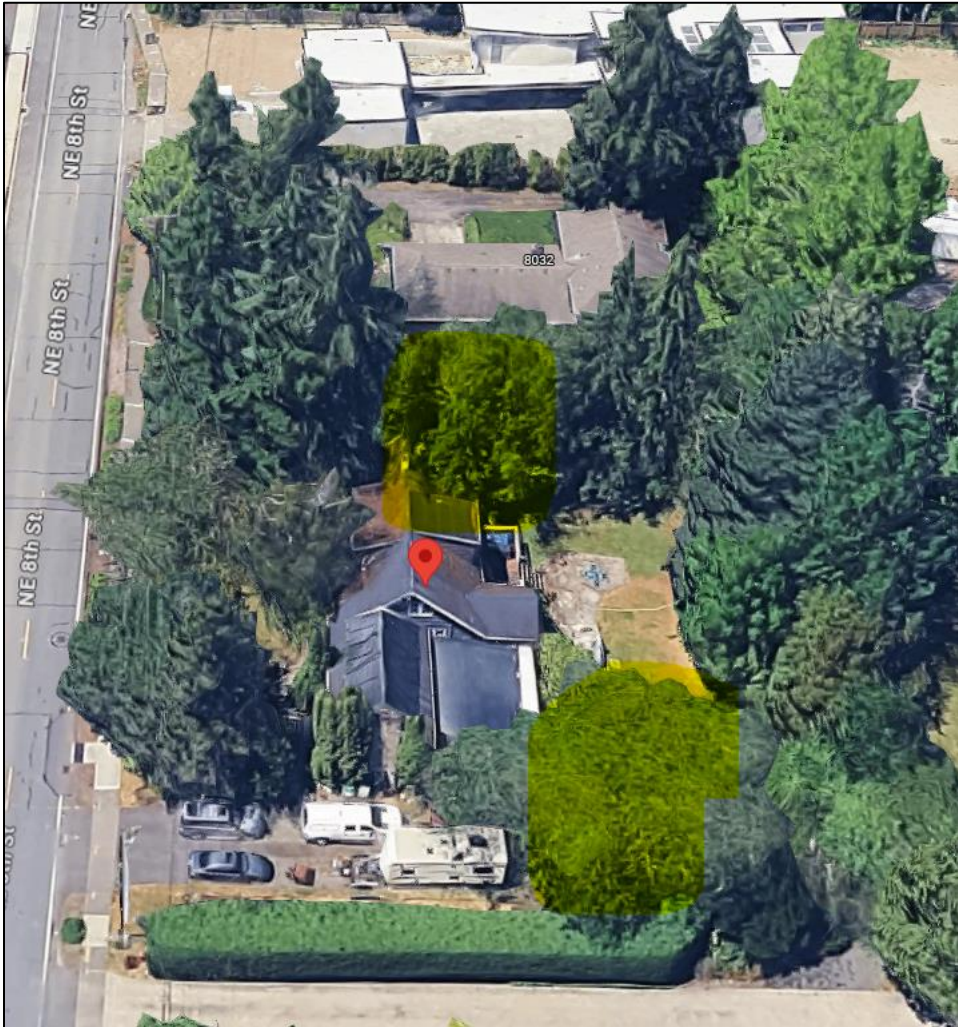
New Development Tree Permit Activity Table						
Picture #	Permit Type	Address	# Trees Removed	Removed Tree (Size)	Supplemental Required	Description
N/A	REVISION – TREE-WITH BUILDING/DEV	8048 NE 8th St	1 Honey locust, 1 Scouler's willow	19", 36"	N/A	Both trees were storm damaged and exhibited decay. Minimum tree unit requirements have been met; therefore, no supplemental replacement trees are required.

Picture 3. 8048 NE 8TH ST: The honey locust is located on the lower side of the photo, with the willow above the home. Both trees experienced primary stem failure during the most recent windstorm and exhibited disease and decay in the remaining wood. Neither tree was viable for preservation following failure. No supplemental planting is required, as the lot will continue to meet the minimum tree unit requirements following removal of these trees.
