Tree Permit Activity Report
February 2026
By Andy Crossett

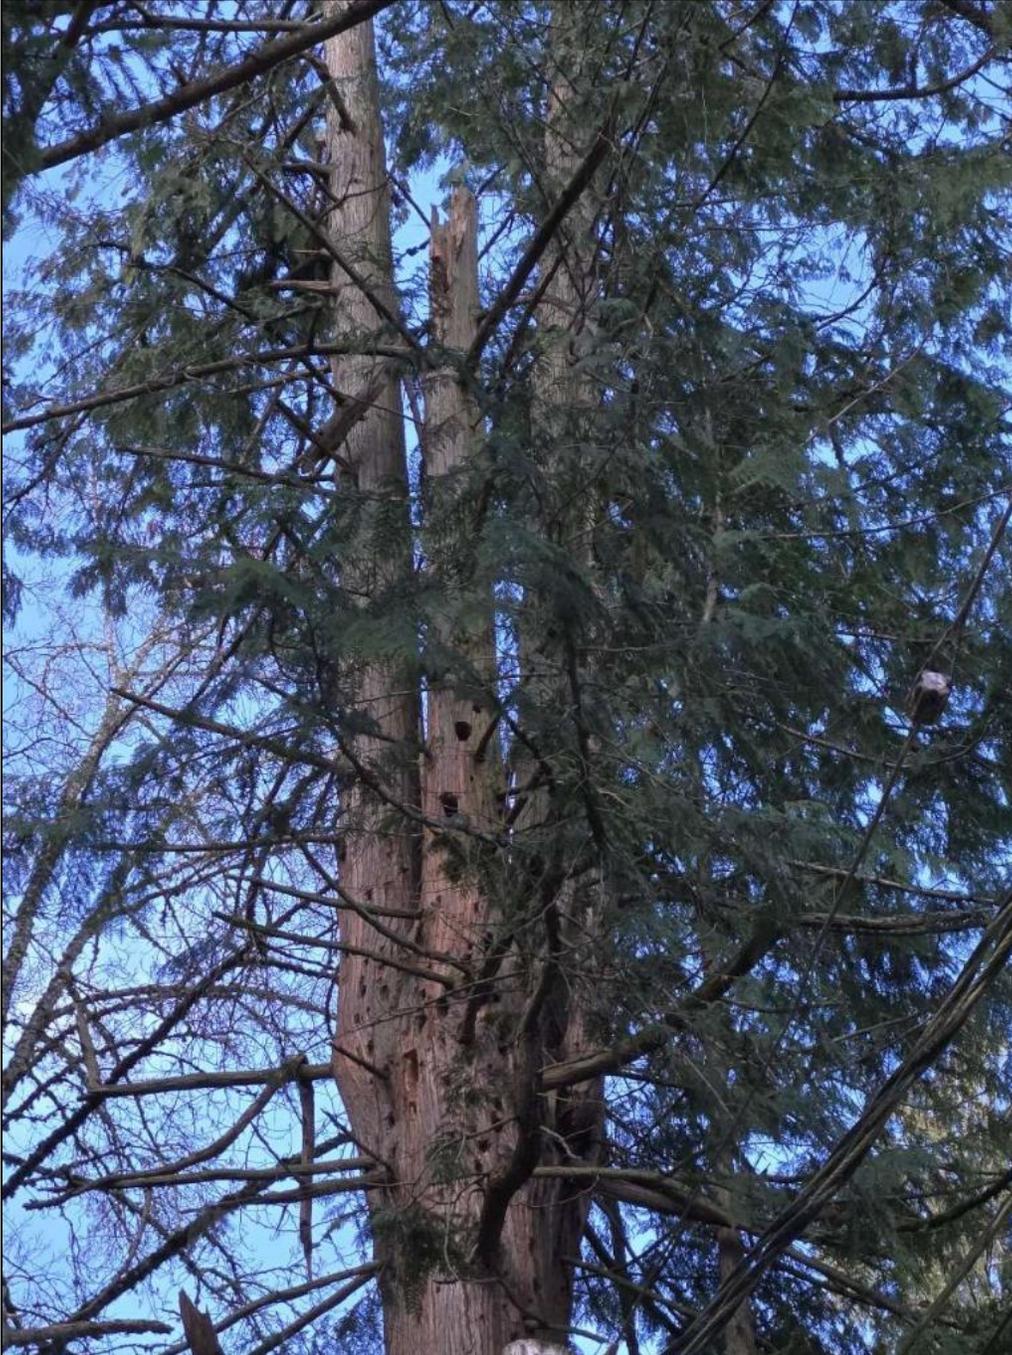
Picture 1. 3419 Evergreen Point Rd. The following trees were independently assessed as high risk and confirmed to be high risk after reviewing the report and visiting the site. The Douglas fir measures 52 inches in diameter and the cedar measures 50 inches in diameter. Both trees have experienced stem failures, have visible cavities, and are unlikely to remain upright much longer.

Western redcedar – Extensive decay and associated cavities are present on the trunk where several multi-stemmed leaders converge. The cavity extends from this point down into the base of the trunk.

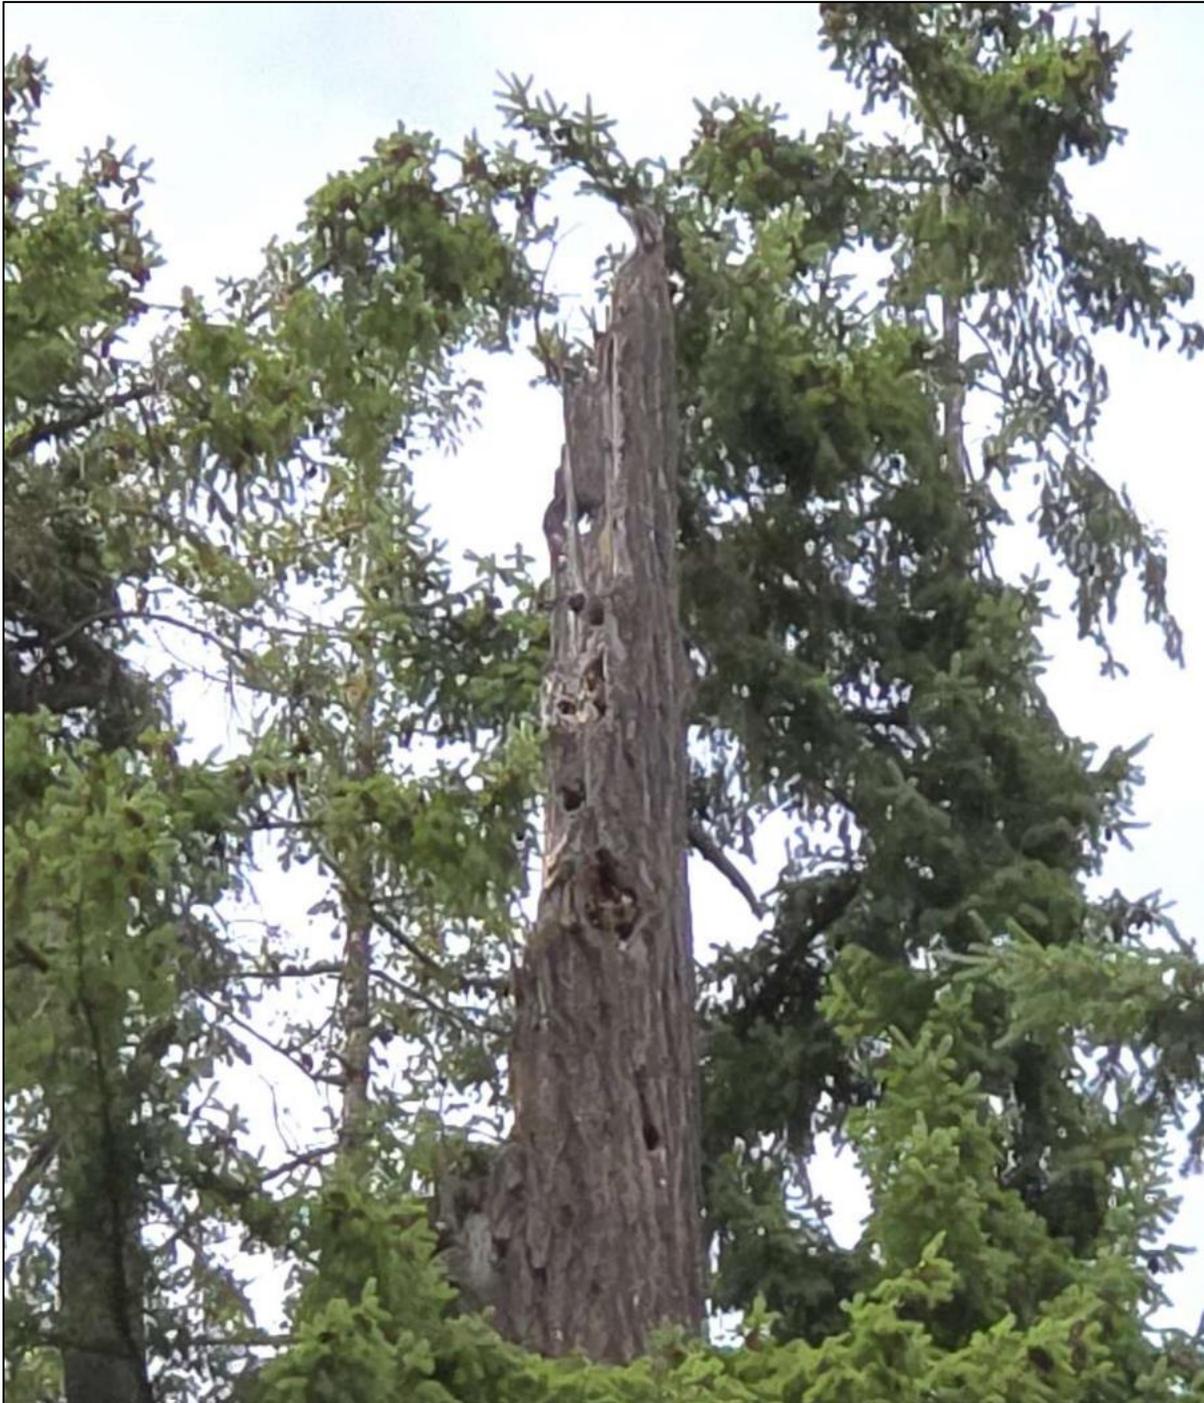
Picture 2. Douglas fir – The top of the tree blew out, leaving the torn section dead. Leaders formed below the torn section. A cavity is present in at least the portion of the trunk supporting the competing leaders. There is a high probability these stems will naturally fail and tear out during wind events. The lower portion of the trunk shows extensive insect activity and resin bleeding. Insects can indicate nesting activity within decayed trunk wood. Heavy resin bleeding on Douglas fir is often associated with honey fungus, which can digest both decayed and living wood and is commonly associated with root failure in many tree species.

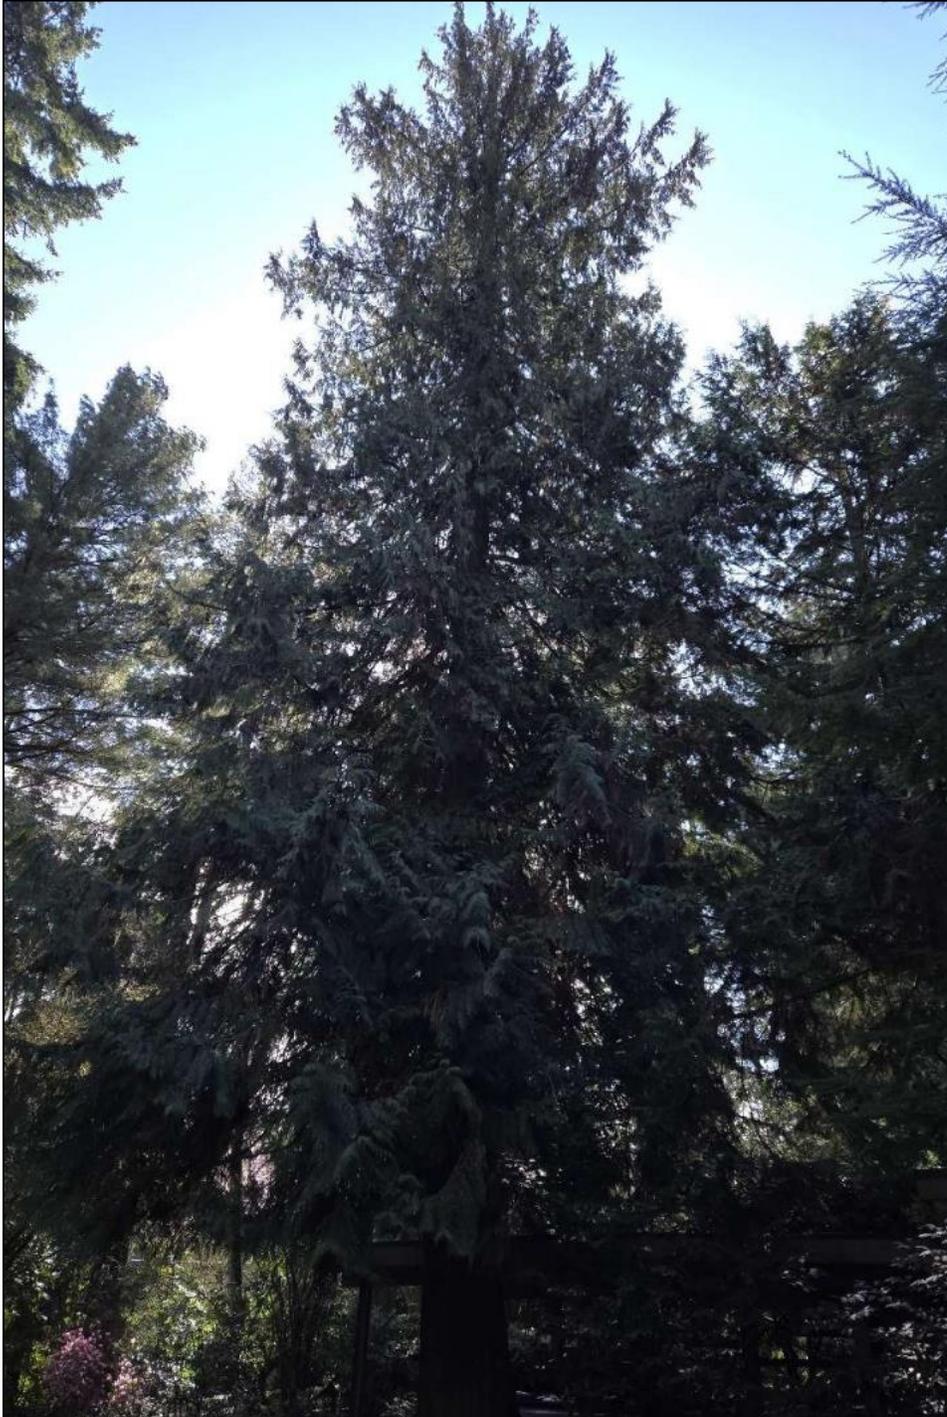
Picture 3. A 50-inch healthy landmark western redcedar is proposed to be removed due to future site development. Notices have been posted and mailers sent during the comment period. This application will proceed to a public hearing, where the Hearing Examiner will determine whether removal is warranted under Medina City Code.
