Tree Permit Activity Report
January 2024
By Andy Crossett

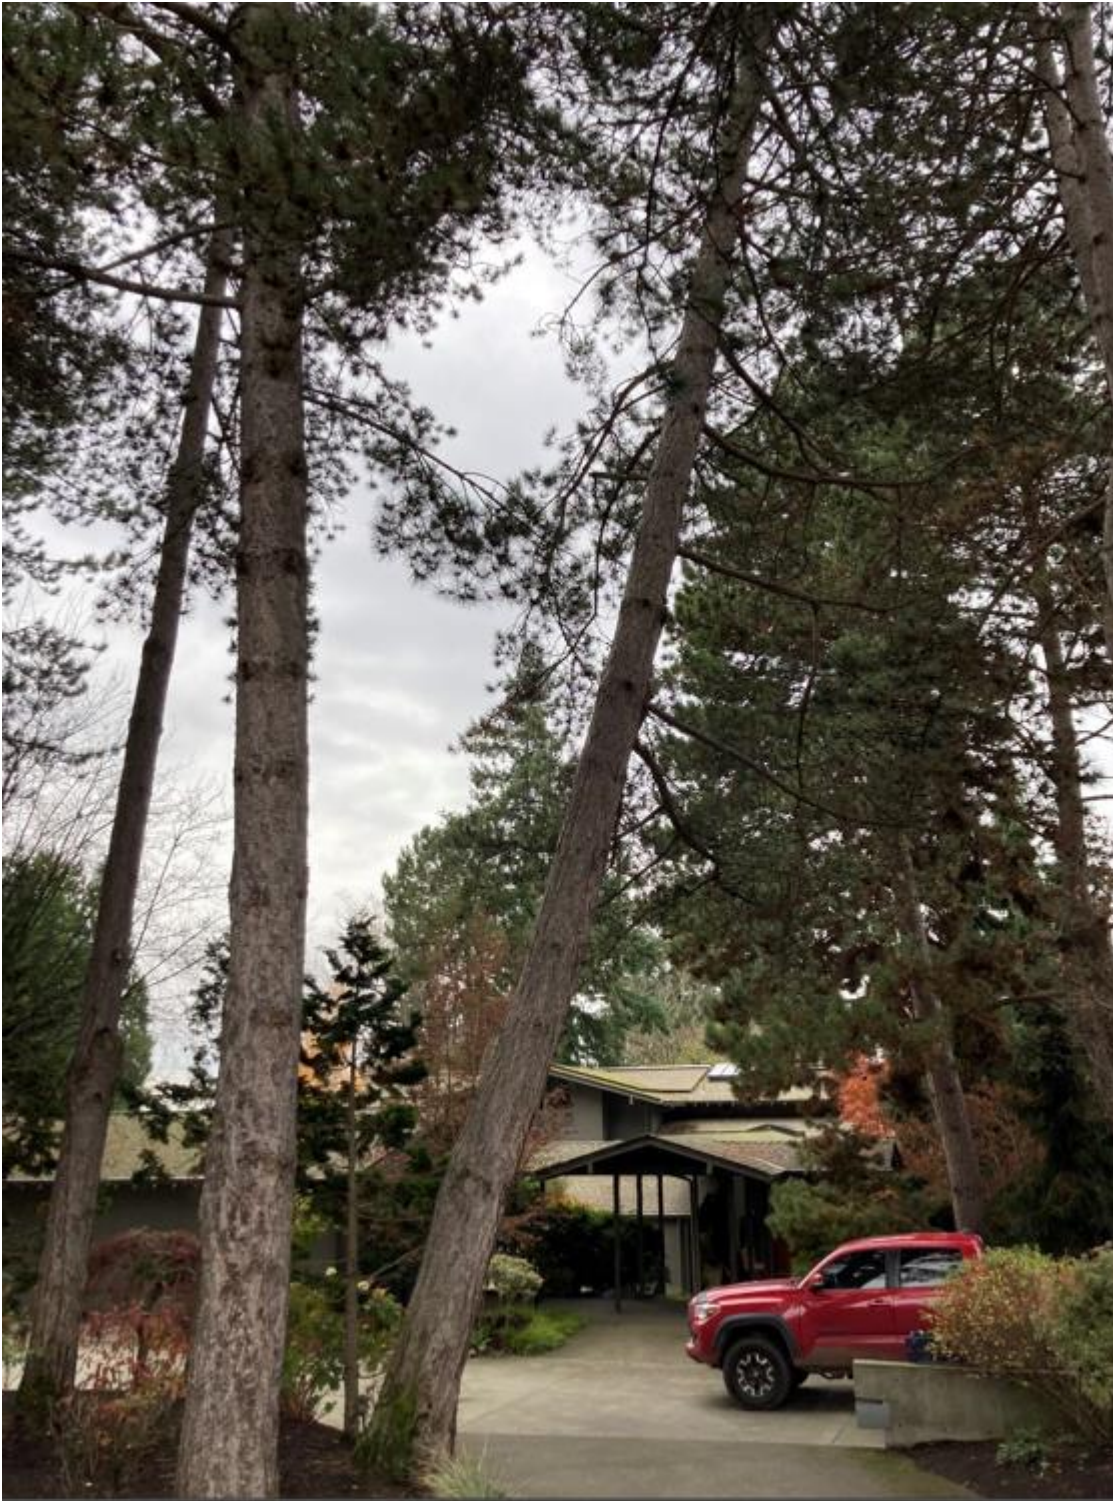
Picture 1. 1631 Rambling LN – Leaning ROW pine.

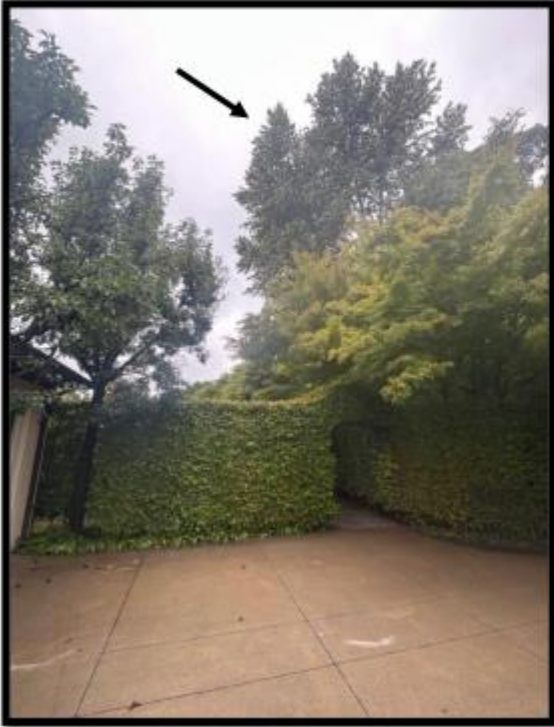
Photo 1: Looking north from driveway. Image shows overhang on yard.

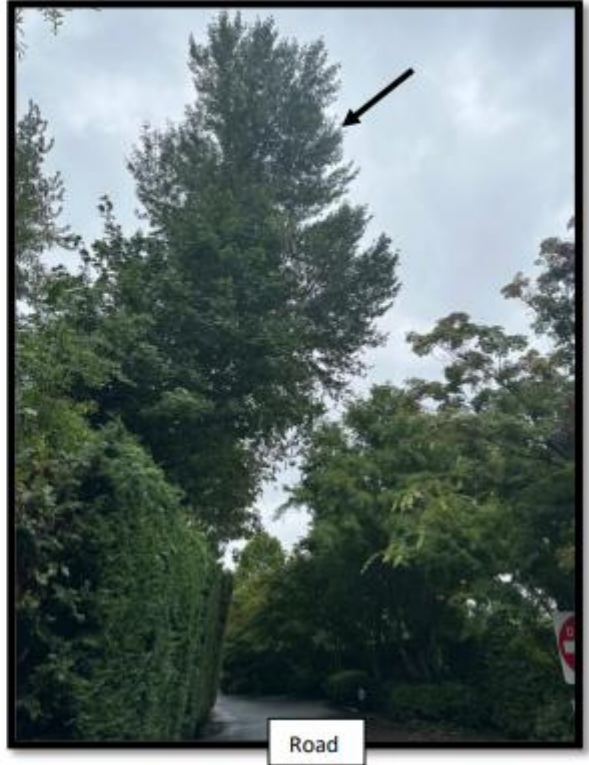
Photo 2: Looking south from 73rd. Image shows overhang on road and yard.

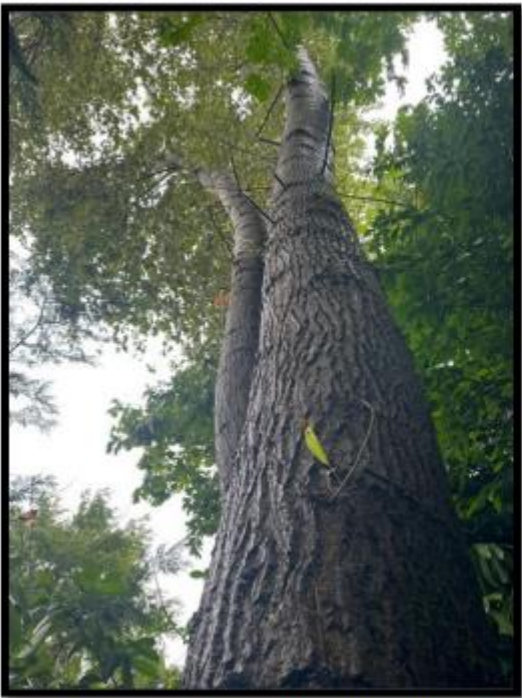
Photo 3: Image shows codominant form of tree #2.

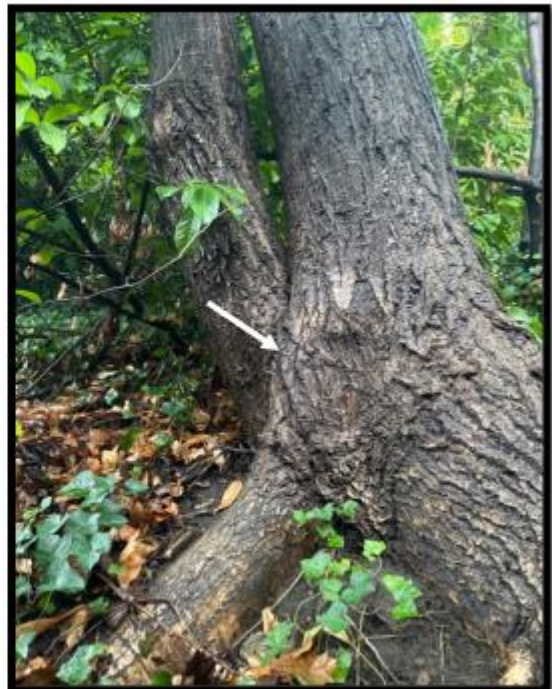
Photo 4: Image shows included bark (arrow) of tree #2.

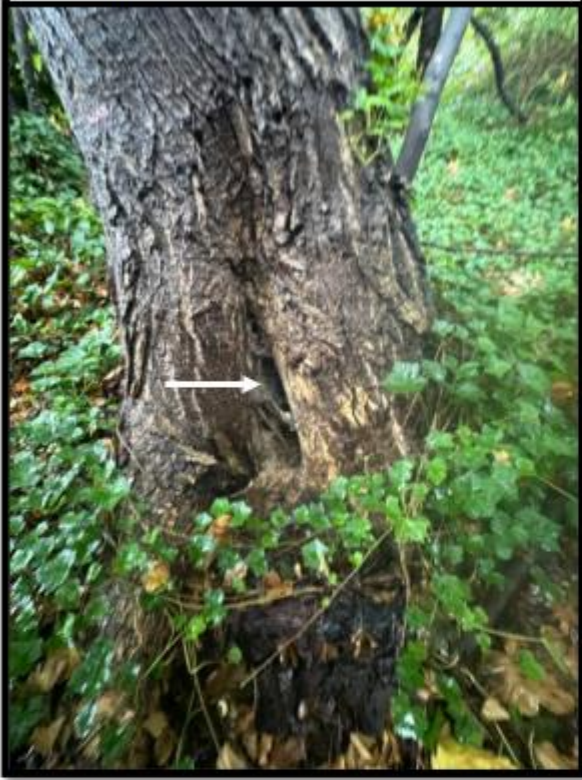
Photo 5: Arrow points to large cavity at base of tree #3.

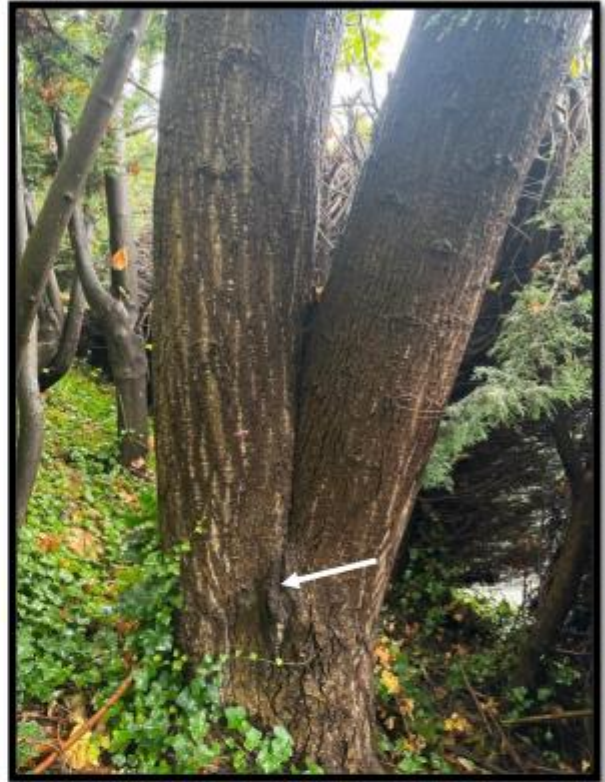
Photo 6: Image of Tree #3 base showing codominant form and included bark.

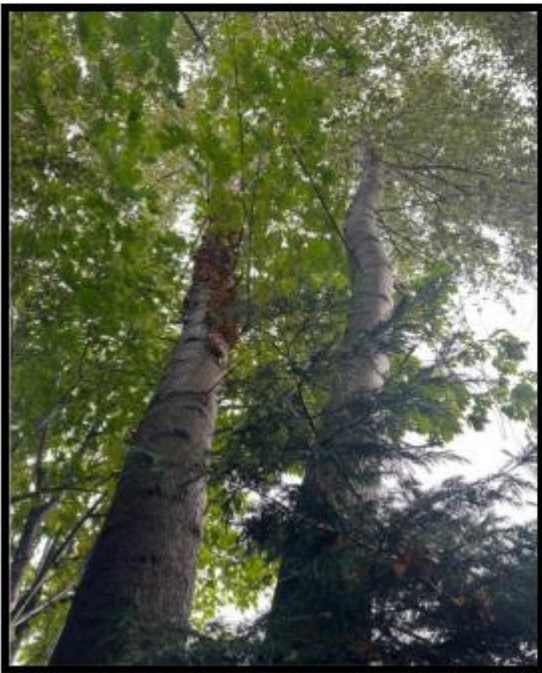
Photo 5: Image shows codominant form of Tree #3.

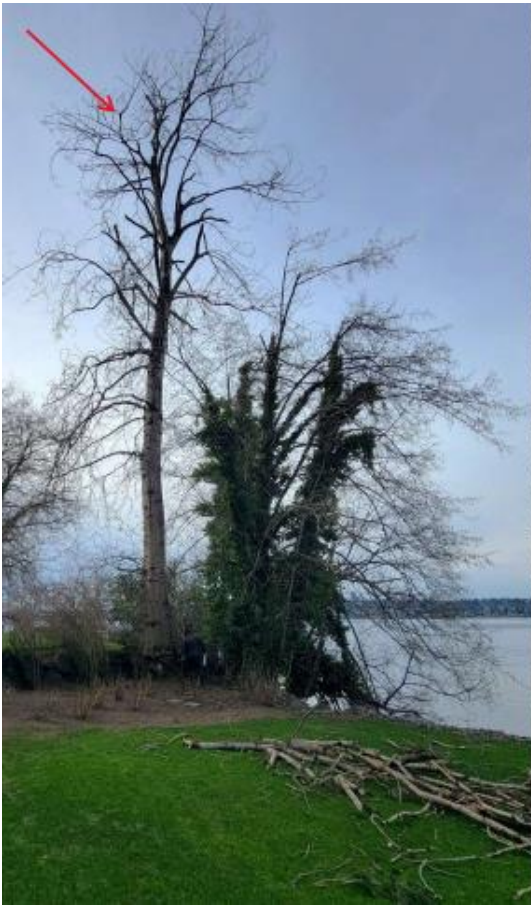
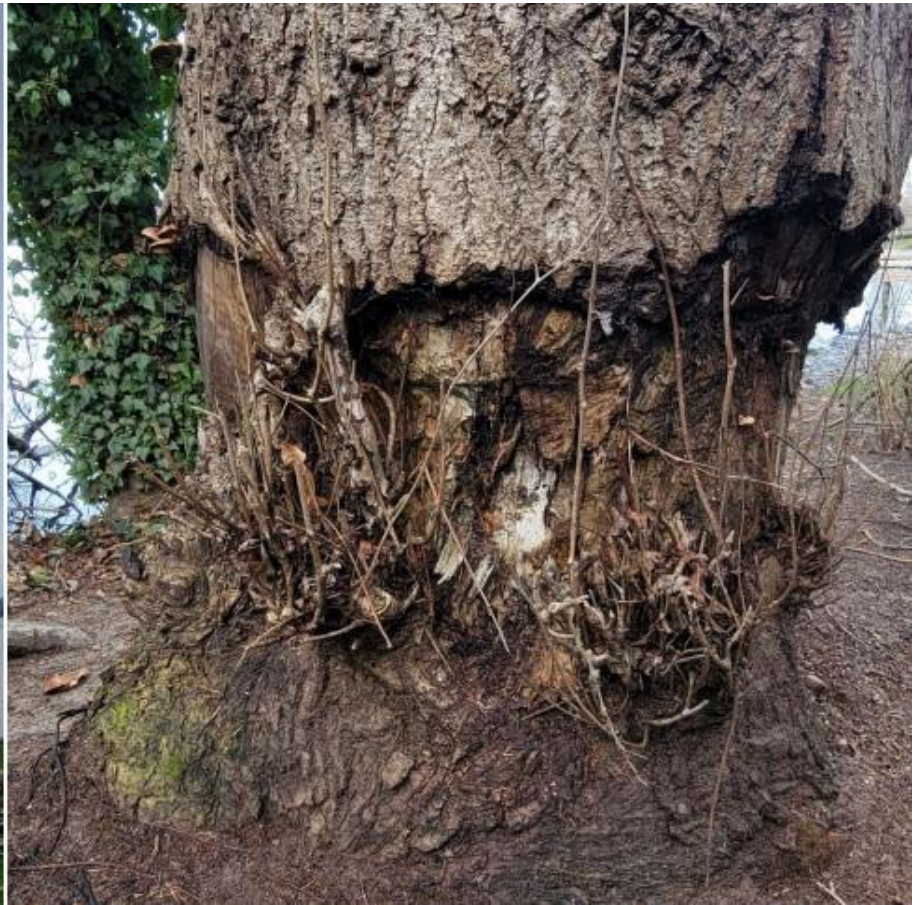
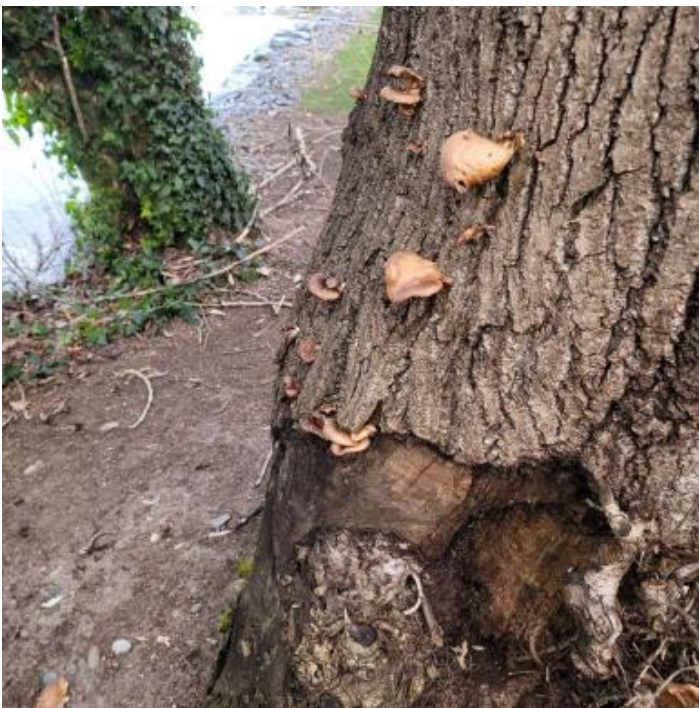
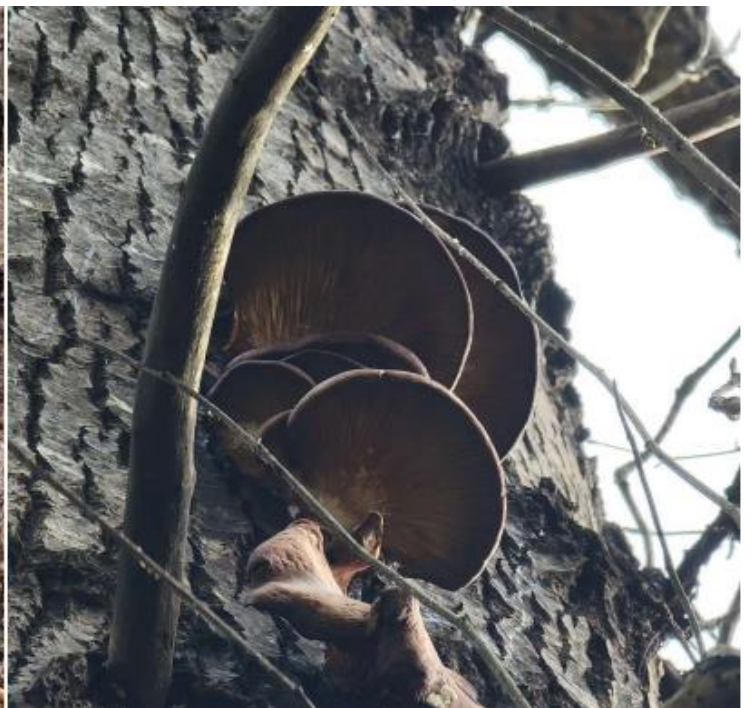
Picture 3. 1255 Evergreen Point Rd – Dying hazardous black cottonwood.

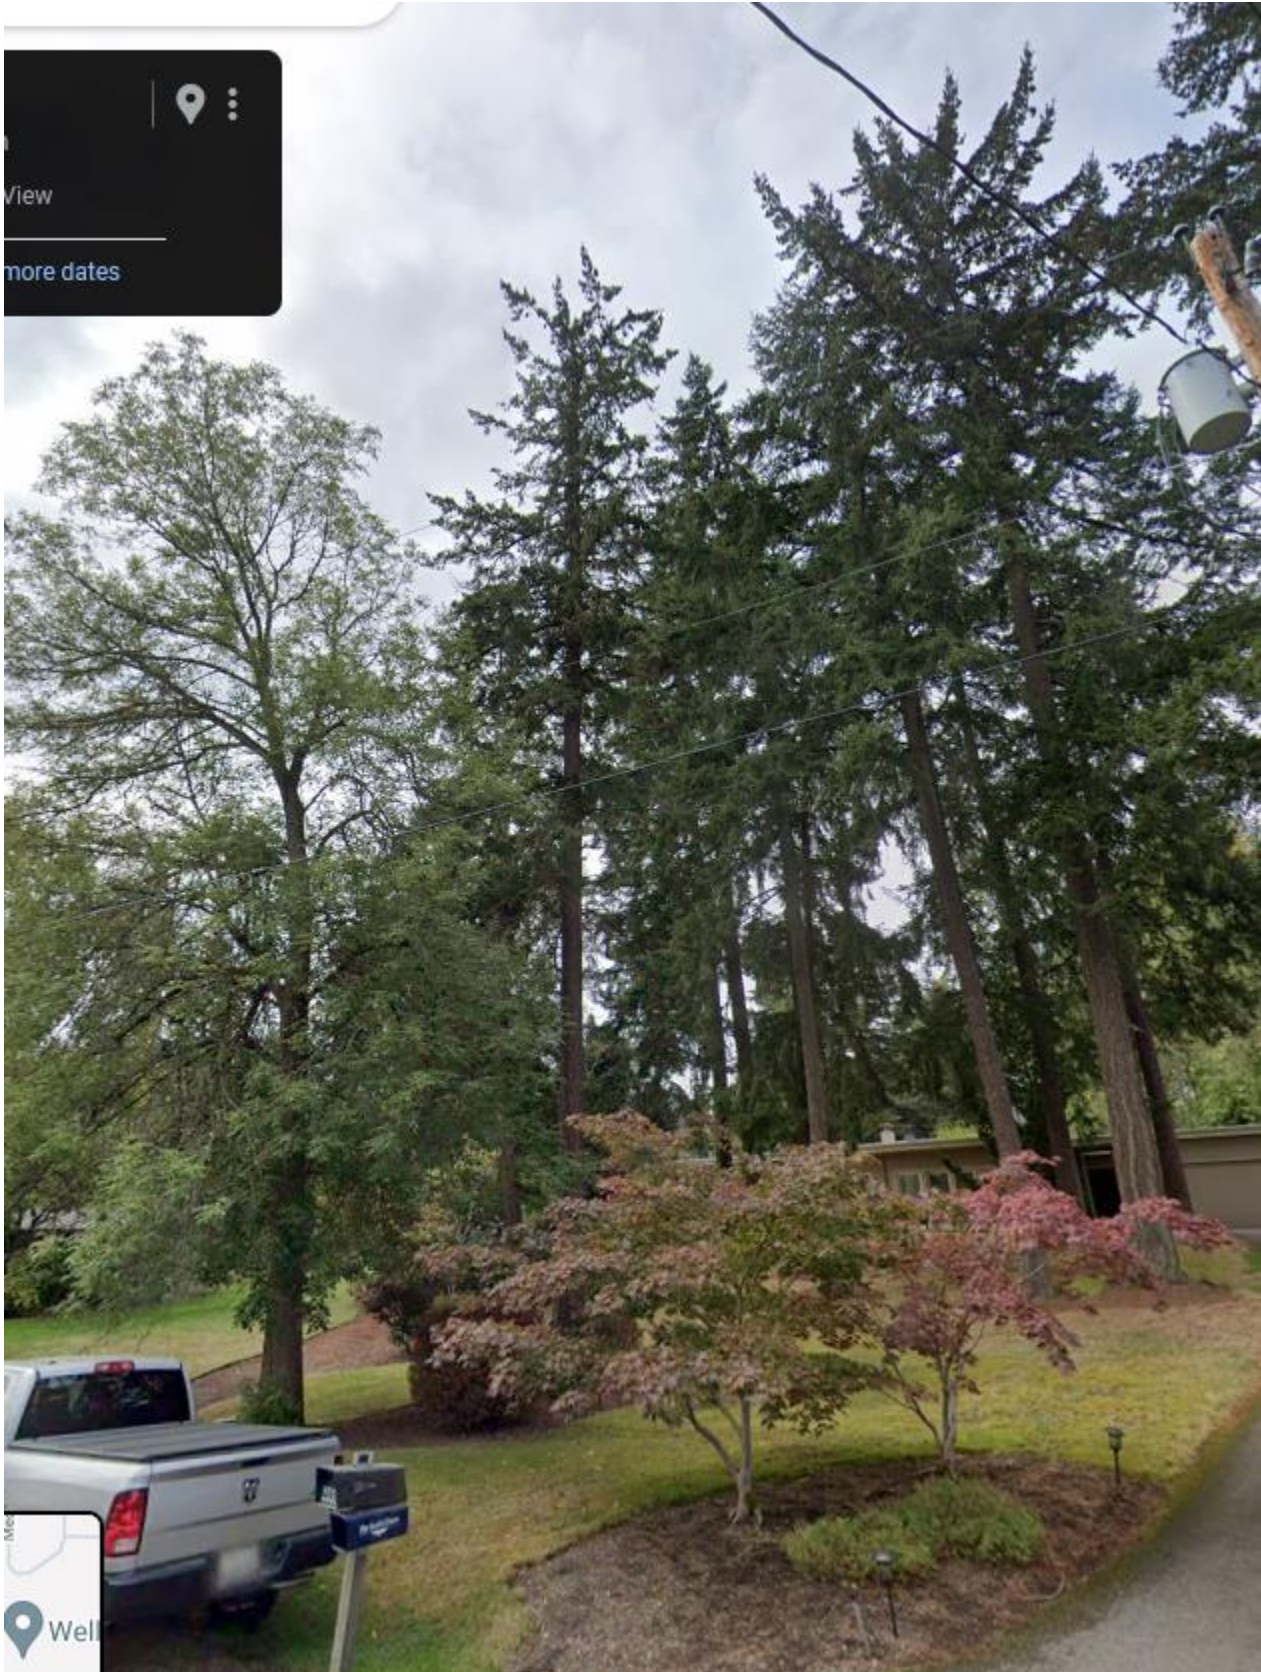
Picture 4. 2539 82nd Ave NE – 11 grove trees to be removed to allow room for new construction.

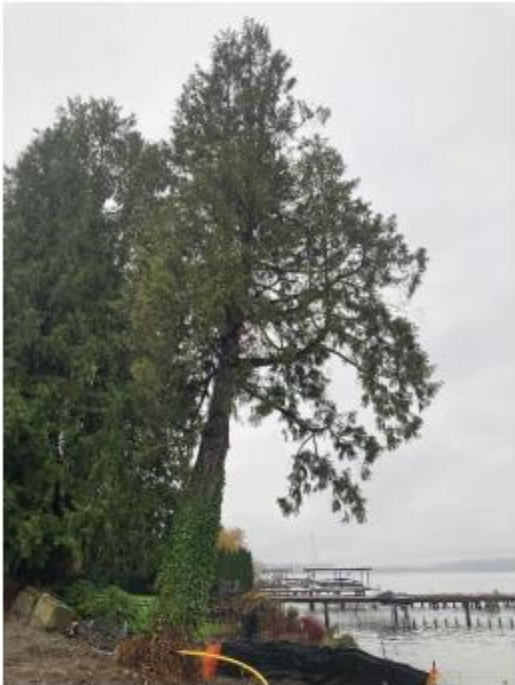
Picture 5. 3436 Evergreen Point Rd – 1 Hazardous Western Redcedar

View northerly, note lean over dock

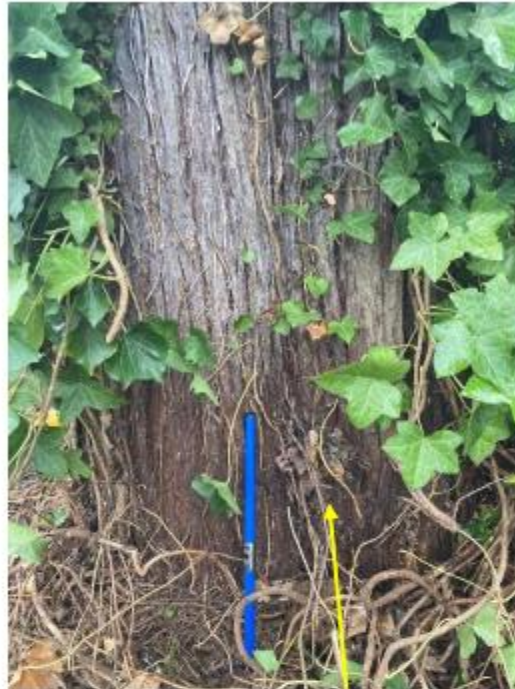
Decay apparent at root crown

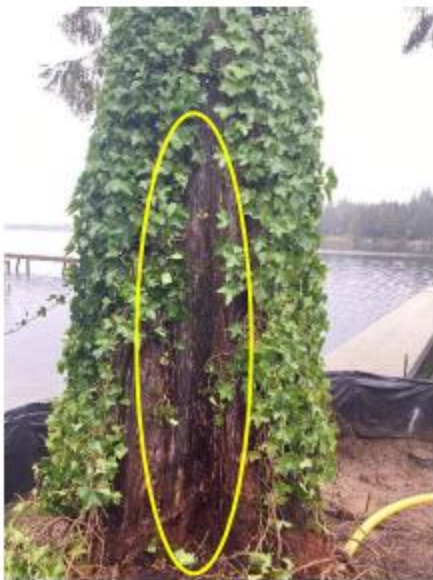
Open cavity at base of tree

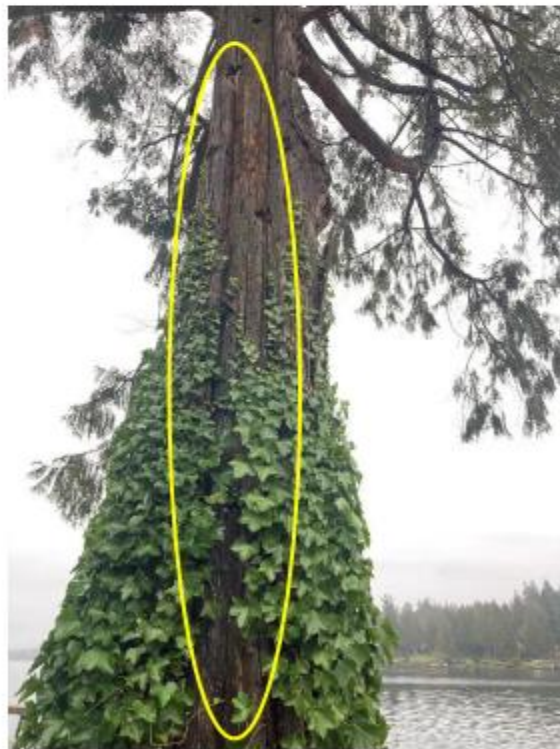
Open cavity the length of the main trunk

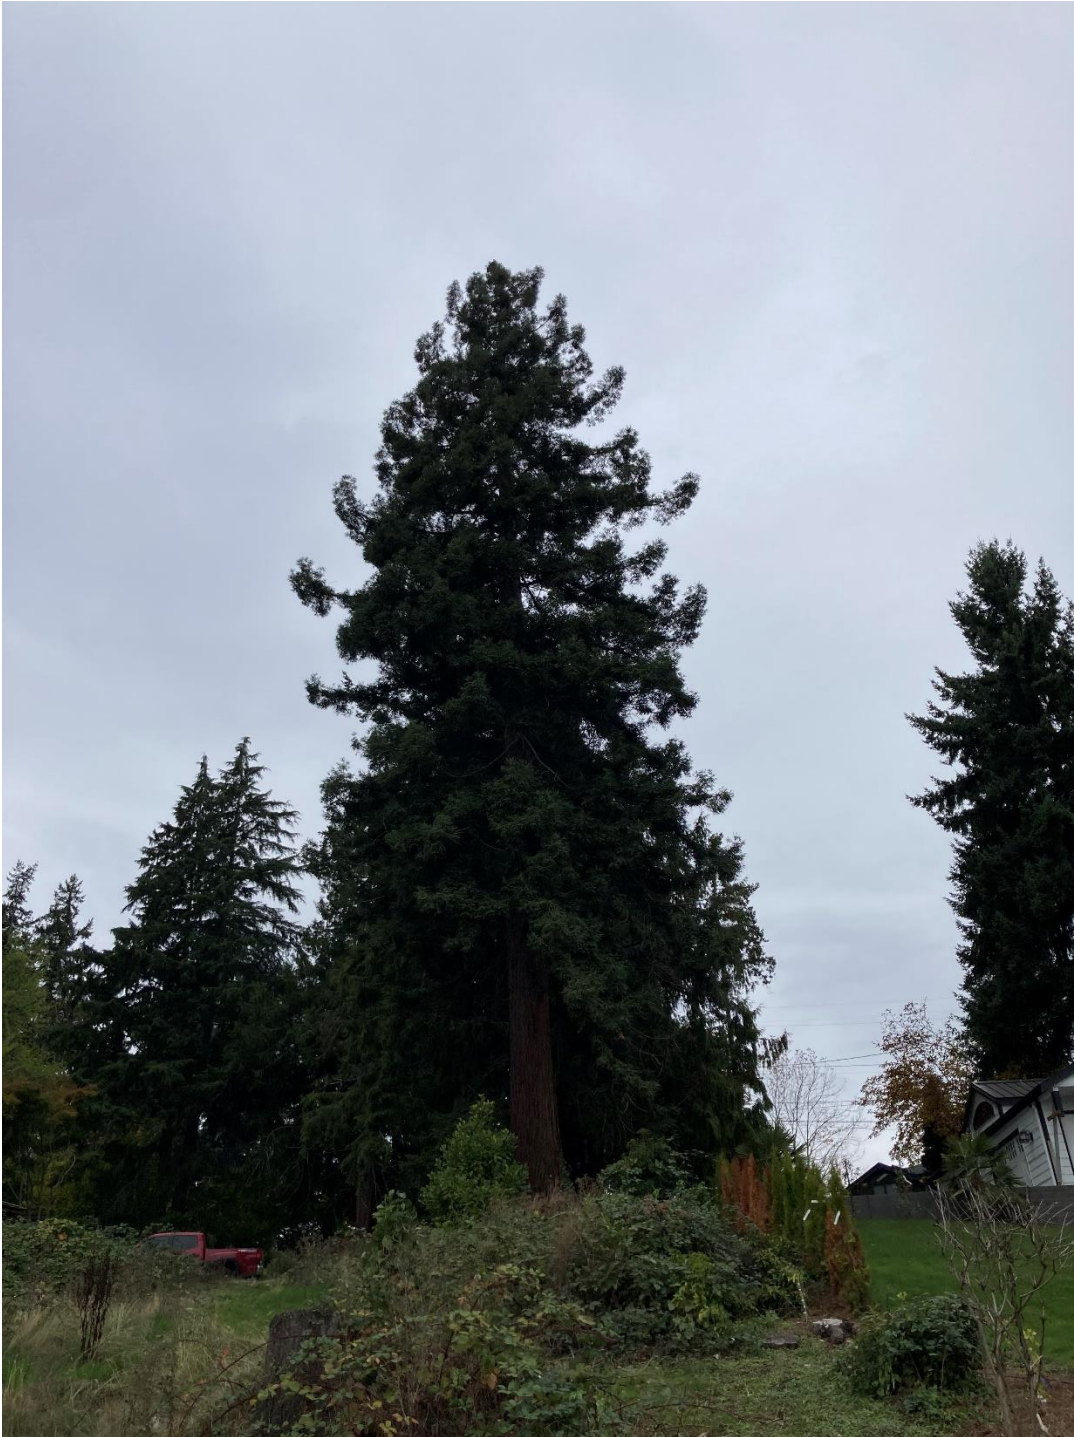
Picture 6. 116 Overlake Dr E – Hearing decision approved removal of 1 50" Giant Sequoia.
