**Tree Permit Activity Report**  
**November 2023**  
**By Andy Crossett**

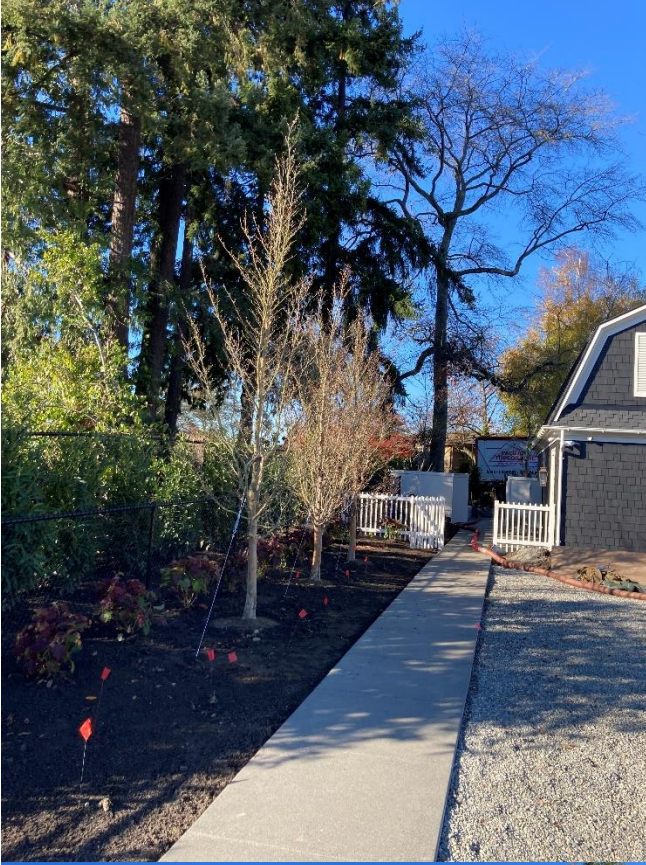
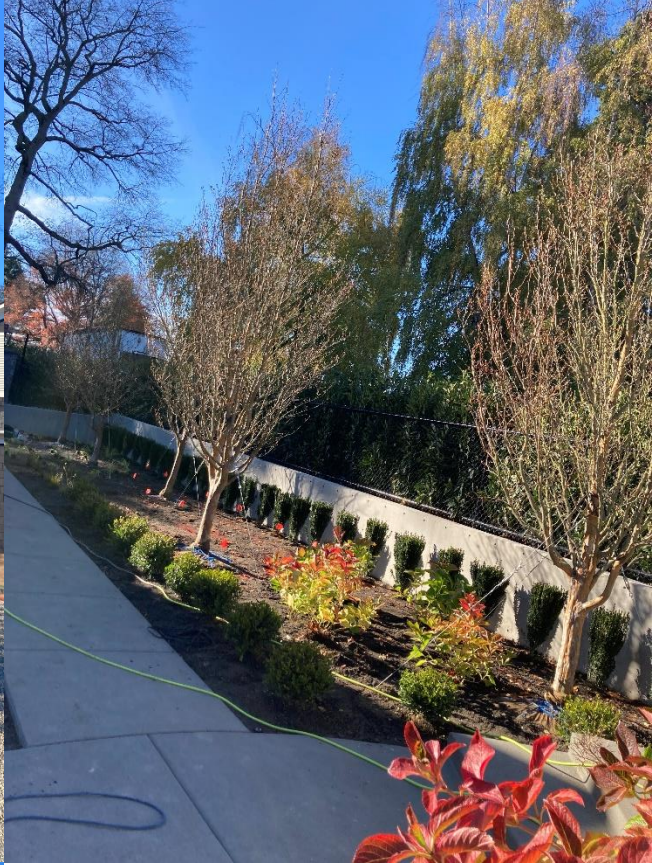
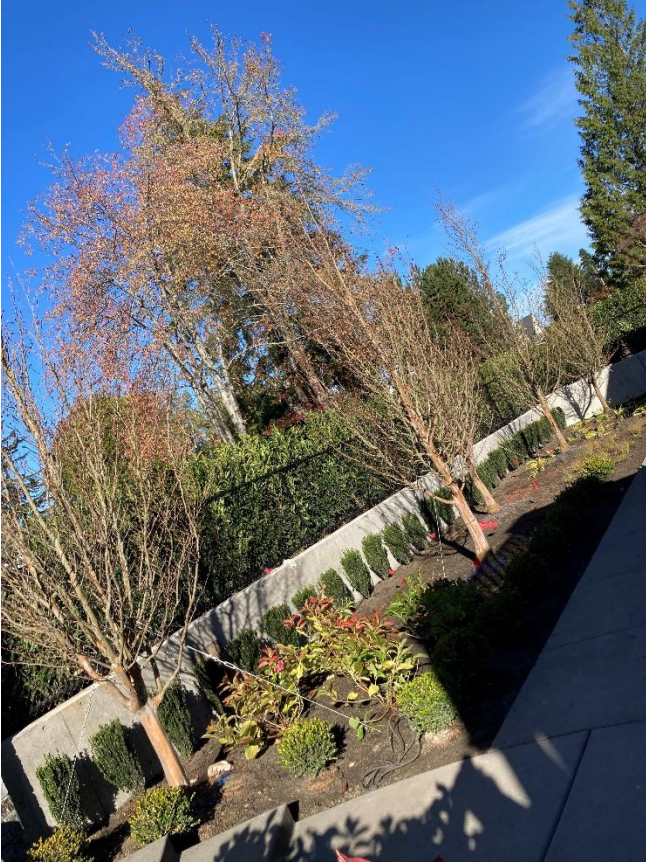
Picture 1. 442 87TH AVE NE – Final tree inspection.

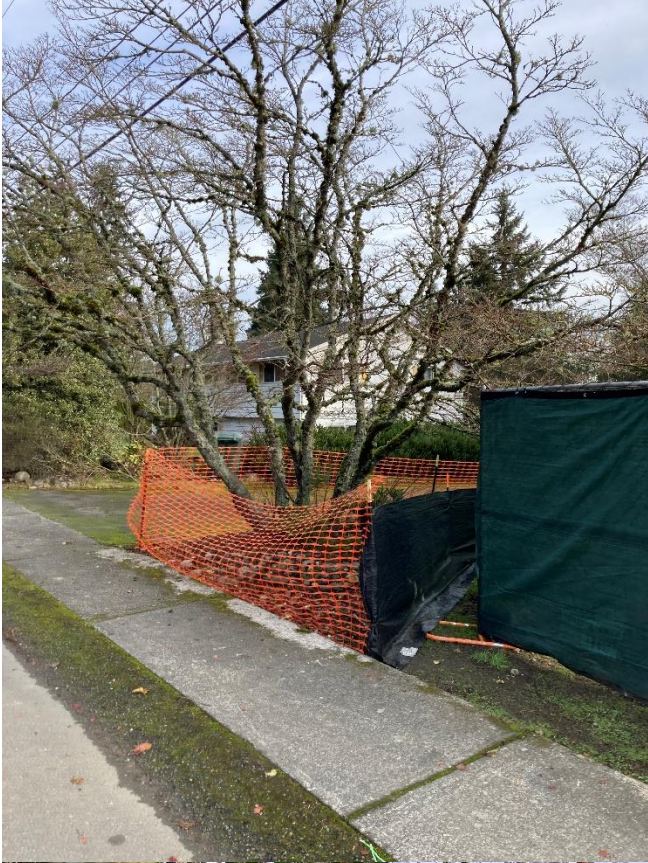
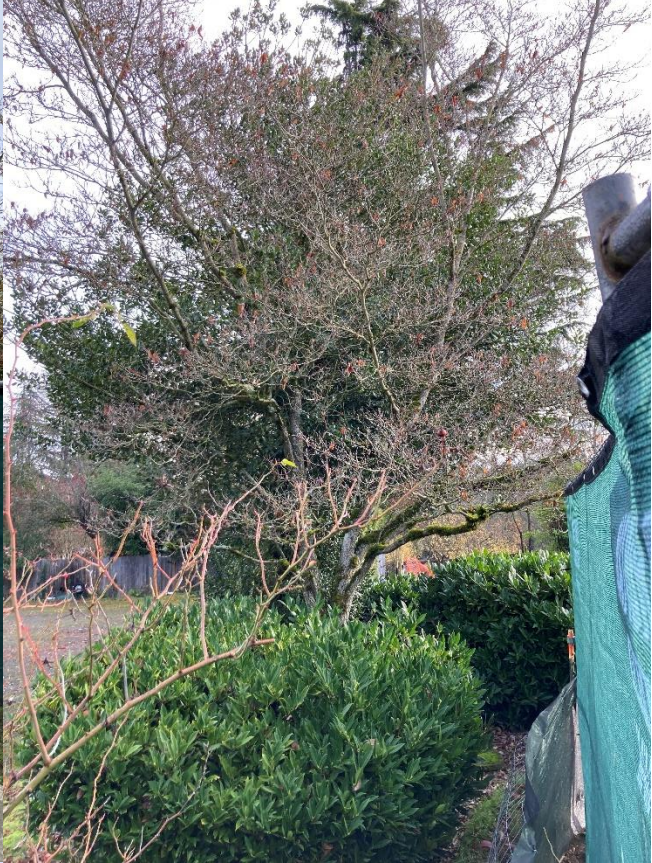
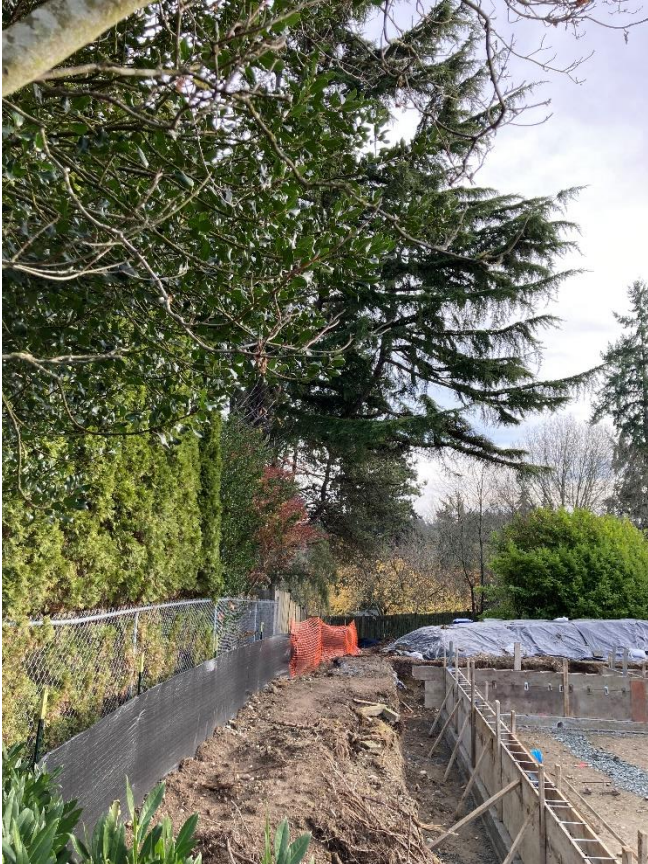
Picture 2. 2438 79th Ave NE – Tree protection inspection.

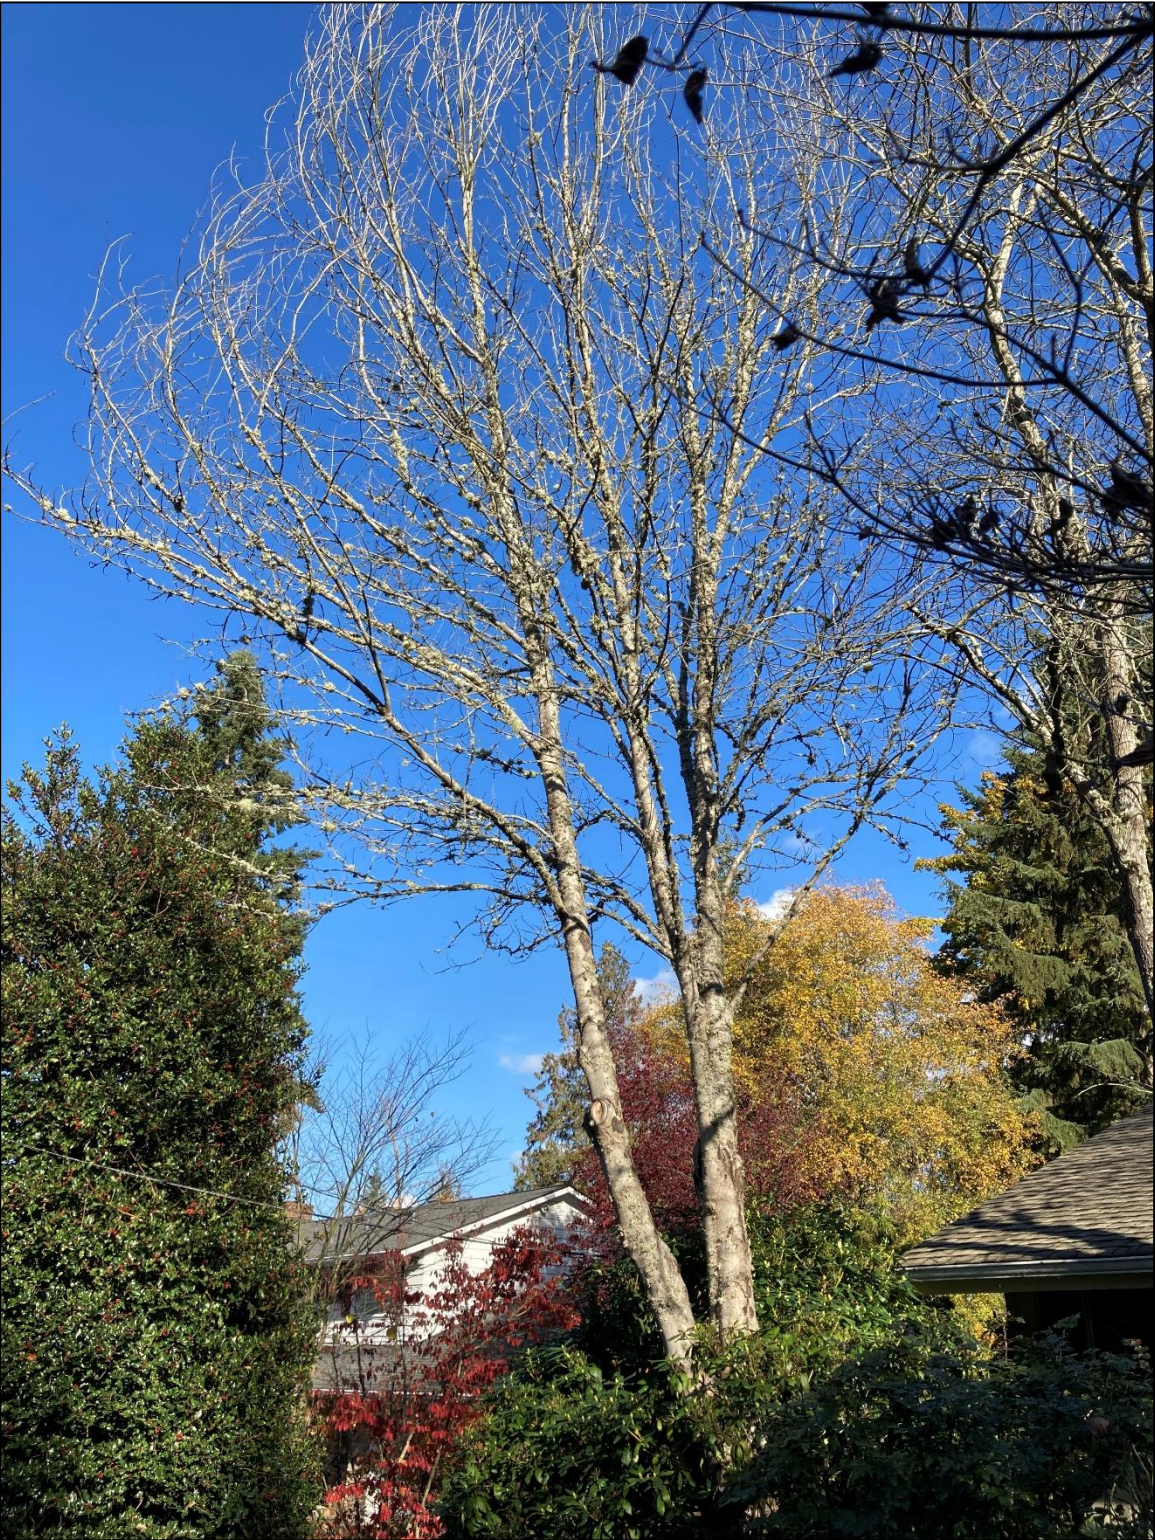
Picture 3. Dead Japanese Maple

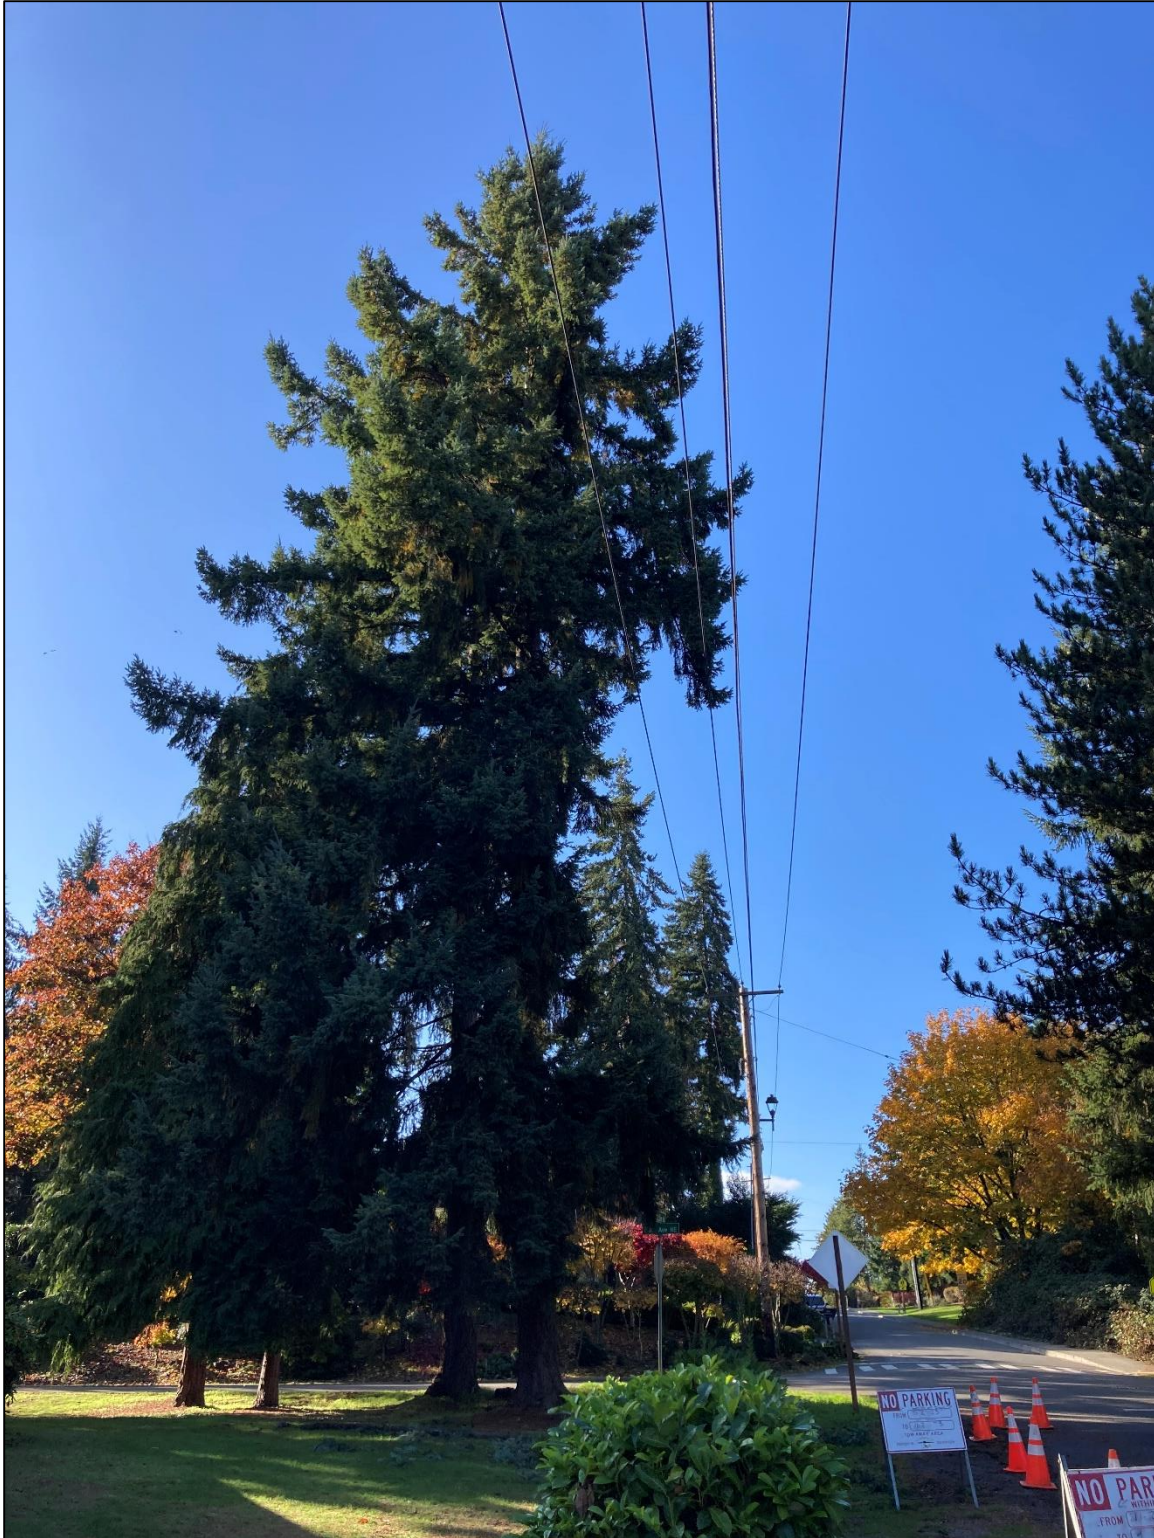
Picture 4. ROW tree risk assessment. The tree looks good with no concern.

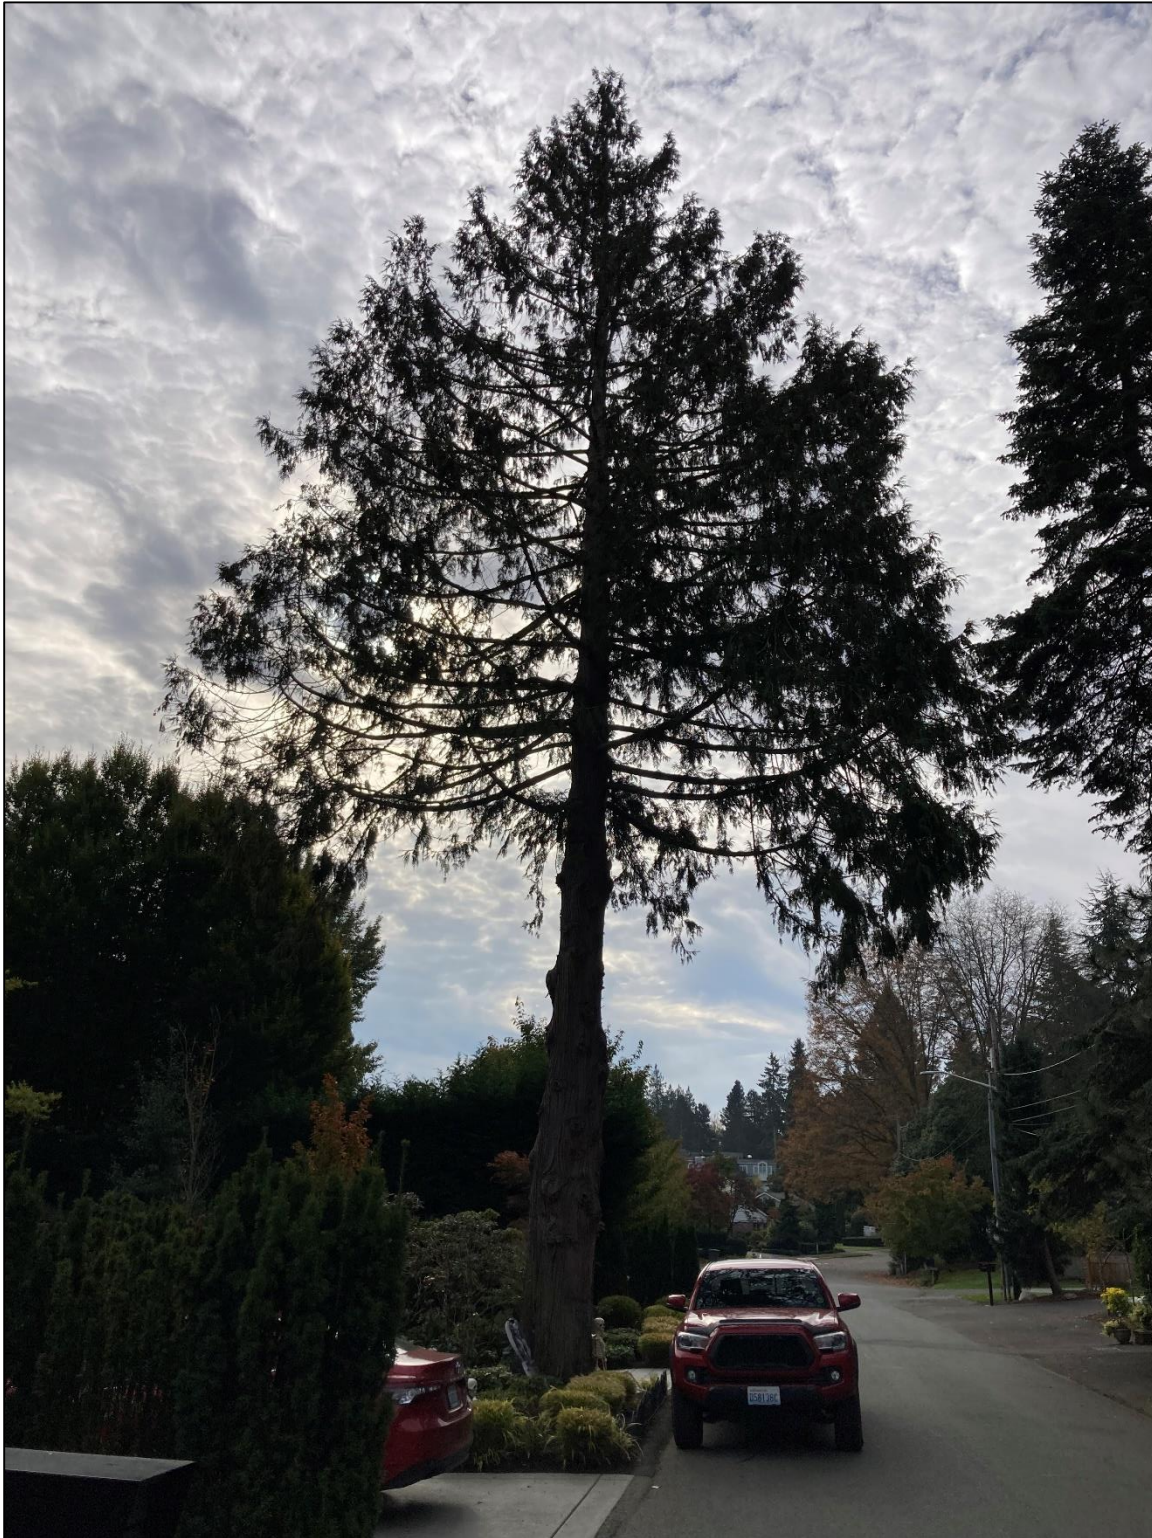
Picture 5. 2042 77th Ave NE – ROW tree removal request. Crown thinning but otherwise okay. Low risk.

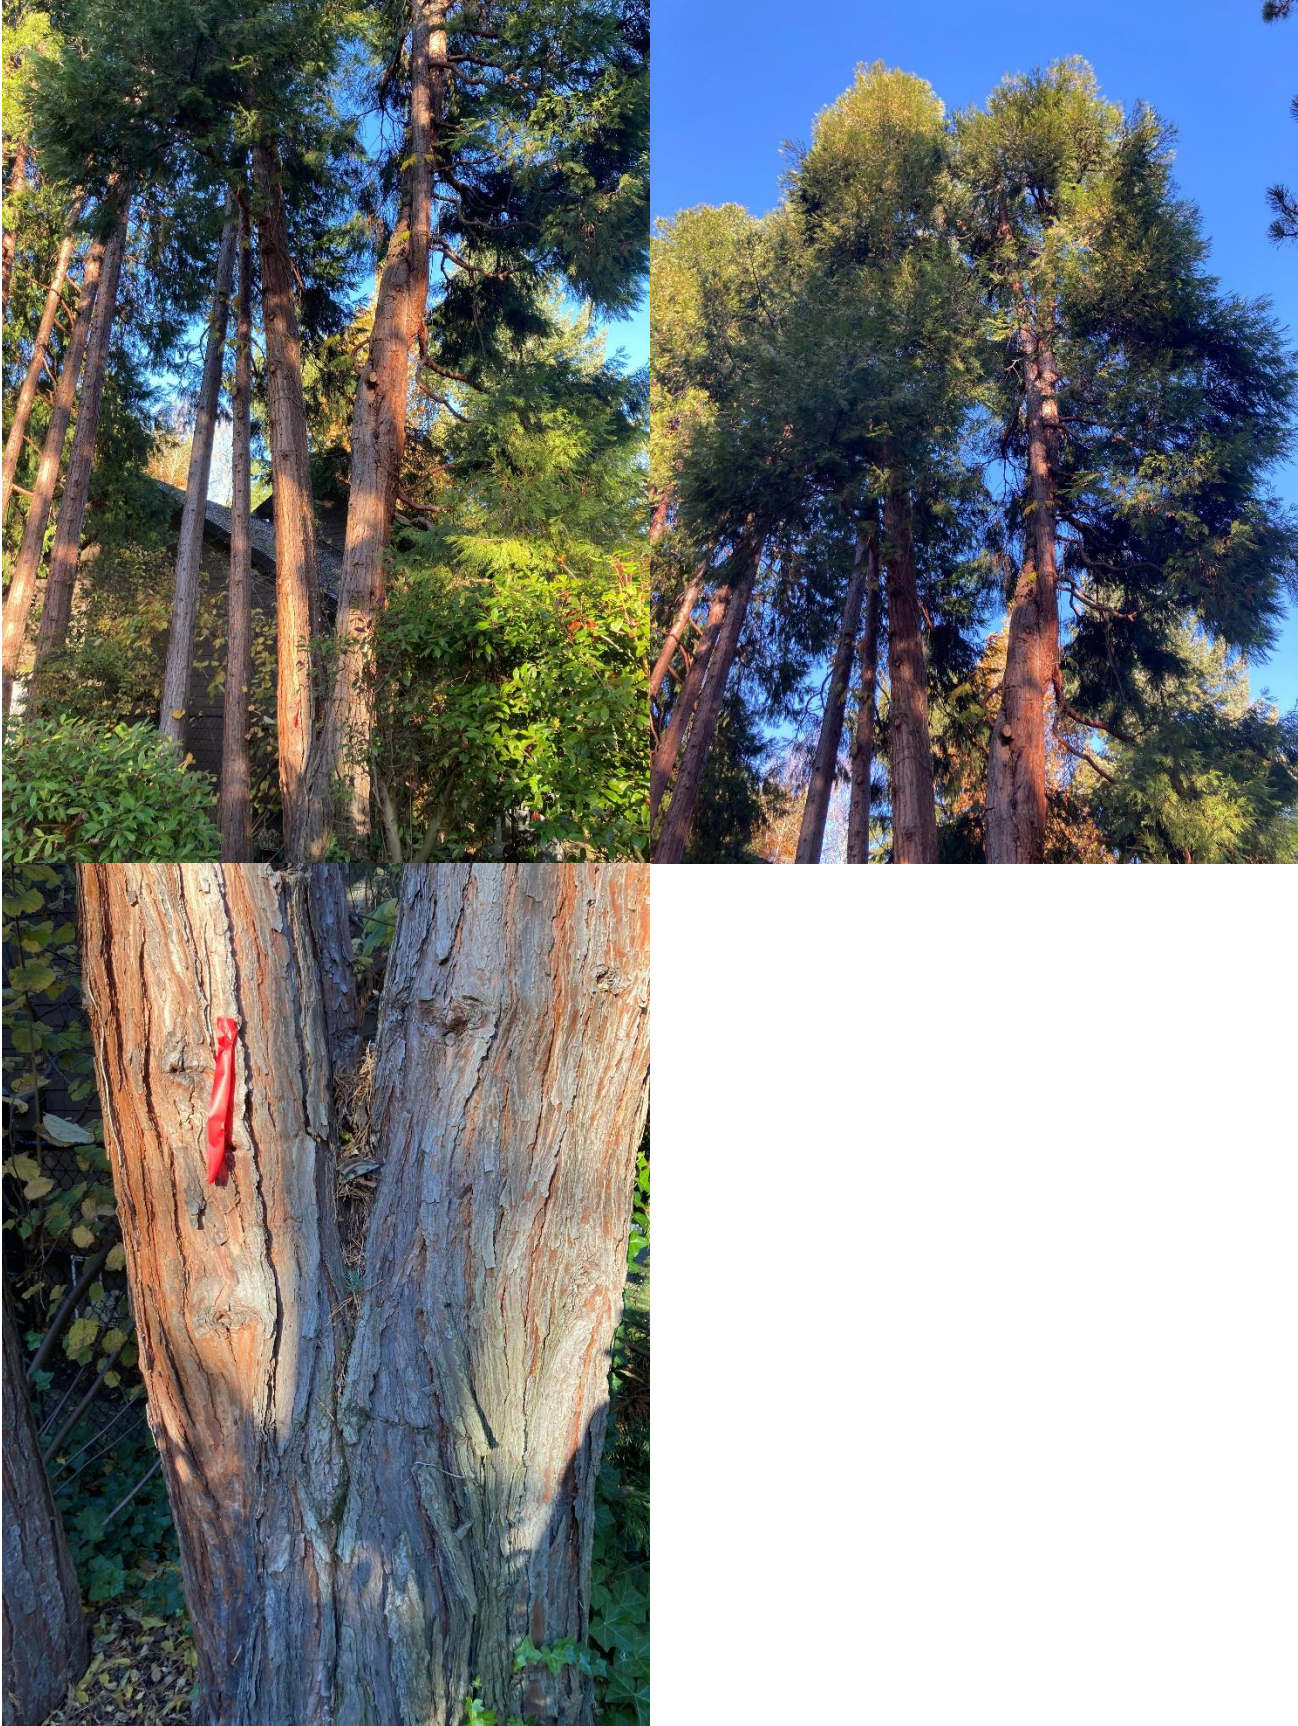
Picture 6. 1011 80th Ave NE – High risk. Codominant, bark inclusion, unsustainable growth due to twisting trunks.

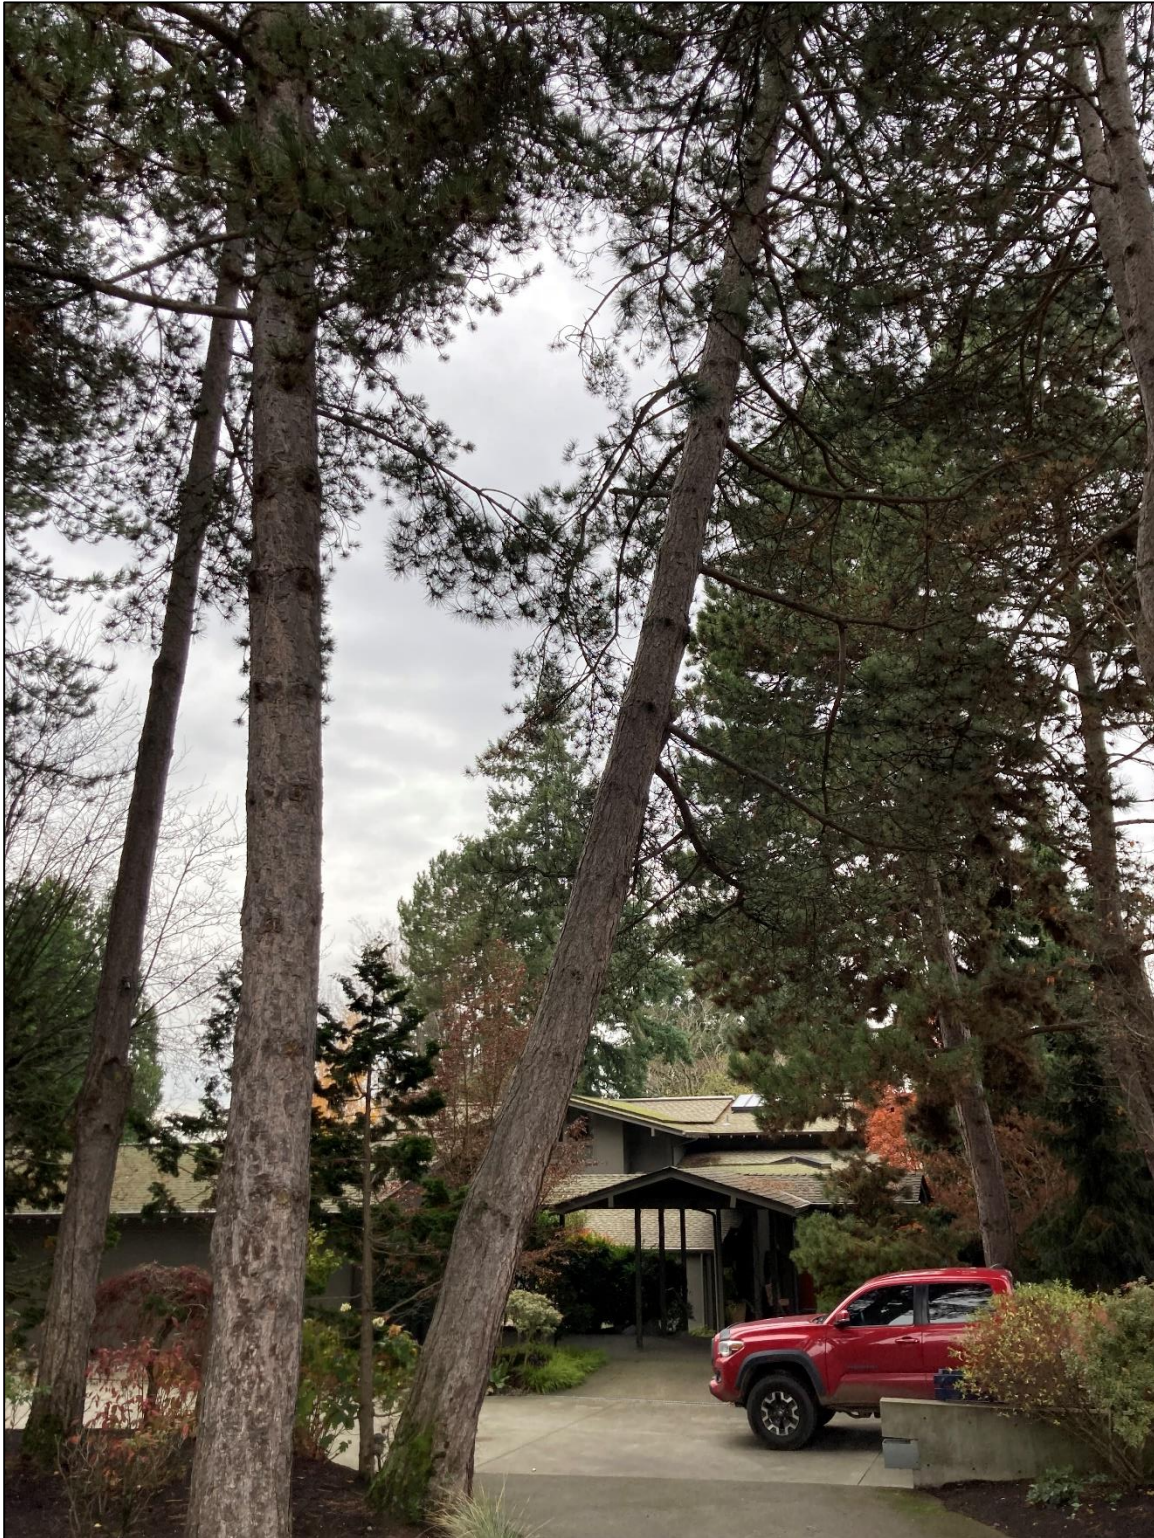
Picture 7. High risk. 20 degree lean. Soil cavity opposite of lean. Multiple potential targets.
