Tree Permit Activity Report
December 2023
By Andy Crossett

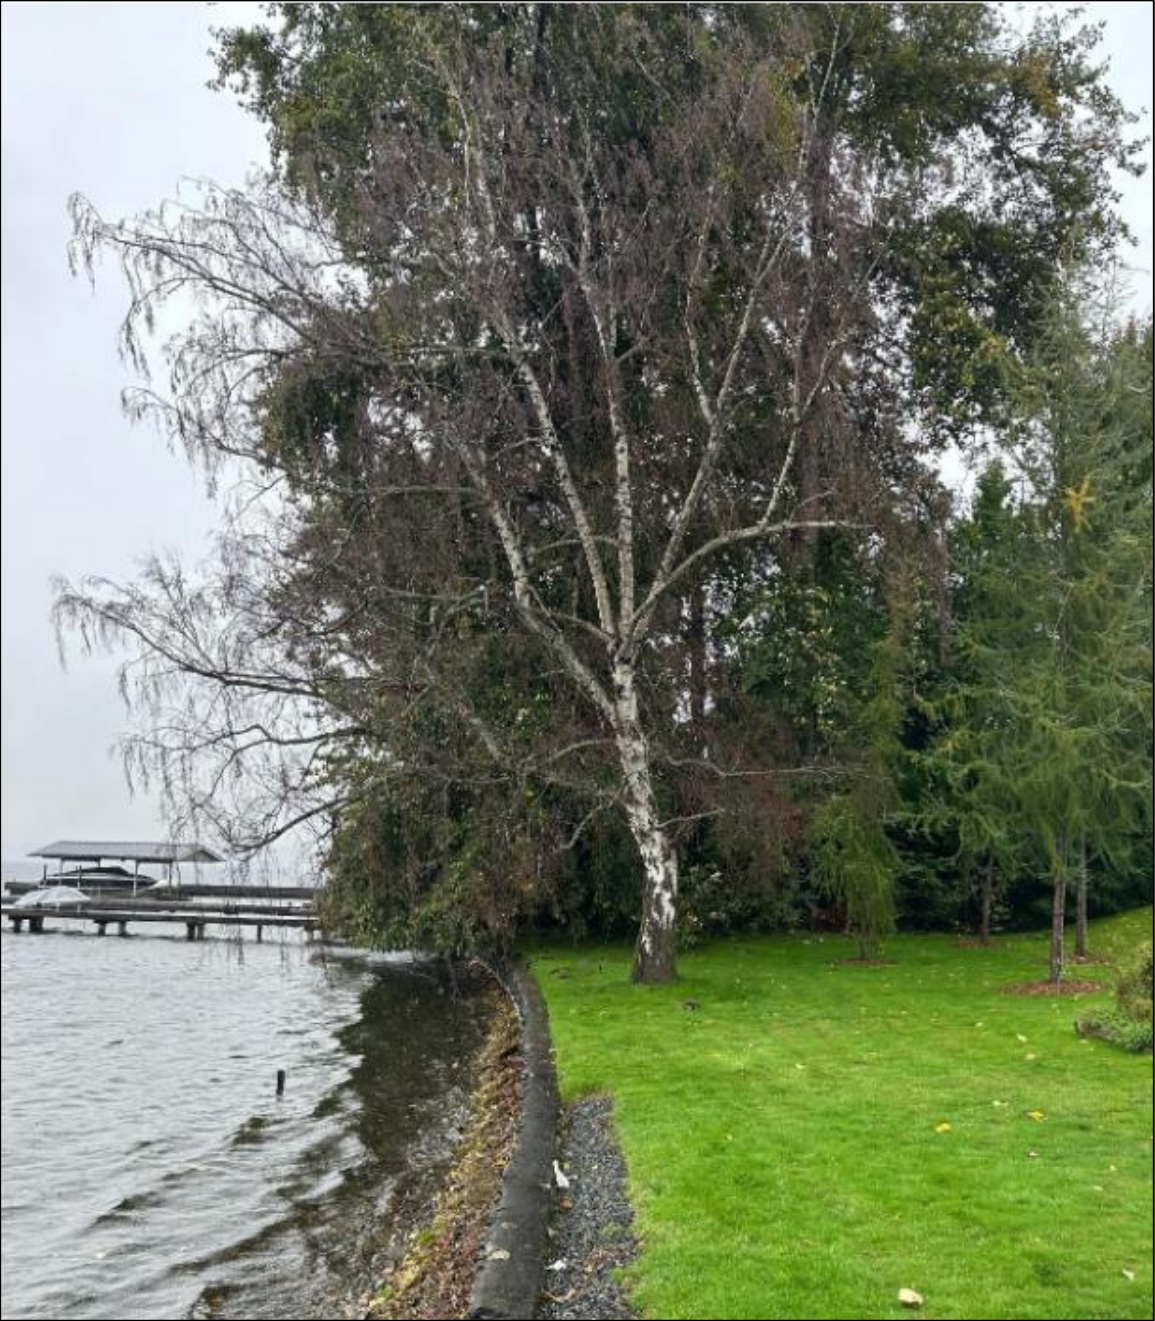
Picture 1. 7777 Overlake Dr. W – Dead silver birch (below) and high-risk dying Oregon ash (no picture).

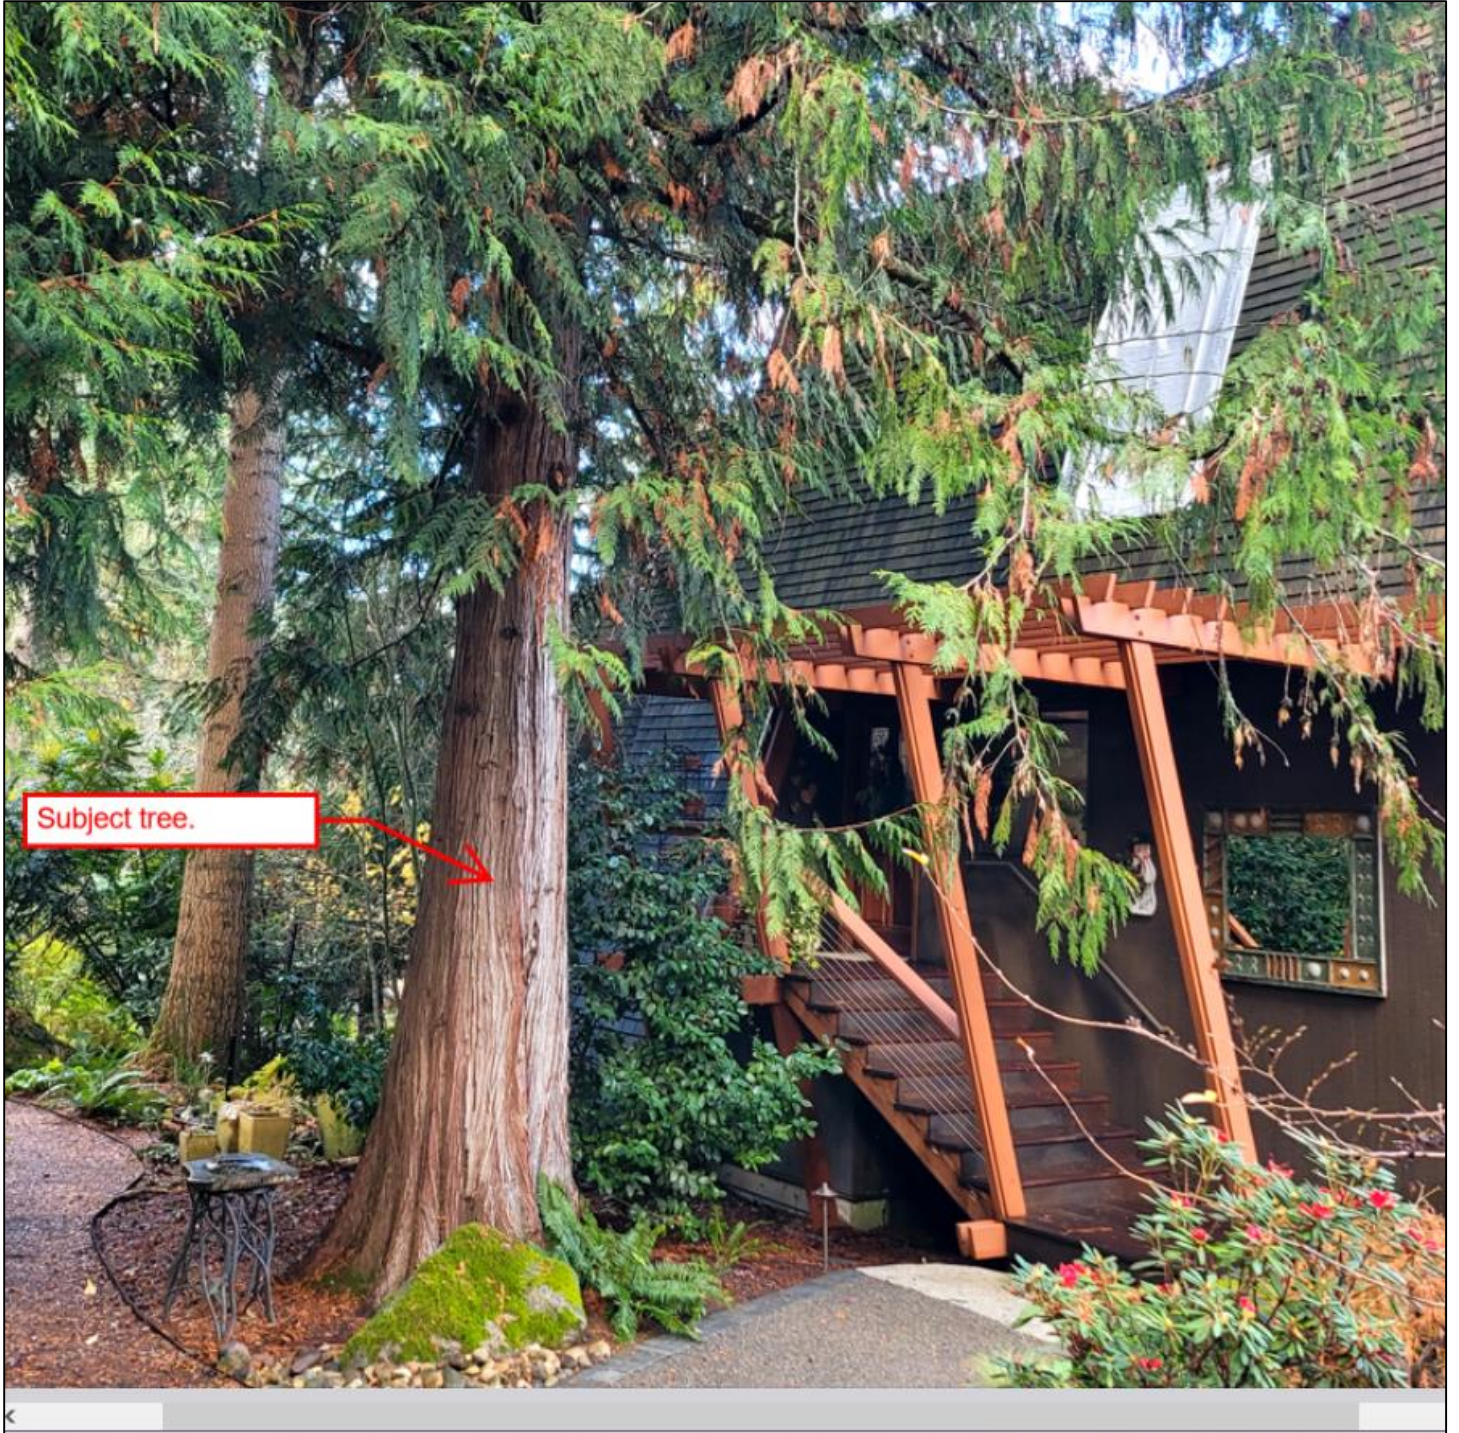
Picture 2. 3340 EVERGREEN POINT RD – Nuisance western redcedar.

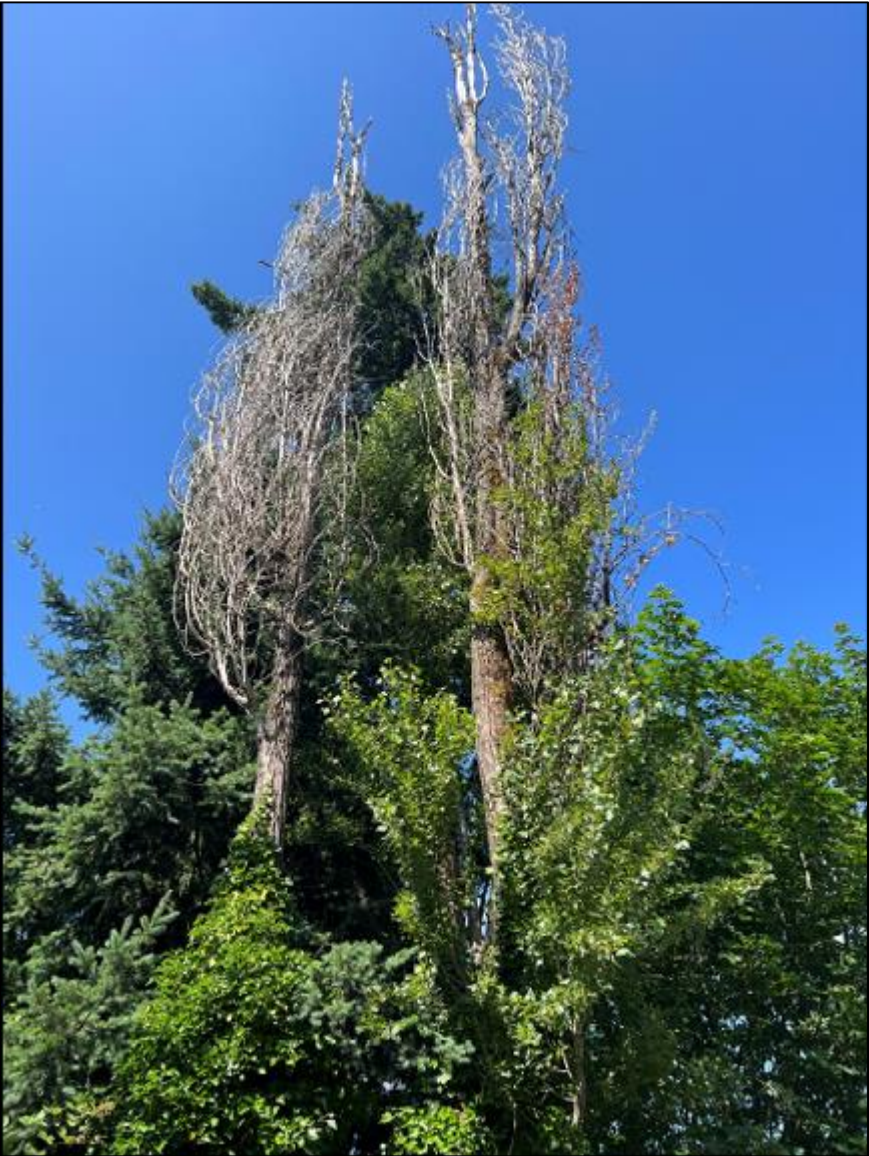
Picture 3. 3201 EVERGREEN POINT RD – Dying and hazardous Lombardy poplar.

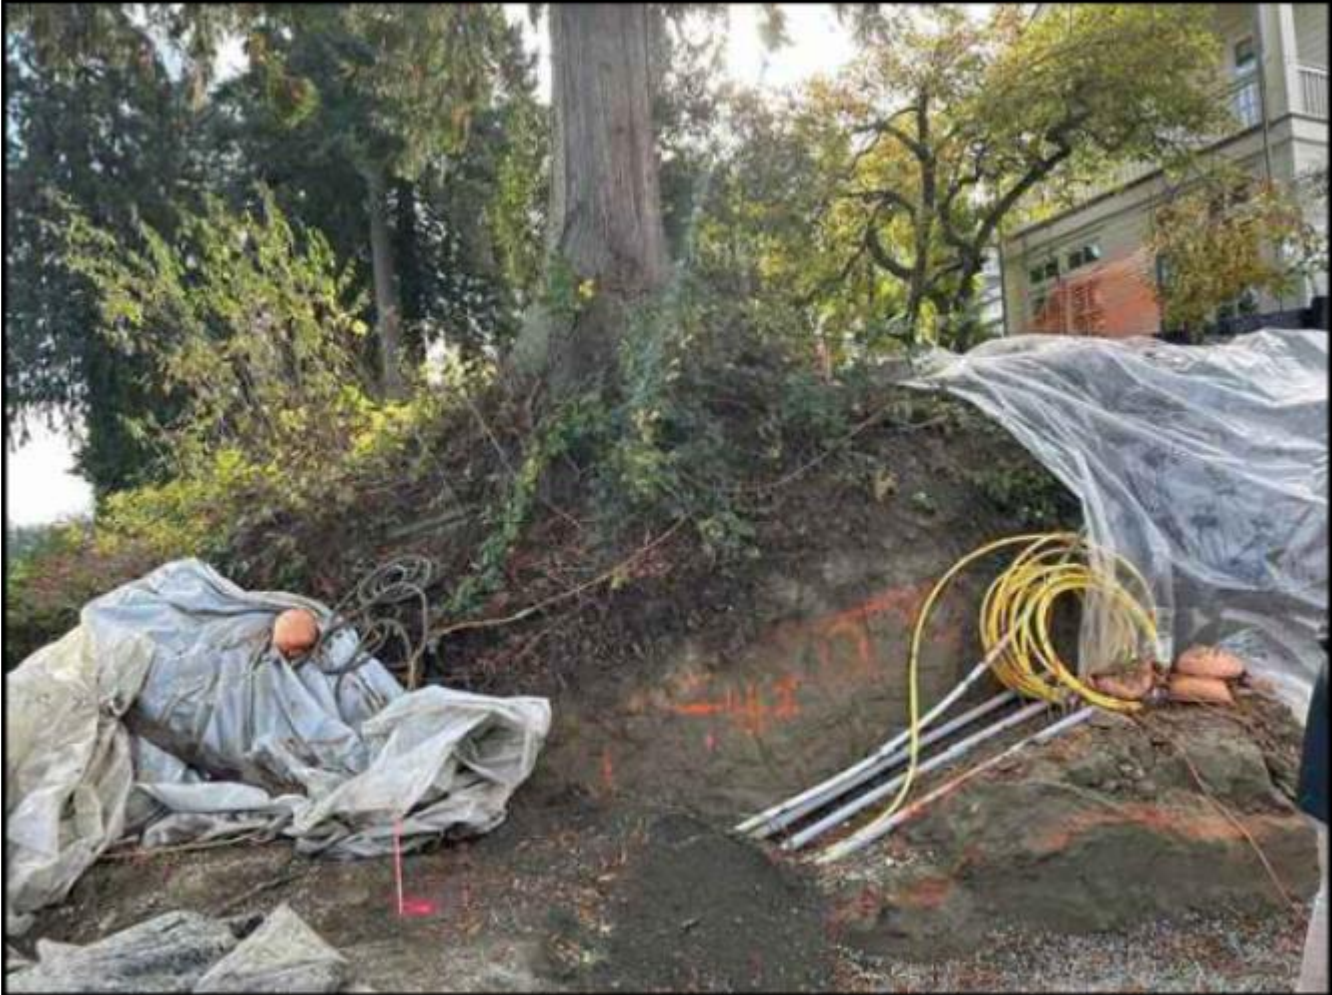
Picture 4. 3444 EVERGREEN POINT RD – High-risk western redcedar due to conditions of slope.
