# Tree Permit Activity Report

## September 2026

### By Andy Crossett

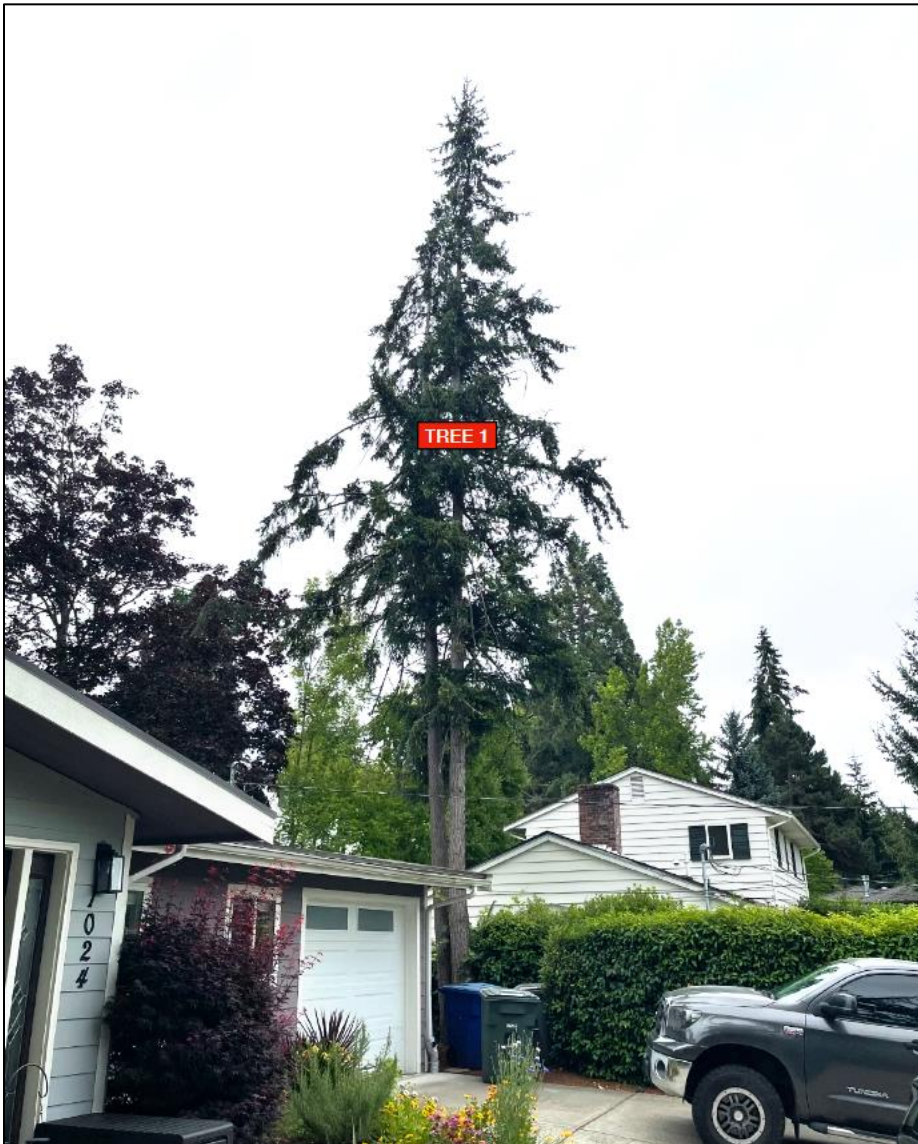
| Issued Non-Development Tree Permit Activity Table | | | | | | |
|---|---|---|---|---|---|---|
| 1 | TREE-RESTORATION | 1024 82 <sup>ND</sup> AVE NE | 1 Douglas fir | 18 | 2 | Douglas-fir with codominant stems. Resident concerned about failure. |

**Picture 1. 1024 82ND AVE NE:** Boundary Douglas-fir that both the applicant and neighbor are concerned may fail. Tree does not meet the High risk threshold, but removal is allowed under a Restoration Permit with required supplemental planting.

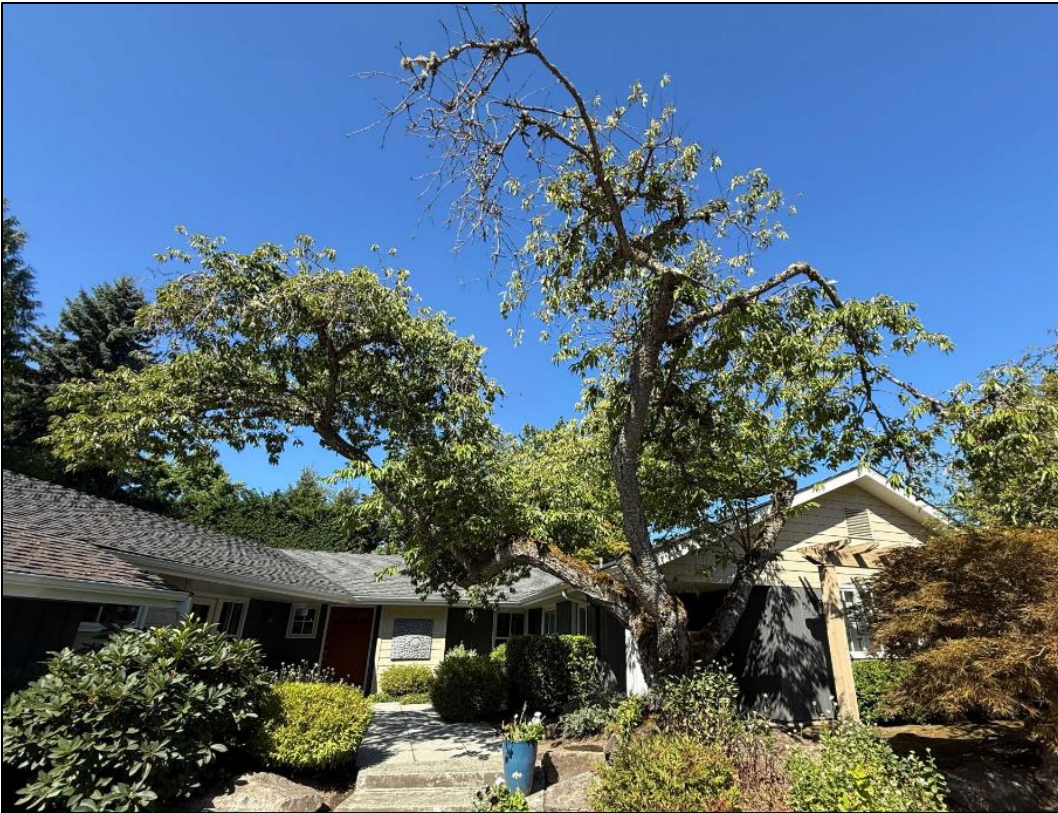
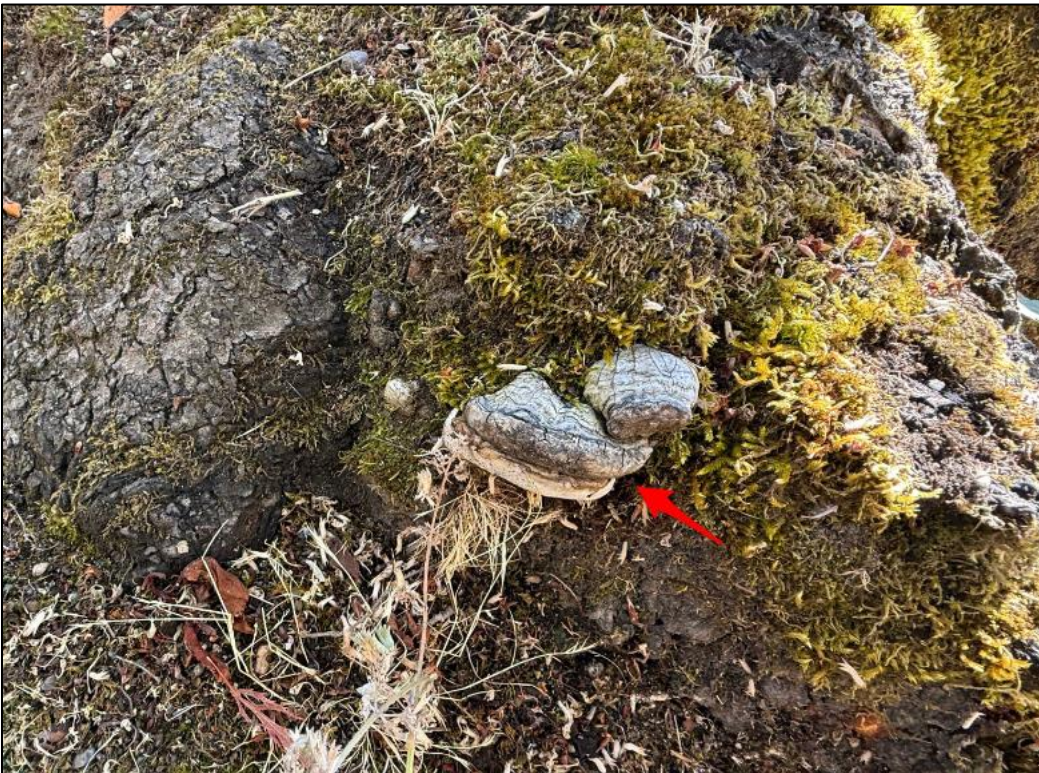
| Issued Non-Development Tree Permit Activity Table | | | | | | |
|---|---|---|---|---|---|---|
| 2 | TREE-PERFORMANCE | 905 88 <sup>TH</sup> AVE NE | 2 x Japanese Snowbell, 1 Cherry | 9, 15, 21 | 3 | Trees were in poor condition. |

**Picture 2. 905 88TH AVE NE:** All three trees were in poor condition and unlikely to recover. The cherry had Ganoderma conks, a type of wood-decay fungus, at its base. Three supplemental trees were required to meet the minimum tree unit requirement for the site.

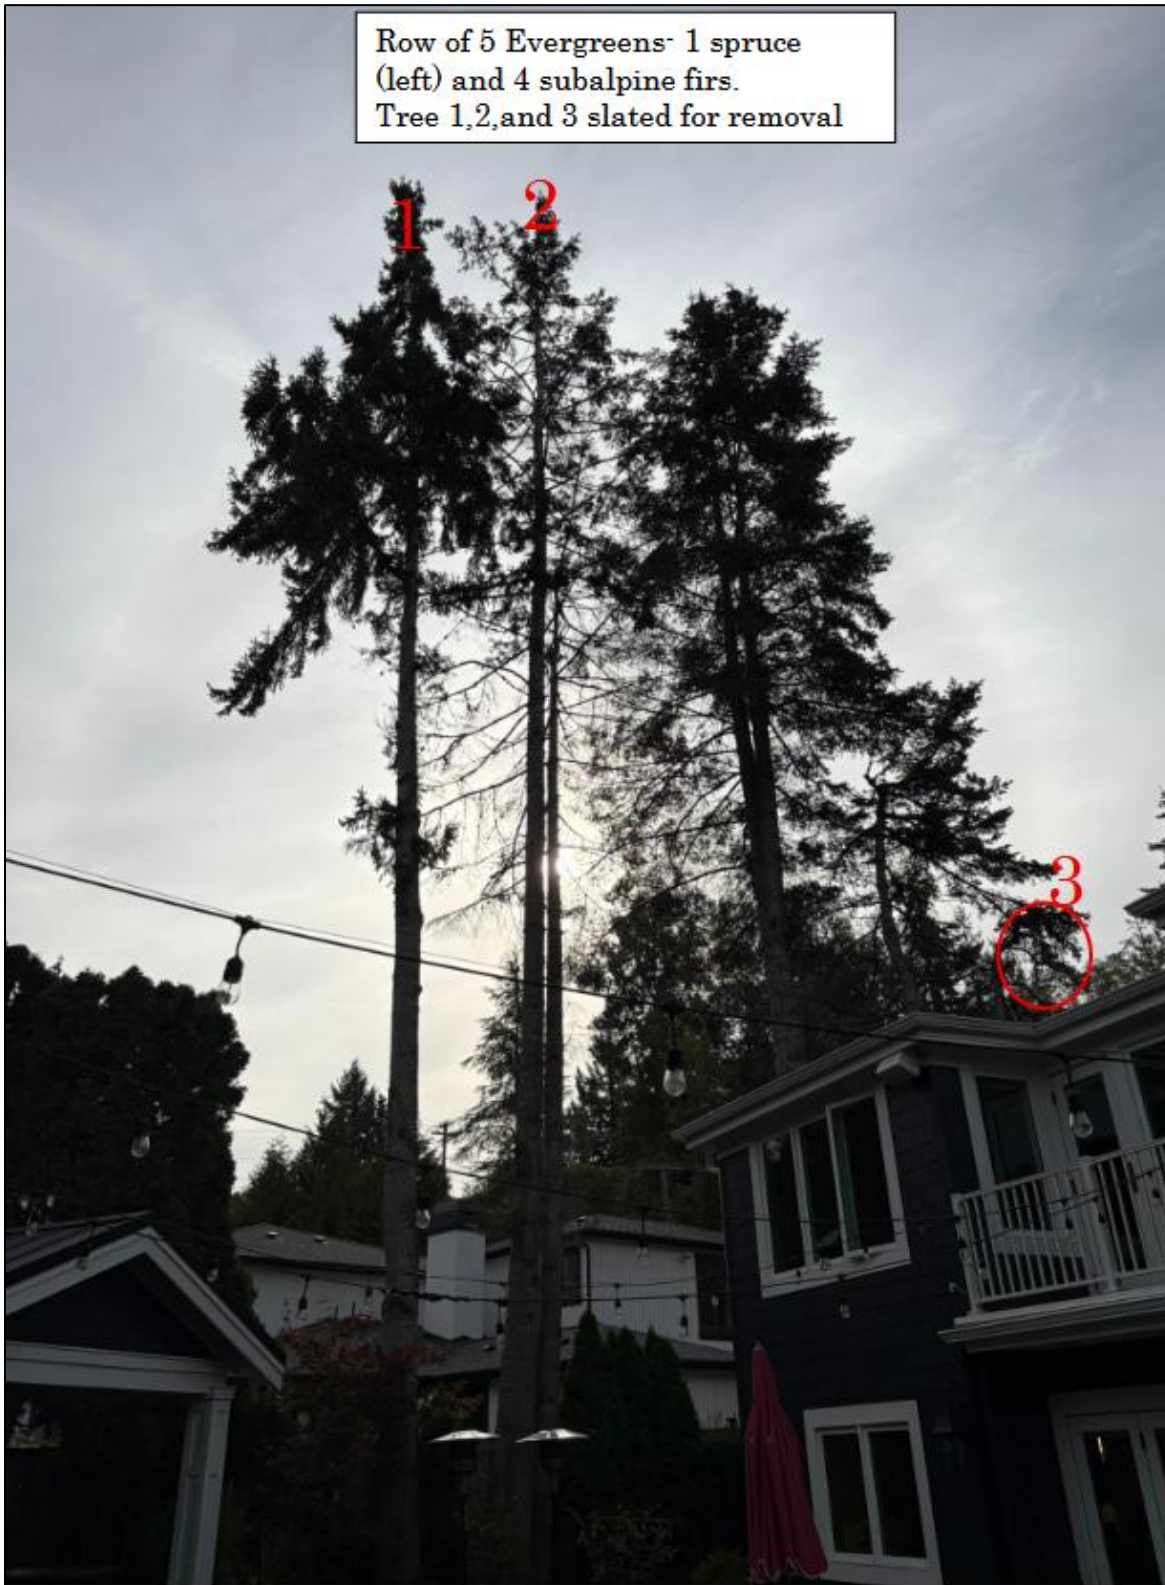
| Issued Non-Development Tree Permit Activity Table | | | | | | |
|---|---|---|---|---|---|---|
| 3 | TREE-RESTORATION | 8224 NE 8 <sup>TH</sup> ST | Blue Spruce, 2 x Alpine Fir | 19, 24, 14 | 3 | Trees in poor condition, likely to decline, and located close to the existing home. |

**Picture 3. 8224 NE 8TH ST:** One spruce and two subalpine firs in poor condition. Detailed risk assessment by The Davey Tree Expert Company determined all three trees to be High risk. Three supplemental trees are required.

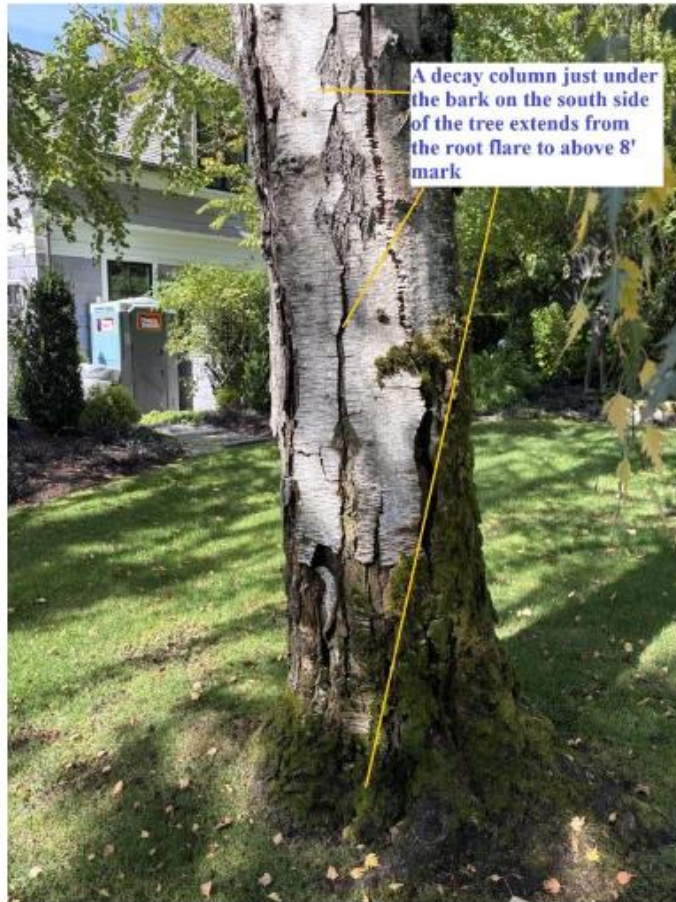
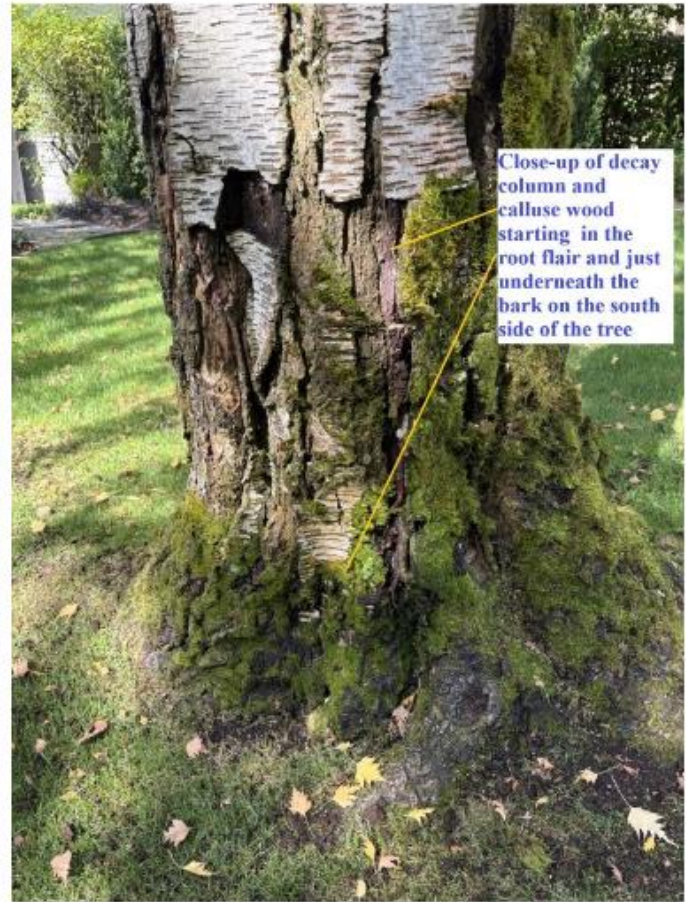
### **Exhibit C – Decay Column and Callus Wood**

| Issued Non-Development Tree Permit Activity Table | | | | | | |
|---|---|---|---|---|---|---|
| 4 | TREE-RESTORATION | 617 EPR | Silver Birch | 19 | 1 | Tree was in poor condition. |

**Picture 4. 617 Evergreen Point Road:** The subject silver birch is the last remaining tree from an original group of five. According to an assessment by Davey Tree Expert Company, the other four trees failed over time due to similar root decay and structural weakness. The most recent failure showed significant root decay, indicating a recurring pattern of root-related failure among the birches at this site.

*South Side of Subject Tree, Extending from the Root Flare to Above the 8' Mark*
