**Tree Permit Activity Report**  
**June 2024**  
**By Andy Crossett**

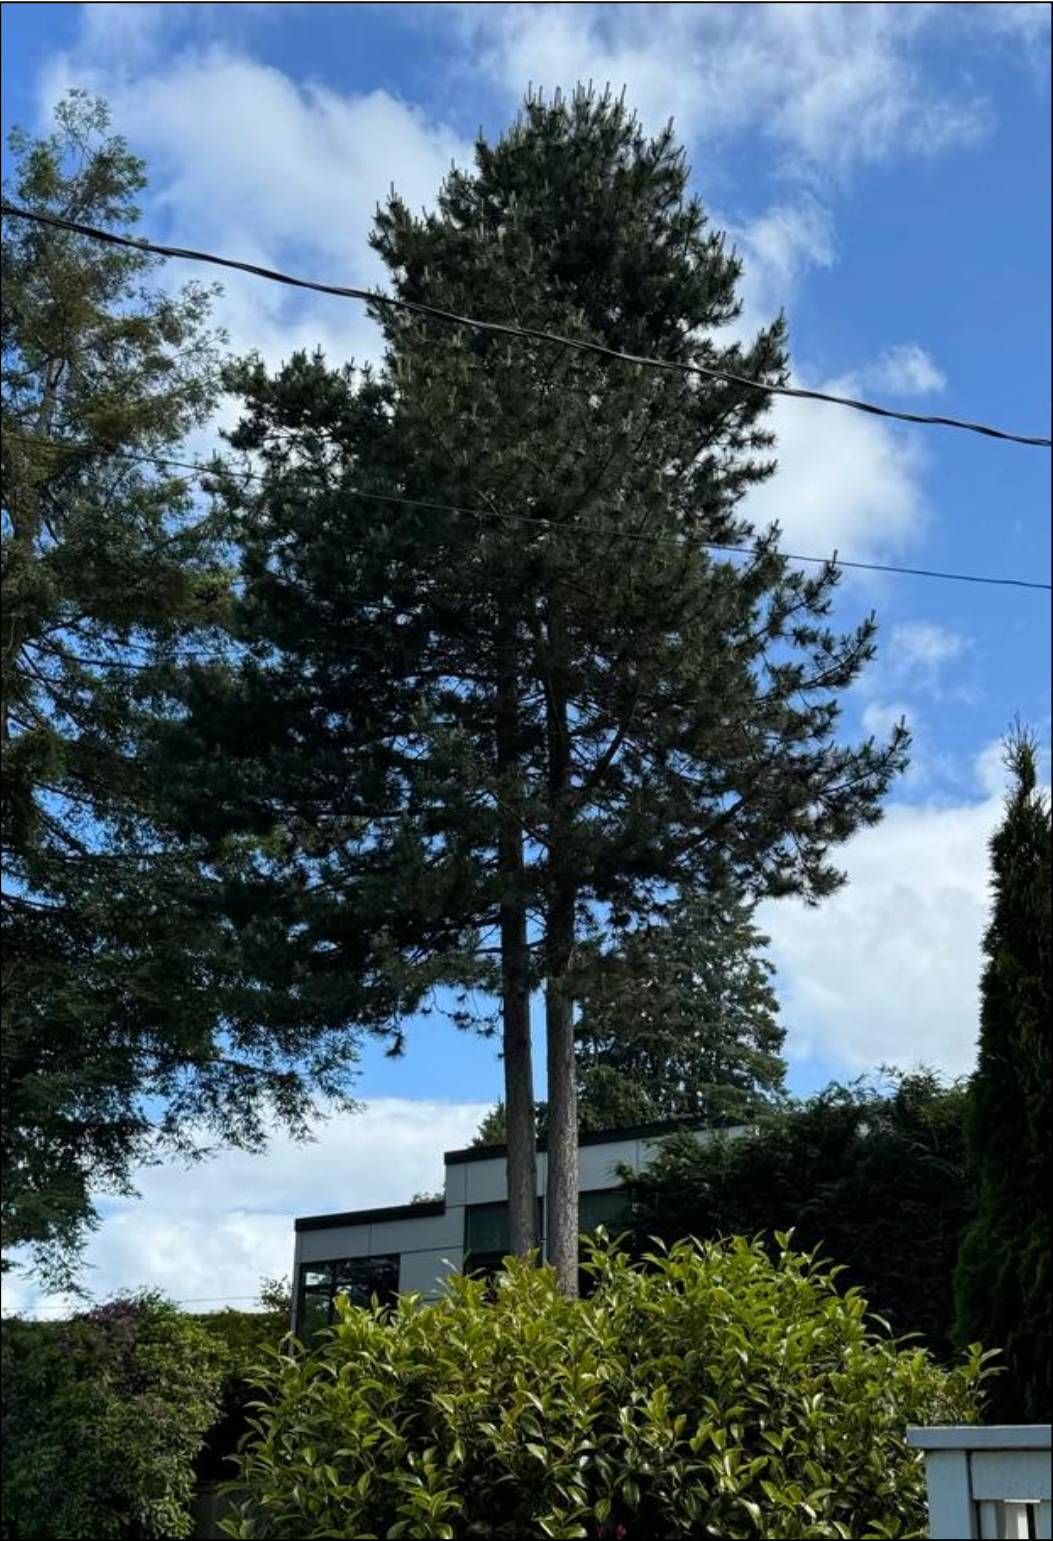
Picture 1. 8812 OVERLAKE DR W – Red pine. No reason given for removal.

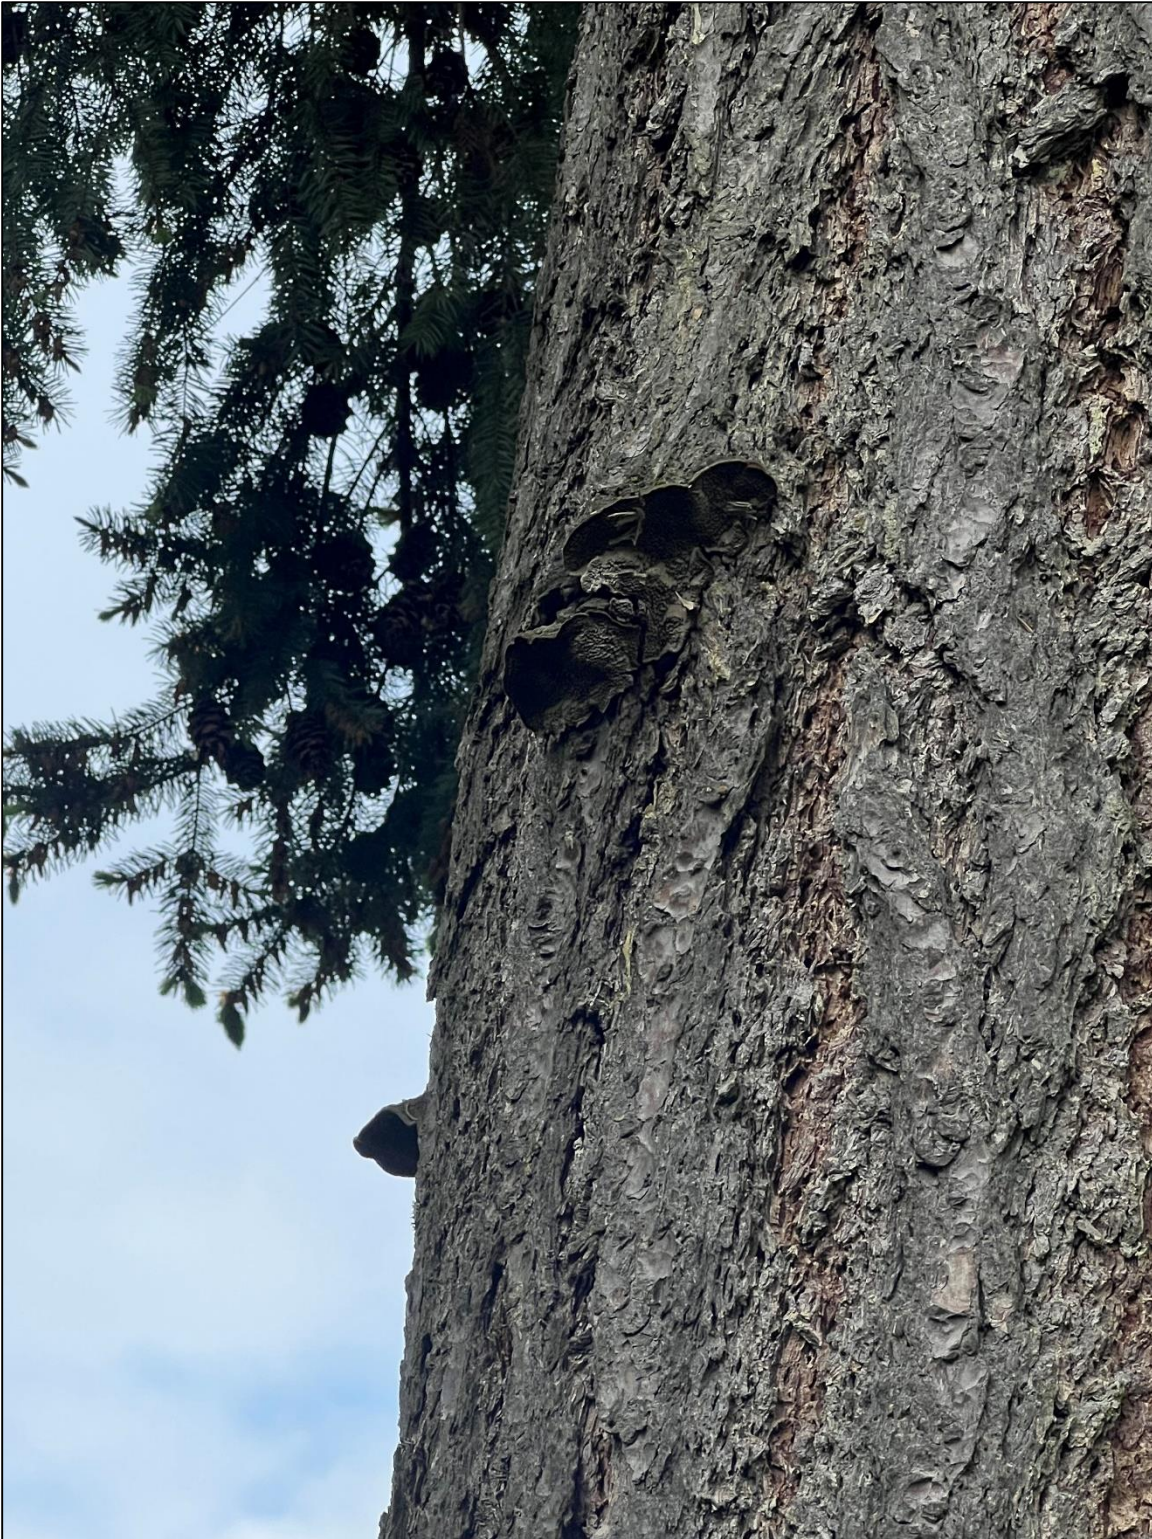
**Picture 2. 1656 73RD AVE NE – ROW Hazard Douglas fir. The tree was rapidly colonized by fungal disease “Red ring rot”.**

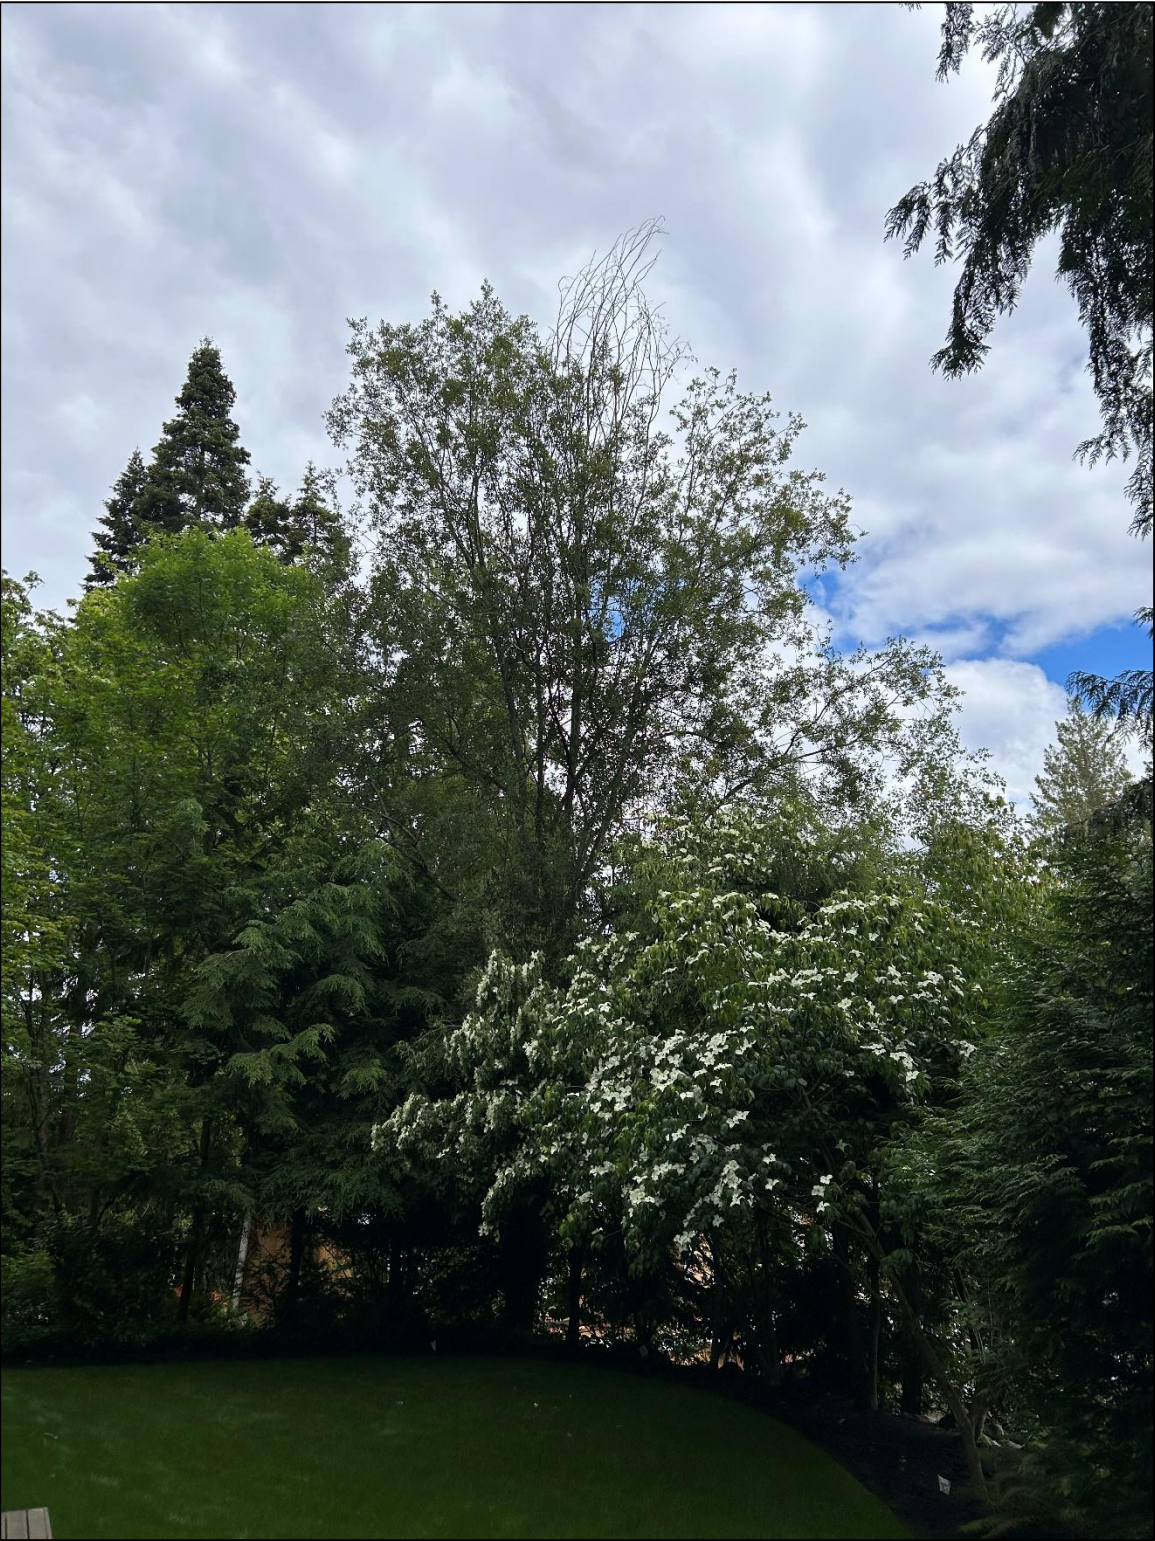
Picture 3. 3434 EVERGREEN POINT RD – Scouler’s willow with crown dieback.

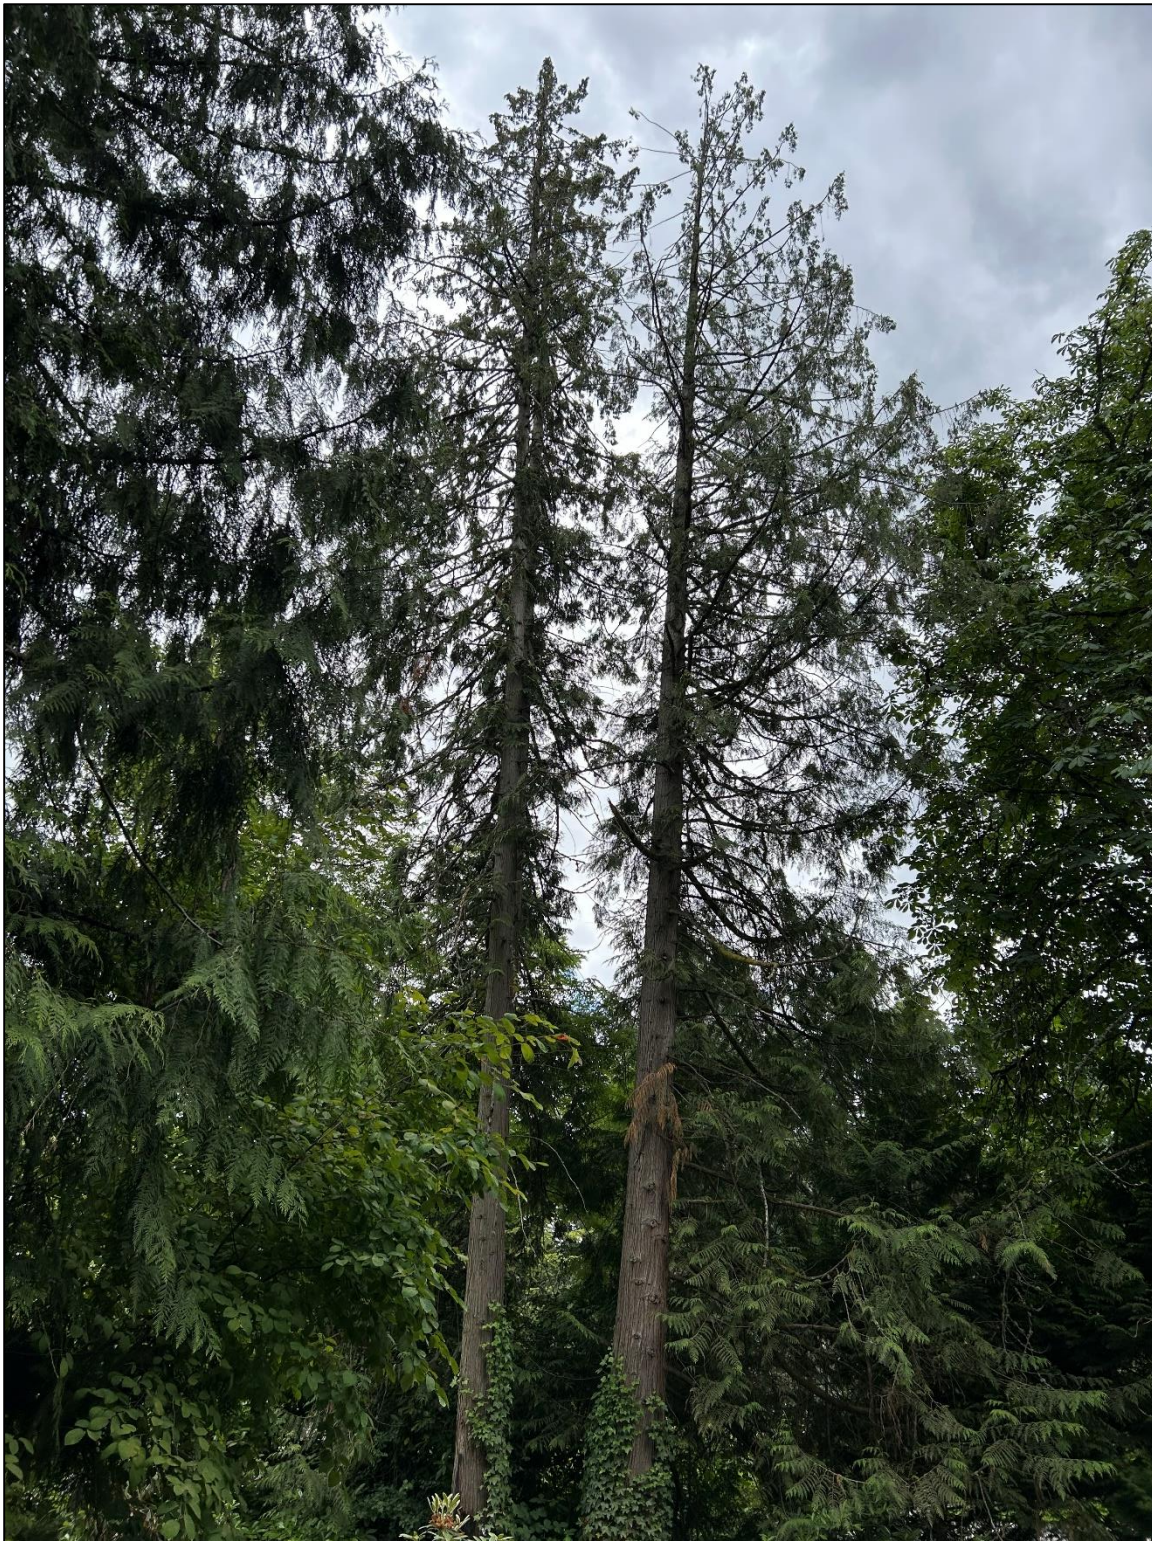
Picture 4. 3434 EVERGREEN POINT RD – Western redcedars with thinning crowns.
