# Arborist Report

## ~ Tree Inventory & Protection Zones ~

**October 20, 2020**

Tree133 LLC was hired to perform a pre-construction tree inventory and recommend appropriate tree protection for street trees adjacent to the Mercer Island Shell Station, 7833 SE 28<sup>th</sup> St. The site visit for this project was completed on October 12, 2020.

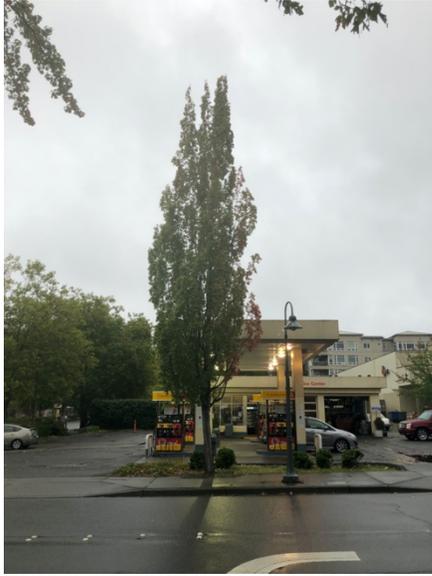
*Tree 1 - North View*

**Tree 1: Red maple (*Acer rubrum*)  
10.4” dsh, 42 ft height, canopy spread 10x10 ft**

This street tree is located at the north end of the property along SE 28<sup>th</sup> St, near the canopy structure. Overall, the tree is in fair condition with visible mechanical damage along with minor canopy dieback on the west aspect of the trunk.

Based on species, size and condition, the recommended tree protection zone (TPZ) radius for this tree is 8x trunk diameter (ie. 83” or approx. 7 ft). As described by Brad Kaul, project architect, the client anticipates excavation will extend to the property line adjacent to/including this tree. If significant excavation (greater than 15% of protected area) is required within the TPZ, proactive removal and replacement is recommended due to anticipated severe impacts to health and/or stability.

Considering all input received, it appears that tree removal and replacement will be necessary. Therefore, site plans should include appropriate space for appropriate replacement as directed by the City of Mercer Island.

If the tree will be retained, tree protection fencing should be installed in accordance with City of Mercer Island guidelines. Please note the defined tree protection zone includes paved areas on the site, and they should be fenced appropriately. Excavation within the tree’s dripline area will require supervision by a Qualified Arborist, per city code.

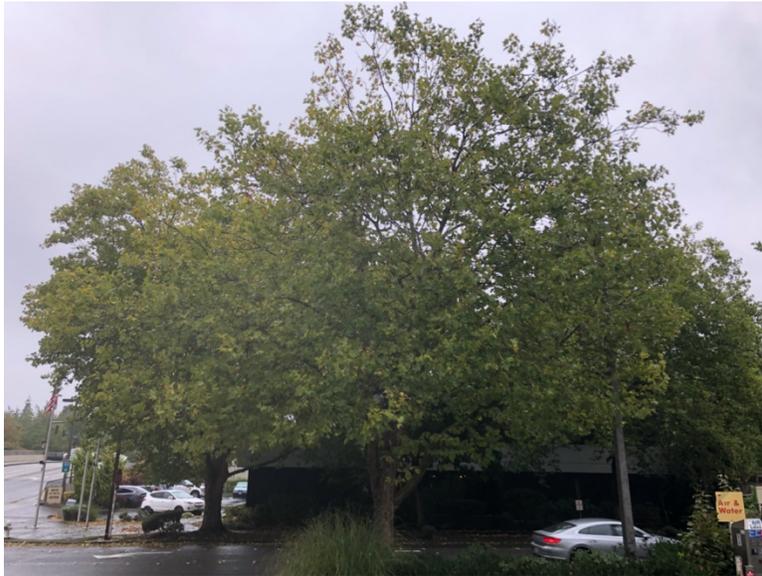
*Tree 2 - West View*

**Tree 2: American sycamore (*Platanus occidentalis*)  
17.8” dsh, 46 ft height, canopy spread 45x39 ft**

This street tree is located at the east edge of the property, along 80<sup>th</sup> Ave SE. The tree appears to be in excellent condition with no visible defects.

Based on species, size and condition, the recommended TPZ radius for this tree is 8x trunk diameter (ie. 142” or approx 12 ft). Similar to Tree 1 (above), the client anticipates excavation will extend to the property line adjacent to/including Tree 2. Several access points for underground fuel infrastructure are located approximately 9 ft northwest of the trunk. We understand these structures will be removed and replaced during the project.

If significant excavation (greater than 15% of protected area) is required within the TPZ, proactive removal and replacement is recommended due to anticipated severe impacts to health and/or stability.

Considering the input received, it appears that removal and replacement will be necessary for this tree. Therefore, site plans should include appropriate space for appropriate replacement as directed by the City of Mercer Island.

If the tree will be retained, tree protection fencing should be installed in accordance with City of Mercer Island guidelines, including paved areas. Excavation within the tree's dripline area will require supervision by a Qualified Arborist.

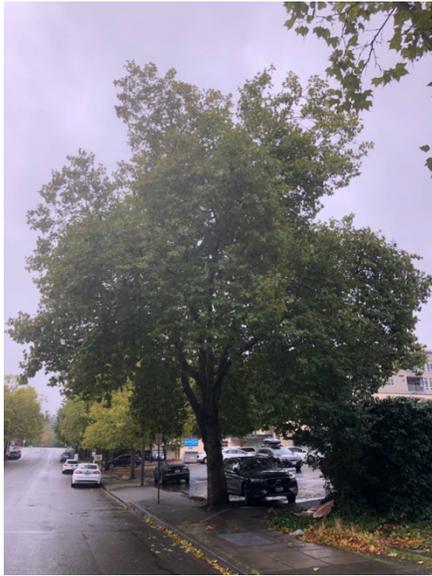
*Tree 3 - Northeast View*

**Tree 3: American sycamore (*Platanus occidentalis*)  
27.0" dsh, 55 ft height, canopy spread 63x51 ft**

This street tree along 80<sup>th</sup> Ave SE overhangs the southeast corner of property. The tree appears to be in excellent condition with no visible defects. The trunk is located approximately 15 feet from the property corner.

Based on species, size and condition, the recommended TPZ radius for this tree is 8x diameter (ie. 216" or approx 18 ft). Due to the limited canopy overhang, it is recommended to establish the TPZ at the property boundary.

Based on available information, and the understanding that excavation is limited to within the property boundary, no significant impact to health or stability are anticipated for this tree.

Tree protection fencing should be installed in accordance with City of Mercer Island guidelines. Excavation within the tree's dripline area will require supervision by a Qualified Arborist.
