June 11, 2024

Re: 478 Eagle River Street - Nomination for Landmark Designation (the “**Designation Request**”)

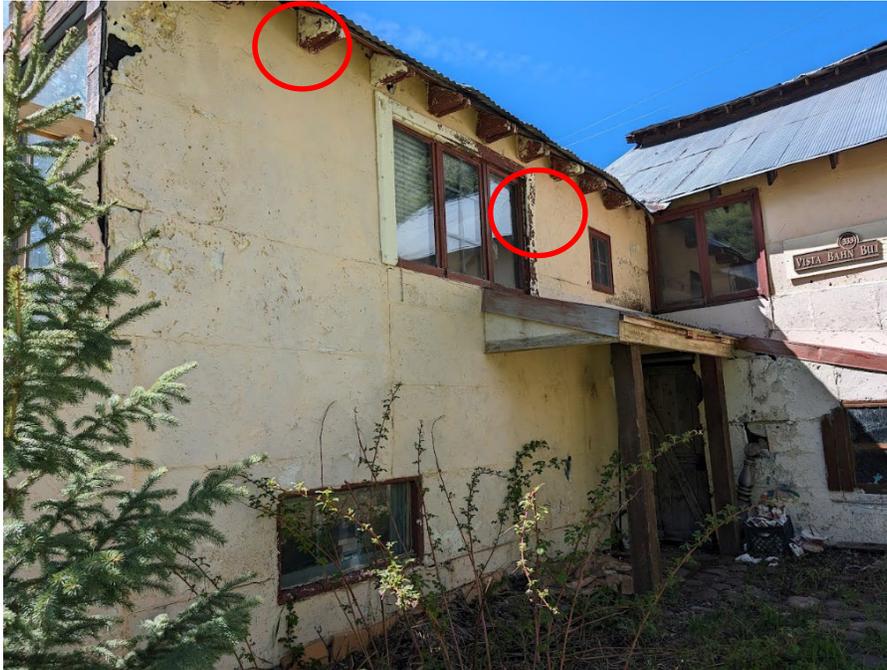
(Detail 1) Foam forms and “siding” on rear addition.

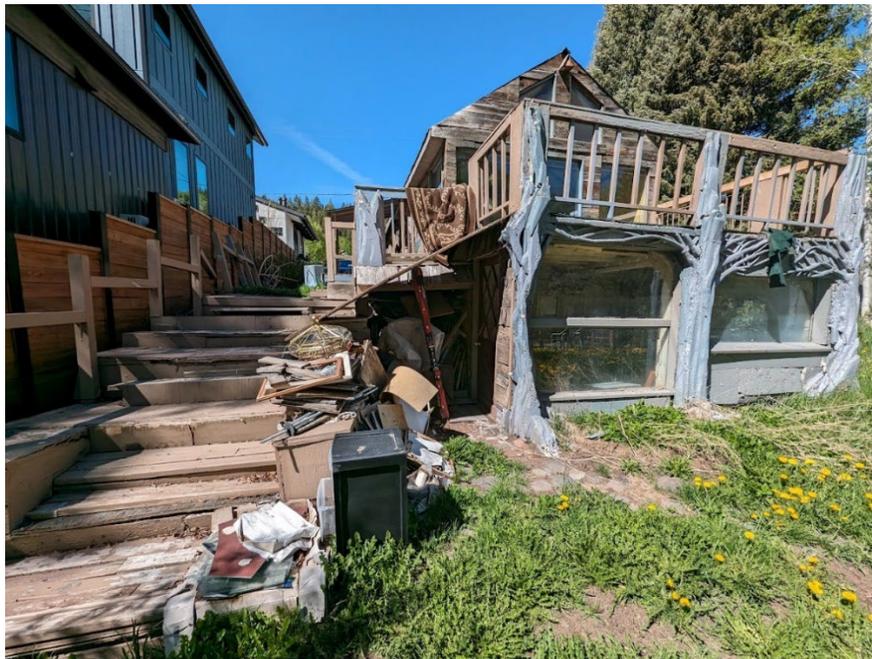
(Detail 2) Deck and stair addition.

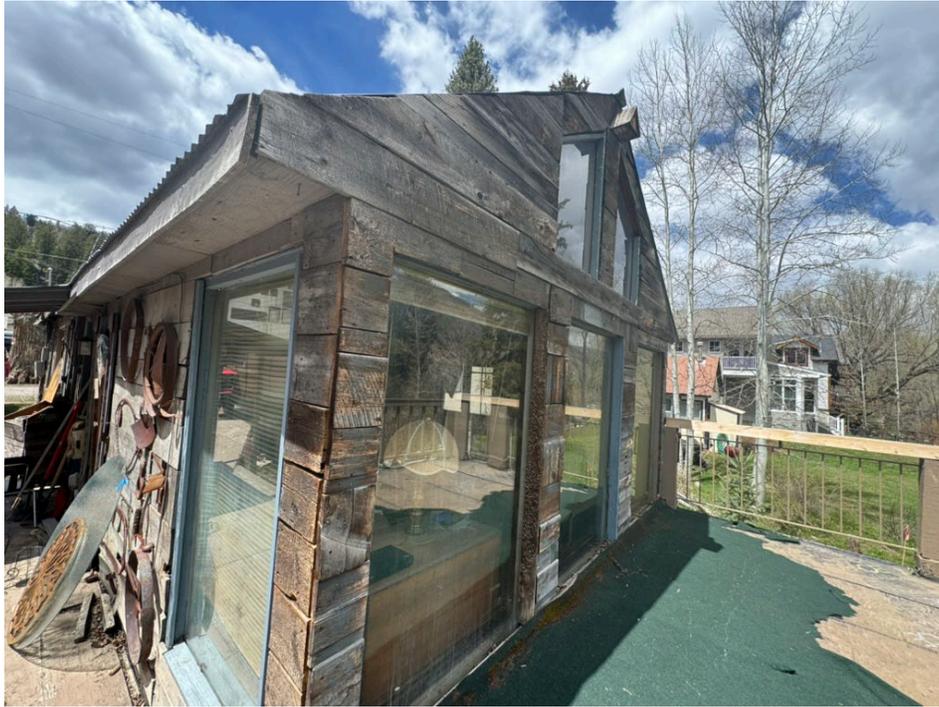
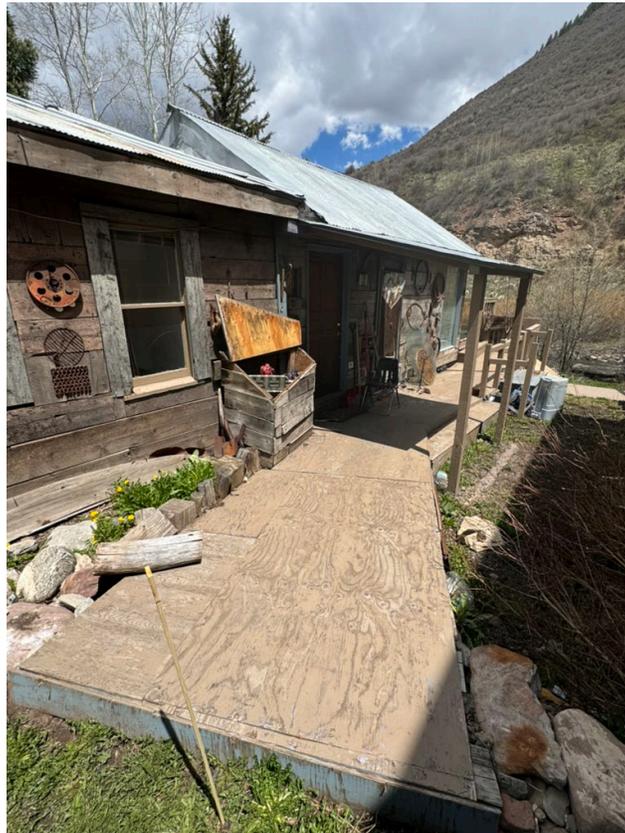
(Details 3 and 4) South addition and plywood decking.

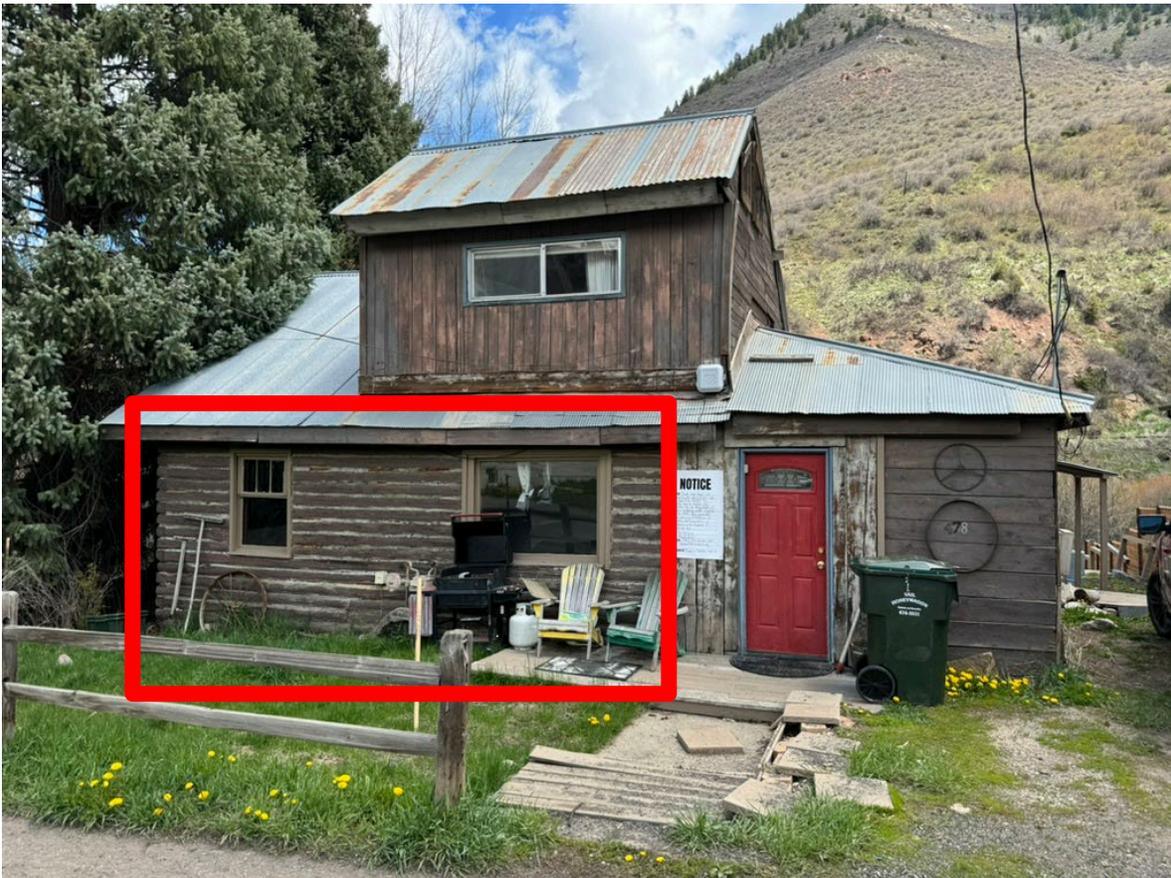
As a result, while some minimal portion of the Structure may have been built before Section 19-3-20(a)'s 75-year threshold, most of it falls well short of that mark, and even the older portion has been modified over the years. As illustrated in the following photo, the portion outlined represents the area of the structure satisfying the 75-year threshold, and the only portion that could conceivably demonstrate "rustic" architecture.

(Detail 5) Original cabin call out (red box). All other Structure components are later additions.

This curved log design is not clearly detectable along additional facades, signifying no clear delineation between what may have been an original section of the Structure and additions/renovations over the course of history. Therefore, there is no way to separate the qualifying and non-qualifying components of the Property and the Property as a whole is not eligible for historic designation.

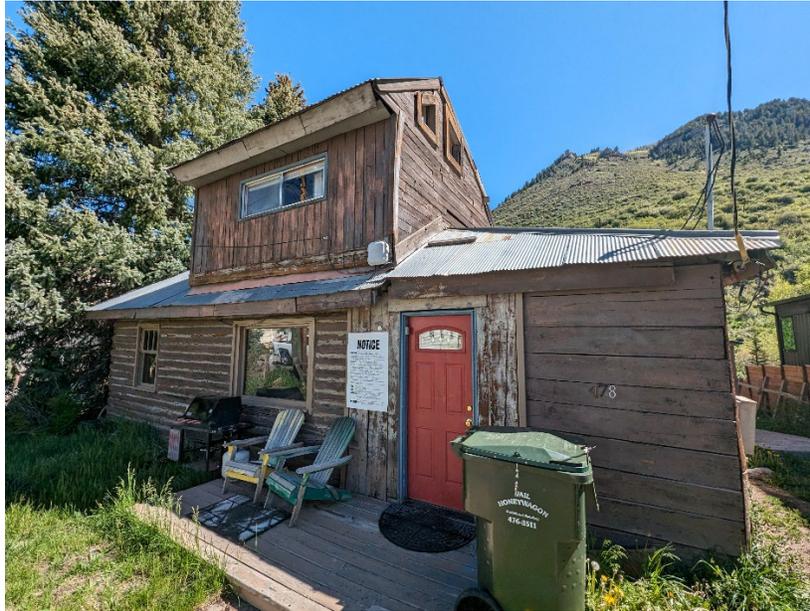
The Structure’s exterior along the street frontage is primarily made of wood, a portion of which is log construction but primarily wood board siding, that is described in the Inspection Report as decaying and requiring attention to restore structural integrity. The Structure’s lack of primarily log construction alone is a major deficiency in identifying the structure as exemplifying the Rustic style architecture, as is the lack of a stone chimney, paned windows and overhanging roof on some of the additions. The Rustic style typically employs a cohesive siding material throughout, and as evidenced by the photos provided herein, the Structure instead has a hodgepodge of different siding material (including extensive use of styrofoam, mis-matched boards, and tree-like adornments).

(Detail 7) Structure west façade.

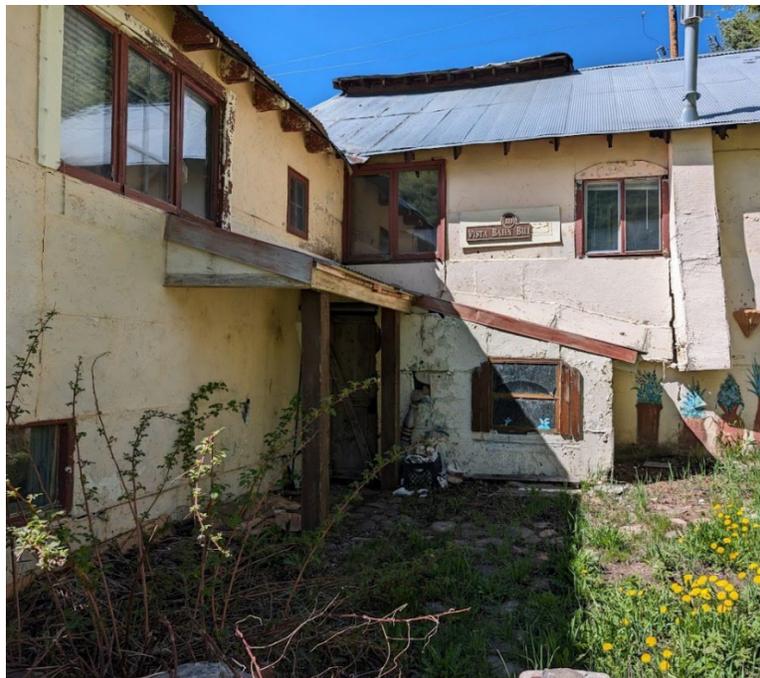
Elsewhere, the wood siding is missing from the Structure on multiple exterior facades, and still others are made of a decaying foam-like material reflected in the image below.⁵

(Detail 8) East and north facades, rear additions, and faux-Italianate components.

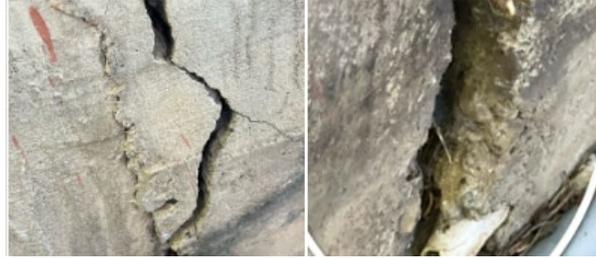
The foundation is made of wood and concrete, rather than stone, and shows signs of major structural damage (e.g., cracked concrete and wood deterioration). In some portions of the Structure, there is no foundation at all.⁶

(Detail 9) Cracking Foundation.

- Areas of the foundation are missing, made of wood, and structural concrete cracking was noted. This would require the addition of a foundation, foundation repair, and likely evaluation of the soils and the ability to support the structure.

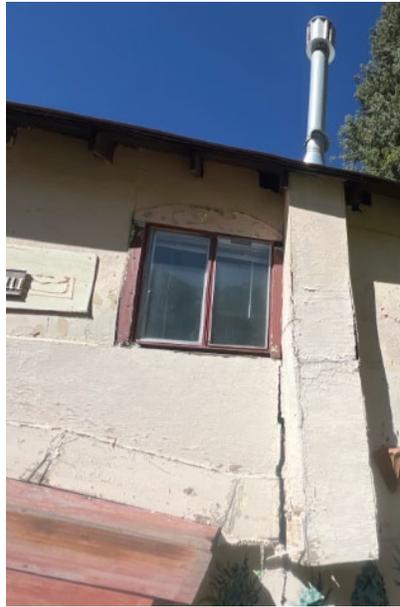
The chimney is constructed of a wood frame cased in styrofoam, not stone, topped with a flue pipe and described as deteriorated and badly damaged, as depicted below. This element of the Structure is flagged as a safety concern requiring repair or replacement to function and prevent fire danger.⁷ It too lacks any connection to the Rustic style.

(Detail 10) Deteriorating foam chimney.
