Dear Planning Commission,

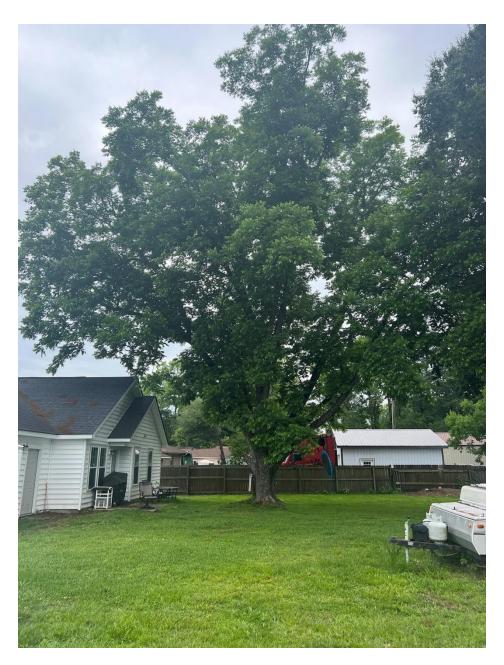
I wish to remove 2 trees from my property. The first tree that I would like to remove is a pecan tree. The tree is directly behind my house, only 16 feet from my bedroom with many large branches that overhang the house. The tree regularly drops branches on the house damaging the roof and siding. The location of our property also magnifies the frequency of this as we live across the street from the airport that experiences higher winds due to the open field. The tree is absolutely a major concern during any hurricane, as my wife and young son are forced to avoid that area of the home under the tree as a precaution for their safety. I have included pictures below of locations where previous branches have fallen as well as a branch that fell just last week. The largest branch of the tree overhangs the house, so removal of that branch will be a significant injury to the tree. The concern for this is intensified because the tree no longer heals damaged areas properly. Previous fallen branches have resulted in cavities and rot that lead into the trunk and major limbs of the tree.

The Pecan Tree

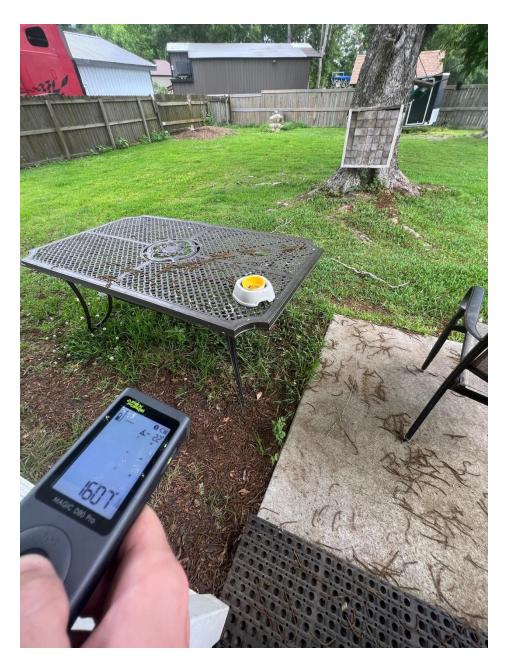
Distance from my bedroom

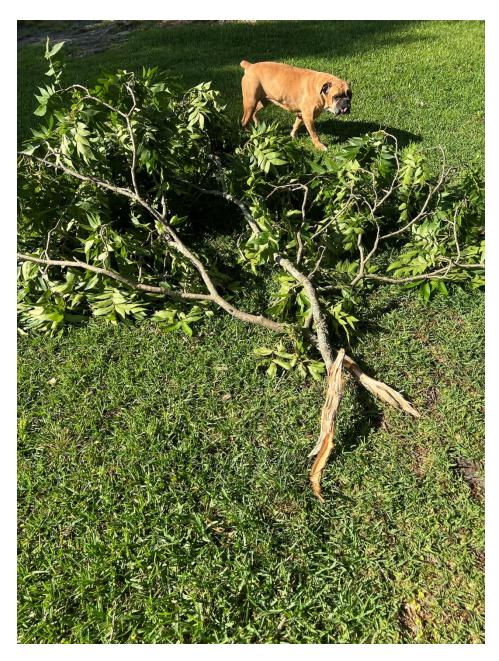
A branch that just fell last week

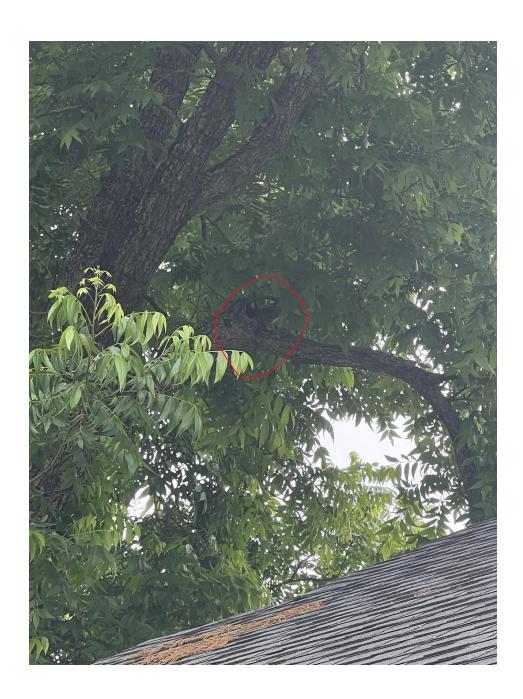
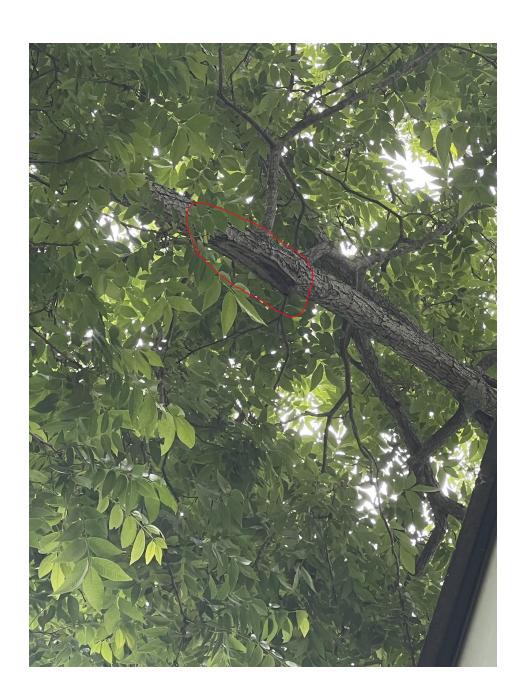
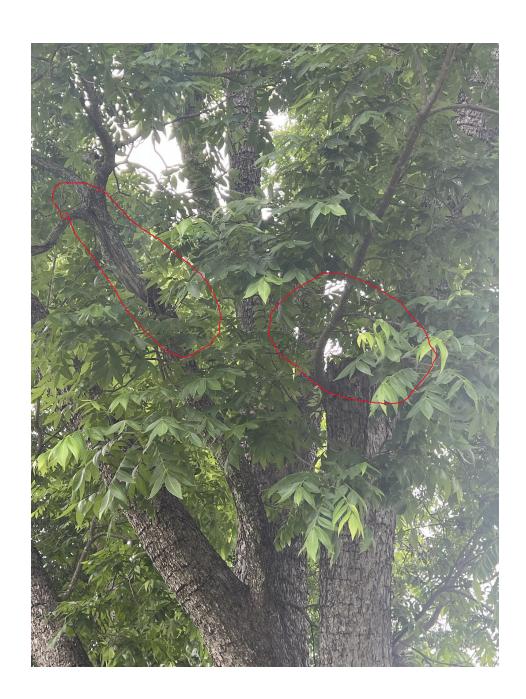
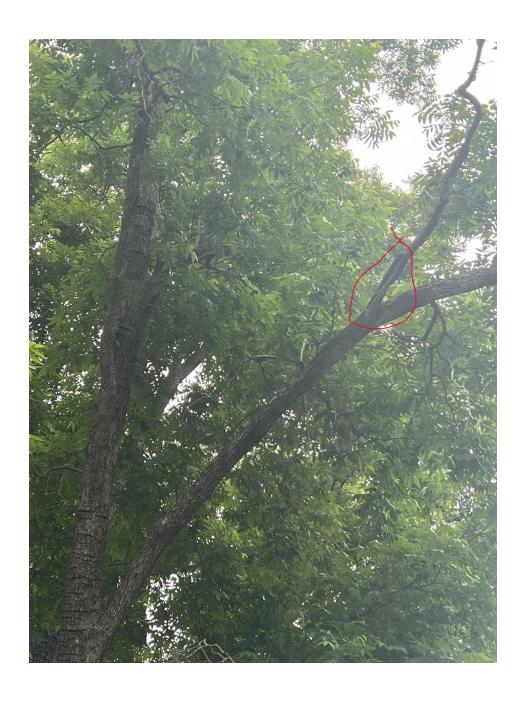
A previous branch that had fallen now has a rot cavity leading into the large branch

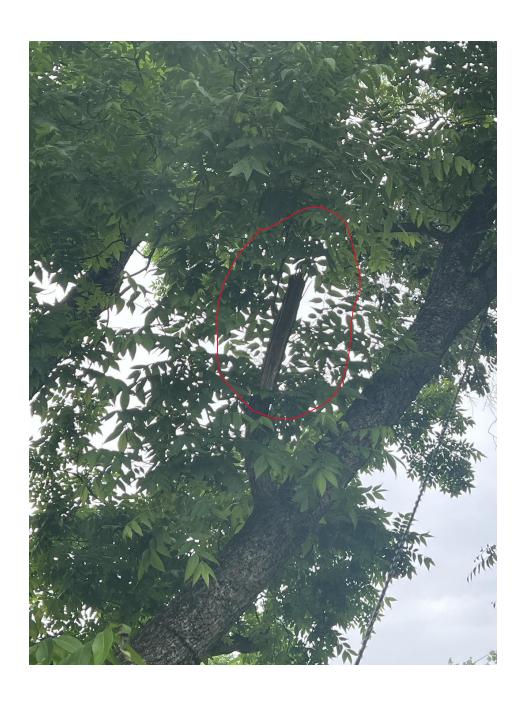
Another fallen limb

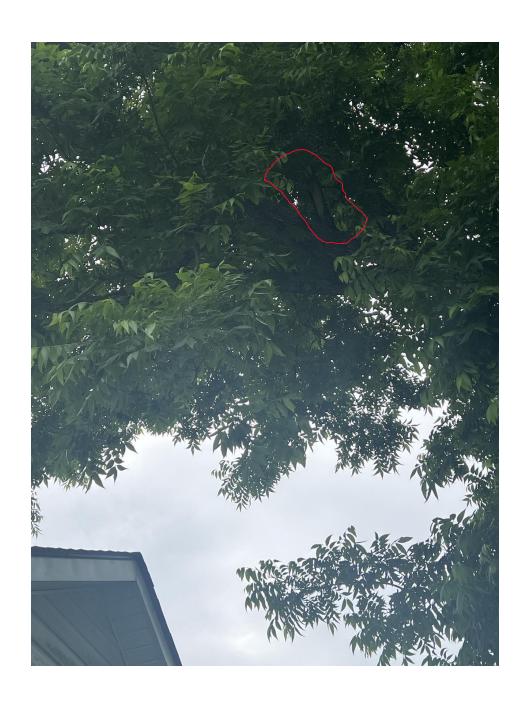
Limb that fell on my house last summer

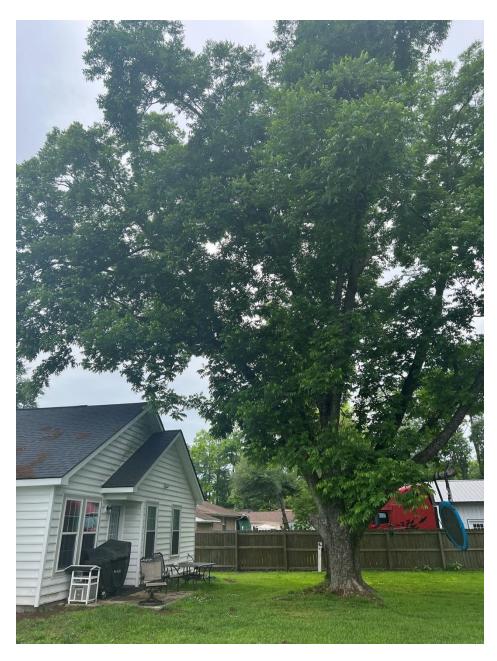
The largest limb hangs over the house

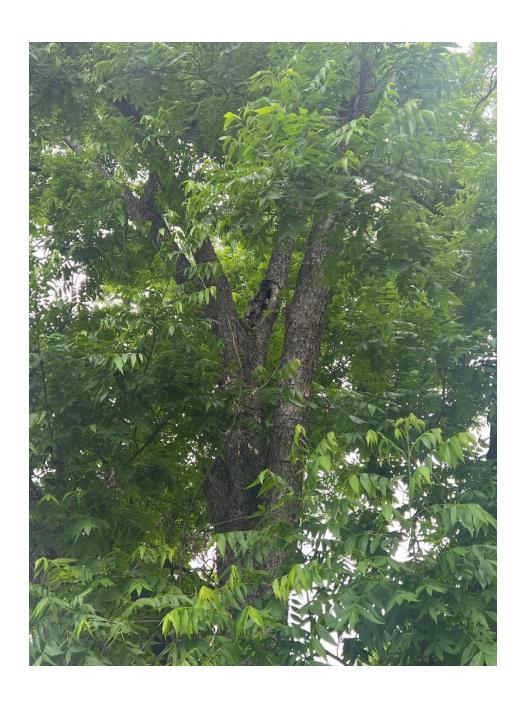
Rot in the trunk that the tree will not repair

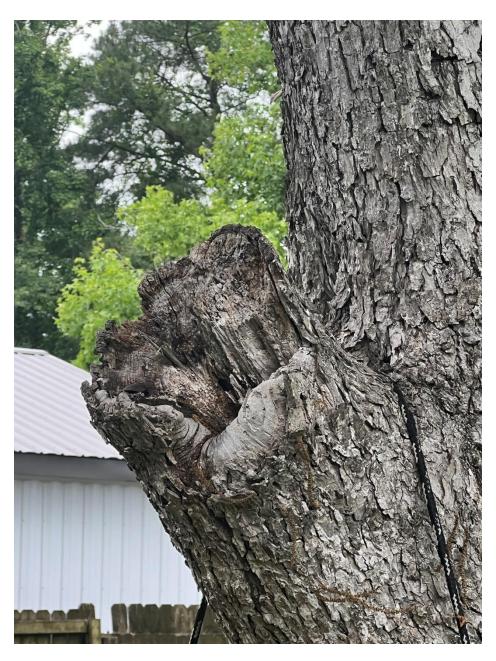
Tree wound after a limb was cut off, all wood is soft there

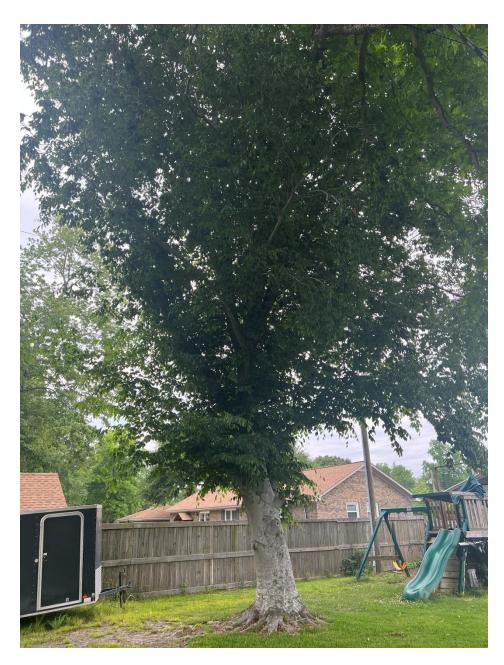
The second tree that I would like to remove is a birch tree. This tree is next to the fence where the power lines are located. Years of trimming the tree back from the powerlines have resulted in it growing to an unhealthy shape.

The birch tree

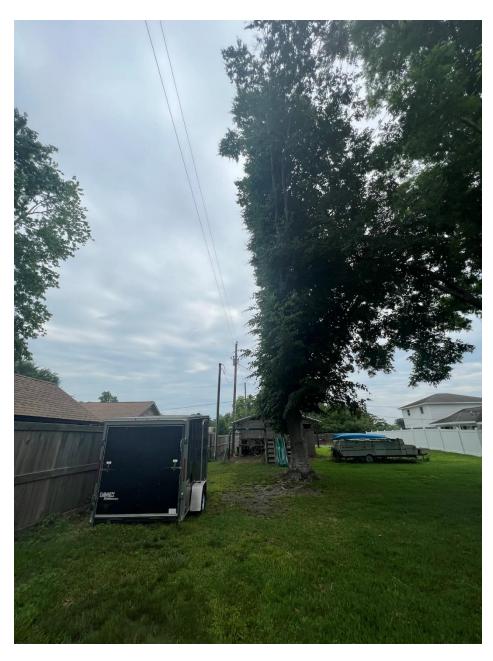
View from one side

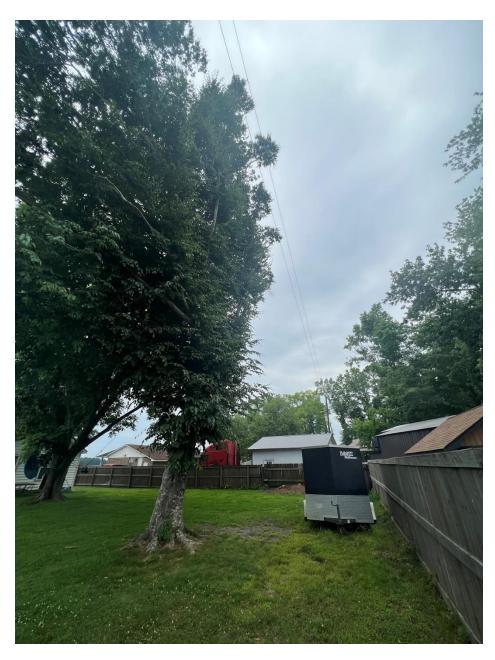
View from opposite side
