Barker Garage - 434 Chautauqua Avenue, Norman, OK 73069: Certificate of Appropriateness

VIEW OF EAST (FRONT) ELEVATION OF GARAGE FROM PUBLIC RIGHT-OF-WAY

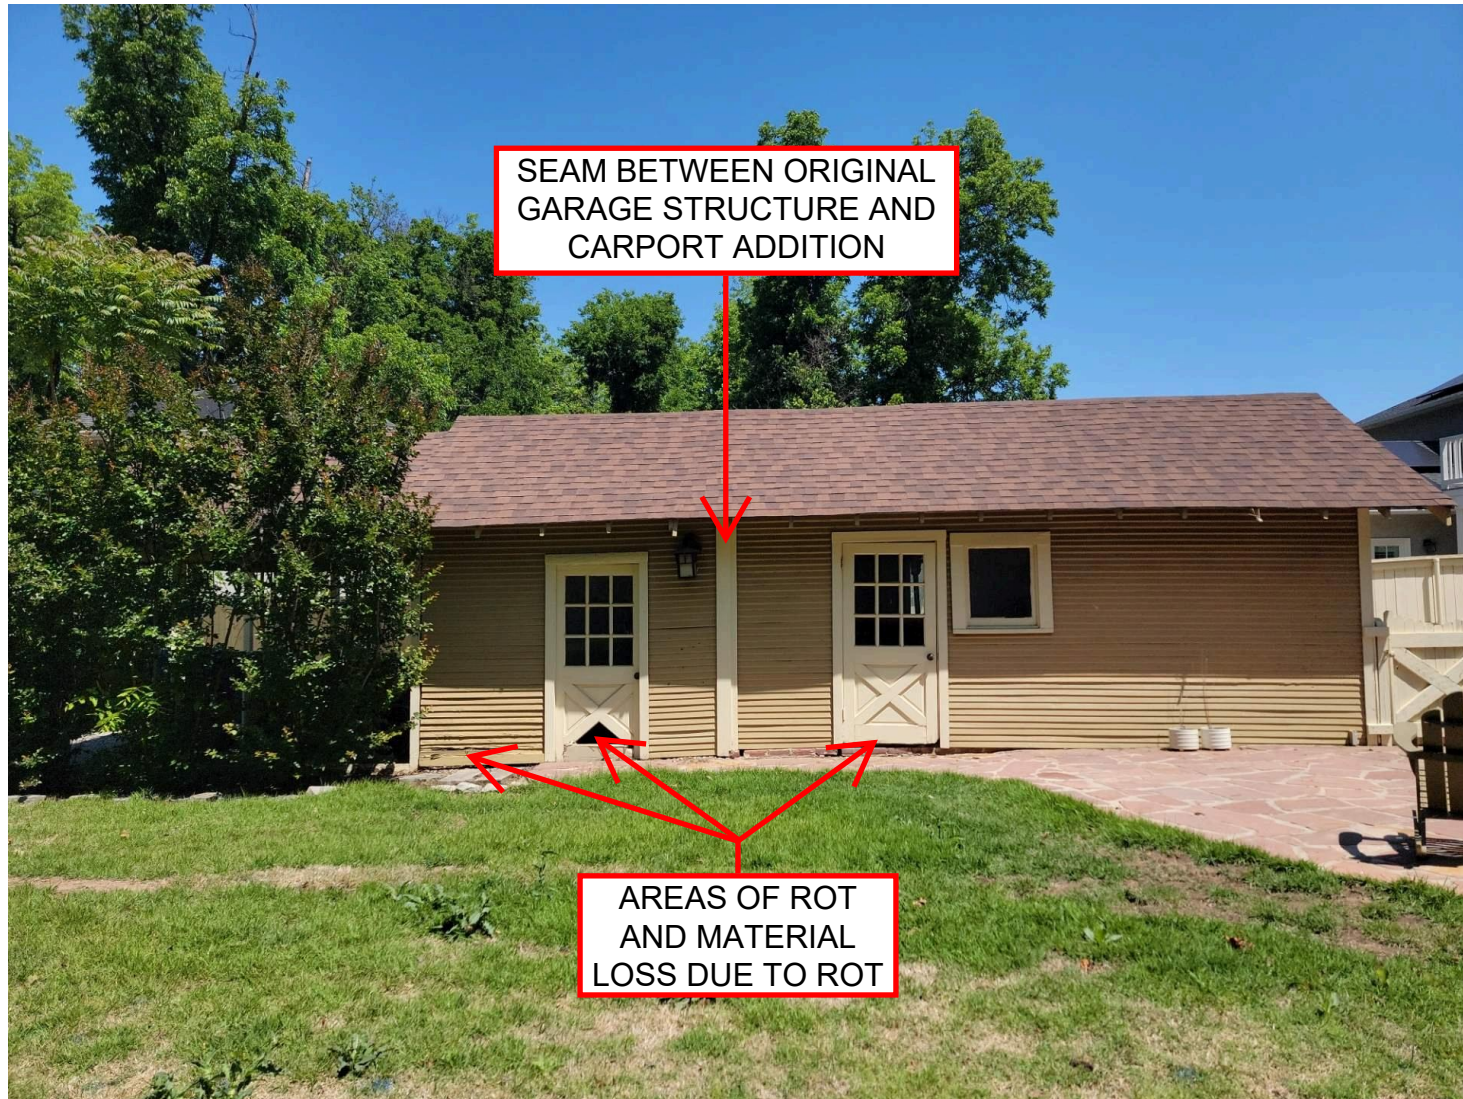
SEAM BETWEEN ORIGINAL GARAGE STRUCTURE AND CARPORT ADDITION

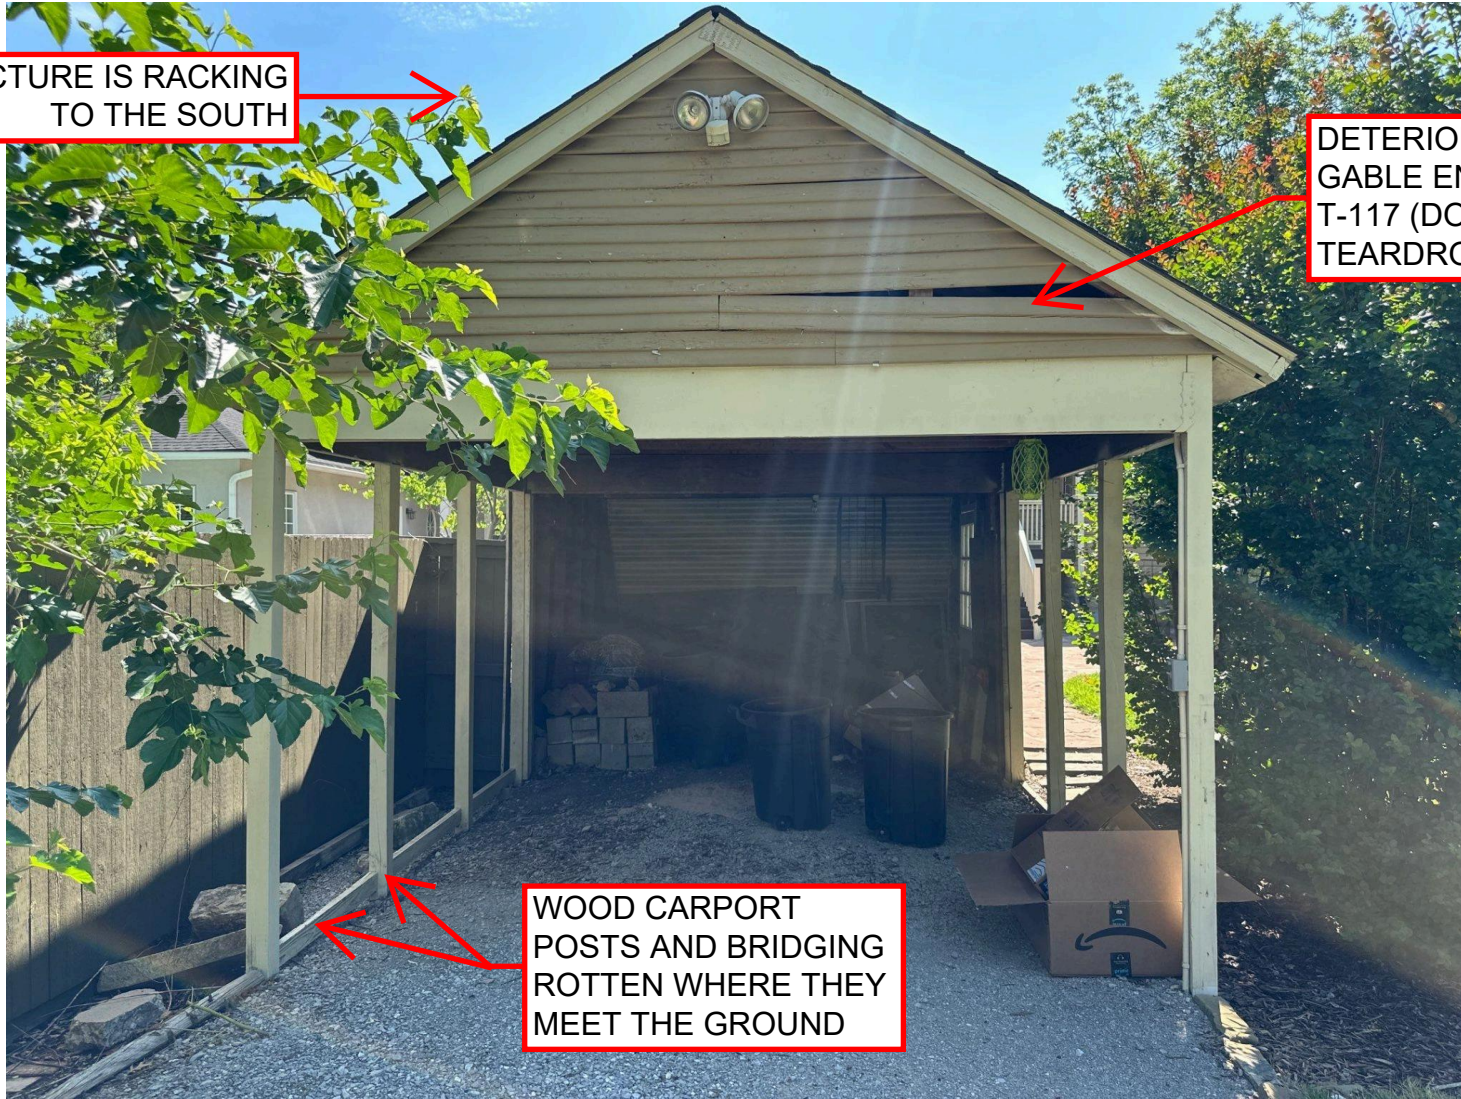
WOOD CARPORT
POSTS AND BRIDGING
ROTTEN WHERE THEY
MEET THE GROUND

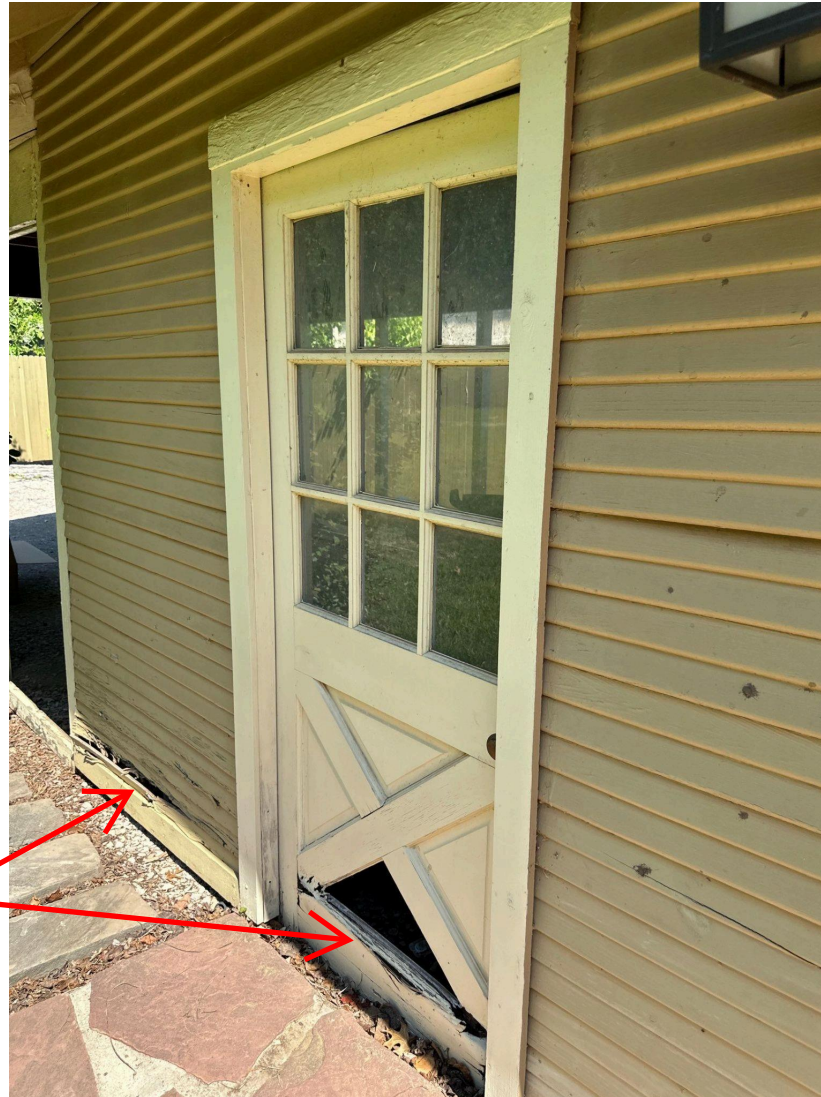
SIGNIFICANT
MATERIAL LOSS
DUE TO ROT

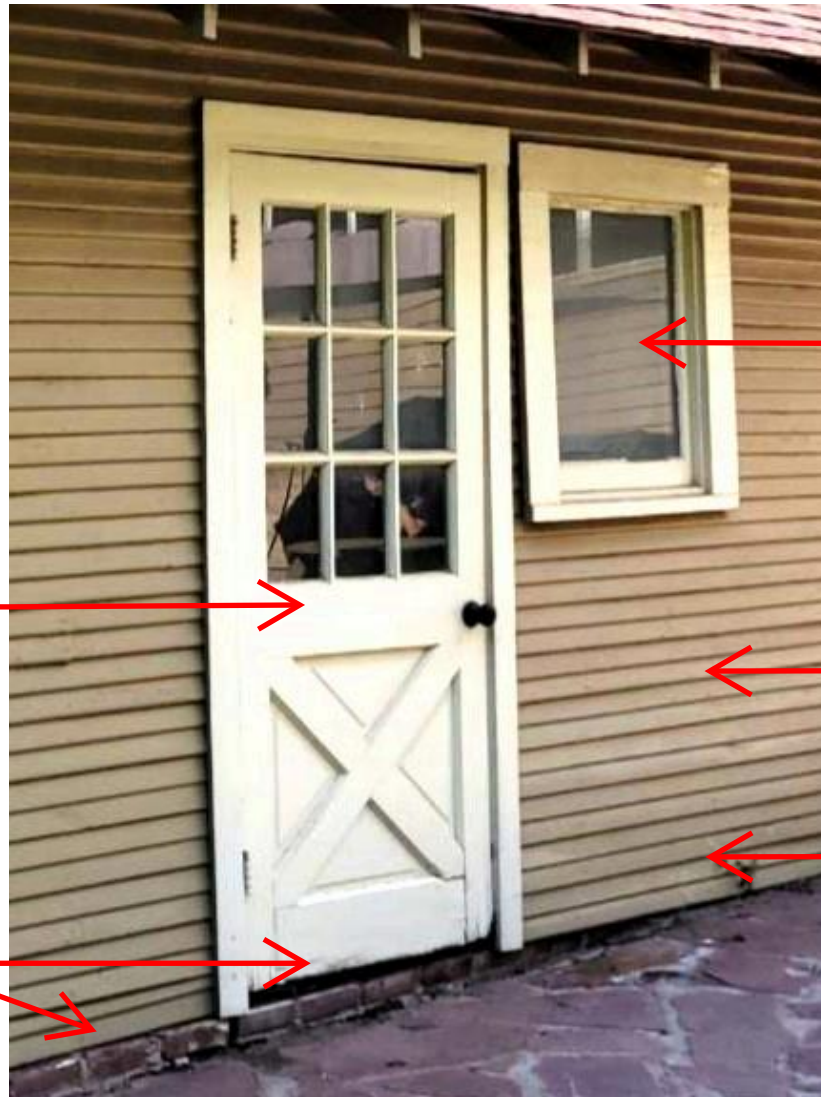
9-LITE WOOD DOOR HAS DETERIORATED AND RACKED SIGNIFICANTLY

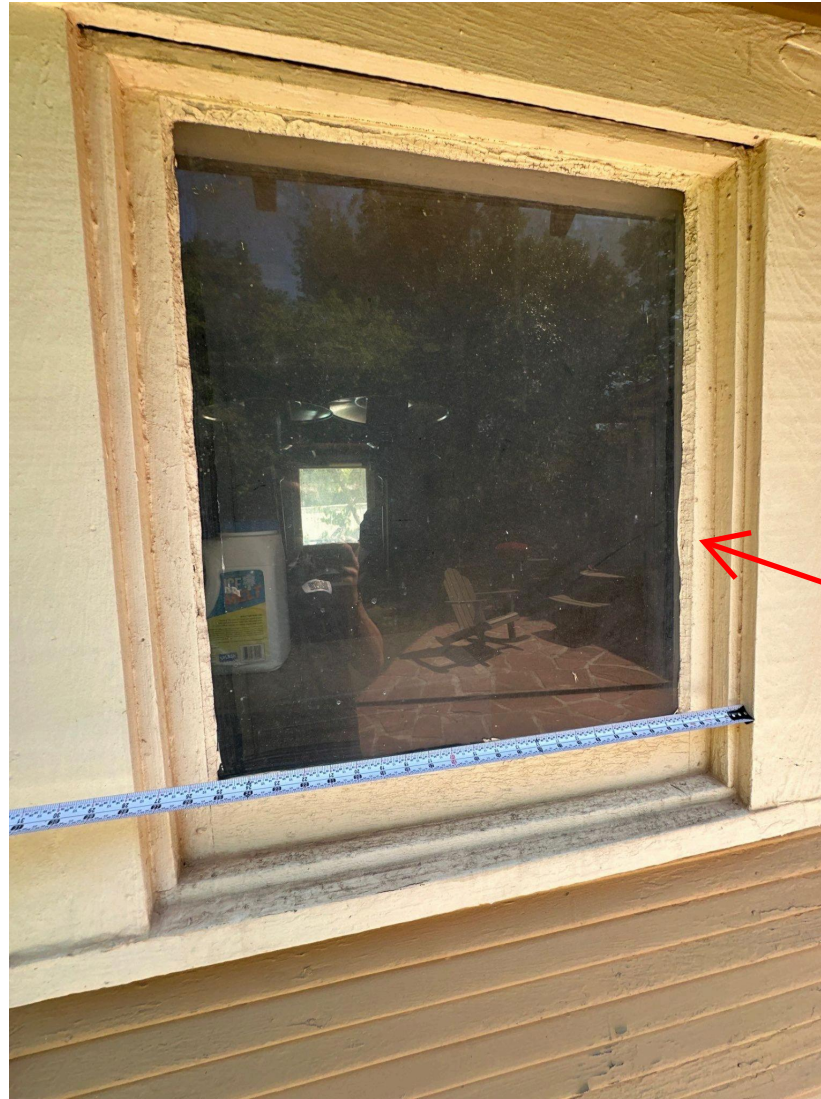
SALVAGE AND REPAIR
WOOD FIXED WINDOW FOR
REUSE IN NEW GARAGE

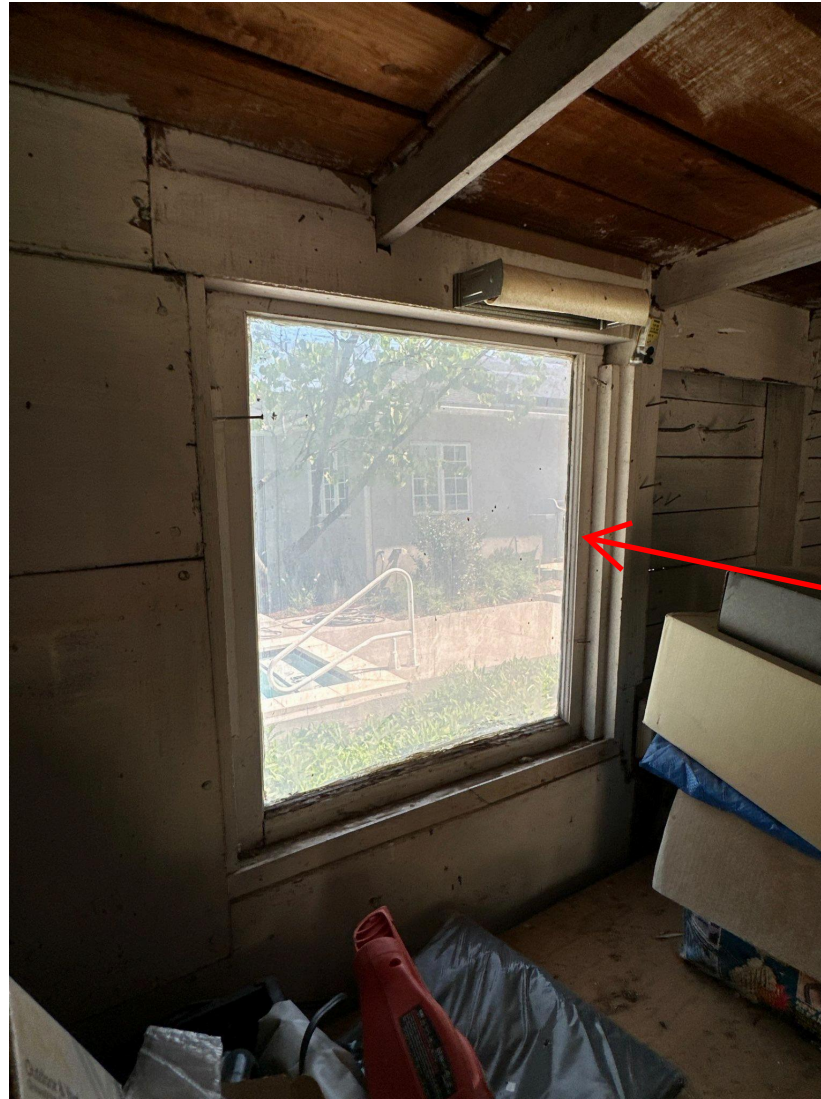
SALVAGE AND REPAIR
WOOD FIXED WINDOW FOR
REUSE IN NEW GARAGE

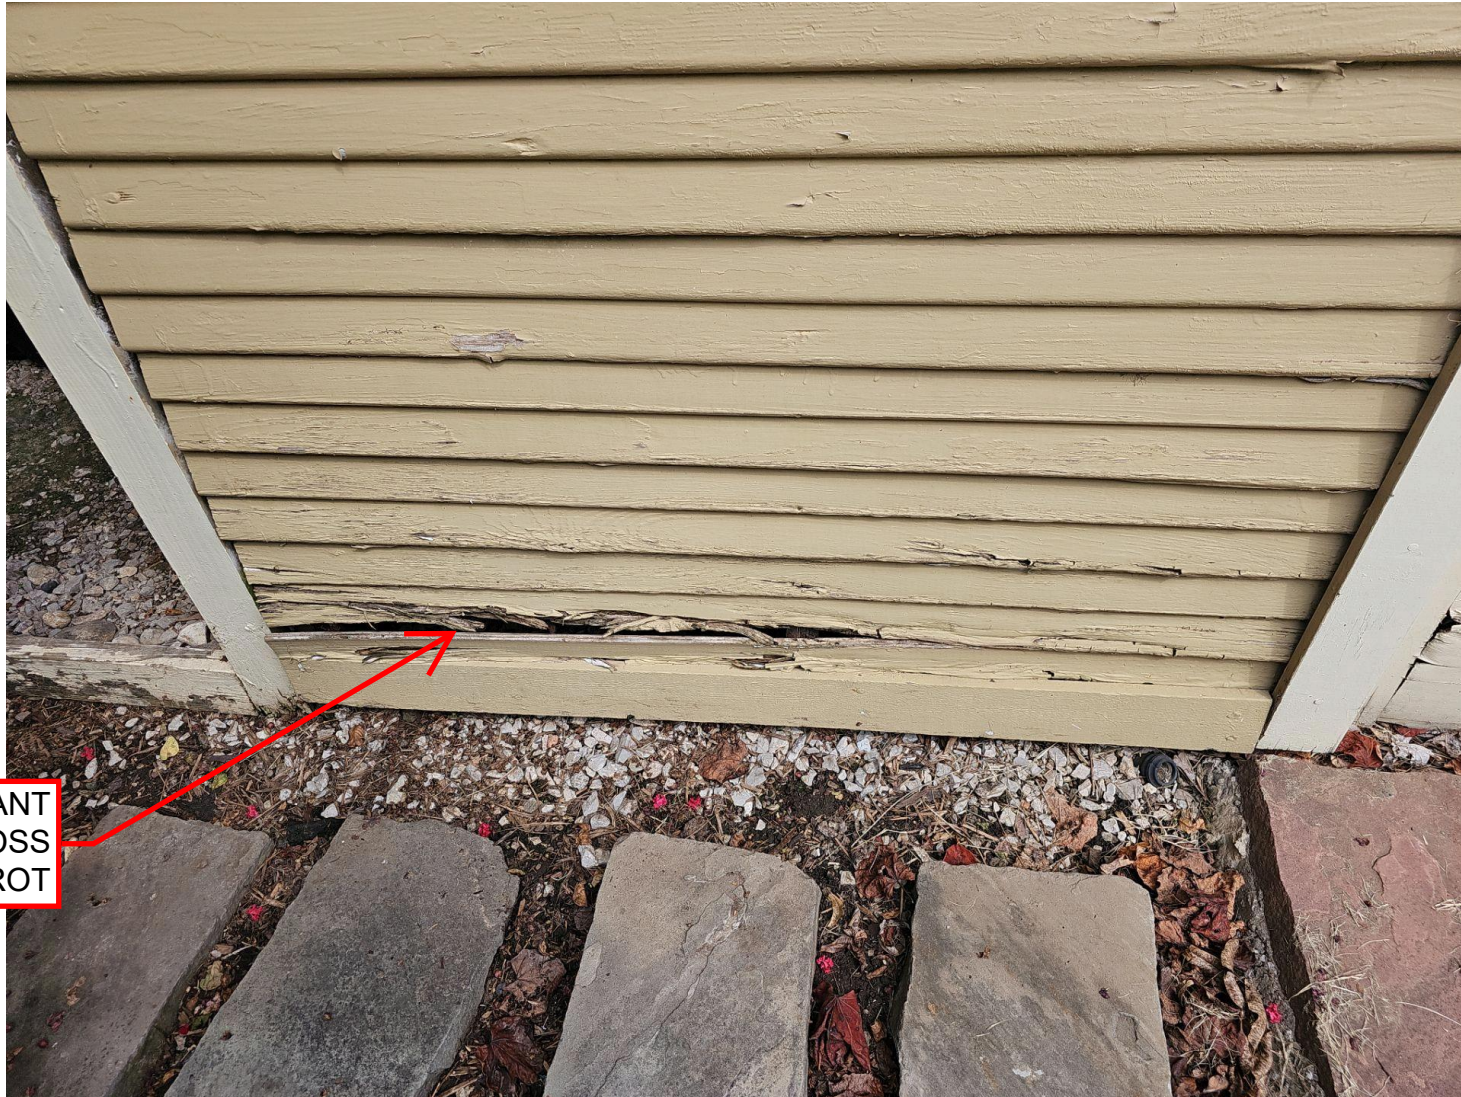
**SIGNIFICANT
MATERIAL LOSS
DUE TO ROT**

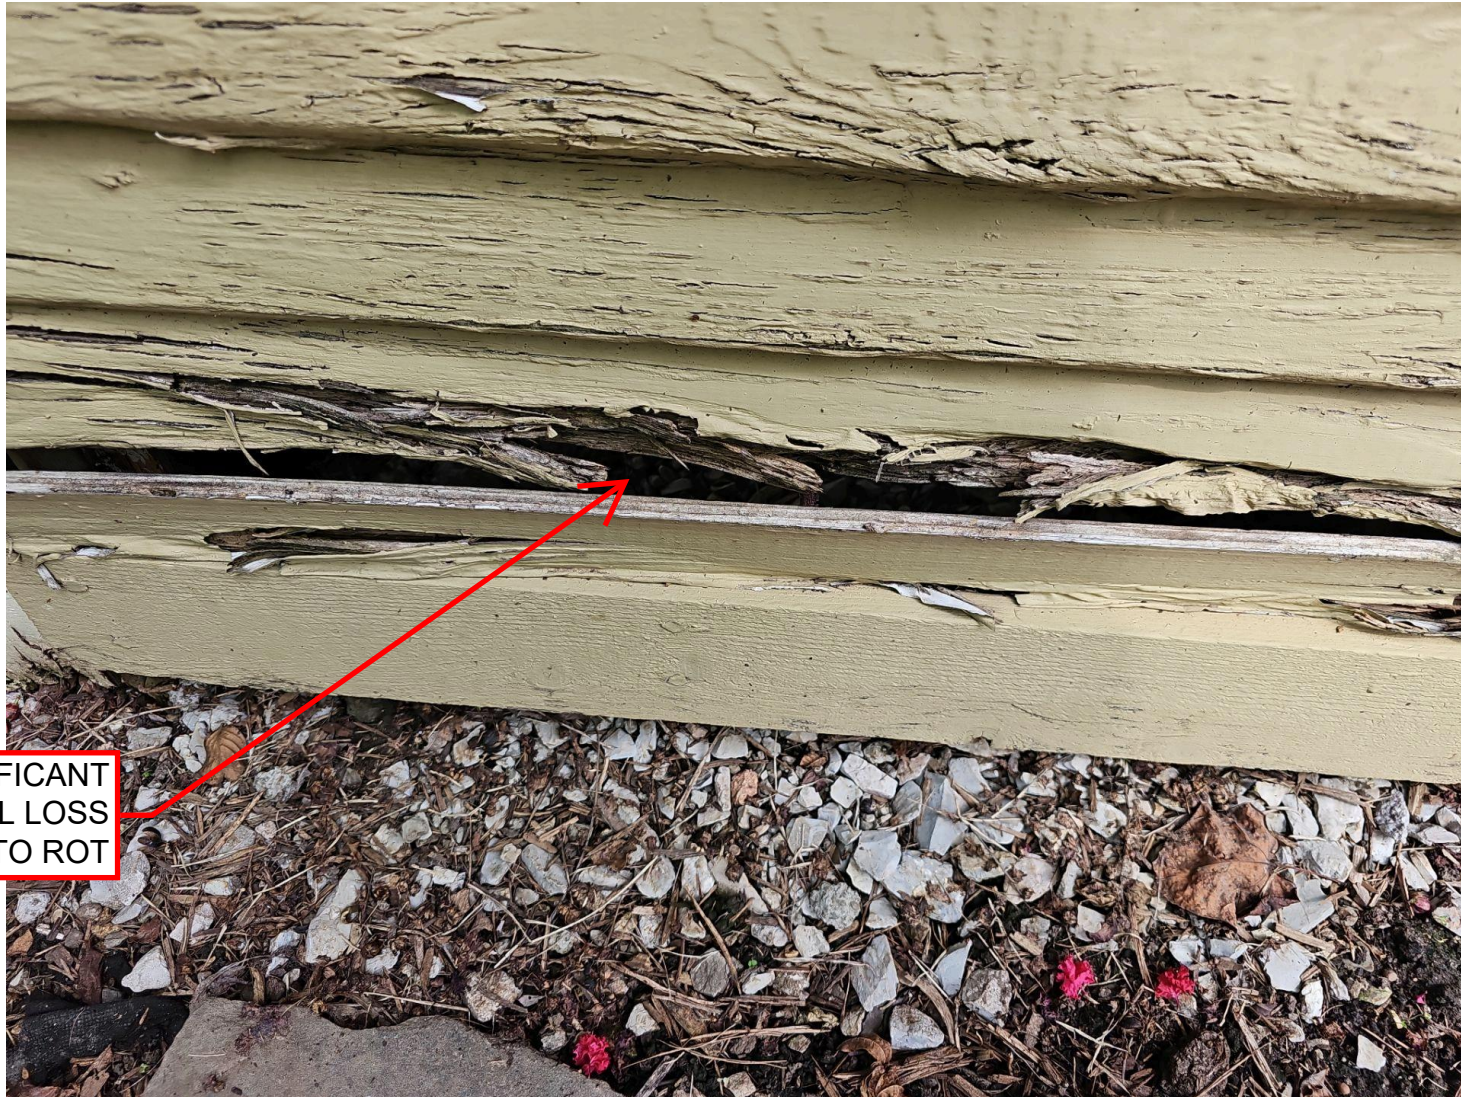
**SIGNIFICANT
MATERIAL LOSS
DUE TO ROT**

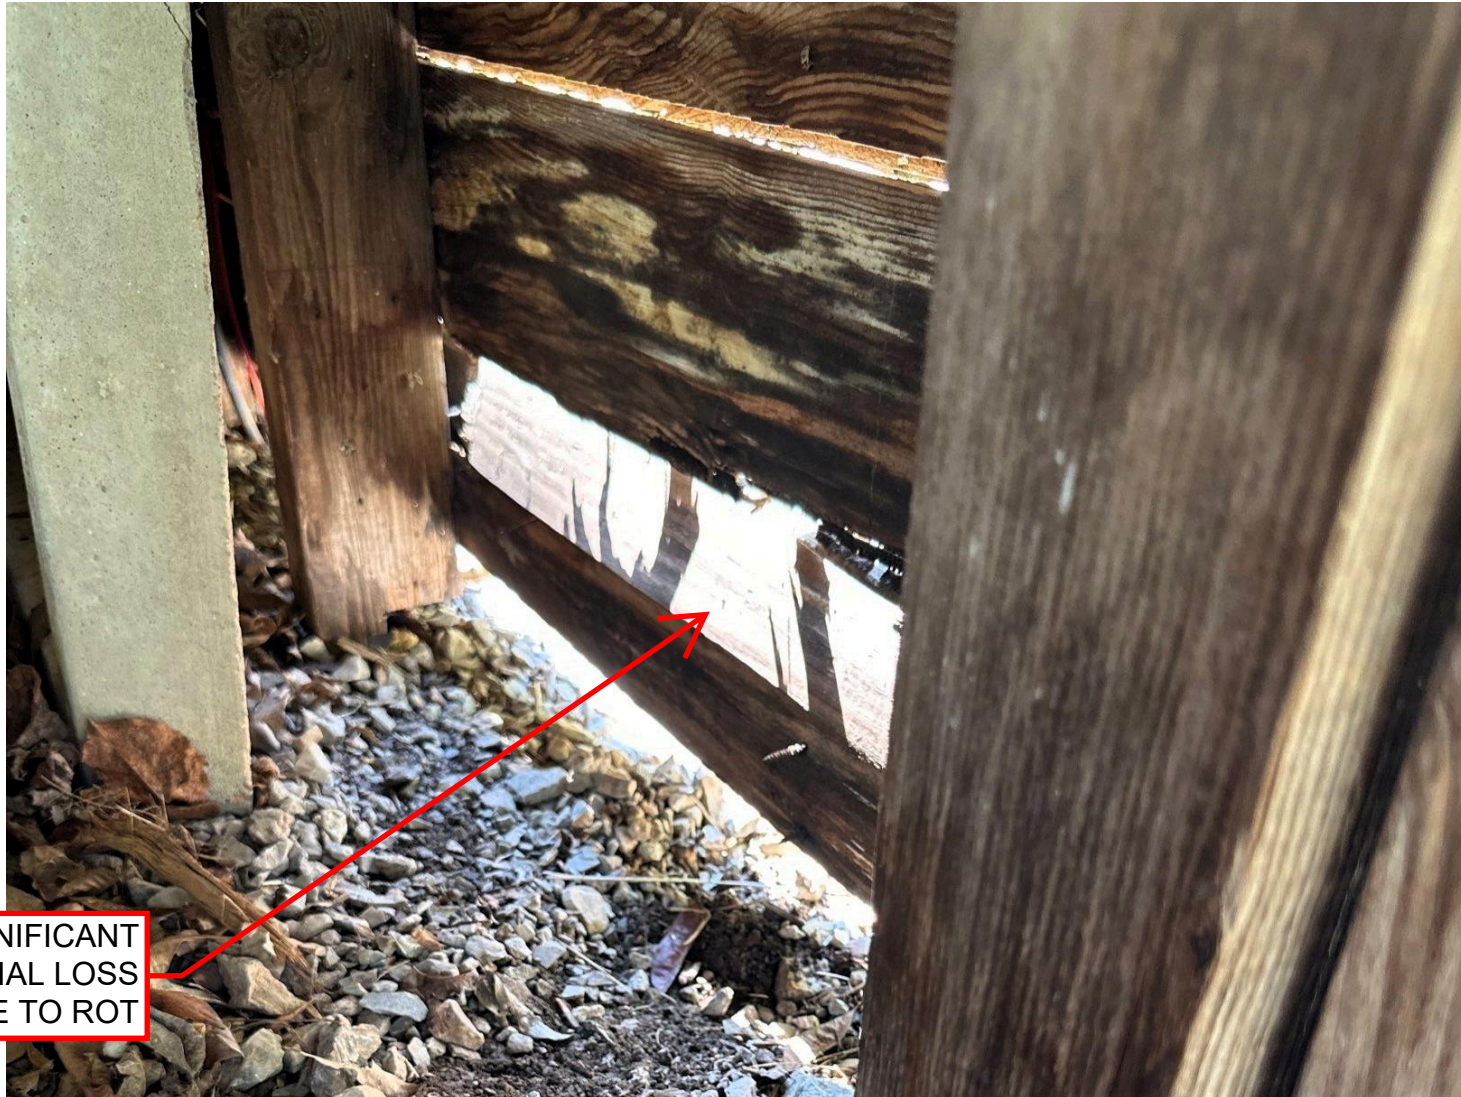
SIGNIFICANT
MATERIAL LOSS
DUE TO ROT

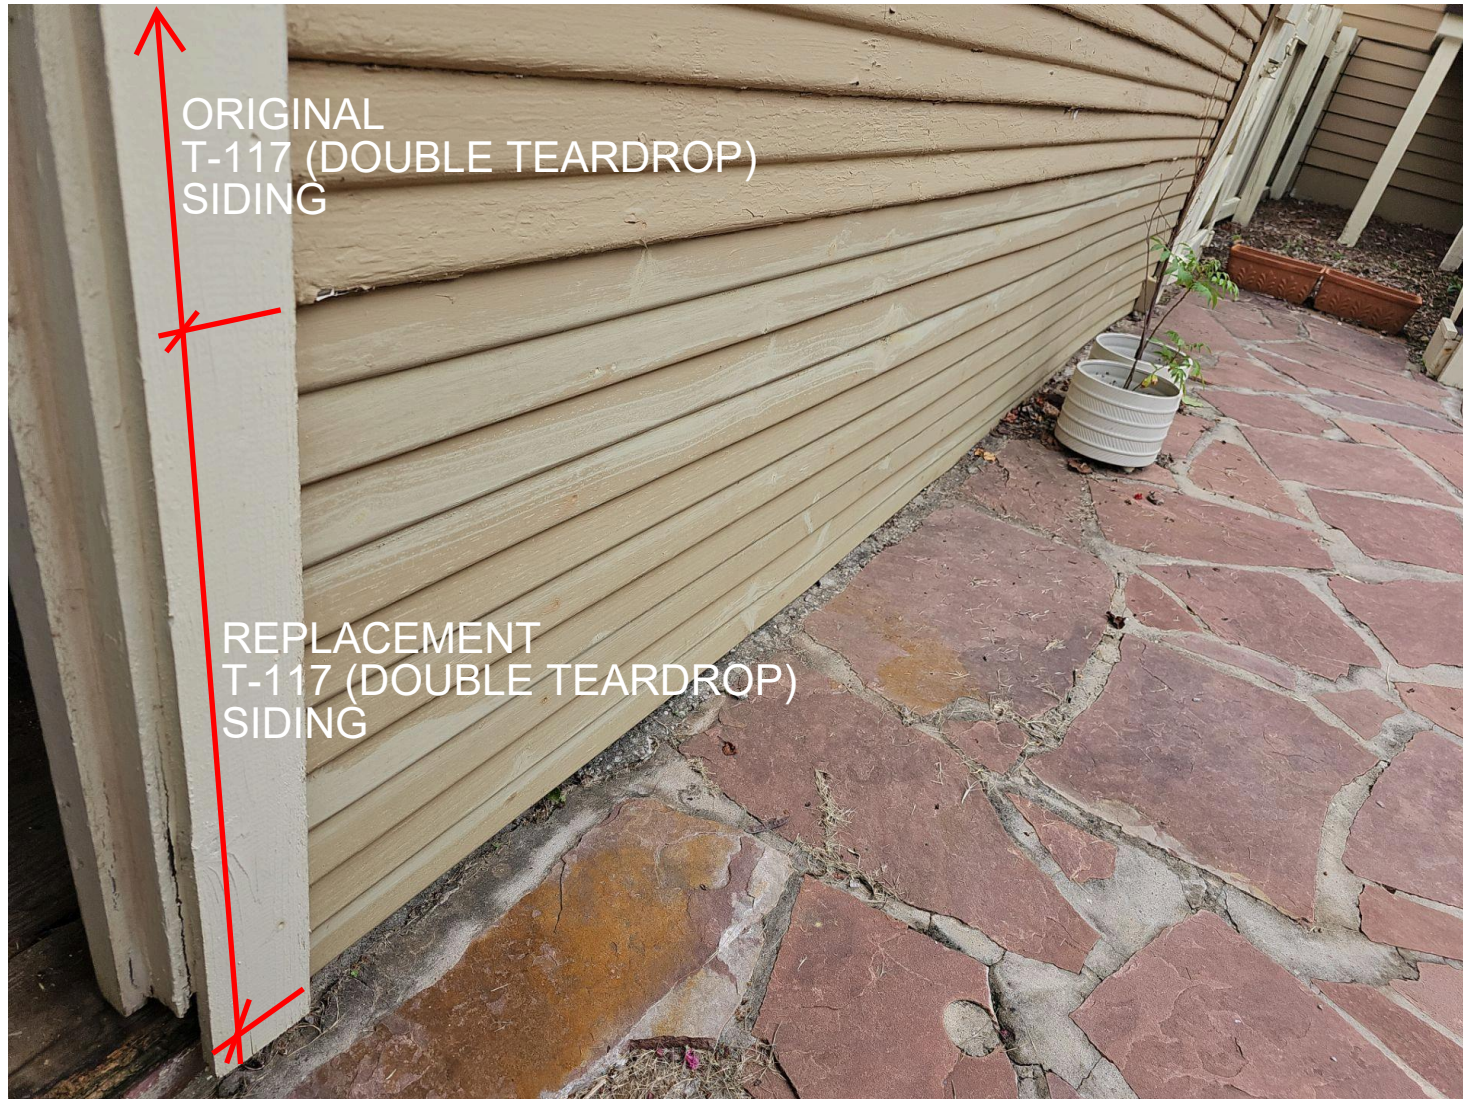
CLOSE UP: AREA OF PREVIOUSLY REPLACED WOOD T-117 (DOUBLE TEARDROP) SIDING

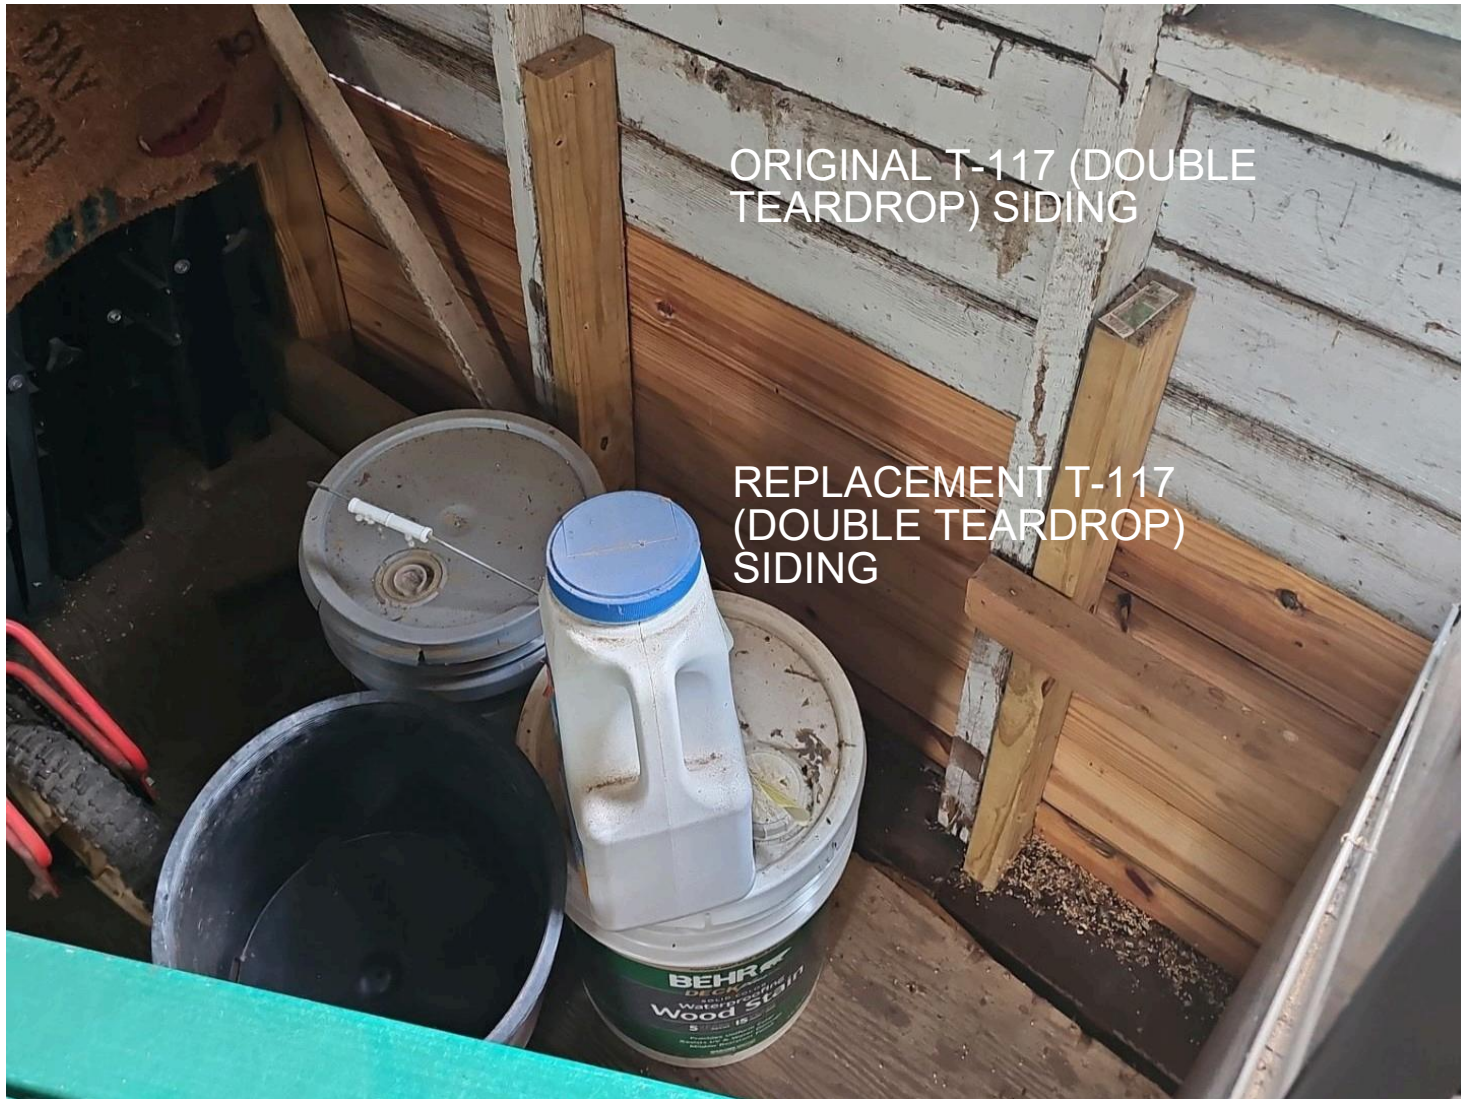
CLOSE UP: AREA OF PREVIOUSLY REPLACED WOOD T-117 (DOUBLE TEARDROP) SIDING

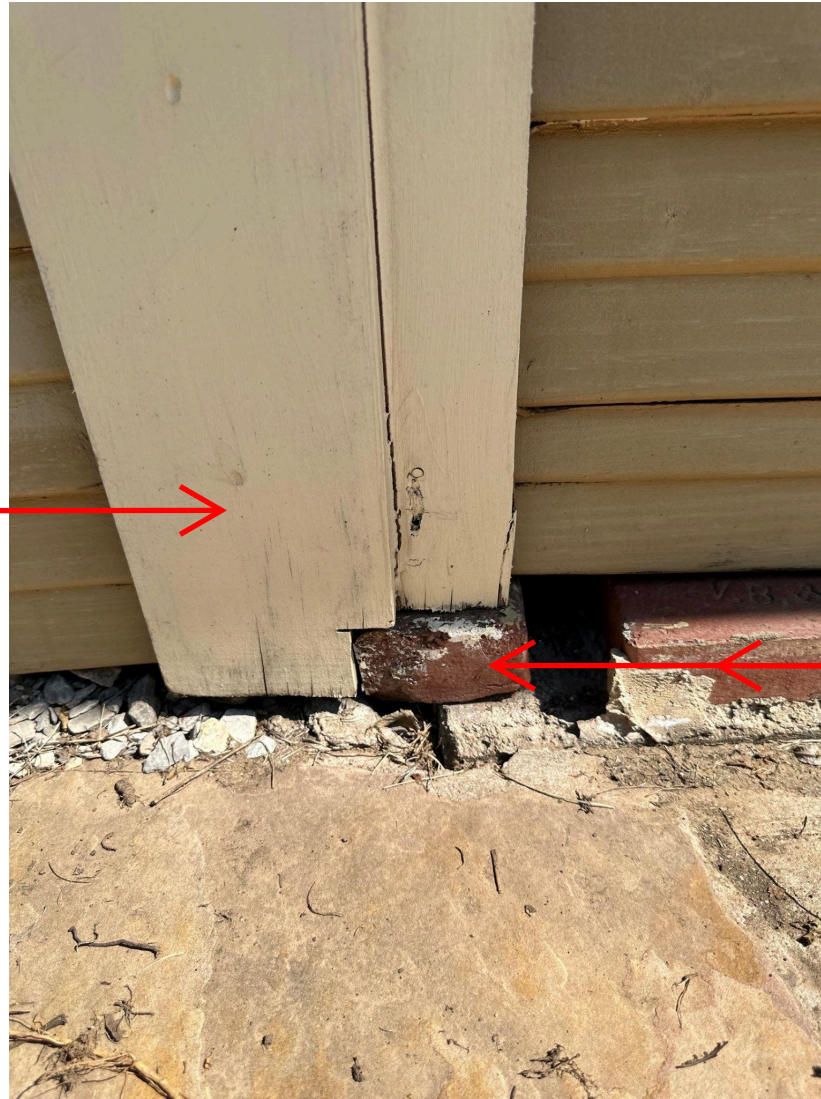
BRICK GARAGE FOUNDATION

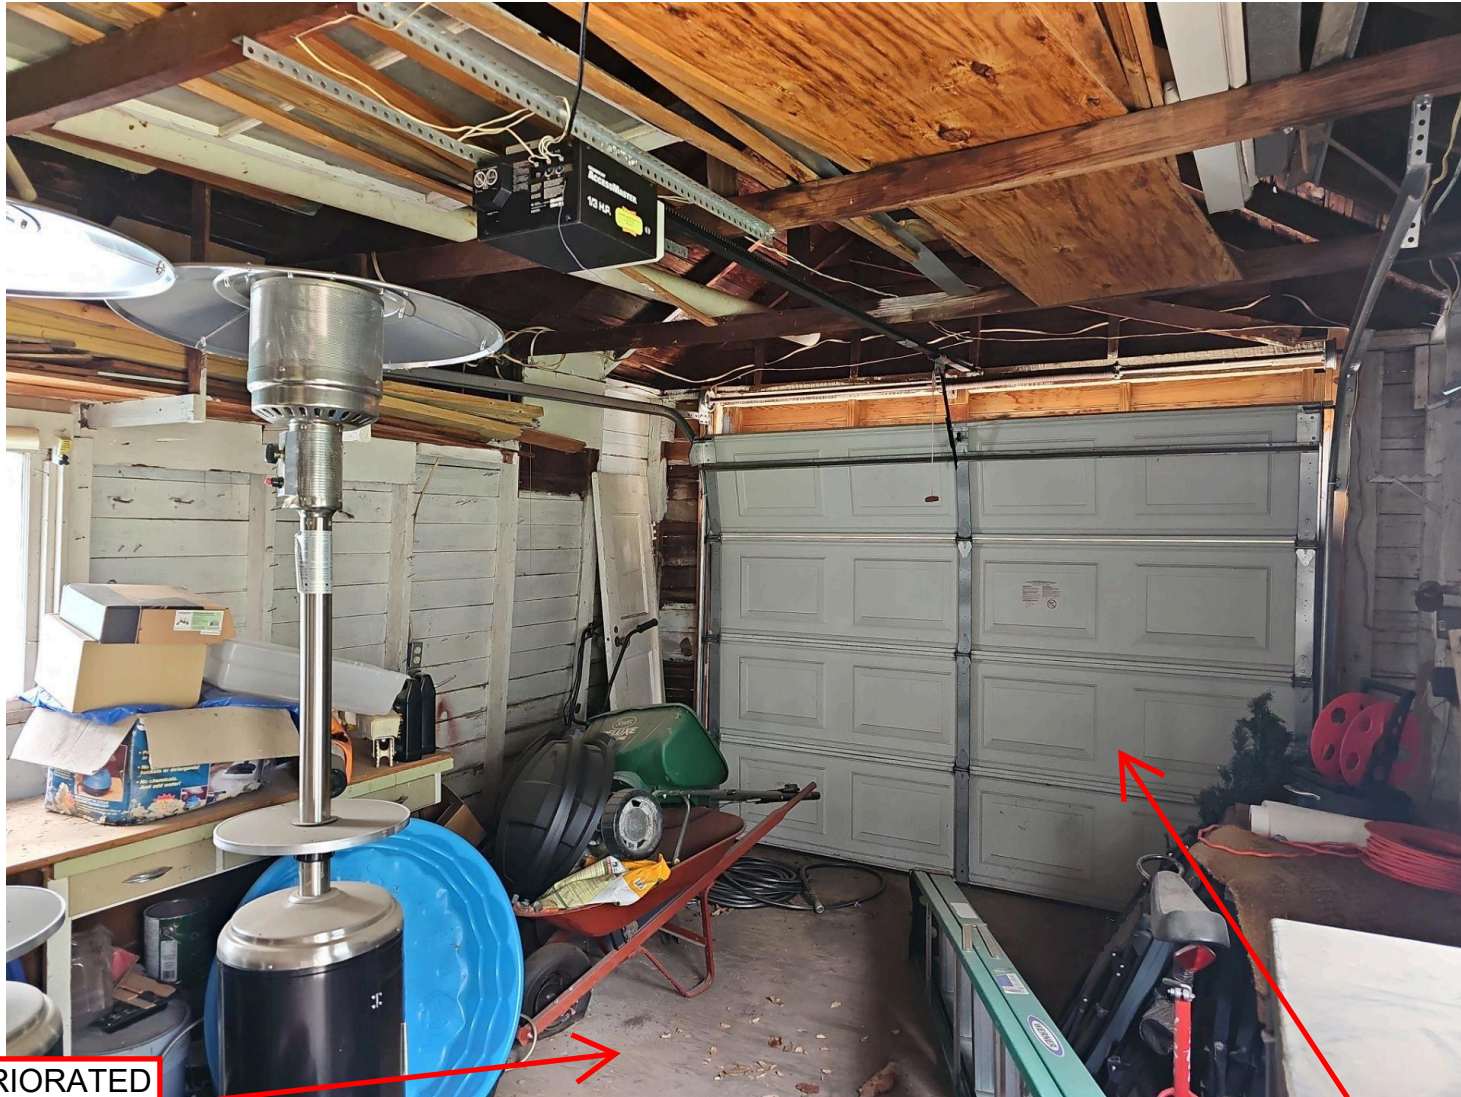
**DETERIORATED
PLYWOOD FLOOR**

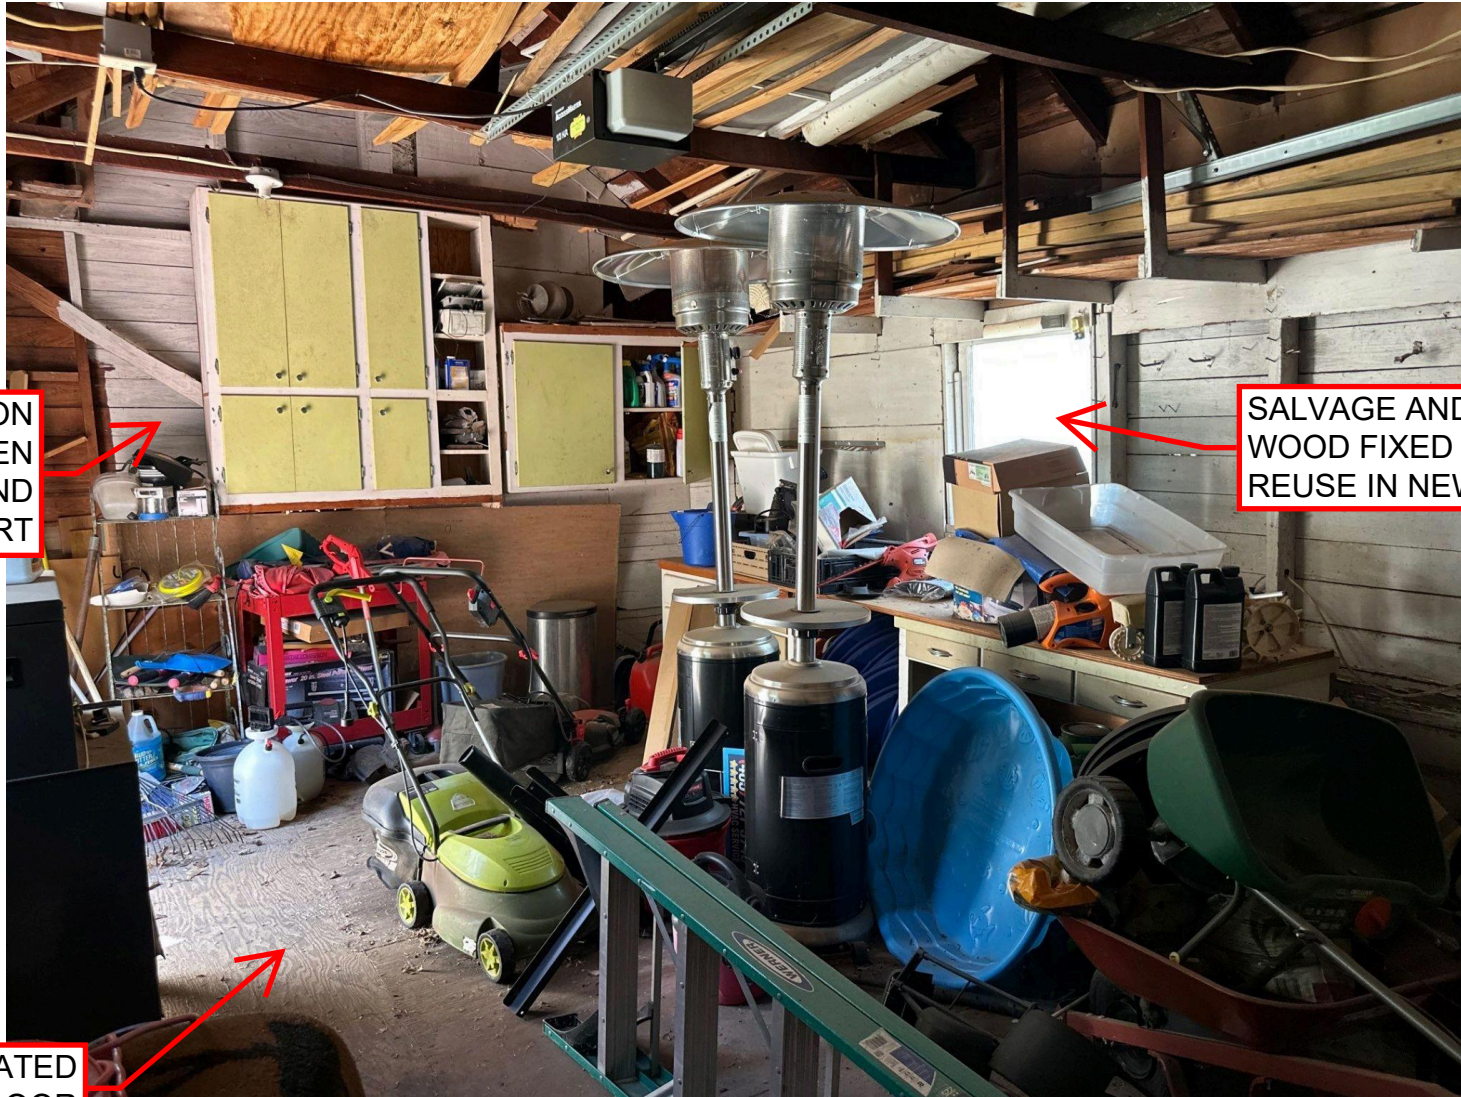
PARTITION WALL BETWEEN GARAGE AND CARPORT

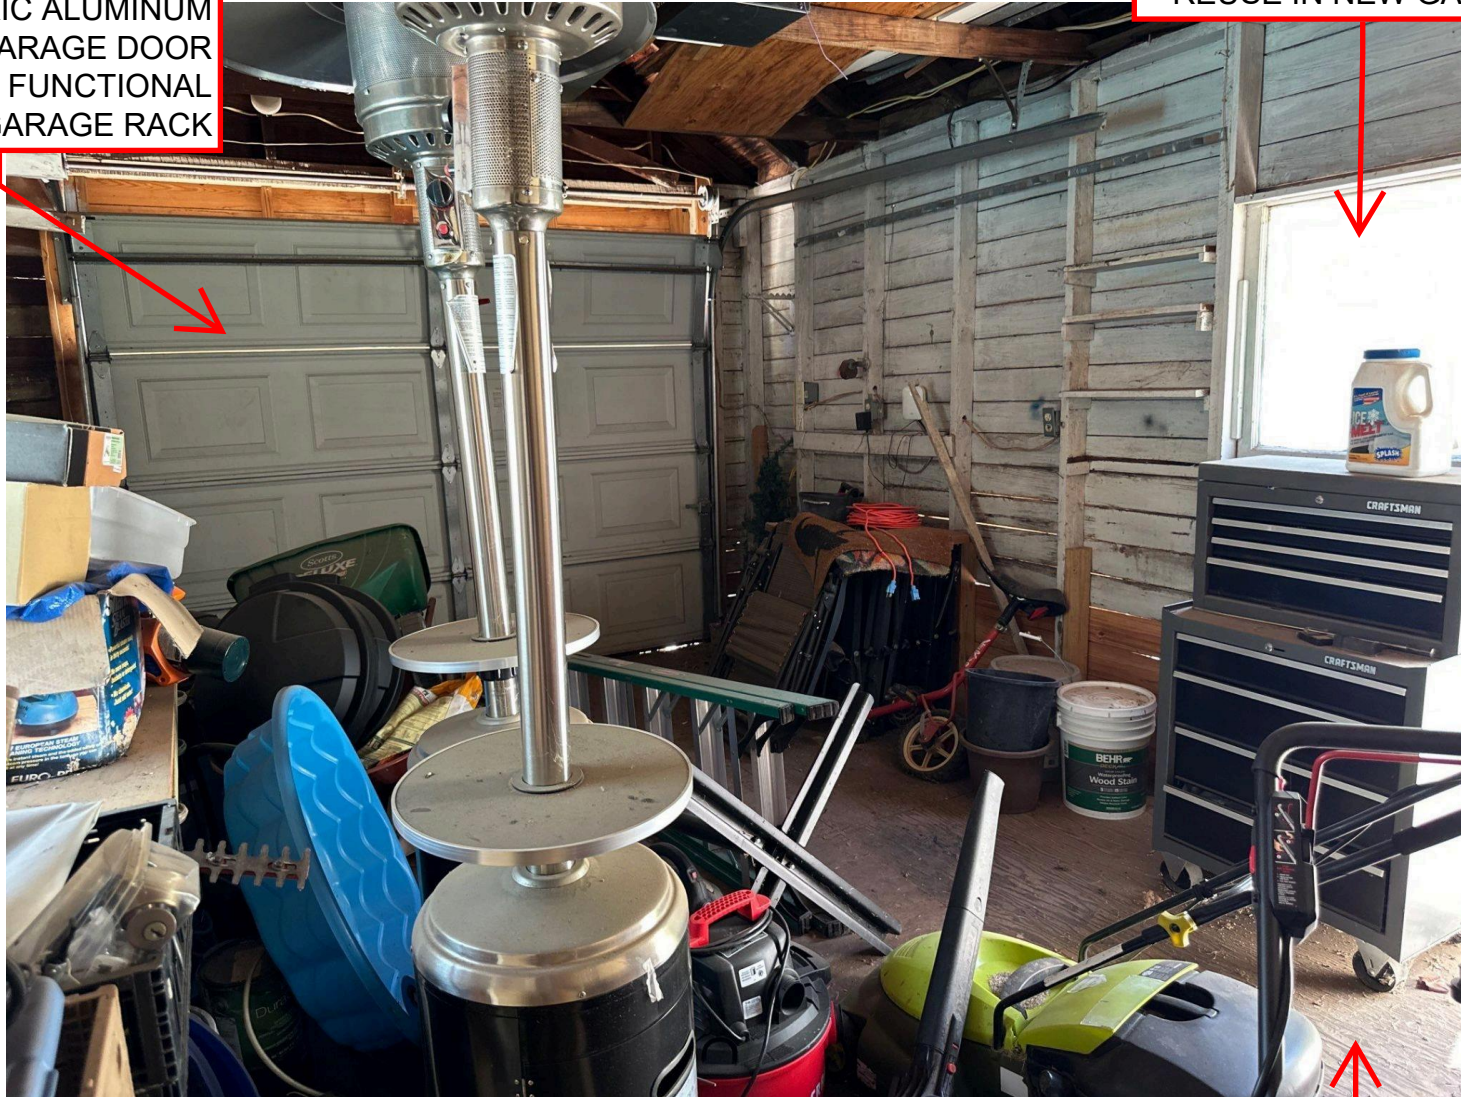
GARAGE INTERIOR LOOKING EAST-SOUTHEAST

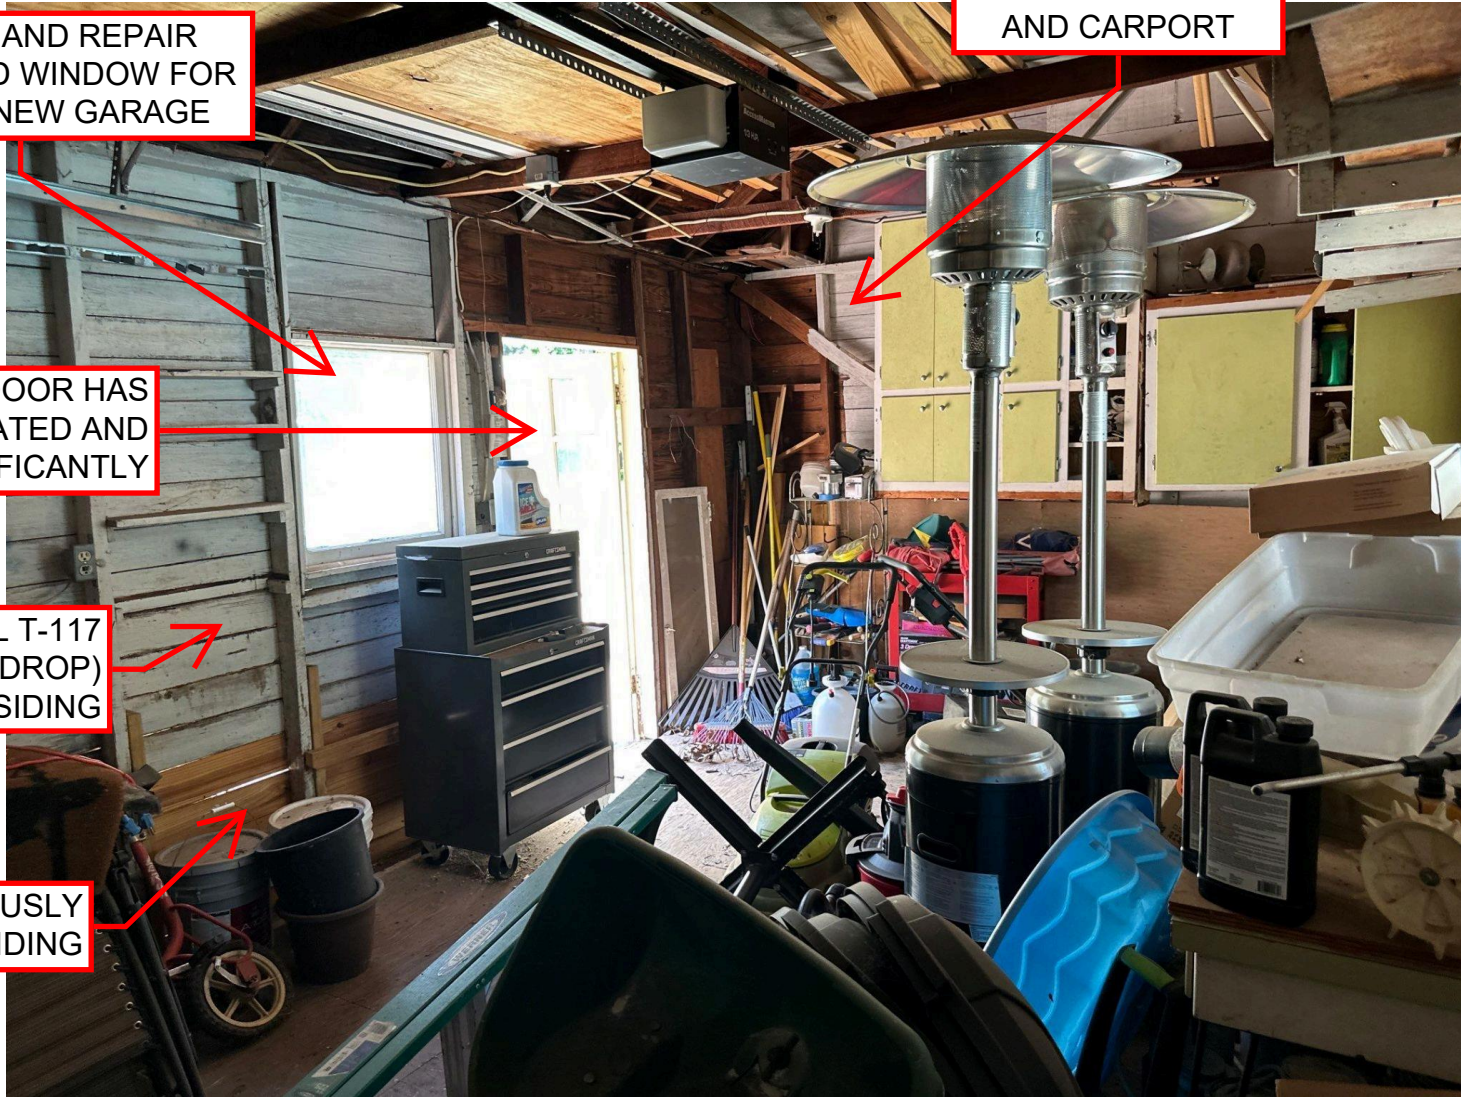
GARAGE INTERIOR LOOKING WEST-SOUTHWEST
