# MEMORANDUM

**TO:** JEFFREY HERCZEG, DIRECTOR OF PUBLIC WORKS  
**FROM:** MATT WIKTOROWSKI, FIELD OPERATIONS MANAGER  
**SUBJECT:** OPEN DRAINS (DITCHES) ASSET MANAGEMENT  
**DATE:** MARCH 20, 2025

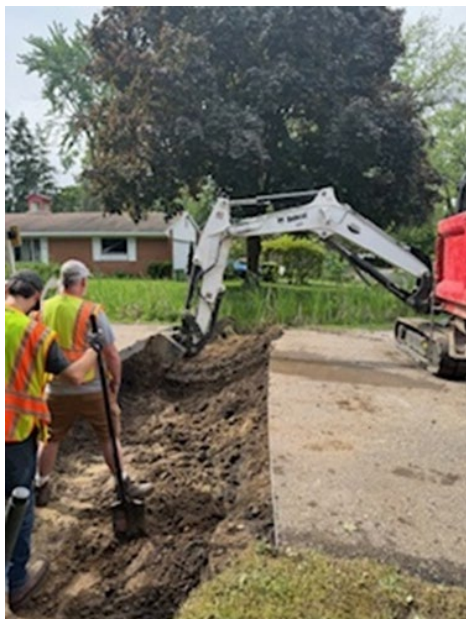
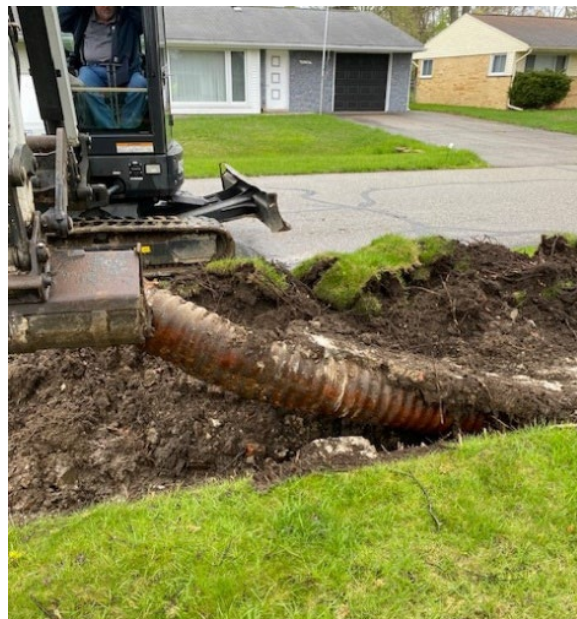
**Removing and replacing culverts between ditches**

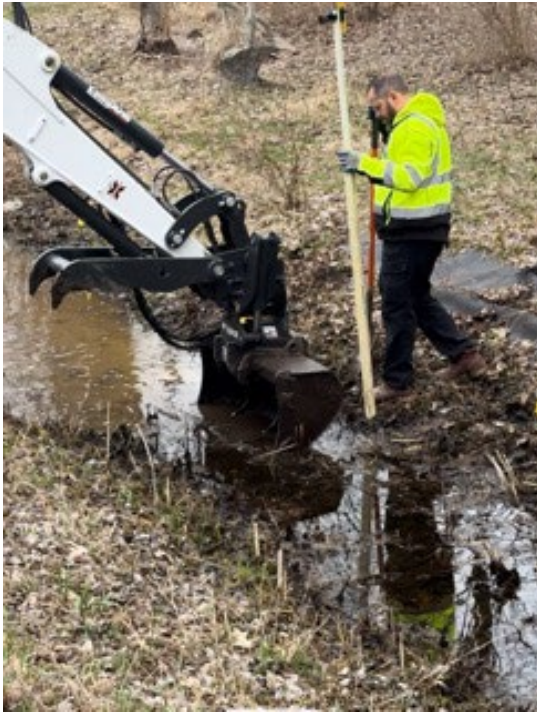
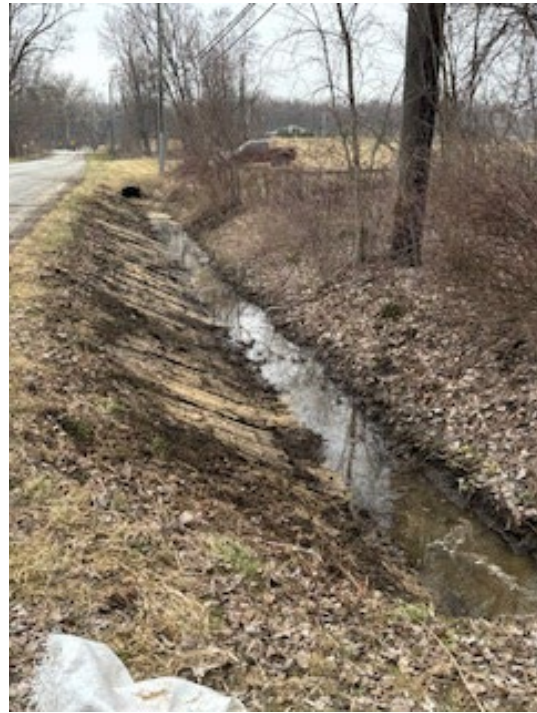
**Cleaning a ditch full of sediment**

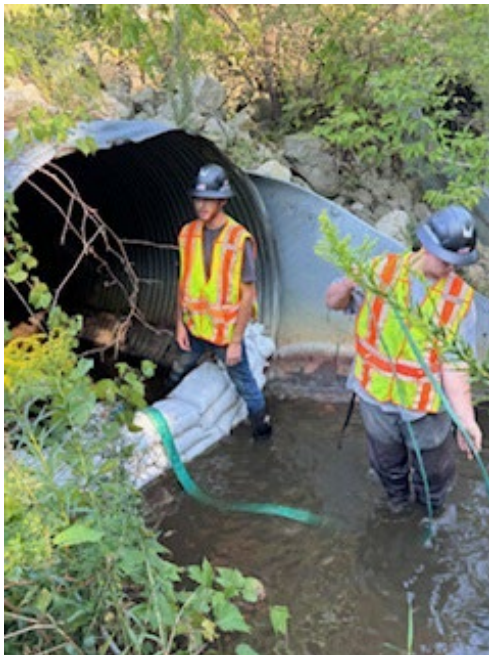
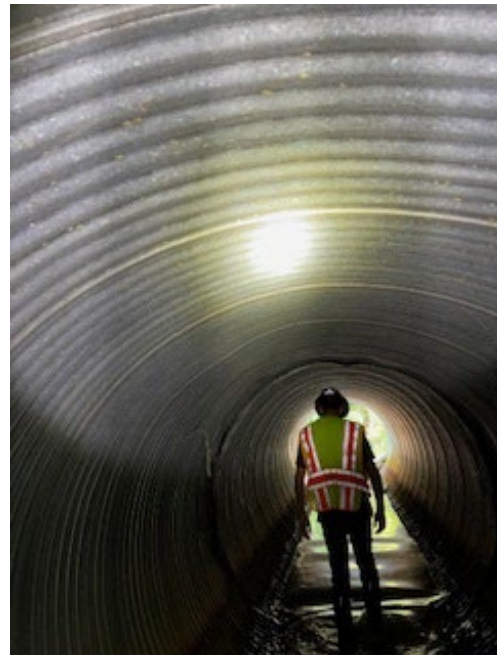
**Inspecting high water volume culverts before making structural repairs**
