CITY PARKING LOT IMPROVEMENTS 2025

218 CHURCH STREET, SANDPOINT, IDAHO

Idaho Department Of Lands Tree Inventory

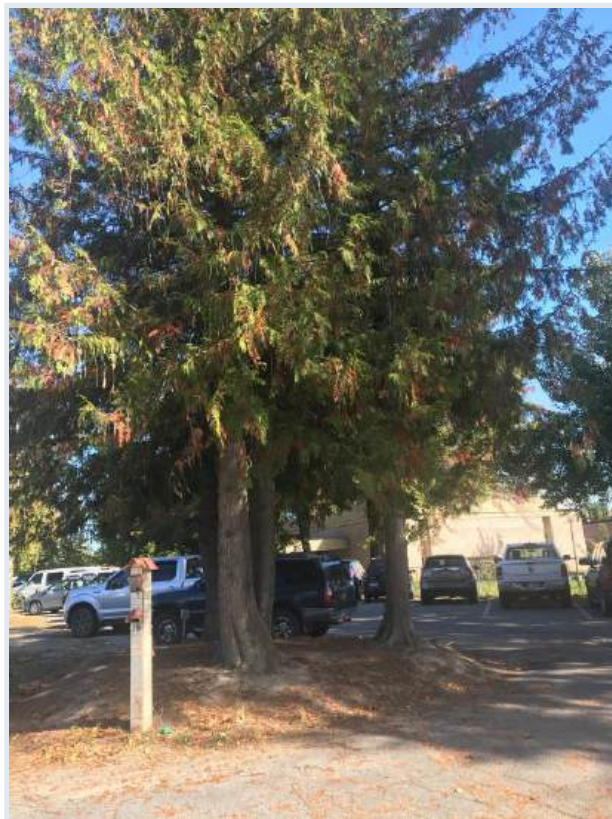
IMG_2707.jpg
9/29/2018

Tree Id:	7764
Latin Name:	Thuja plicata
Common Name:	Western Redcedar
Cultivar:	
Genus:	Thuja
Code:	THPL
Status:	Alive
Year Planted:	
DBH:	14
DBH Range:	12-18in
Tree Height:	
Number of Stems:	1
Condition:	Good - No Apparent Problems
Percent Dieback:	None
Crown Class:	Co-Dominant
Clearance Conflicts:	None

Observations:	
Stock Type:	
Tree Comments:	
Family:	Cupressaceae
Has Ecobenefits:	Yes
Last Modified:	09/29/2018
Upload ID:	upld_5818ec7cd30a8
User - Upload:	
Last Inspection:	
Next Inspection:	
Inspection Cycle:	
Crown Light Exposure:	
Archived:	No
Tree Protection Zone(TPZ):	
Critical Root Zone(CRZ):	
TPZ Ratio:	
CRZ Ratio:

Management Needs	
Primary Maintenance:	Large Tree (routine)
Secondary Maintenance:	None Needed
Wires:	No Lines
Watch This Tree? :	No
Maintenance Comments:	Consider removing one of the two trunks to prevent future problem. Not high priority.
Organization:	Sandpoint
User:	SP_sdrinkard

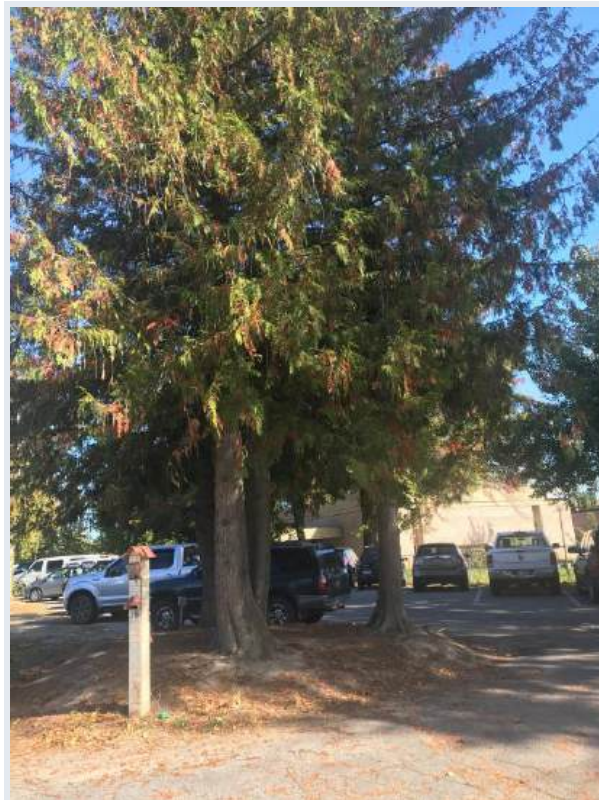
IMG_2707.jpg
9/29/2018

Condition:	Good - No Apparent Problems
Percent Dieback:	None
Crown Class:	Co-Dominant
Clearance Conflicts:	None
Observations:	Poor Structure, Double Leader
Stock Type:	
Tree Comments:	Two trunked cedar.
Family:	Cupressaceae
Has Ecobenefits:	Yes
Last Modified:	09/29/2018
Upload ID:	upld_5818ec7cd30a8
User - Upload:	
Last Inspection:	
Next Inspection:	
Inspection Cycle:	
Crown Light Exposure:	
Archived:	No
Tree Protection Zone(TPZ):	
Critical Root Zone(CRZ):	
TPZ Ratio:	
CRZ Ratio:

Management Needs	
Primary Maintenance:	Large Tree (routine)
Secondary Maintenance:	Monitor, Prune-structural
Wires:	No Lines
Watch This Tree? :	No
Maintenance Comments:	Consider removing one of the two trunks to prevent future problem. Not high priority.
Organization:	Sandpoint
User:

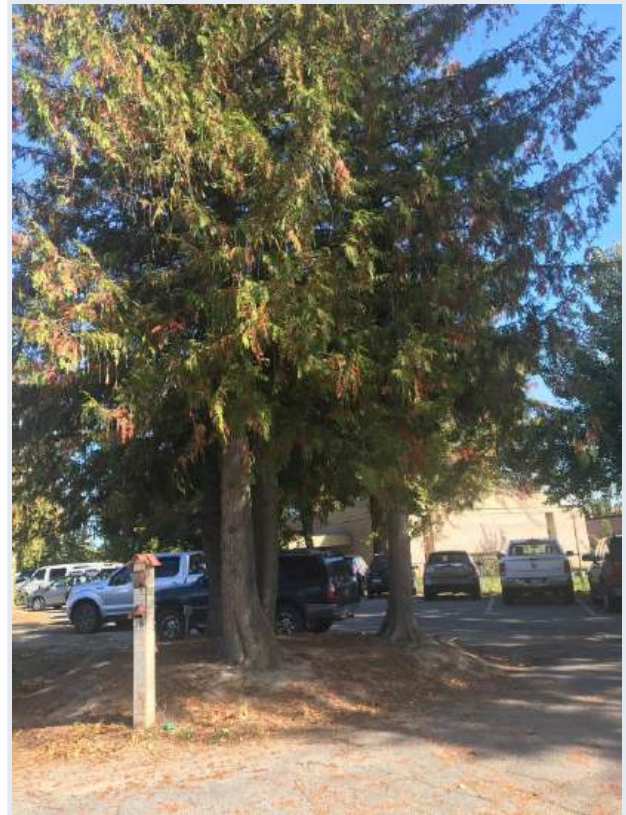
IMG_2707.jpg
9/29/2018

Tree Id:	7765
Latin Name:	Thuja plicata
Common Name:	Western Redcedar
Cultivar:	
Genus:	Thuja
Code:	THPL
Status:	Alive
Year Planted:	
DBH:	14
DBH Range:	12-18in
Tree Height:	
Number of Stems:	1
Condition:	Good - No Apparent Problems
Percent Dieback:	None
Crown Class:	Co-Dominant
Clearance Conflicts:	None

Observations:	
Stock Type:	
Tree Comments:	
Family:	Cupressaceae
Has Ecobenefits:	Yes
Last Modified:	09/29/2018
Upload ID:	upld_5818ec7cd30a8
User - Upload:	
Last Inspection:	
Next Inspection:	
Inspection Cycle:	
Crown Light Exposure:	
Archived:	No
Tree Protection Zone(TPZ):	
Critical Root Zone(CRZ):	
TPZ Ratio:	
CRZ Ratio:

Management Needs	
Primary Maintenance:	Large Tree (routine)
Secondary Maintenance:	None Needed
Wires:	No Lines
Watch This Tree? :	No
Maintenance Comments:	Consider removing one of the two trunks to prevent future problem. Not high priority.
Organization:	Sandpoint
User:	SP_sdrinkard

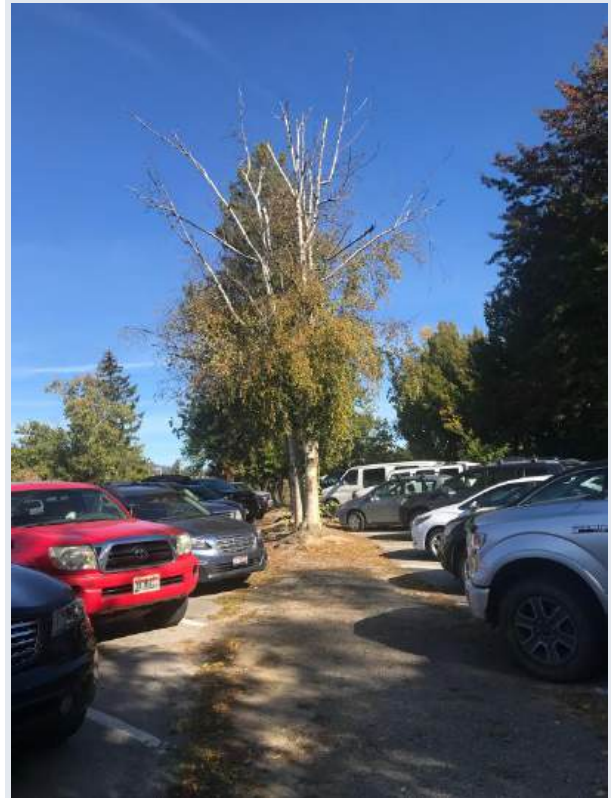
IMG_2708.jpg
9/29/2018

Tree Id:	7766
Latin Name:	Betula papyrifera
Common Name:	Paper Birch
Cultivar:	
Genus:	Betula
Code:	BEPA
Status:	Alive
Year Planted:	
DBH:	25
DBH Range:	24-30in
Tree Height:	
Number of Stems:	Multiple Stems
Condition:	Dead / Dying

Percent Dieback:	50-75%
Crown Class:	Co-Dominant
Clearance Conflicts:	None
Observations:	Crown Dieback
Stock Type:	
Tree Comments:	Tree in serious decline
Family:	Betulaceae
Has Ecobenefits:	Yes
Last Modified:	09/29/2018
Upload ID:	upld_5818ec7cd30a8
User - Upload:	
Last Inspection:	
Next Inspection:	
Inspection Cycle:	
Crown Light Exposure:	
Archived:	No
Tree Protection Zone(TPZ):	
Critical Root Zone(CRZ):	
TPZ Ratio:	
CRZ Ratio:

Management Needs	
Primary Maintenance:	Large Tree (routine)
Secondary Maintenance:	Remove
Wires:	No Lines
Watch This Tree? :	Yes
Maintenance Comments:	Remove. Serious decline. Not aesthetically pleasing in popular lot.
Organization:	Sandpoint
User:	SP_sdrinkard

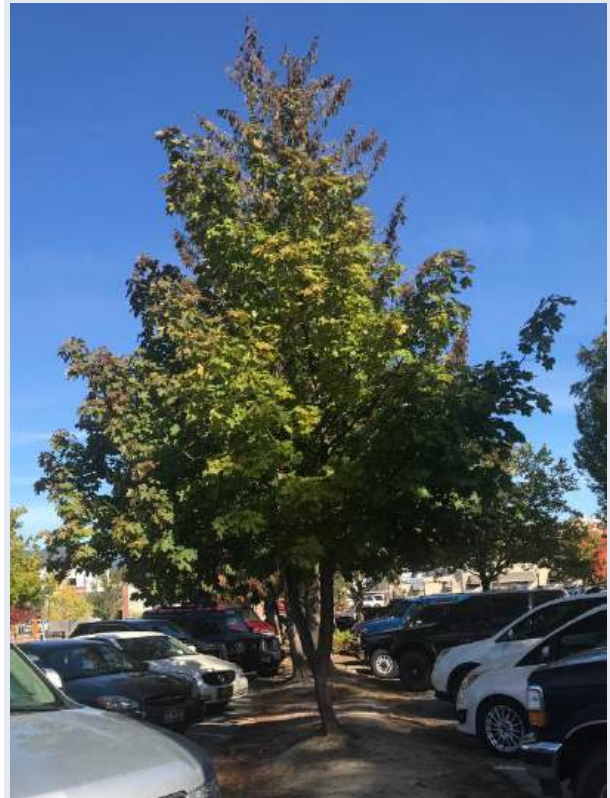
IMG_2712 (1).jpg
9/30/2018

Tree Id:	7768
Latin Name:	Acer saccharum
Common Name:	Sugar Maple
Cultivar:	
Genus:	Acer
Code:	ACSA2
Status:	Alive
Year Planted:	
DBH:	6
DBH Range:	6-12in
Tree Height:	
Number of Stems:	1
Condition:	Fair - Minor Problems

Percent Dieback:	None
Crown Class:	Dominant
Clearance Conflicts:	None
Observations:	Poor Structure, Double Leader
Stock Type:	
Tree Comments:	Double trunk.
Family:	Sapindaceae
Has Ecobenefits:	Yes
Last Modified:	09/30/2018
Upload ID:	upld_5818ec7cd30a8
User - Upload:	
Last Inspection:	
Next Inspection:	
Inspection Cycle:	
Crown Light Exposure:	
Archived:	No
Tree Protection Zone(TPZ):	
Critical Root Zone(CRZ):	
TPZ Ratio:	
CRZ Ratio:

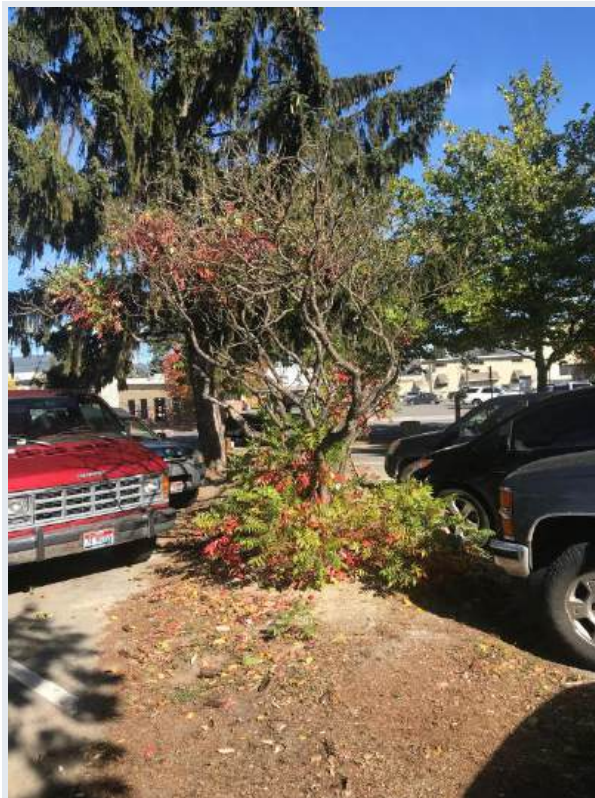
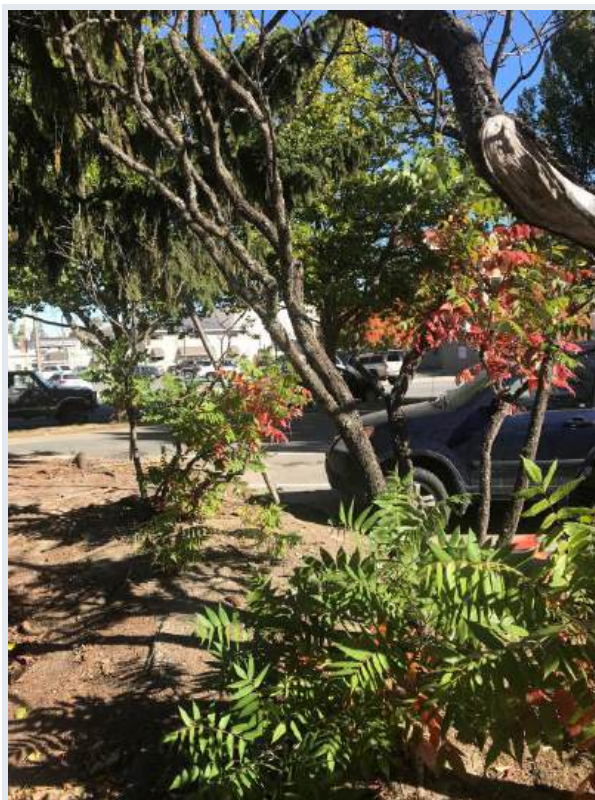
IMG_2714.jpg
9/30/2018

Tree Id:	7770
Latin Name:	Rhus spp
Common Name:	Sumac
Cultivar:	
Genus:	Rhus
Code:	RHSP
Status:	Alive
Year Planted:	
DBH:	3
DBH Range:	3-6in
Tree Height:	
Number of Stems:	Multiple Stems
Condition:	Poor - Major Problems

Percent Dieback:	25-50%
Crown Class:	Overtopped
Clearance Conflicts:	None
Observations:	Nutrient Deficiency, Poor Location, Poor Structure, Serious Decline, Crown Dieback
Stock Type:	
Tree Comments:	There are three "shrub trees" in a row. Perhaps Sumac is species, but in any case there is significant "crown" dieback. Don't really belong if they cannot be trained to be one trunk trees.
Family:	Anacardiaceae
Has Ecobenefits:	Yes
Last Modified:	09/30/2018
Upload ID:	upld_5818ec7cd30a8
User - Upload:	
Last Inspection:	
Next Inspection:	
Inspection Cycle:	
Crown Light Exposure:	
Archived:	No
Tree Protection Zone(TPZ):	
Critical Root Zone(CRZ):	
TPZ Ratio:	
CRZ Ratio:

Management Needs	
Primary Maintenance:	Small Tree (immediate)
Secondary Maintenance:	Remove
Wires:	No Lines
Watch This Tree? :	Yes

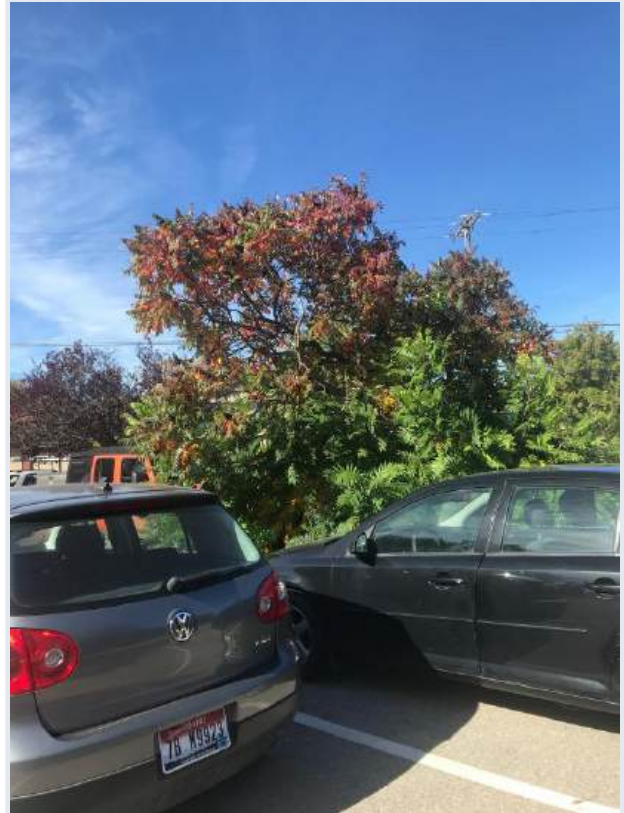
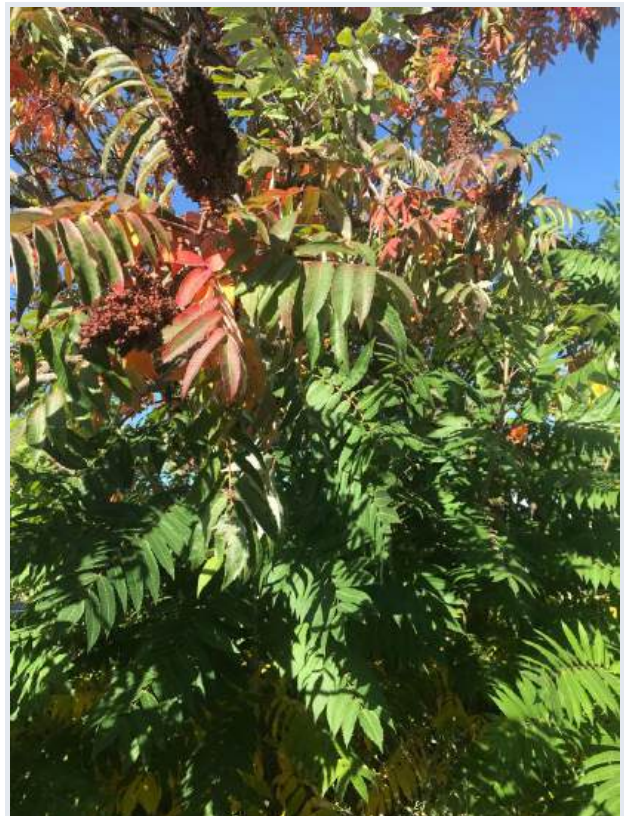
IMG_2704.jpg
9/29/2018

Tree Id:	7763
Latin Name:	Rhus spp
Common Name:	Sumac
Cultivar:	
Genus:	Rhus
Code:	RHSP
Status:	Alive
Year Planted:	
DBH:	3
DBH Range:	3-6in
Tree Height:	
Number of Stems:	Multiple Stems
Condition:	Fair - Minor Problems
Percent Dieback:	25-50%
Crown Class:	Overtopped
Clearance Conflicts:	None

Observations:	Improperly Pruned, Poor Location, Poor Structure
Stock Type:	
Tree Comments:	Not sure that this is a sumac. In any case it needs to be heavily pruned for tree shape or removed.
Family:	Anacardiaceae
Has Ecobenefits:	Yes
Last Modified:	09/29/2018
Upload ID:	
User - Upload:	
Last Inspection:	
Next Inspection:	
Inspection Cycle:	
Crown Light Exposure:	
Archived:	No
Tree Protection Zone(TPZ):	
Critical Root Zone(CRZ):	
TPZ Ratio:	
CRZ Ratio:

Management Needs	
Primary Maintenance:	Small Tree (routine/train)
Secondary Maintenance:	Prune-structural, Remove, Remove Suckers
Wires:	No Lines
Watch This Tree? :	Yes
Maintenance Comments:	Train to be single trunk tree or remove.
Organization:	Sandpoint
User:	SP_sdrinkard

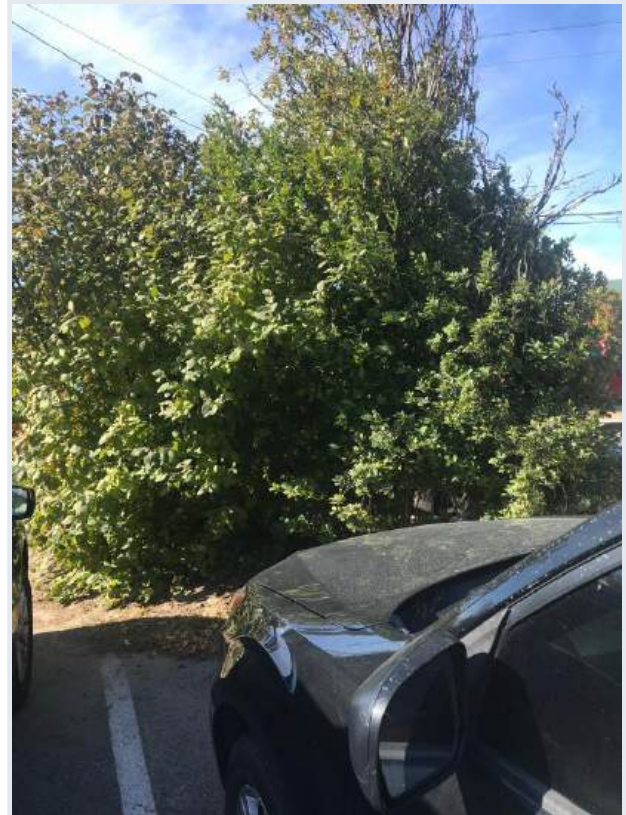
IMG_2702.jpg
9/29/2018

Tree Id:	7762
Latin Name:	Amelanchier spp
Common Name:	Serviceberry
Cultivar:	
Genus:	Amelanchier
Code:	AM
Status:	Alive
Year Planted:	
DBH:	3
DBH Range:	3-6in
Tree Height:	
Number of Stems:	Multiple Stems
Condition:	Fair - Minor Problems
Percent Dieback:	25-50%
Crown Class:	Overtopped
Clearance Conflicts:	None

Observations:	Improperly Pruned, Poor Location
Stock Type:	
Tree Comments:	Not sure that this is a service berry. In any case it needs to be heavily pruned for tree shape or removed.
Family:	Rosaceae
Has Ecobenefits:	Yes
Last Modified:	09/29/2018
Upload ID:	
User - Upload:	
Last Inspection:	
Next Inspection:	
Inspection Cycle:	
Crown Light Exposure:	
Archived:	No
Tree Protection Zone(TPZ):	
Critical Root Zone(CRZ):	
TPZ Ratio:	
CRZ Ratio:

Management Needs	
Primary Maintenance:	Small Tree (routine/train)
Secondary Maintenance:	Prune-structural, Remove, Remove Suckers
Wires:	No Lines
Watch This Tree? :	Yes
Maintenance Comments:	
Organization:	Sandpoint
User:	SP_sdrinkard

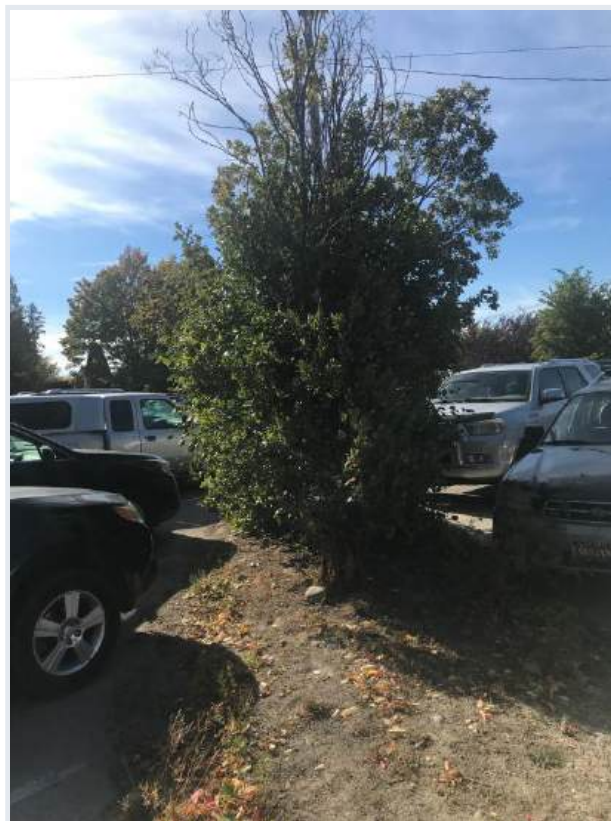
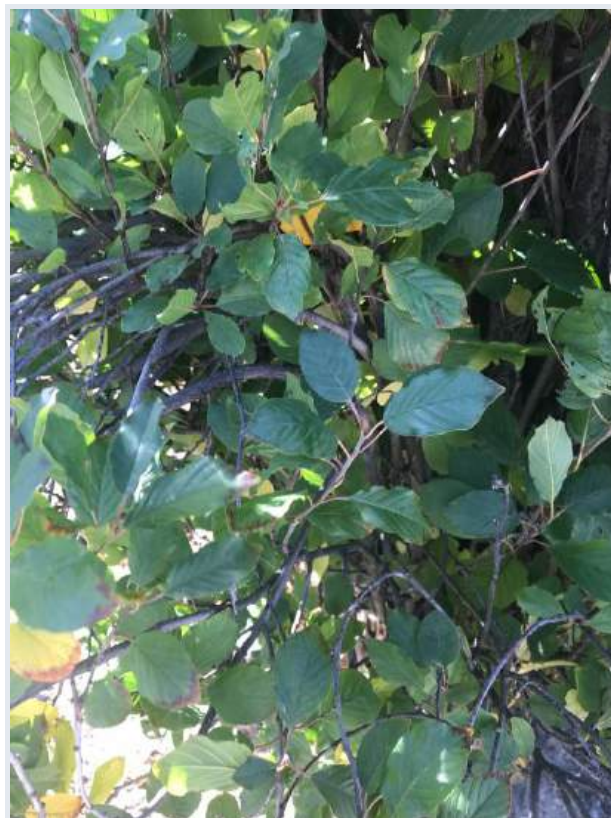
IMG_2699.jpg
9/29/2018

Tree Id:	7761
Latin Name:	Other
Common Name:	Other
Cultivar:	
Genus:	Other
Code:	
Status:	Alive
Year Planted:	
DBH:	
DBH Range:	
Tree Height:	3
Number of Stems:	Multiple Stems
Condition:	Fair - Minor Problems
Percent Dieback:	25-50%
Crown Class:	Overtopped
Clearance Conflicts:	None

Observations:	Improperly Pruned, Poor Location, Poor Structure
Stock Type:	
Tree Comments:	This is tree turned shrub. Not sure at this time is species.
Family:	
Has Ecobenefits:	No
Last Modified:	12/19/2022
Upload ID:	
User - Upload:	
Last Inspection:	
Next Inspection:	
Inspection Cycle:	
Crown Light Exposure:	Three sides of the crown are exposed to light.
Archived:	No
Tree Protection Zone(TPZ):	
Critical Root Zone(CRZ):	
TPZ Ratio:	
CRZ Ratio:

Primary Maintenance:	Remove Tree
Secondary Maintenance:	Remove
Wires:	No Lines
Watch This Tree? :	Yes
Maintenance Comments:	Need to replace with a single trunk tree that doesn't "hide" areas of the lot.
Organization:	Sandpoint
User:	SP_sdrinkard

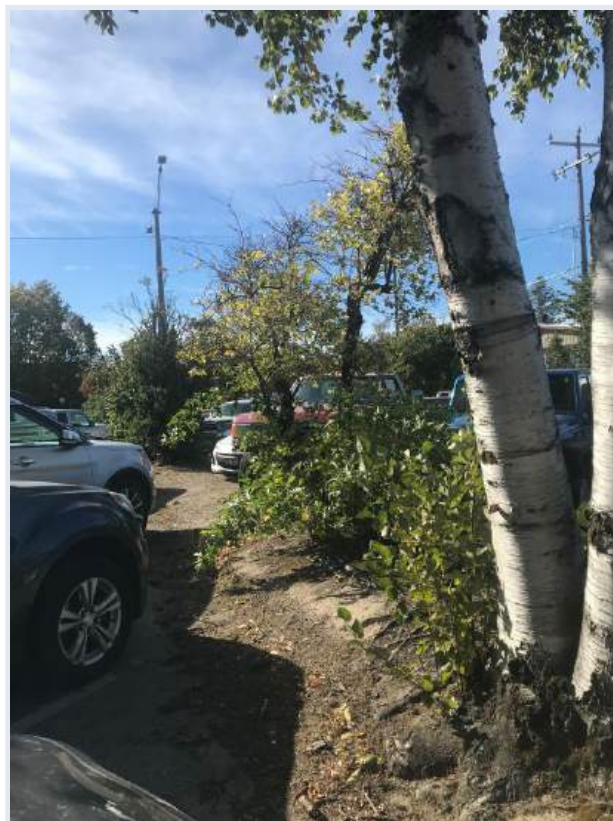
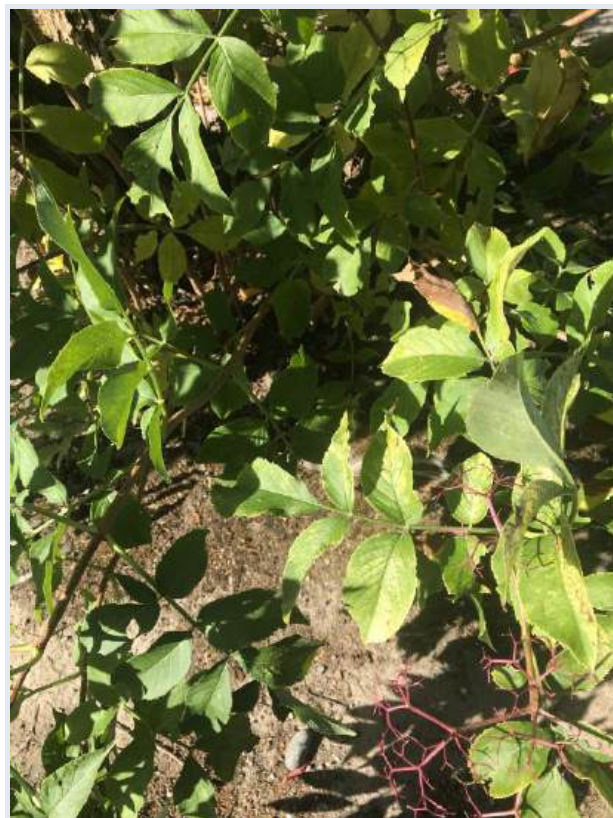
IMG_2697.jpg
9/29/2018

Condition: Poor - Major Problems

Stock Type:	
Tree Comments:	This is a shrub shape that MAY be a paper birch.
Family:	Betulaceae
Has Ecobenefits:	Yes
Last Modified:	09/29/2018
Upload ID:	upld_5818ec7cd30a8
User - Upload:	
Last Inspection:	
Next Inspection:	
Inspection Cycle:	
Crown Light Exposure:	
Archived:	No
Tree Protection Zone(TPZ):	
Critical Root Zone(CRZ):	
TPZ Ratio:	
CRZ Ratio:

Management Needs	
Primary Maintenance:	Remove Suckers
Secondary Maintenance:	Remove, Remove Suckers
Wires:	No Lines
Watch This Tree? :	Yes
Maintenance Comments:	
Organization:	Sandpoint
User:

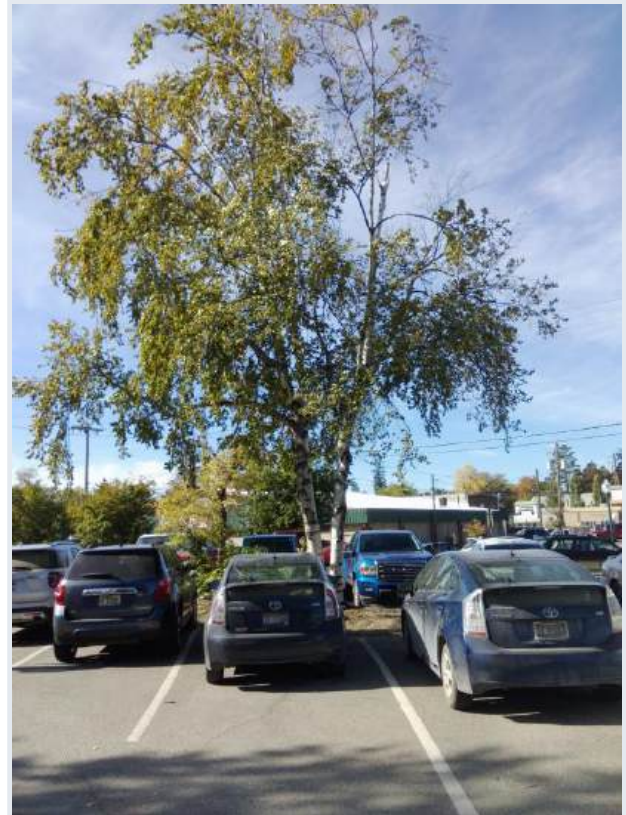
1538156107113336297303.jpg
9/28/2018

Tree Id:	
Latin Name:	Betula papyrifera
Common Name:	Paper Birch
Cultivar:	
Genus:	Betula
Code:	BEPA
Status:	Alive
Year Planted:	
DBH:	20
DBH Range:	18-24in
Tree Height:	
Number of Stems:	Multiple Stems
Condition:	Fair - Minor Problems
Percent Dieback:	25-50%
Crown Class:	Intermediate
Clearance Conflicts:	None

Observations:	Improperly Mulched, Crown Dieback
Stock Type:	
Tree Comments:	
Family:	Betulaceae
Has Ecobenefits:	Yes
Last Modified:	09/29/2018
Upload ID:	upld_5818ec7cd30a8
User - Upload:	
Last Inspection:	
Next Inspection:	
Inspection Cycle:	
Crown Light Exposure:	
Archived:	No
Tree Protection Zone(TPZ):	
Critical Root Zone(CRZ):	
TPZ Ratio:	
CRZ Ratio:

Management Needs	
Primary Maintenance:	Large Tree (routine)
Secondary Maintenance:	Crown Cleaning, Prune- structural, Remove Suckers
Wires:	No Lines
Watch This Tree? :	Yes
Maintenance Comments:	Lots of suckers. Including what may be all the plant material immediately south of this tree.
Organization:	Sandpoint
User:
