SWANSBORO HISTORIC PRESERVATION COMMISSION CERTIFICATE OF APPROPRIATENESS

Application # COA-2023-03

The Clen Irvin House

To: Brad & Kenna Phillips
From: Sean Corcoran, PE
Subj: 205 S. Walnut St., Swansboro: Evaluation of General Structural-Related Issues
Date: 12-6-22

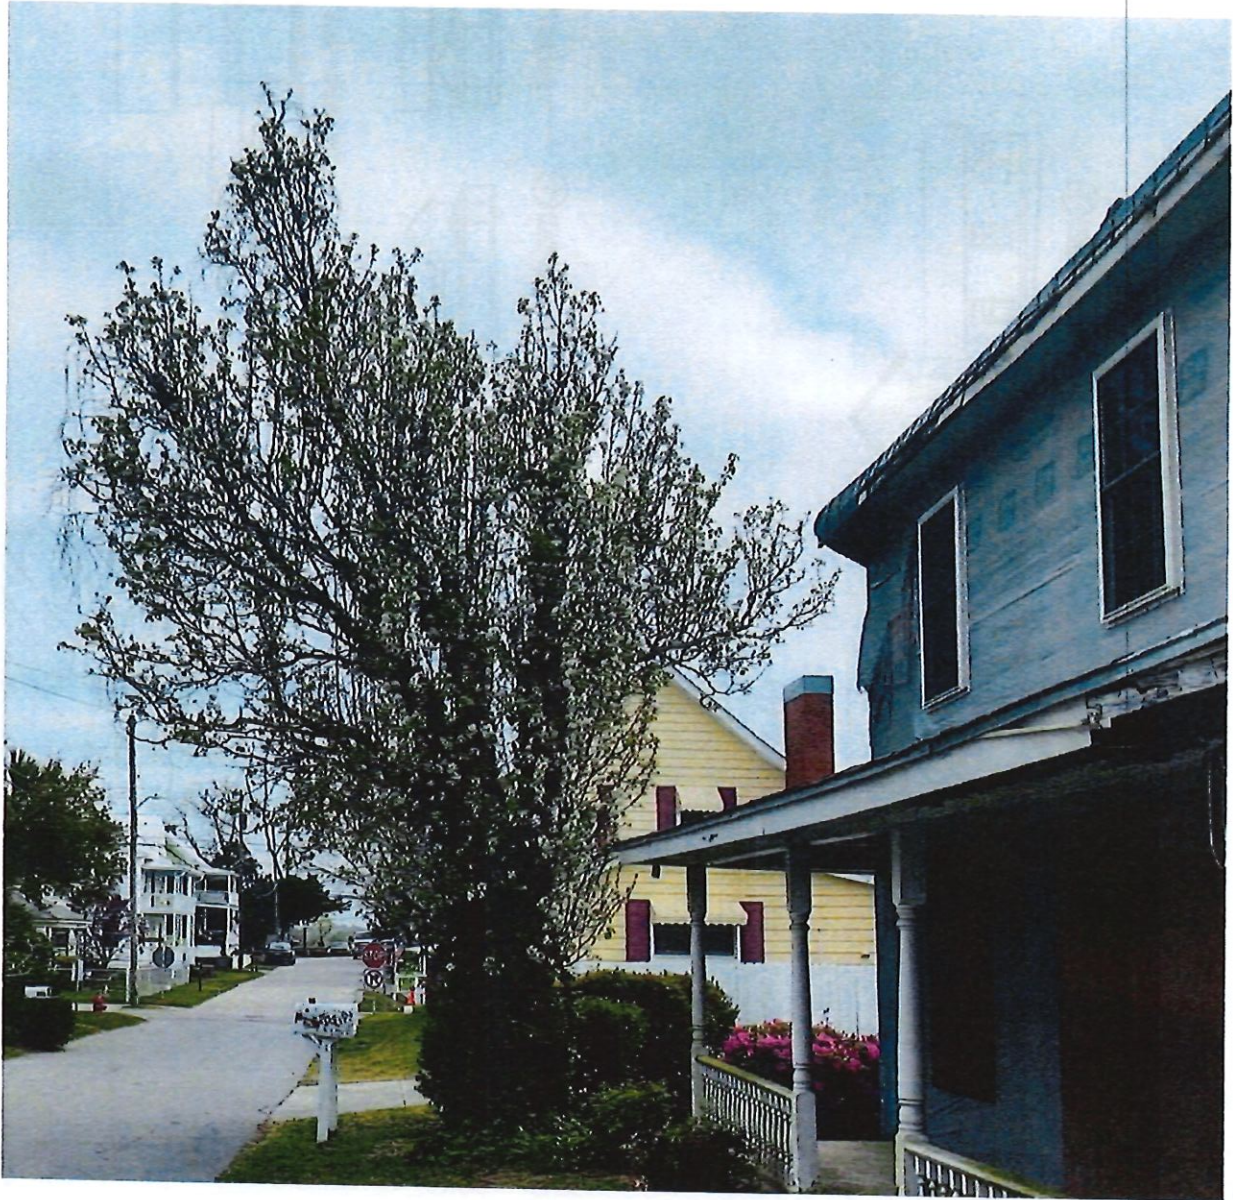
We will remove two trees, both Bradford pears, that were damaged in the hurricane. They are weakened, split, and endanger the house and property. Replacement will be with palms or similar trees.

Damaged tree to be removed

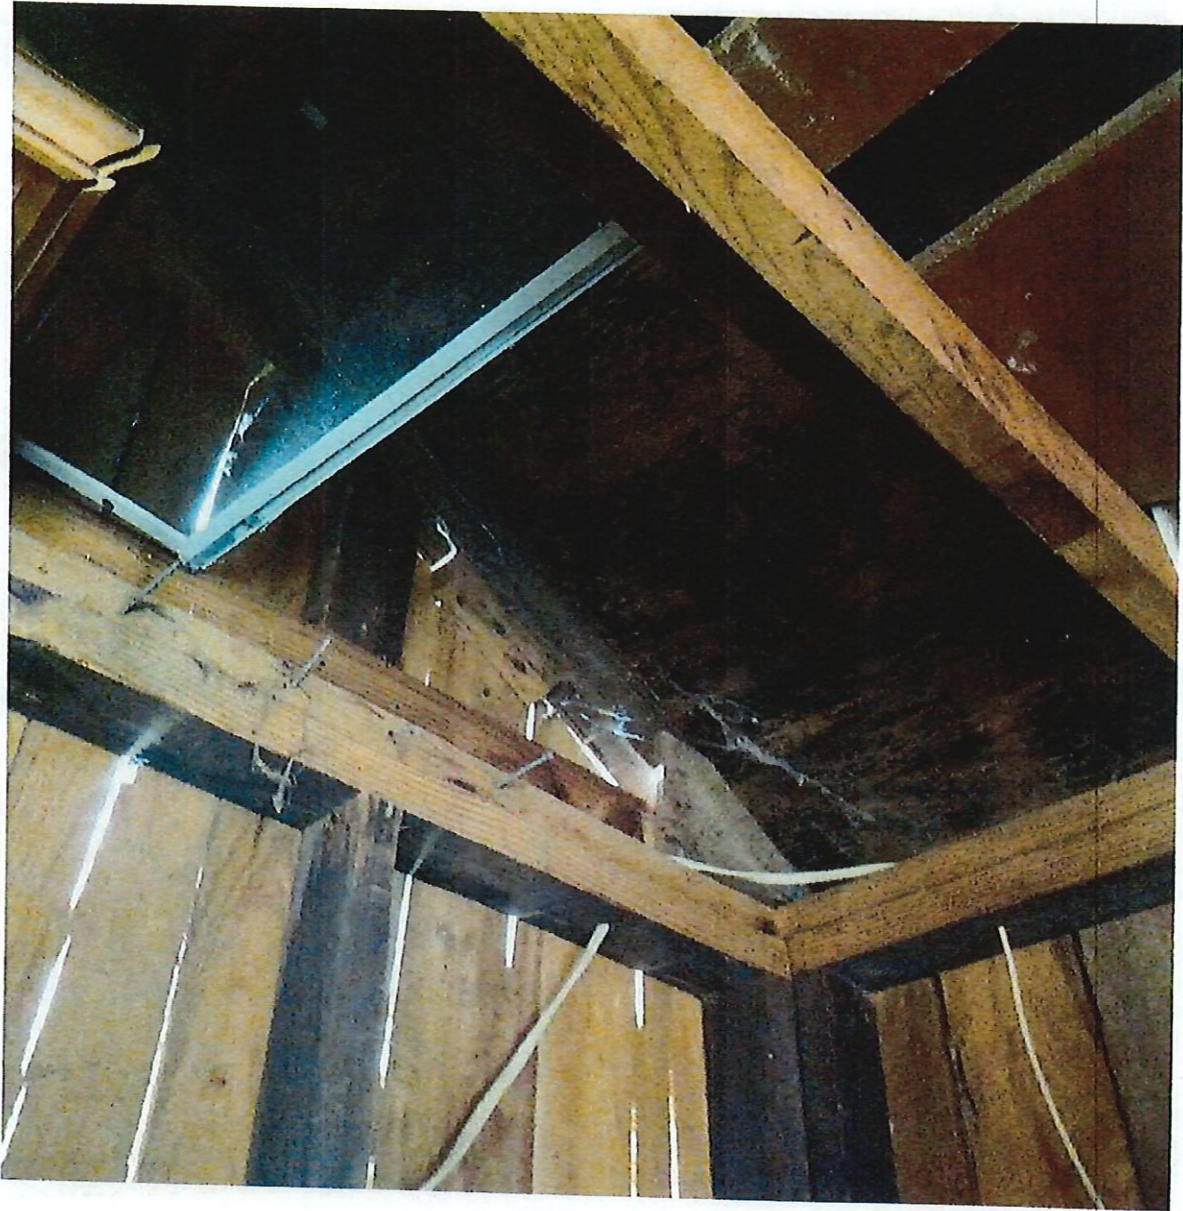
Shed Interior/Ceiling damage

The shed/workshop will be renovated and converted to a detached front-loading garage, per consultation with John Wood. New siding and roof matching the house will be installed.

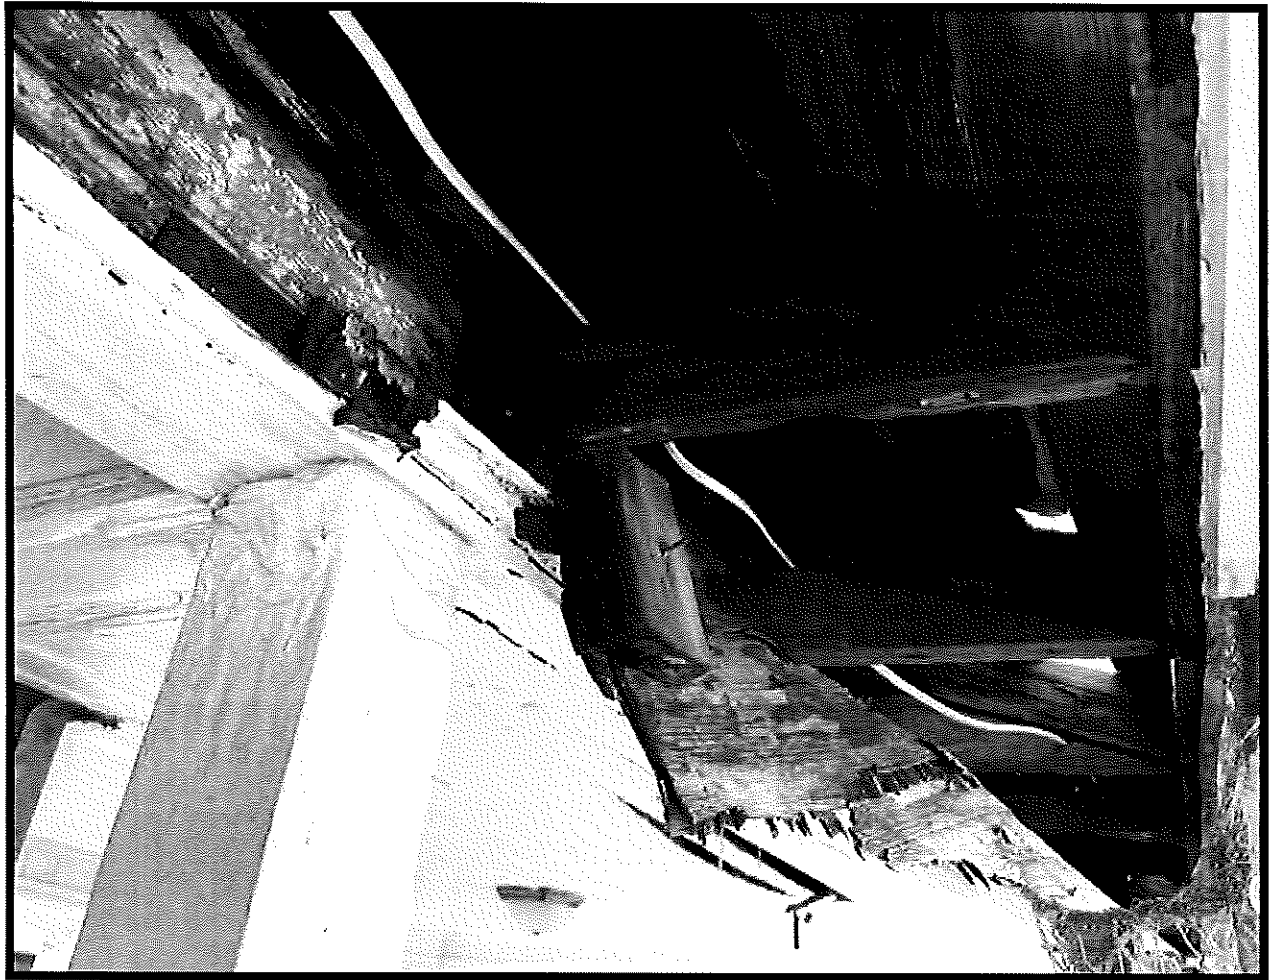
- Significant water damage was observed at the front and right-side porch structure, which is not considered serviceable. *See photo #1.*
- Much of the roof surface is concealed by tarps. The exposed portions are considered damaged or poorly executed, including the rear low-slope fiberglass shingle installation.
- Various modifications were present in the attic such as: new roof sheathing, collar-ties, and gable end framing. *See photo #2.*
- The ceiling joists have also been reinforced with 2 x 12's and ¾" plywood decking for storage. *See photo #3.*
- The front wall header over the front door is incomplete. *See photo #4.*
- Most of the walls have been significantly reinforced with 'sistered' wall studs and new sheathing. *See photo #5.*

Photo #1: Significant water damage was observed to the roof system associated with the front porch/carport structure.

1. The front porch and carport structure require complete reconstruction.
2. The roof surfaces should be restored using metal roofing components.
3. The reinforcement of the upper roof structure is considered effective. Perform similar improvements to all portions of the roof structure.
4. Wall structural improvements are also considered to be adequate. Some wall portions require completion.
5. The floor system main girders/piers require only minor/general modifications to be restored.
6. The foundation perimeter 'in-fill' requires restoration.
7. See Crawlspace recommendations below.

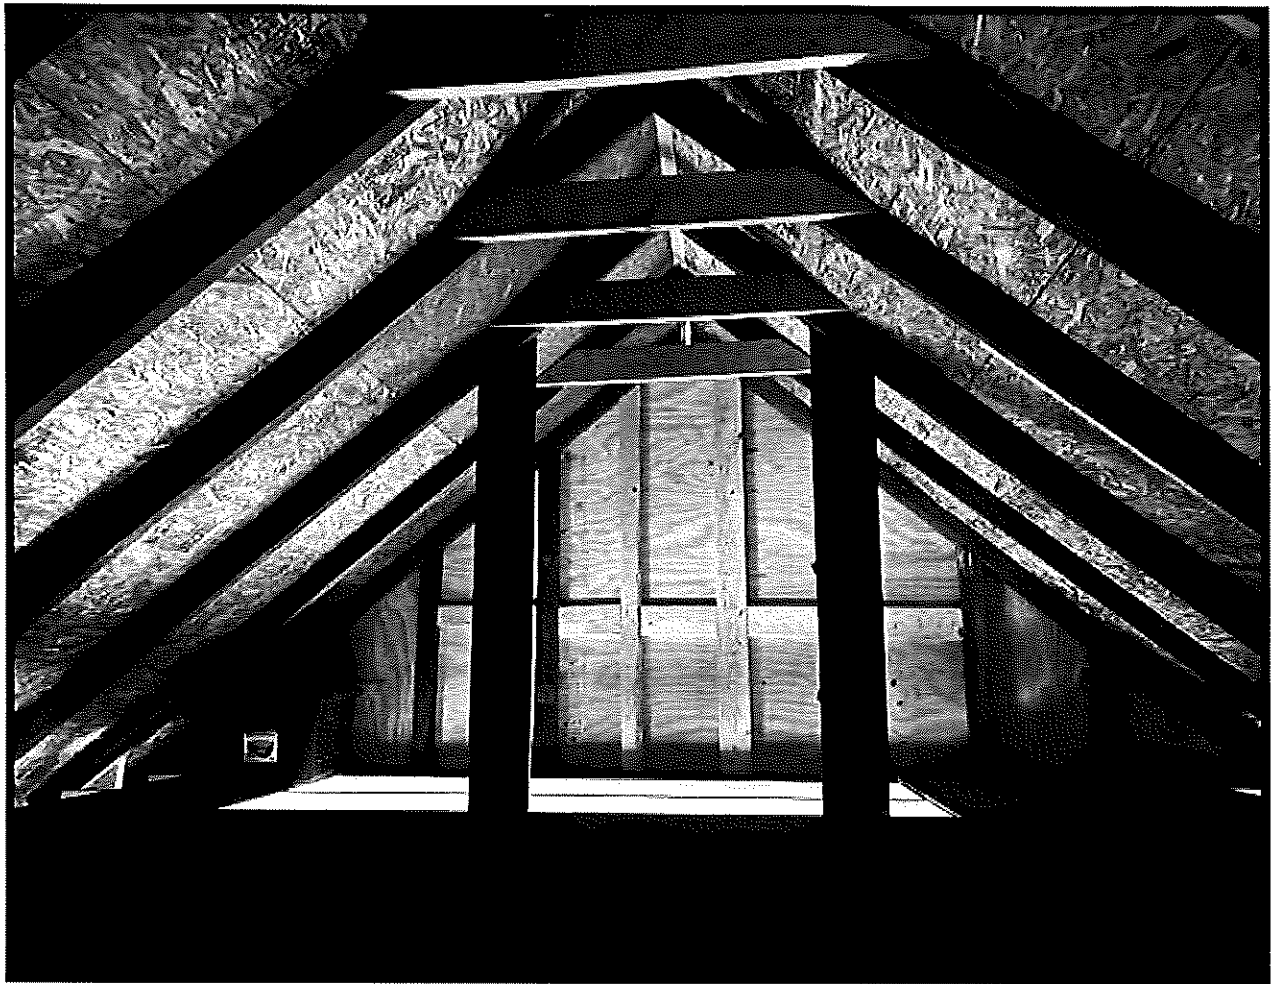
Photo #2: Attic construction: new roof sheathing, gable end wall studs/sheathing, collar-ties, reinforced ceiling joists and 3/4" plywood attic decking.

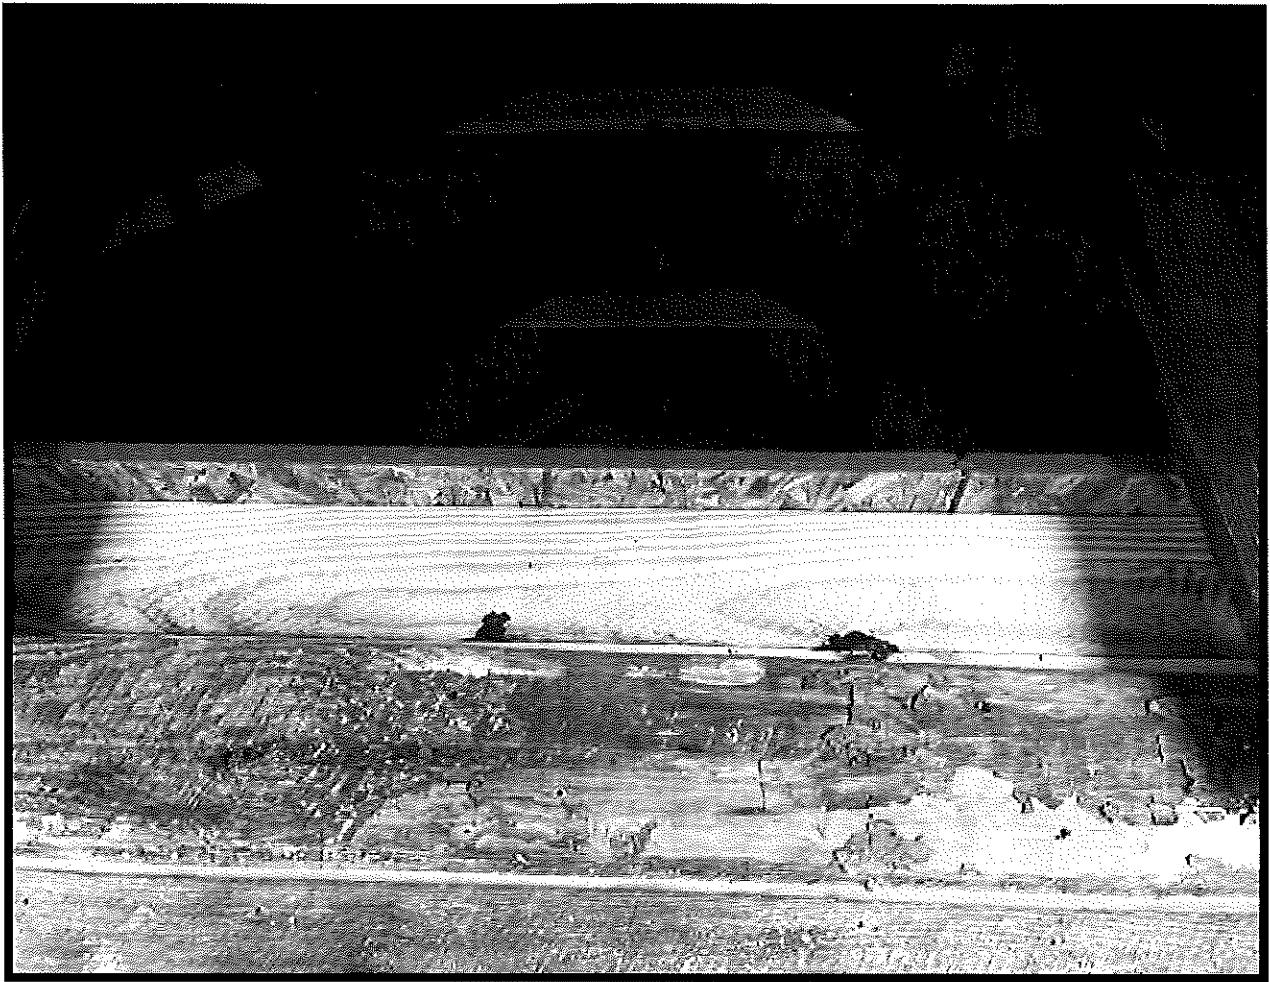
Photo #3: The upper ceiling joists have been reinforced with 2 x 10's and $\frac{3}{4}$ " plywood.

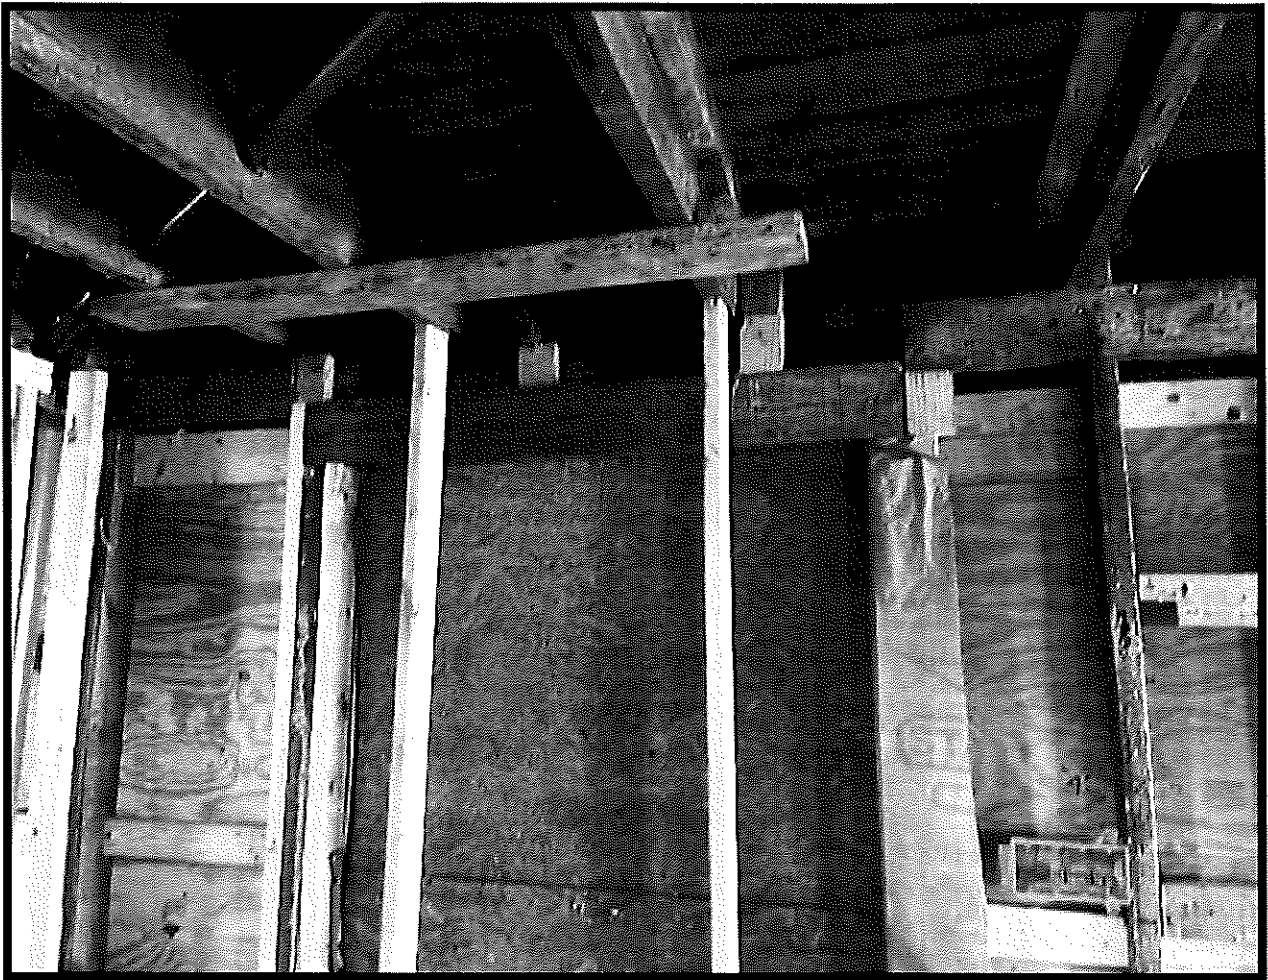
Photo #4: The front door/wall framing support is incomplete.

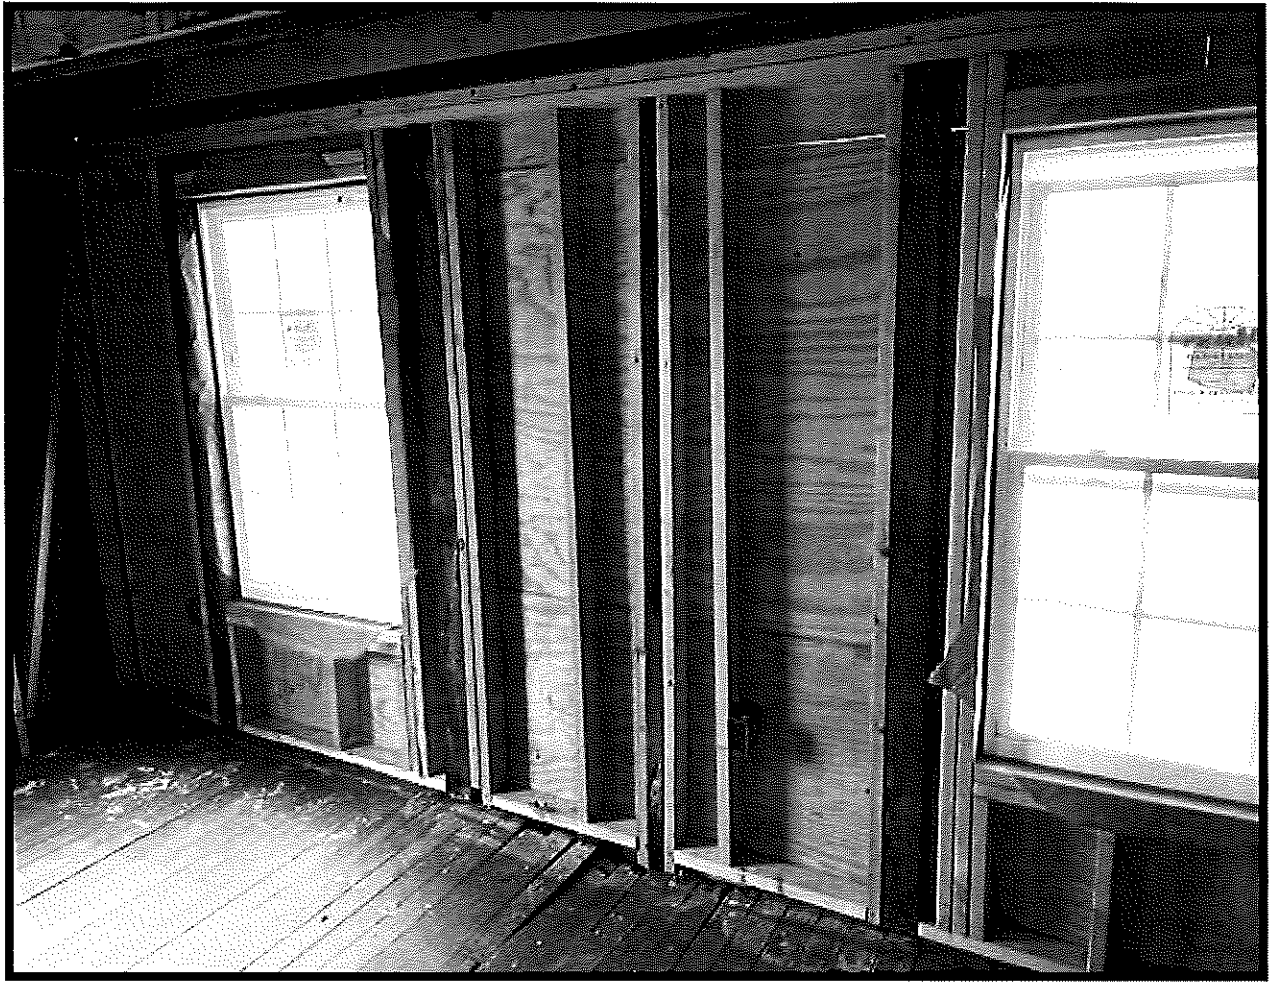
Photo #5: Significantly modified/reinforced stud walls/structural sheathing & new windows.

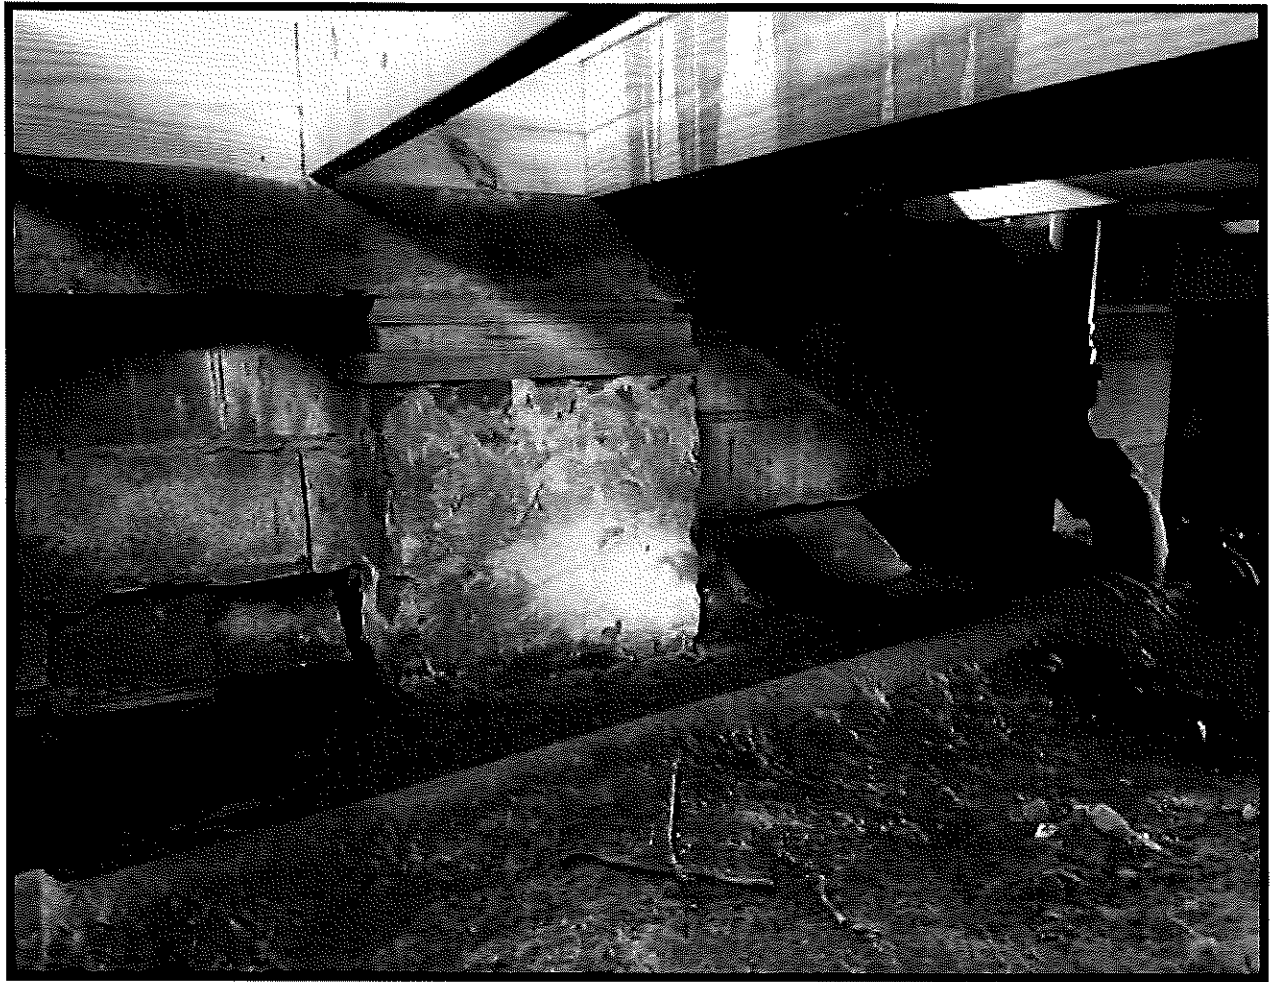
- The front porch masonry perimeter is damaged at its base, visible from the crawlspace. *See photo #6.* The driveway exhibits severe cracking/displacement from nearby roots.

Photo #6: The masonry front porch perimeter exhibits damage to its interior perimeter, as noted from the crawlspace.

- Allowance to remove & replace the previous poorly installed dry-stacked blocks, using new concrete mortared block pier supports, where necessary. [REDACTED]
- Front Porch Surface: Consider demolition/replacement of the front porch with a wooden deck structure. [REDACTED]s.
- Close/complete the foundation perimeter, using like-kind masonry. Allowance: [REDACTED]

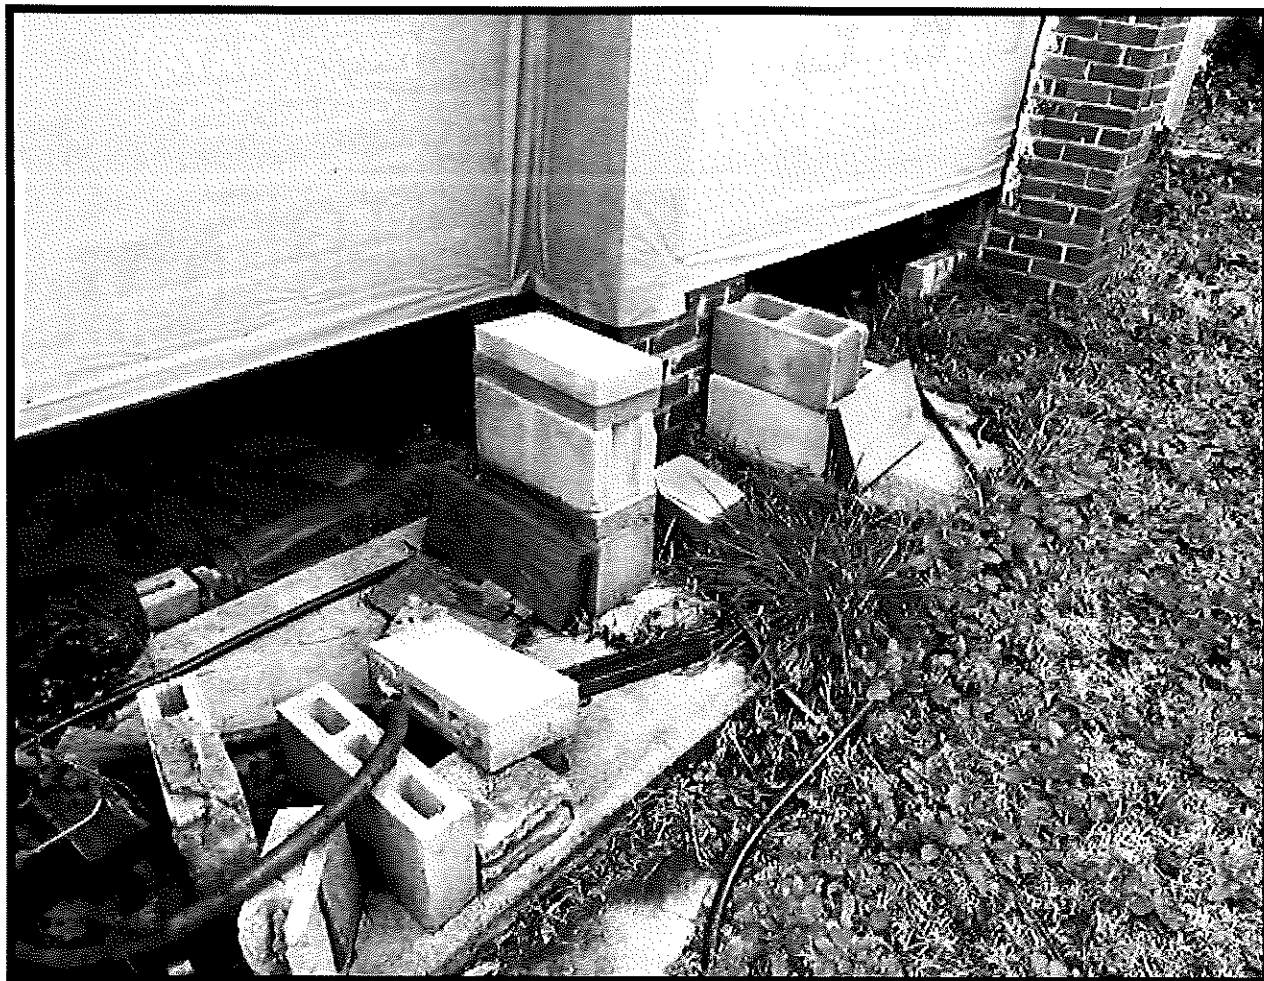
- A general loss of masonry perimeter 'infill' was also noted along the left side of the home, leaving the crawlspace perimeter open to the elements. *See photo #7.*
- The crawlspace soil grade is uneven. General debris is present, which requires removal.
- Several poorly installed dry-stacked blocks have been placed below various areas of the floor.
- No formal crawlspace entry door is present. There is no vapor barrier or floor insulation (thermal barrier) present.
- The majority of the floor system has been completely replaced. An allowance should be considered to address the various interior block piers/girder installations. *See photo #8.*
- During the process of repairing the foundation perimeter, considered shifting the foundation to a 'closed & moisture controlled' space, devoid of foundation vents.

Photo #7: A general loss of masonry infill has occurred along the left side of the home.

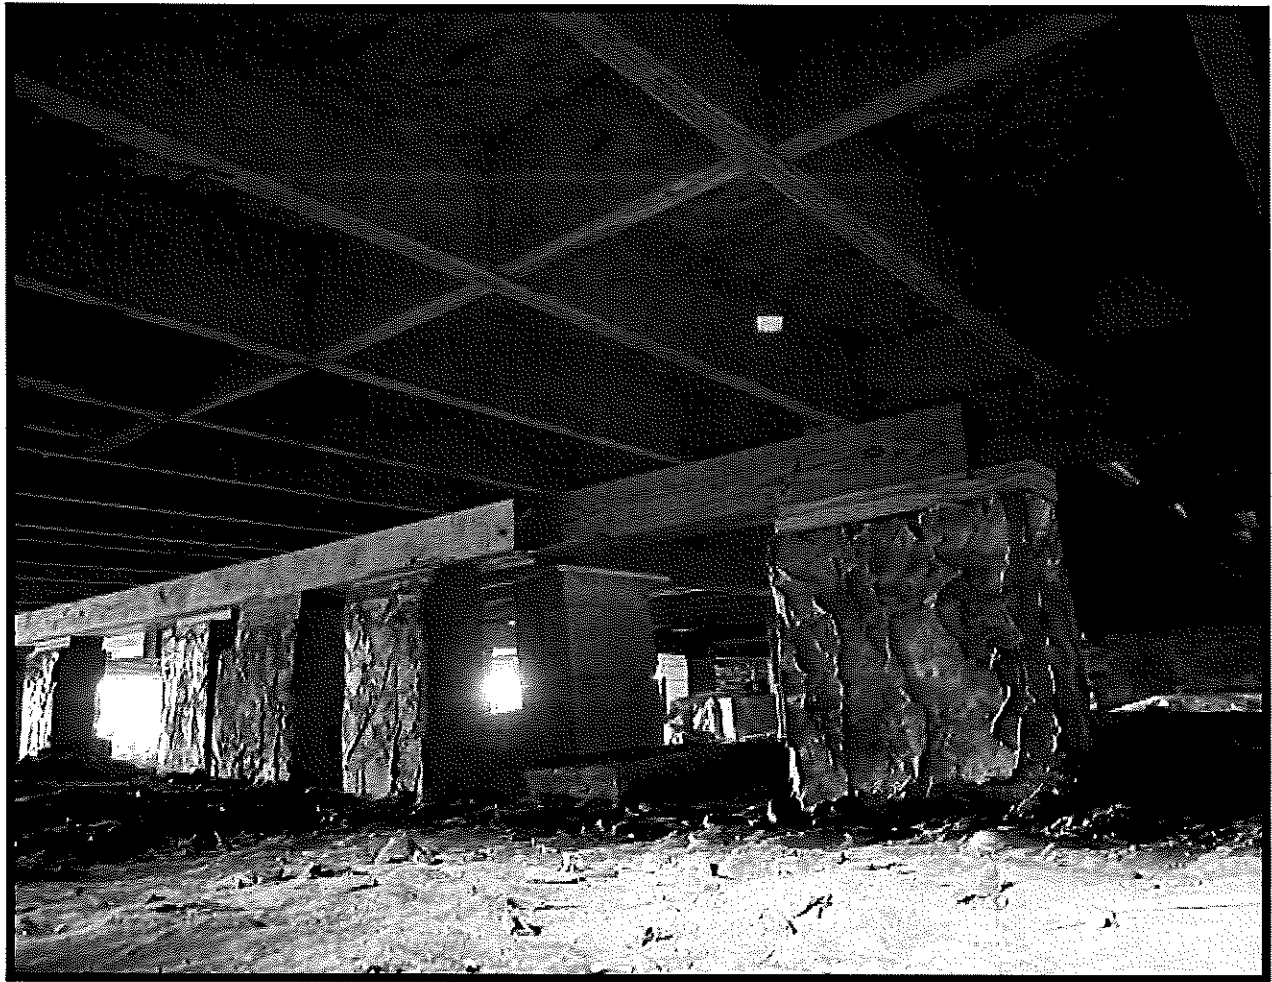
Photo #8: The floor system is comprised of new/treated components. New girders are present which are supported upon some residual dry-stacked block piers. No floor insulation is present.
